**APPENDIX A**

**TERRATHERM, INC. VENDOR REPORT: IN-SITU THERMAL DESTRUCTION (ISTD)  
AT ROCKY MOUNTAIN ARSENAL HEX PIT**

Ralph S. Baker, James P. Galligan, and John M. Bierschenk  
(TerraTherm, Inc., Fitchburg, Massachusetts 01450, USA)

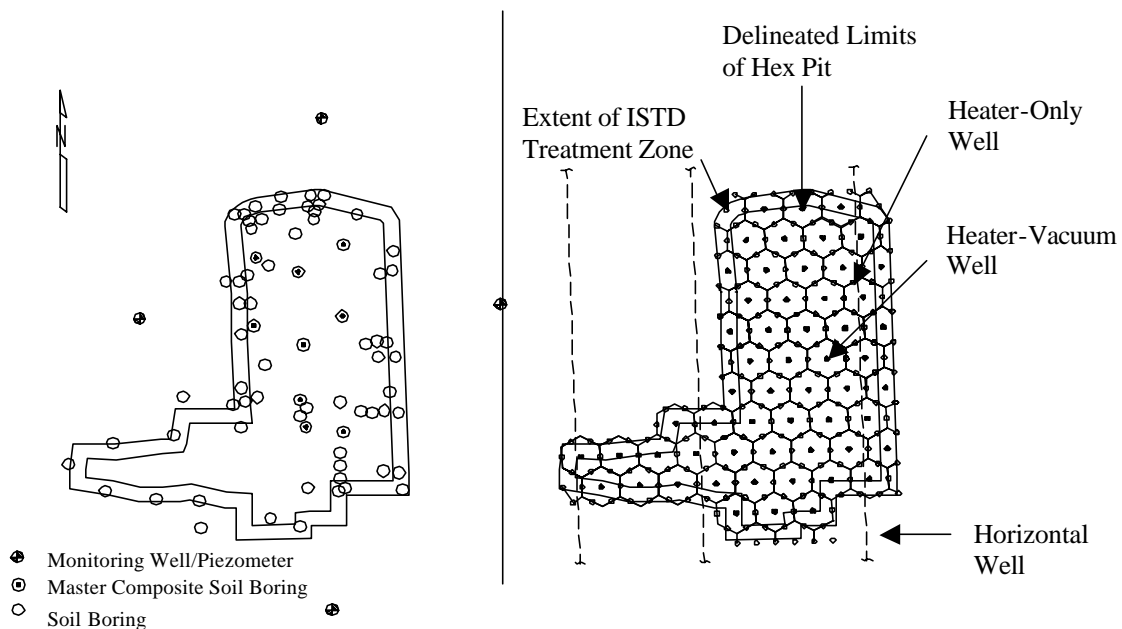
**Figure 2 – Hex Pit Delineation and ISTD Heater/Heater-Vacuum Well Layout. a) Locations of soil borings used to delineate limits of Hex Pit and to produce Master Composite for Treatability Study; b) Positions of thermal wells within and outside delineated limits of Hex Pit, and of horizontal wells installed beneath ISTD well field.**

Prior to the start of ISTD heating operation, in February 2002, a drilling subcontractor to FWENC installed three horizontal wells beneath the completed ISTD well field (refer to locations indicated in Figure 2b and Figure 5), during which "frac-out" events occurred that resulted in emergence of drilling fluids around the ISTD well field and beneath the ISTD surface seal at a number of known locations. The horizontal wells were an afterthought on the part of FWENC, intended to enable the water table to be depressed in the event that wet weather caused the groundwater table to rise to near the bottom of the Hex pit during ISTD. TerraTherm agreed with this in concept, but did not participate in the design or implementation of the drilling itself, nor was TerraTherm consulted on the drilling methods and their possible impacts on the ISTD project. The horizontal drilling method that FWENC selected involved injection of drilling fluids (e.g., water and drilling mud) into each borehole under high pressure for the purpose of advancing the borehole and clearing the cuttings from it. Resistance at the cutting head can cause the drilling fluids to over-pressurize. A frac-out occurs when the drilling fluids, rather than returning back out the entry point of the borehole, instead suddenly fracture the subsurface formation above it and emerge at the ground surface in a pool of fluid. TerraTherm observed such pools around the completed ISTD well field and at several locations underneath its surface seal during the installation of the horizontal wells. TerraTherm reported these events to FWENC on February 19, 2002 in a Notice of Changed Conditions. FWENC's response was to downplay the significance of the frac-outs.

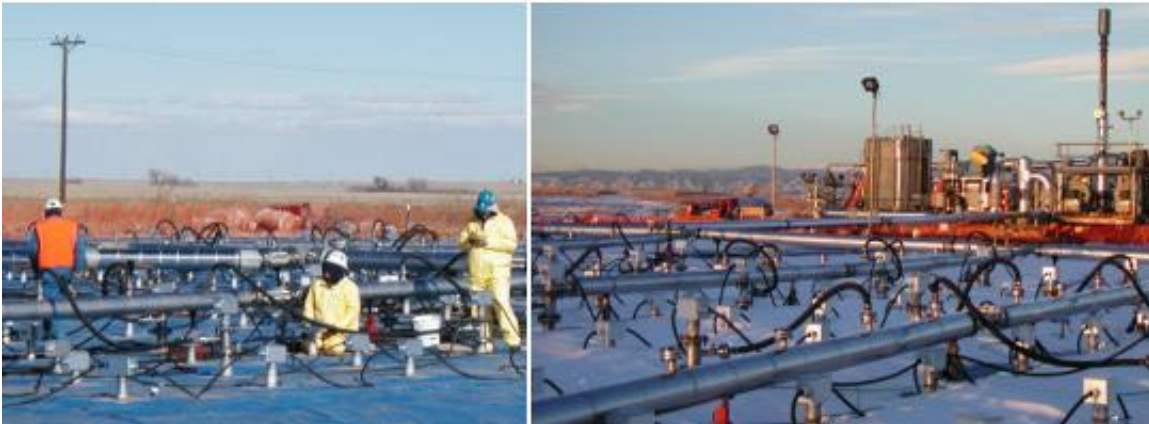
**Figure 5 – Photographs of Installation and Operation of Hex Pit ISTD Well Field.** Several inches of snow cover the surface seal. In the foreground of photo at left is a row of heater-only wells (shorter wells with electrical junction boxes on top). In the left foreground of photo at right is a heater-vacuum well (taller well with black vapor extraction line leading into jacketed and insulated horizontal manifold piping). The AQC system in the background of the photo at right includes thermal oxidizer in rear center (behind light stand); blowers and stack are at right.

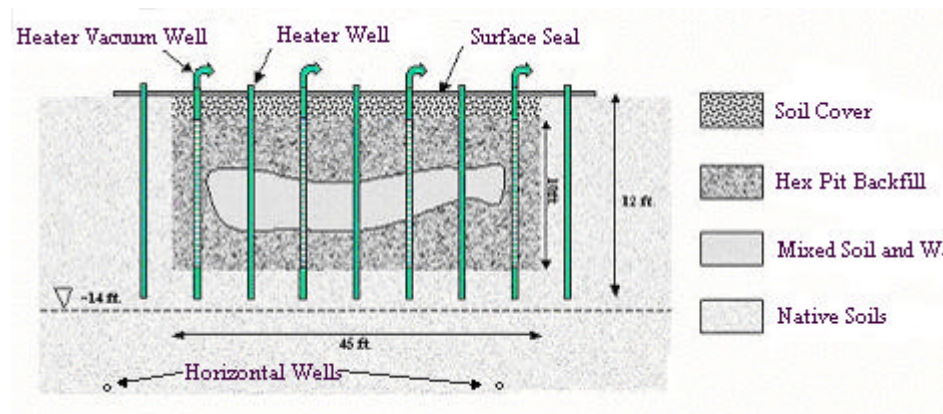
**Figure 6 – Typical Cross-Section through the Hex Pit ISTD Treatment Zone,** looking from south towards north. During installation of the horizontal wells by others, a number of “frac-outs” occurred, several above the eastern-most horizontal well. Subsequently, during the Failure Assessment, seven out of the nine most seriously corroded heater-vacuum wells were found to be in column “P”, located almost directly above the eastern-most of the horizontal wells. It is believed that the “frac-outs” forced movement of hex fluids into the heater-vacuum well annuli prior to heating, compromising their operation.

The locations of the known frac-outs appear to correlate with locations of the earliest as well as the most severe cases of corrosion during ISTD operation. The first known frac-out occurred during the drilling of the westernmost horizontal well, and emerged close to the location where the first two manifold taps subsequently failed. In addition, a number of frac-outs occurred while the easternmost horizontal well was being drilled. In the Assessment Report, TerraTherm reported that seven out of the nine most severely corroded heater-vacuum wells, plus the third failed manifold tap and the sole instance of a corroded heater-only well, all occurred directly above the path of that easternmost horizontal well. Considering the relatively large number of heater-vacuum wells (56) and heater-only wells (210), this linear co-location of frac-out events and wells showing severe corrosion is, in TerraTherm's opinion, more than can be explained by chance.

TerraTherm believes that the over-pressurization that produced the frac-out incidents must have caused a displacement of the pit liquids, and in doing so the injection pressure may have forced tarry liquids into a large number of the thermal wells (the open annuli of which would have served as paths of least resistance providing pressure relief). Injection of tarry liquids into some of the well screens would have pre-loaded them with hex and other chlorinated pesticides. Upon being heated, they quickly hydrolyzed within the well annuli into boiling HCl. We believe that this, in large part, led to the premature destruction of the piping system. Absent the frac-out events, hydrolysis of the pit contents would have occurred outside the heater-vacuum wells, and the HCl that would have arrived there would have been in the vapor phase, which is what the materials of construction were designed to withstand. 304SS is far more resistant to HCl in the vapor phase than as a liquid. There would also have been more in-situ neutralization of acid gas by buffering within the soil than could occur with acidic liquids forming directly in the wells. The frac-outs and their effects constitute a changed condition relative to what was known about the Hex Pit prior to design and installation.

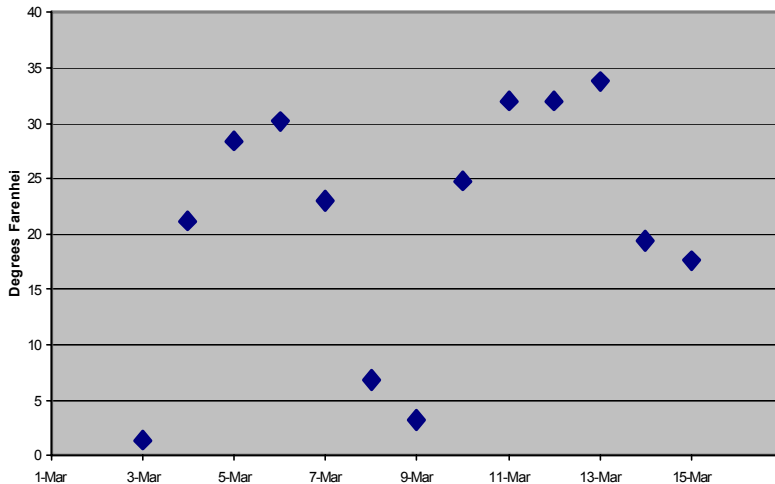
Ambient temperatures during the last week of shakedown/pre-heating and during ISTD operation were abnormally cold. Minimum ambient temperatures for the period March 3 through March 15, 2002 are presented in Figure 7. These cold ambient temperatures, along with average winds of 10-15 mph, had the effect of reducing the near-surface soil temperatures prior to the start of heating. However, more significantly, these cold temperatures may have resulted in greater than anticipated heat losses in the vapor tees, the short (approx. 2”) exposed stubs of the manifold taps, and flexible hoses connecting these points, based on the field observations described in subsequent sections. This, we believe, contributed to the condensation of steam, pesticide vapors and HCl vapors and resulting accumulation of acidic, corrosive liquids at such locations.

**Figure 7 – Minimum daily temperatures during the period of ISTD operation as reported by the National Weather Bureau, Denver, CO. Startup began on March 3, and ISTD operation continued until March 15, 2002.**
