Coal Combustion Residue Impoundment

Round 9 - Dam Assessment Report

Oklahoma Power Station

Wastewater Evaporation Pond 6 – WMU 001

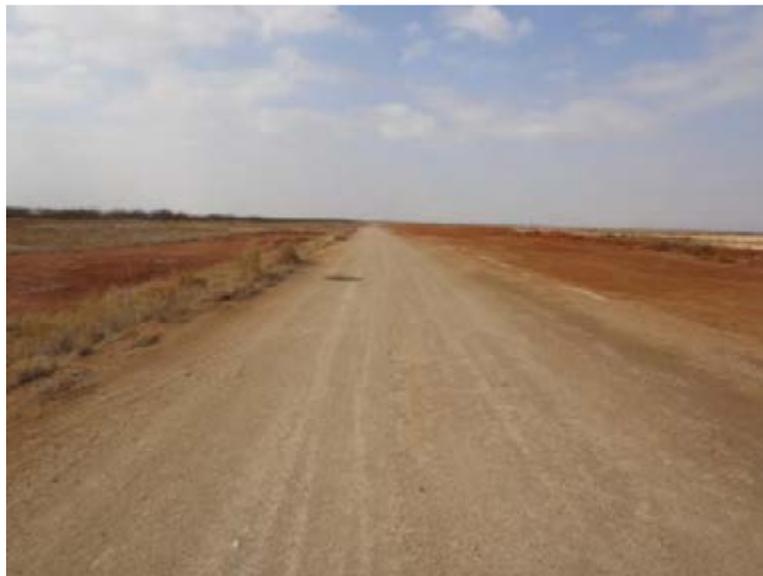
The crest of the South Embankment showed no signs of depressions, tension cracks, or other indications of settlement or shear failure, and appeared to be in satisfactory condition. Figure 5.2.1-1 shows the conditions of the crest of the South Embankment.

Figure 5.2.1-1. Figure showing the South Embankment crest and outside slope conditions.

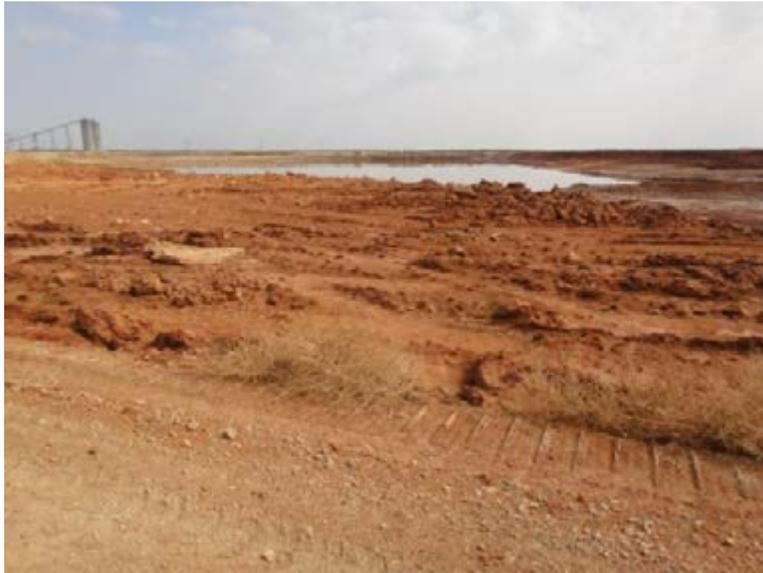
The South Embankment's inside slope has been filled up to the crest elevation with native soil, effectively eliminating this slope on the east end of the embankment. Figure 5.2.2-1 shows these areas.

Figure 5.2.2-1. Figure showing the South Embankment lack of inside slope.

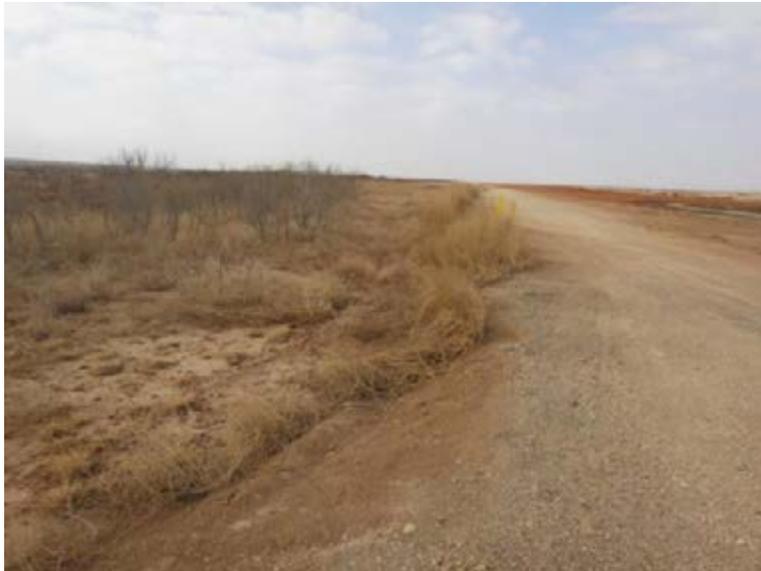
There were no observed scarps, sloughs, bulging, cracks, or depressions indicating slope instability or signs of erosion. The outside slope of the South Embankment was covered with sparse overgrown vegetation. The outside slope appears to be in good condition. Figure 5.2.3-1 shows the general condition of the outside slope of the South Embankment.

Figure 5.2.3-1 general good condition of the outside slope of the South Embankment.

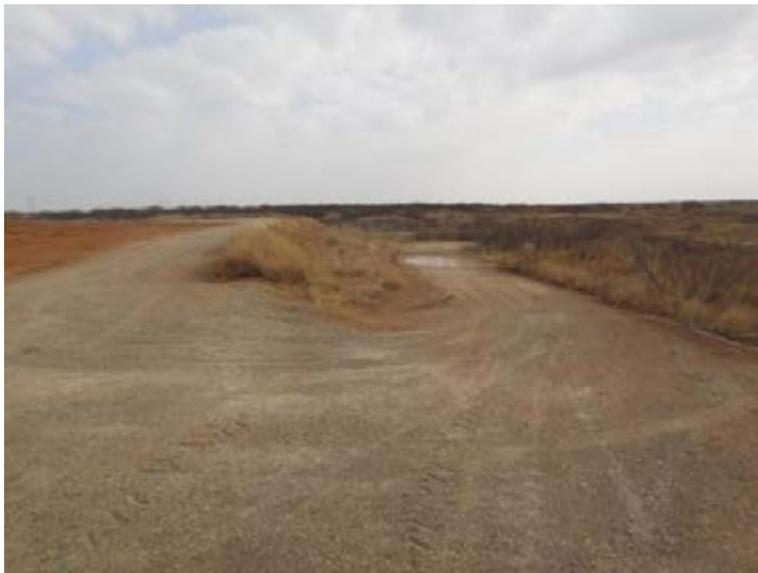
The outside slope of the abutments and groin were uniformly graded and covered with sparse grass. Erosion or uncontrolled seepage was not observed along either groin. Figure 5.2.4-1 shows the general condition of the Abutments and Groin.

Figure 5.2.4-1. Southern Groin.

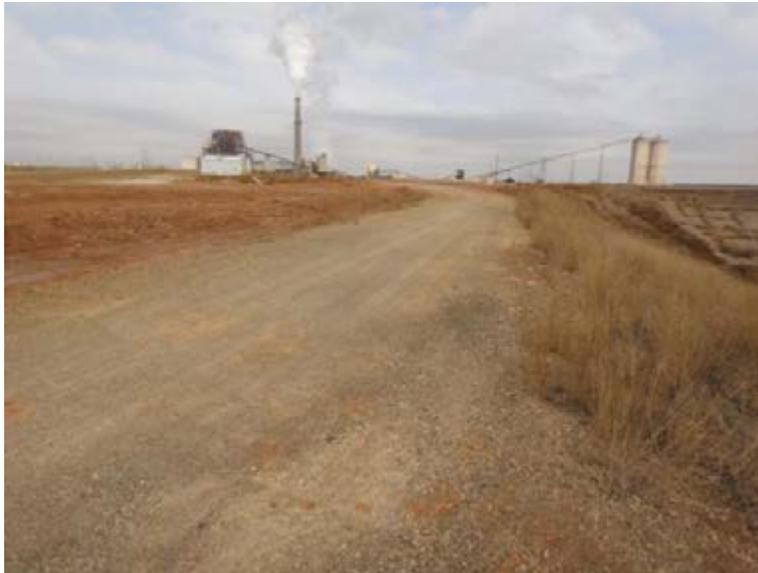
The crest of the East Embankment showed no signs of depressions, tension cracks, or other indications of settlement or shear failure, and appeared to be in satisfactory condition. Figure 5.3.1-1 shows the conditions of the crest of the East Embankment.

Figure 5.3.1-1. Figure showing the East Embankment crest and outside slope conditions.

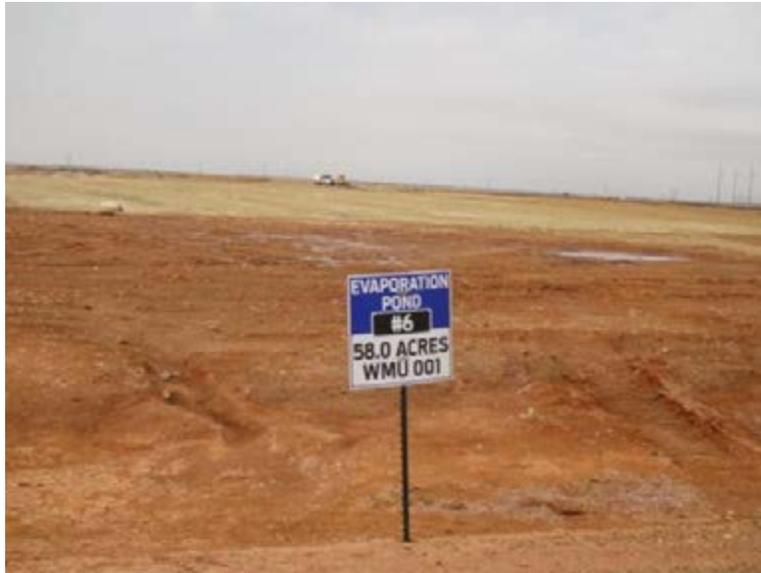
The East Embankment's inside slope is non-existent with the waste in the pond being allowed to remain in place up to near the crest elevation of the embankment. The Pond appears to be allowed to fill up with solid ash waste working its way east to west. This condition can be viewed in Figure 5.3.2-1.

Figure 5.3.2-1. East Embankment, lack of inside slope.

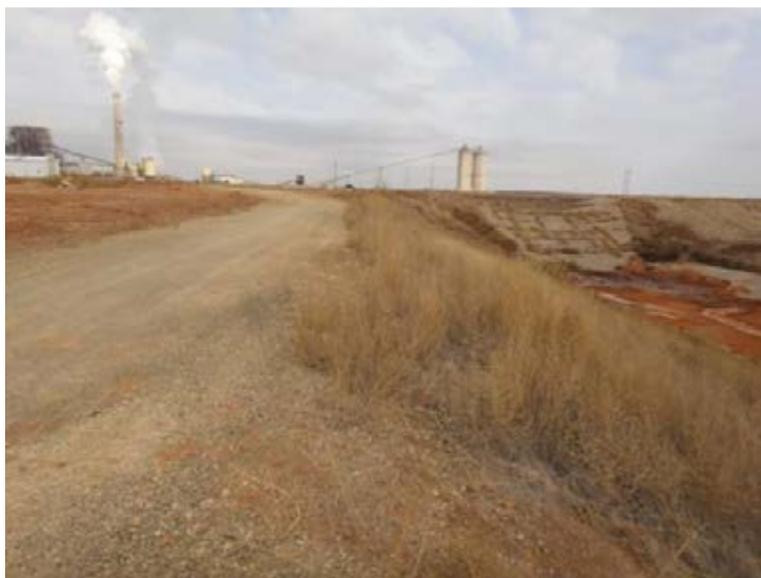
There were no observed scarps, sloughs, bulging, cracks, or depressions indicating slope instability or signs of erosion. The outside slope of the East Embankment is the upstream slope of the Emergency Spillway. It is uniformly graded and covered with sparsely overgrown grass. Figure 5.3.3-1 shows the general condition of the East Embankment's crest, outside slope and groin.

Figure 5.3.3-1. Crest, outside slope and groin of East Embankment.

There were no observed scarps, sloughs, bulging, cracks, or depressions indicating slope instability or signs of erosion on the groins of the East Embankment. The top right-side of Figure 5.3.3-1 shows the general condition of the East Embankment's groin.
