Coal Combustion Residue Impoundment

Round 9 - Dam Assessment Report

Oklahoma Power Station

Wastewater Evaporation Pond 6 – WMU 001

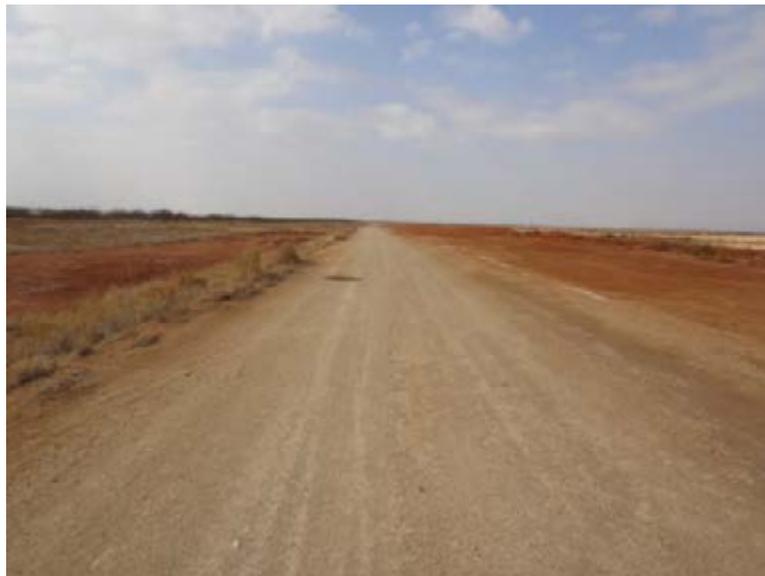
The crest of the South Embankment showed no signs of depressions, tension cracks, or other indications of settlement or shear failure, and appeared to be in satisfactory condition. Figure 5.2.1-1 shows the conditions of the crest of the South Embankment.

Figure 5.2.1-1. Figure showing the South Embankment crest and outside slope conditions.

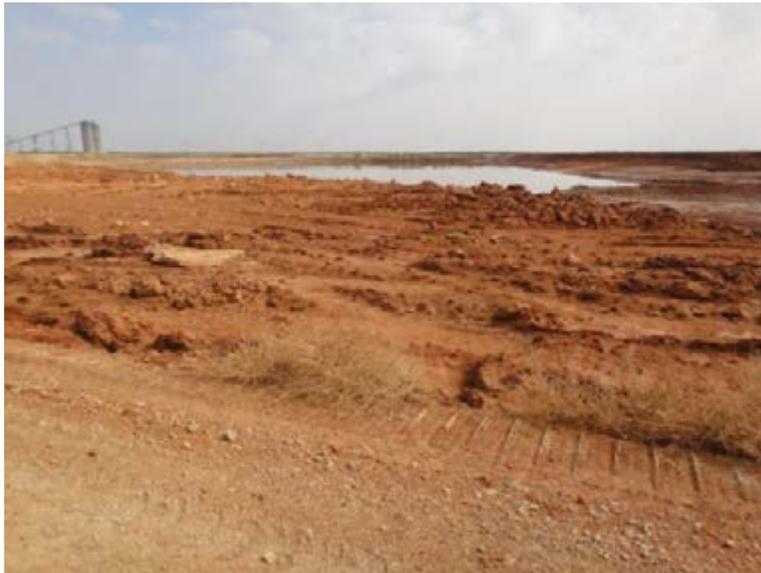
The South Embankment's inside slope has been filled up to the crest elevation with native soil, effectively eliminating this slope on the east end of the embankment. Figure 5.2.2-1 shows these areas.

Figure 5.2.2-1. Figure showing the South Embankment lack of inside slope.

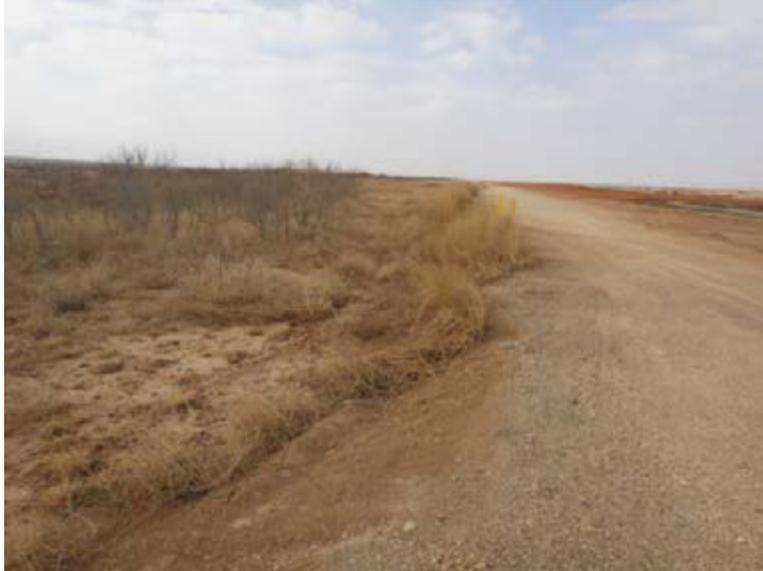
There were no observed scarps, sloughs, bulging, cracks, or depressions indicating slope instability or signs of erosion. The outside slope of the South Embankment was covered with sparse overgrown vegetation. The outside slope appears to be in good condition. Figure 5.2.3-1 shows the general condition of the outside slope of the South Embankment.

Figure 5.2.3-1 general good condition of the outside slope of the South Embankment.

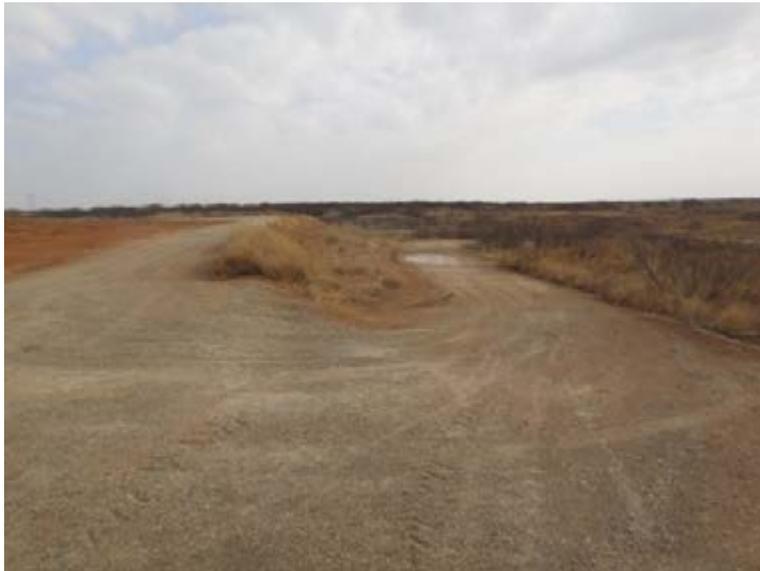
The outside slope of the abutments and groin were uniformly graded and covered with sparse grass. Erosion or uncontrolled seepage was not observed along either groin. Figure 5.2.4-1 shows the general condition of the Abutments and Groin.

Figure 5.2.4-1. Southern Groin.

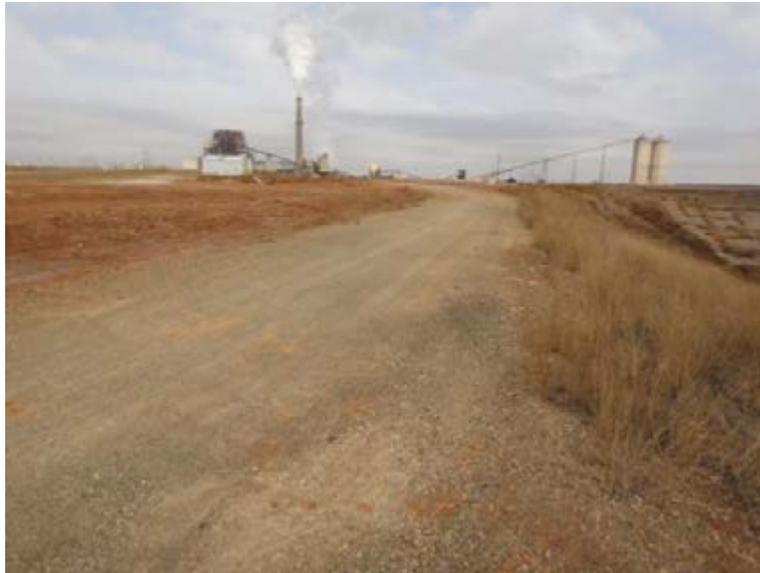
The crest of the East Embankment showed no signs of depressions, tension cracks, or other indications of settlement or shear failure, and appeared to be in satisfactory condition. Figure 5.3.1-1 shows the conditions of the crest of the East Embankment.

Figure 5.3.1-1. Figure showing the East Embankment crest and outside slope conditions.

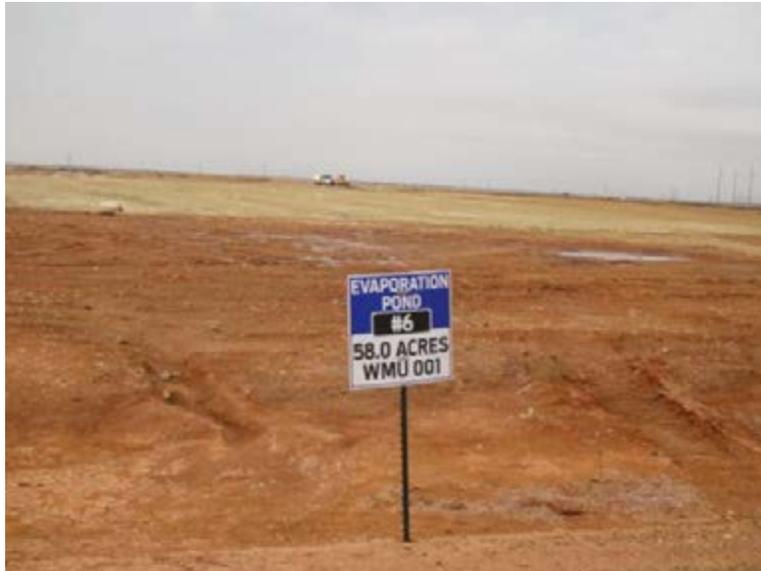
The East Embankment's inside slope is non-existent with the waste in the pond being allowed to remain in place up to near the crest elevation of the embankment. The Pond appears to be allowed to fill up with solid ash waste working its way east to west. This condition can be viewed in Figure 5.3.2-1.

Figure 5.3.2-1. East Embankment, lack of inside slope.

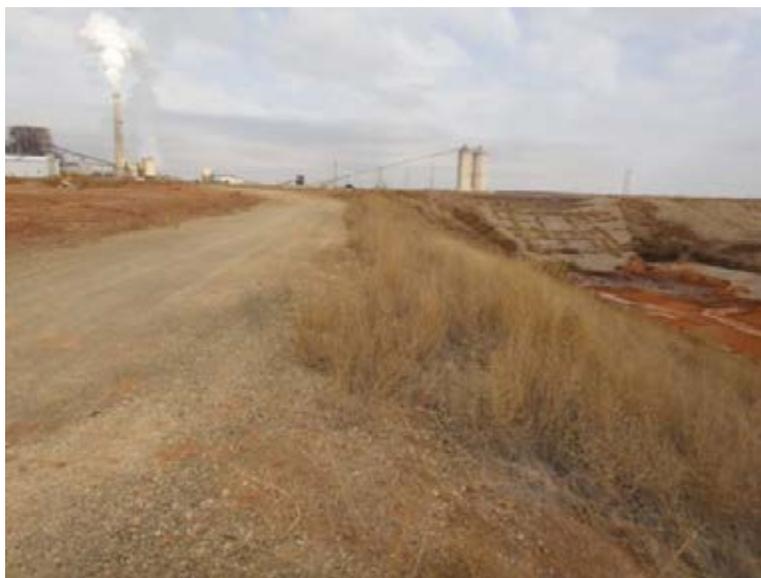
There were no observed scarps, sloughs, bulging, cracks, or depressions indicating slope instability or signs of erosion. The outside slope of the East Embankment is the upstream slope of the Emergency Spillway. It is uniformly graded and covered with sparsely overgrown grass. Figure 5.3.3-1 shows the general condition of the East Embankment's crest, outside slope and groin.

Figure 5.3.3-1. Crest, outside slope and groin of East Embankment.

There were no observed scarps, sloughs, bulging, cracks, or depressions indicating slope instability or signs of erosion on the groins of the East Embankment. The top right-side of Figure 5.3.3-1 shows the general condition of the East Embankment's groin.

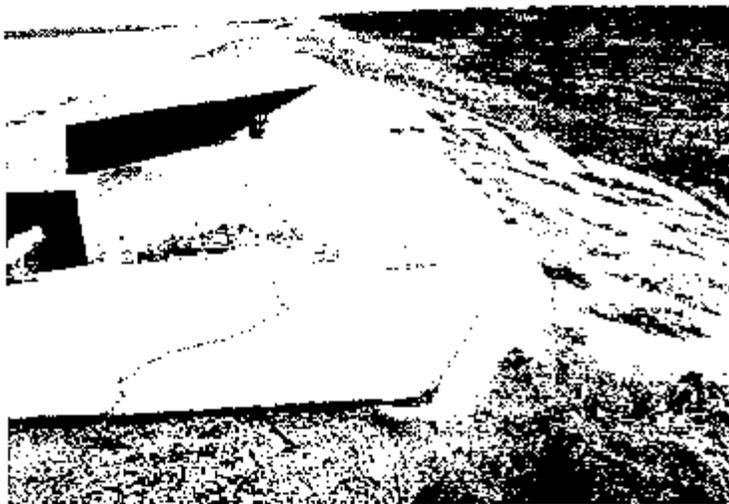
Photo 2

Pond #7 photo taken in March 2010 showing spillway control section in generally poor condition with extensively cracked concrete elements. The concrete wall blocking potential flow through the spillway is at the left in the photo.

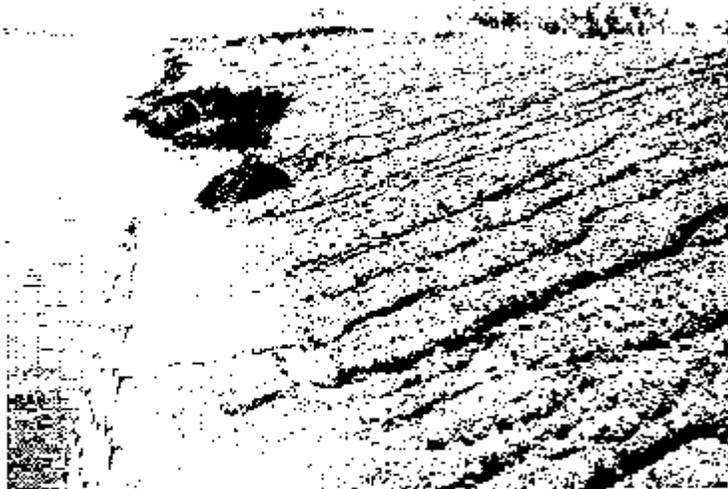
Photo 13

Pond #7 upstream slope area above the east end of the shore protection revetment around the spillway, looking east, with many erosion rills forming on the barren ground and embankment erosion beyond the end of the revetment (opposite view from Photo 12).
