Report of Dam Safety Assessment of Coal
Combustion Surface Impoundments
American Electric Power (AEP) and Southwest
Electric Power Company (SWEPCO)
H.W. Pirkey Power Plant, Hallsville, TX

AMEC Project No. 3-2106-0183.0003

November 2010

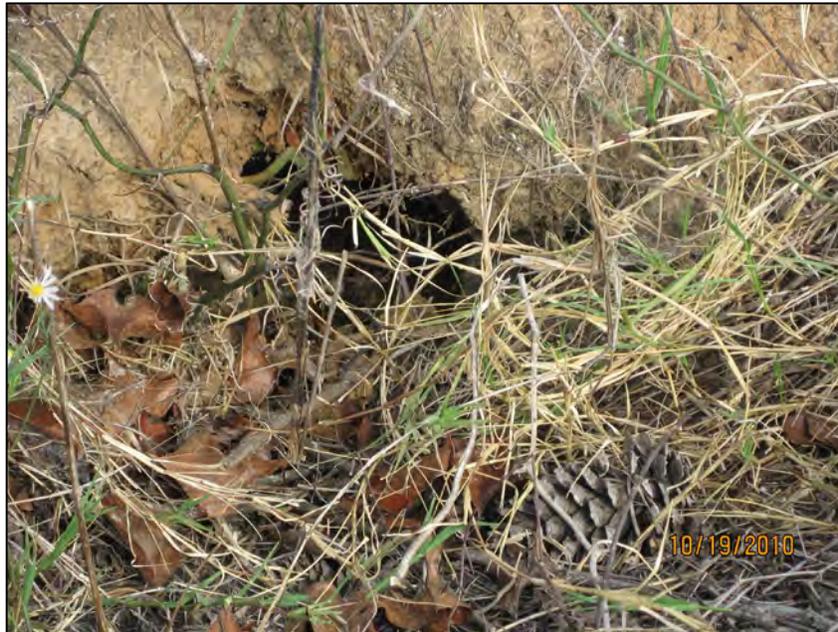
WAP-9

ANIMAL BURROW ON SOUTH DOWNSTREAM EMBANKMENT

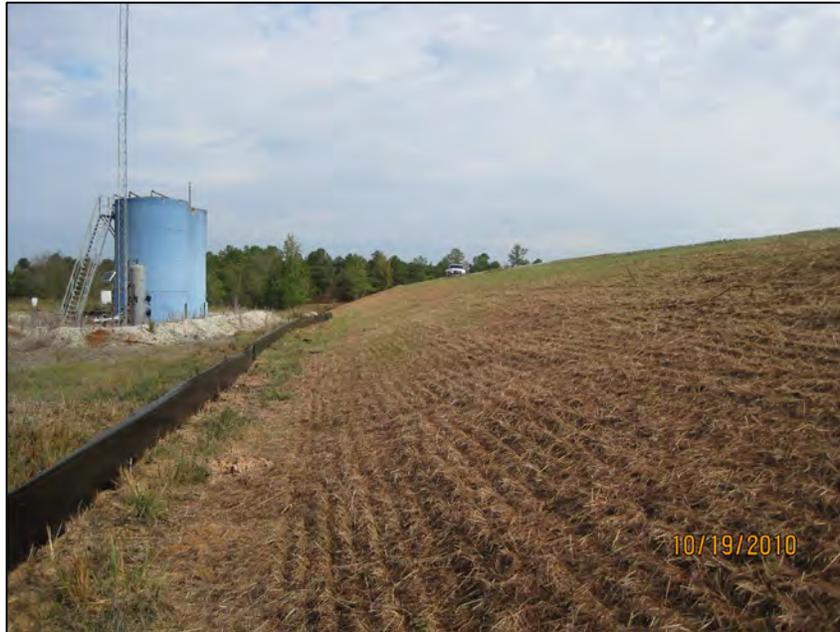
WAP-11
LOOKING NORTH ALONG WESTERN DOWNSTREAM
EMBANKMENT AT RECENT SURFACE WORK

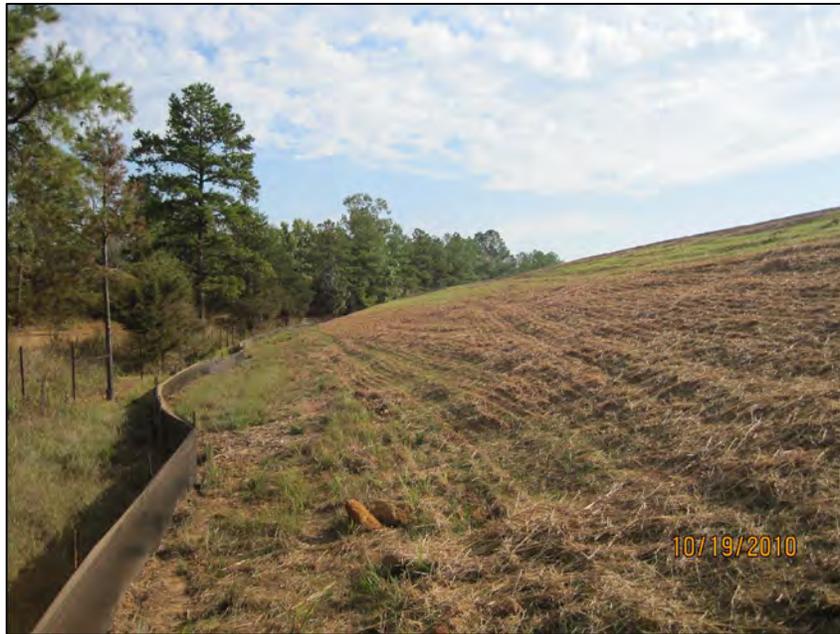
WAP-12
LOOKING NORTHEAST ALONG NORTHERN DOWNSTREAM
EMBANKMENT AT RECENT SURFACE WORK

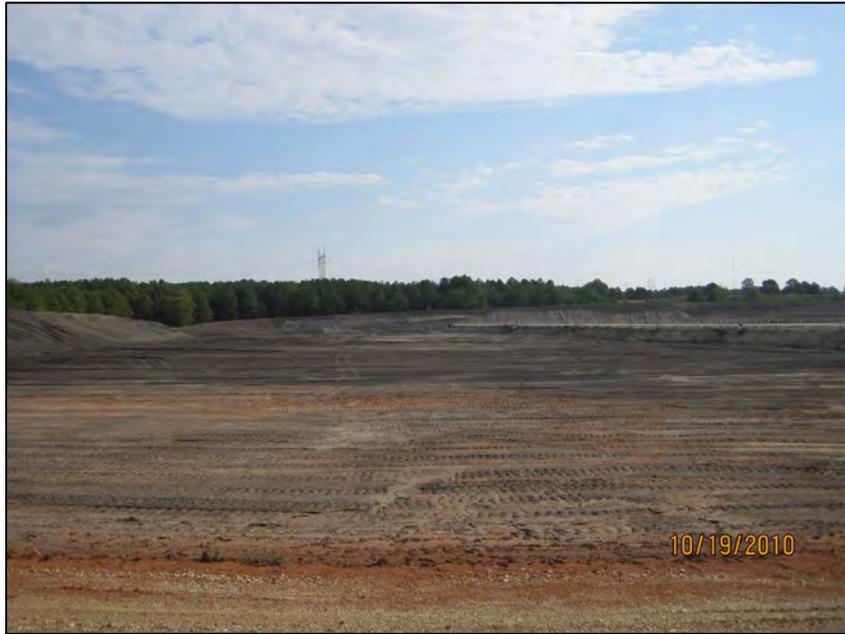
This pond is completely incised and was not in service during the site visit. Photos EAP-1, EAP-5, and EAP-6 show the interior of the East Ash Pond, as well as areas of stacked ash. A drainage swale, to redirect runoff flows away from the pond, exists outside the pond's southeast, east and north perimeter crest road. The crest road is gravel covered as shown on Photos EAP-2, EAP-10, and EAP-11. A piezometer was noted on the northwest crest road (Photo EAP-3). Photo EAP-8 illustrates a gas pipeline indicator located off the northeast crest road.

EAP-1
LOOKING EAST ACROSS POND FROM WESTERN CREST

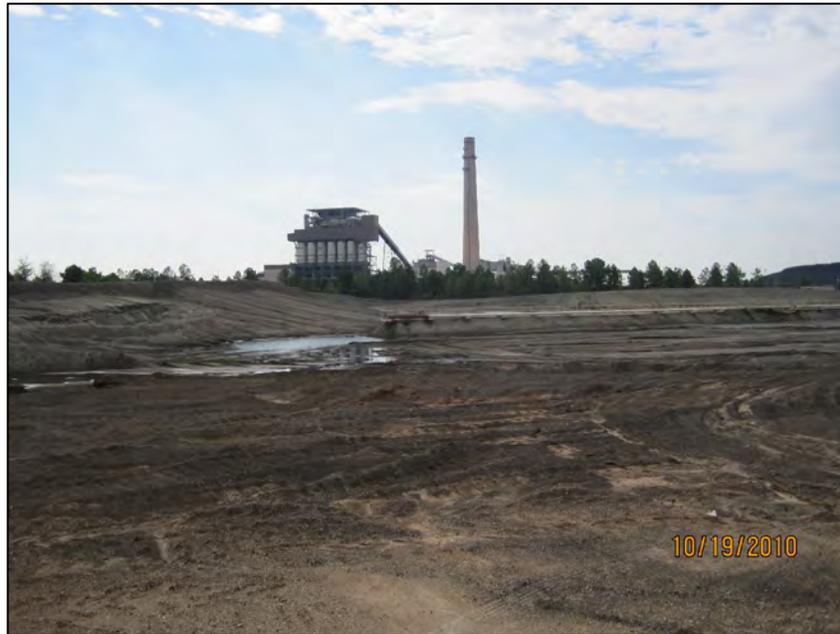
EAP-5
LOOKING SOUTH FROM NORTHERN EMBANKMENT

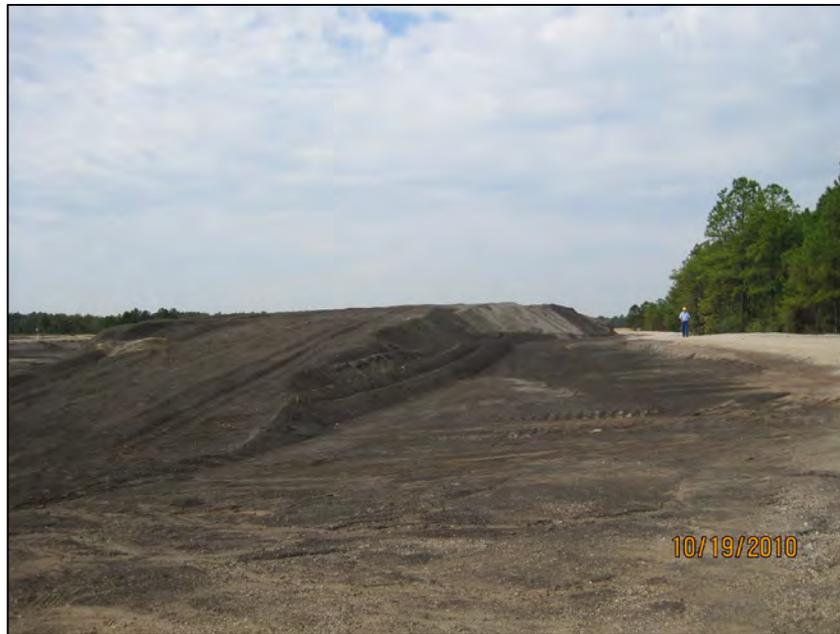
EAP-6
LOOKING SOUTHWEST FROM NORTHERN EMBANKMENT AT STACKED ASH

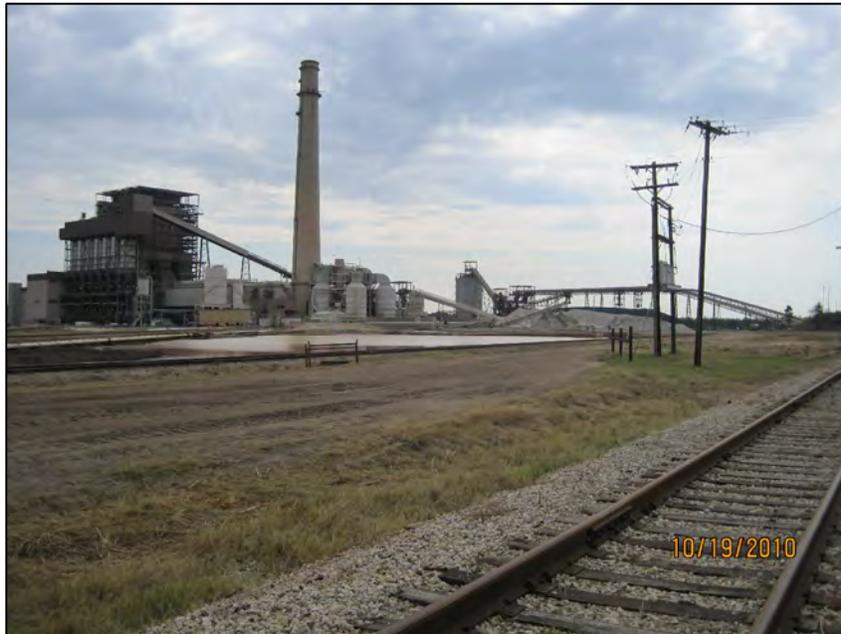
This pond is primarily incised. However, a road and railroad are located along its western boundary. The ground immediately to the west of the railroad slopes away steeply (Photos SP-1 and SP-2). Additionally, there is a below grade limestone unloading area beneath a portion of the railroad (Photo SP-3). A stormwater culvert was visible through the embankment south of the limestone unloading area (Photo SP-4). A monitoring well was noted at the southwest corner of the pond (Photo SP-5).

SP-1
RAILROAD TRACKS WEST OF SURGE POND-FROM
NORTHERN CORNER LOOKING SOUTHEAST

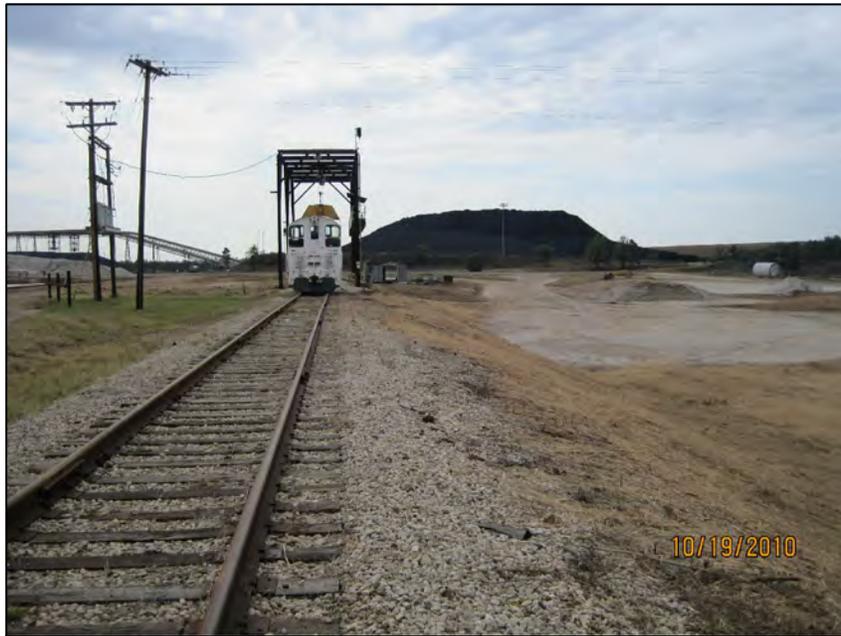
SP-2
NORTHWEST OF POND LOOKING
SOUTH AT LIMESTONE UNLOADING AREA

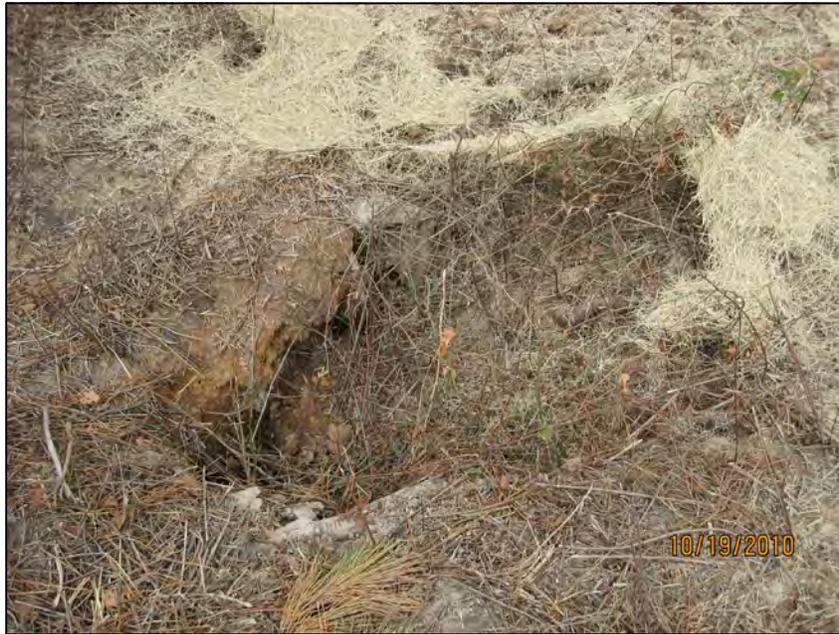
SP-4
STORM WATER CULVERT (18-INCH) THROUGH
EMBANKMENT SOUTH OF LIMESTONE UNLOADER

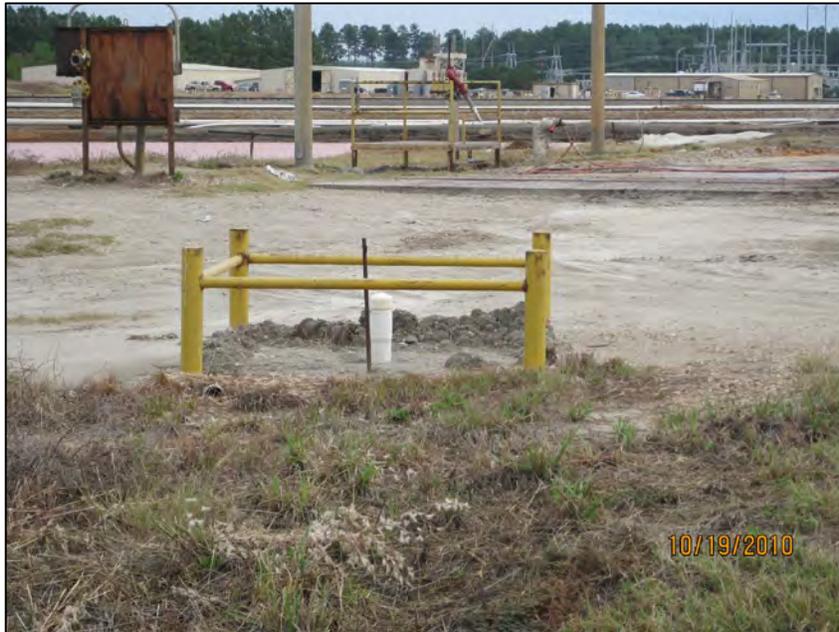
**SP-5
MONITORING WELL LOCATED ADJACENT
TO SOUTHWEST CORNER OF POND**

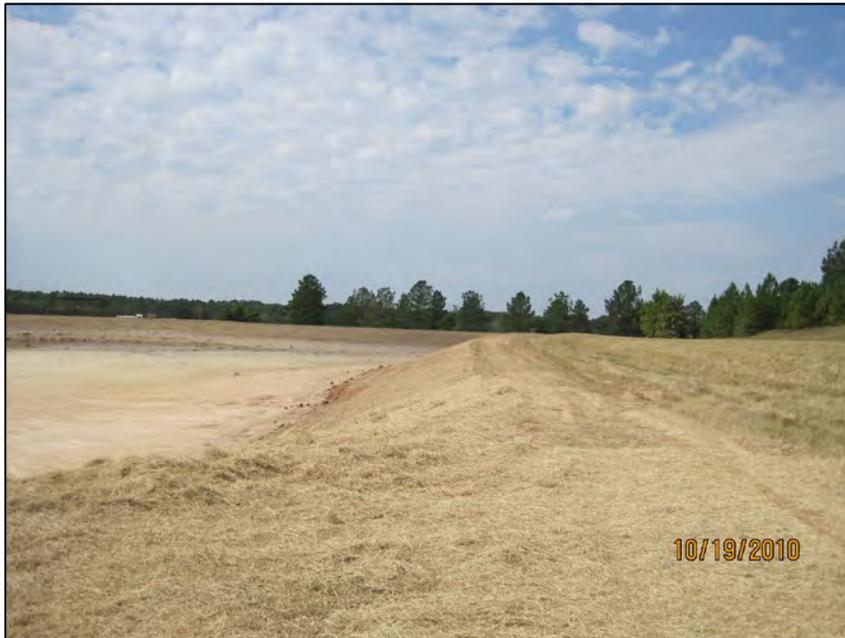
The northern portion of the Auxiliary Surge Pond is incised, while the remainder is diked (Photo ASP-1 and ASP-2). A piezometer was noted on the southwest corner of the pond embankment (Photo ASP-3).

ASP-1
LOOKING WEST FROM NORTHEAST
CORNER EMBANKMENT

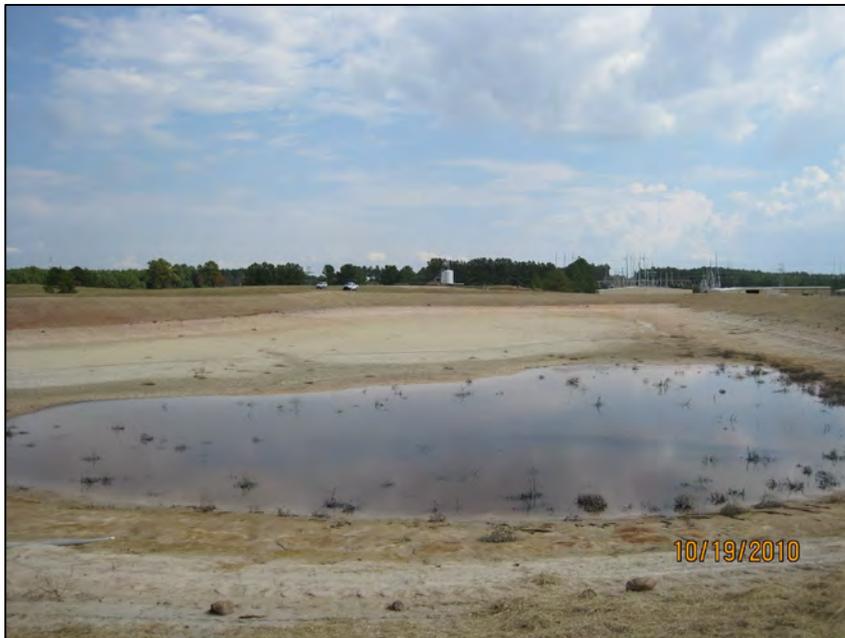
ASP-2
LOOKING EAST ACROSS POND
FROM WESTERN EMBANKMENT

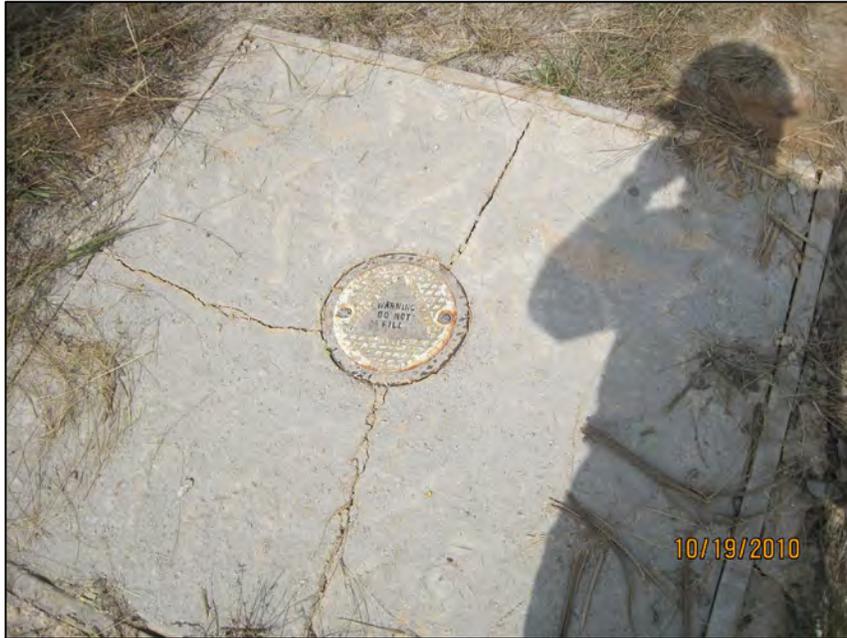
**ASP-3
PIEZOMETER ON SOUTHWEST
CORNER OF POND EMBANKMENT**

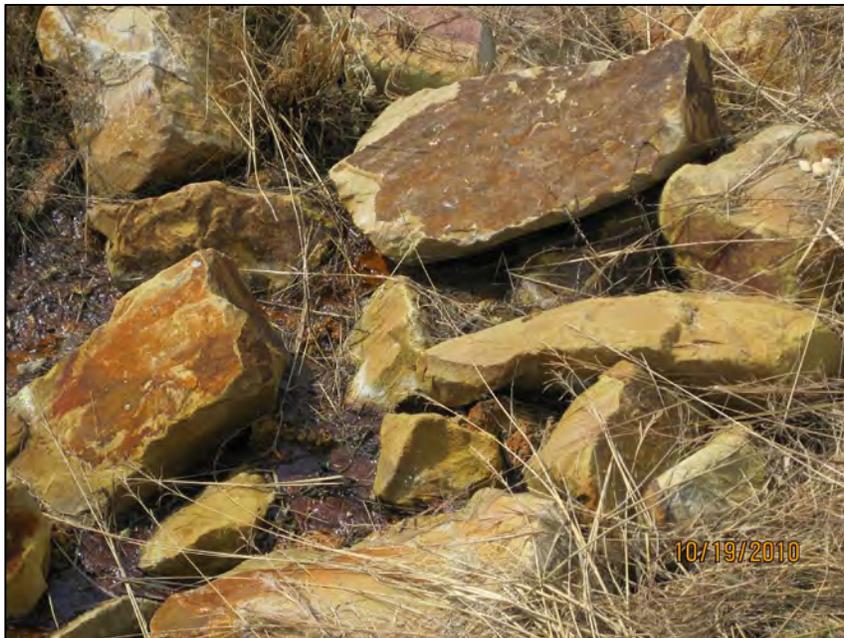
**LRP-4
POSSIBLE SEEPAGE ON DOWNSTREAM SIDE OF
EMBANKMENT ADJACENT TO NPDES OUTFALL 004**

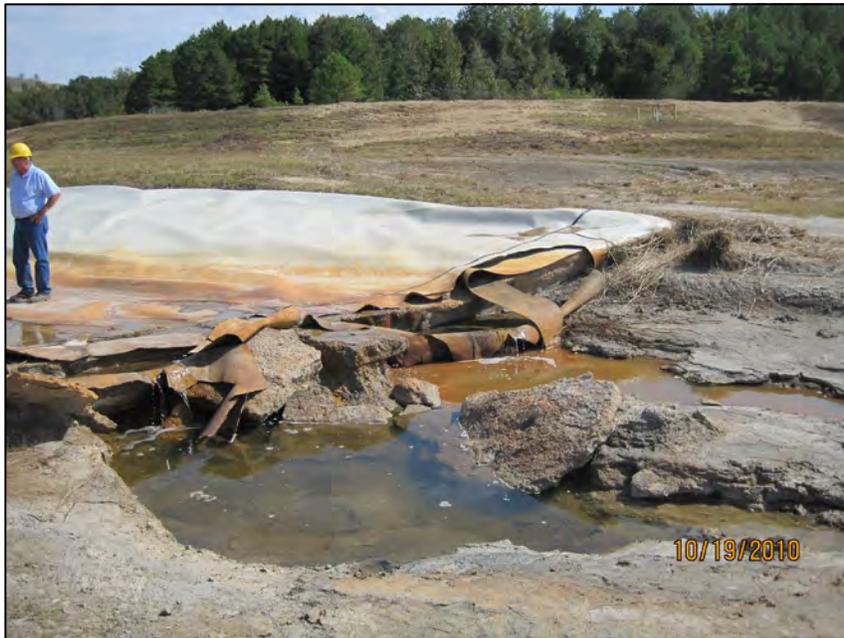
Flow enters the pond via a trapezoidal channel that is lined with 60 mil HDPE as shown on Photo LRP-6. A monitoring well was noted located to the southeast of the influent channel above the northern reach of the pond (Photo LRP-7).

**LRP-6
LOOKING EAST AT DOWNSTREAM DISCHARGE OF 60
ML HDPE LINED LANDFILL RUNOFF/LEACHATE CHANNEL**

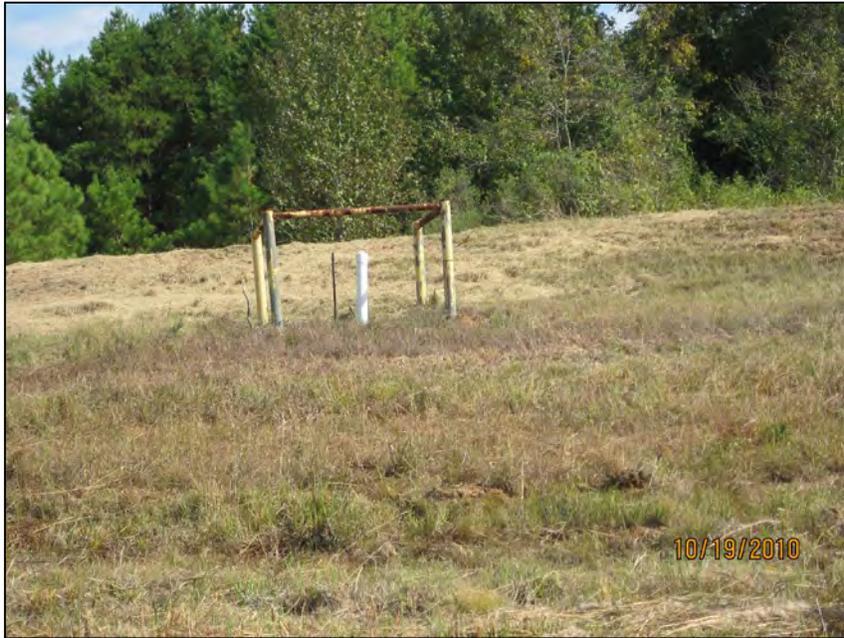
LRP-7
MONITORING WELL ADJACENT TO
NORTHEASTERN CORNER OF POND

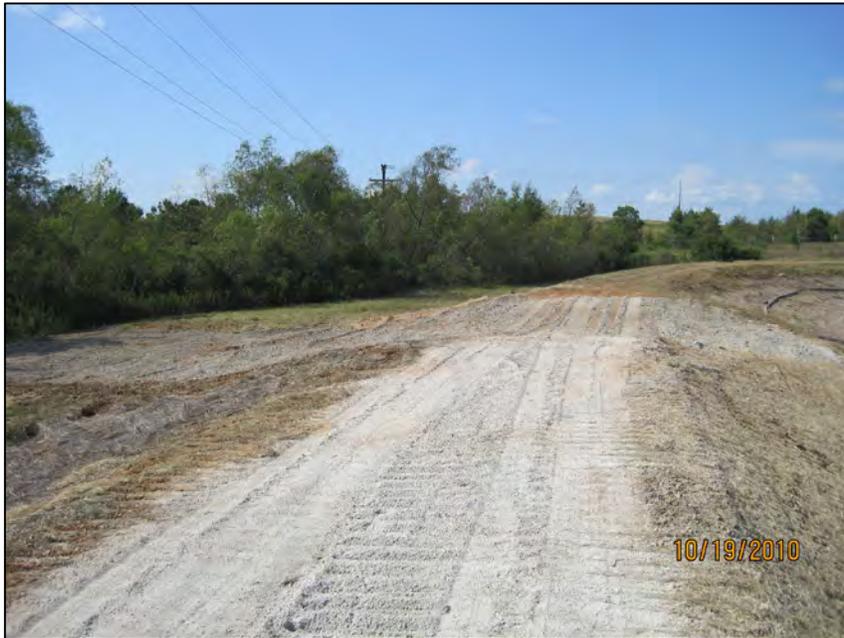
An emergency, earthen spillway was noted to exist to the west of the main discharge pipe, as shown on Photo LRP-8.

LRP-8
LOOKING WEST FROM CREST AT
UNLINED EARTHEN EMERGENCY SPILLWAY
