**DRAFT REPORT
ROUND 7 DAM ASSESSMENT - WISCONSIN POWER & LIGHT
COLUMBIA GENERATING STATION
PRIMARY ASH, SECONDARY ASH, POLISHING & LANDFILL
STORMWATER PONDS
PARDEEVILLE, WISCONSIN**

January 17, 2011

Re: Round 7 Dam Assessment - Draft Report
EPA Contract No. EP10W001313
Wisconsin Power & Light – Columbia Generating Station
Primary Ash, Secondary Ash, Polishing & Landfill Storm Water Ponds
Pardeeville, Wisconsin

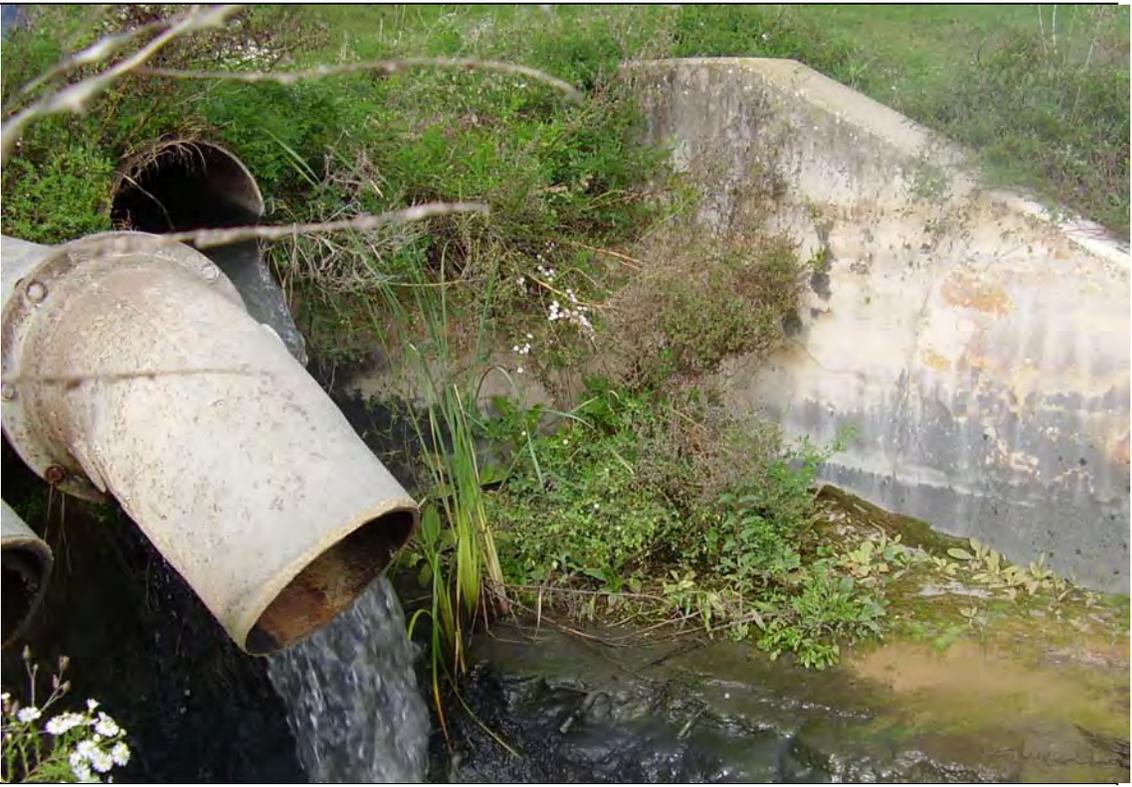
Photo No. 4	Date: 9/28/10
Direction Photo Taken: Northwest

Description:
Discharge Pipeline (behind
12" Diameter pipeline):
(1) 18" Diameter in PAP

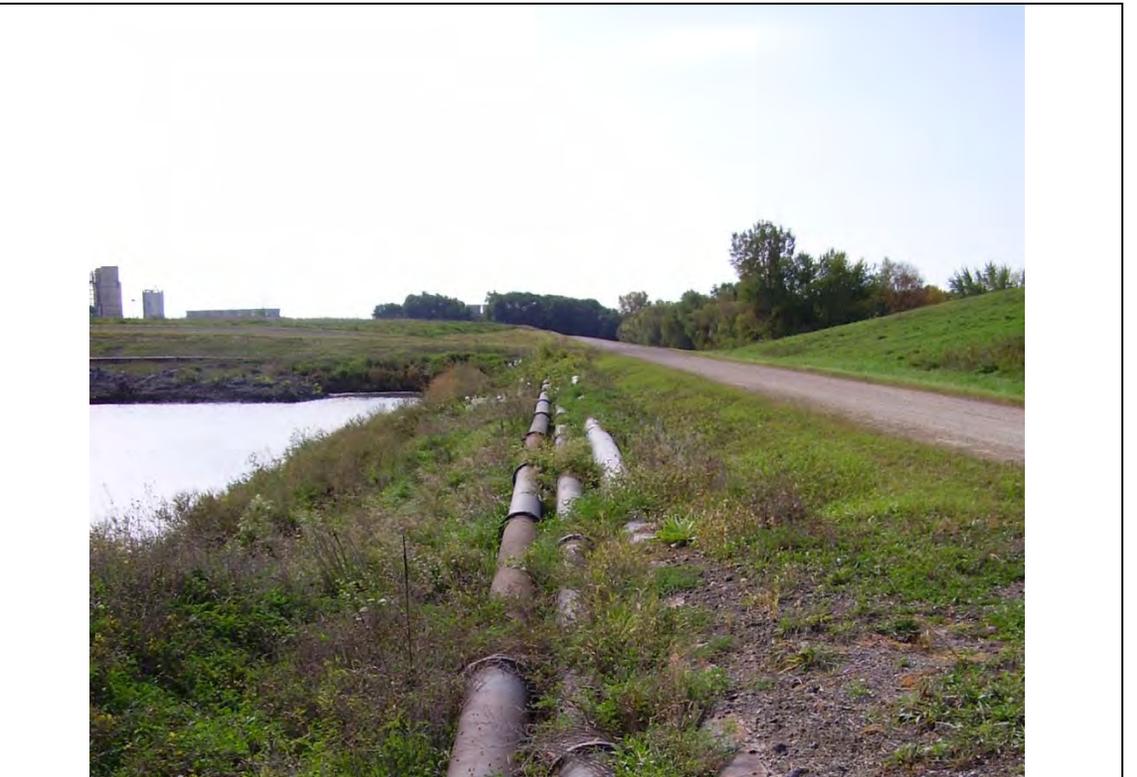
Photo No. 6	Date: 9/28/10
------------------------------	-------------------------

Description:
Upstream slope, top of embankment of PAP, and discharge pipelines.

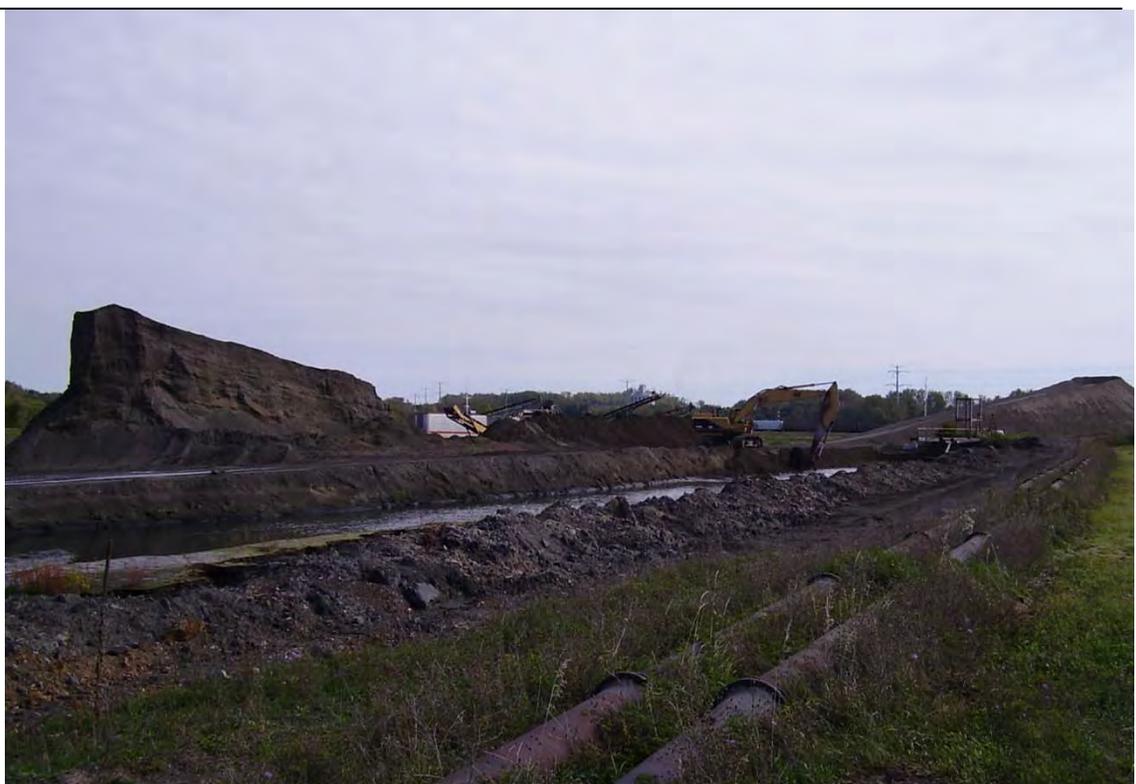
Photo No. 8	Date: 9/28/10
Direction Photo Taken: East

Description:
Upstream slope of PAP, ash recovery operations, and discharge pipelines.

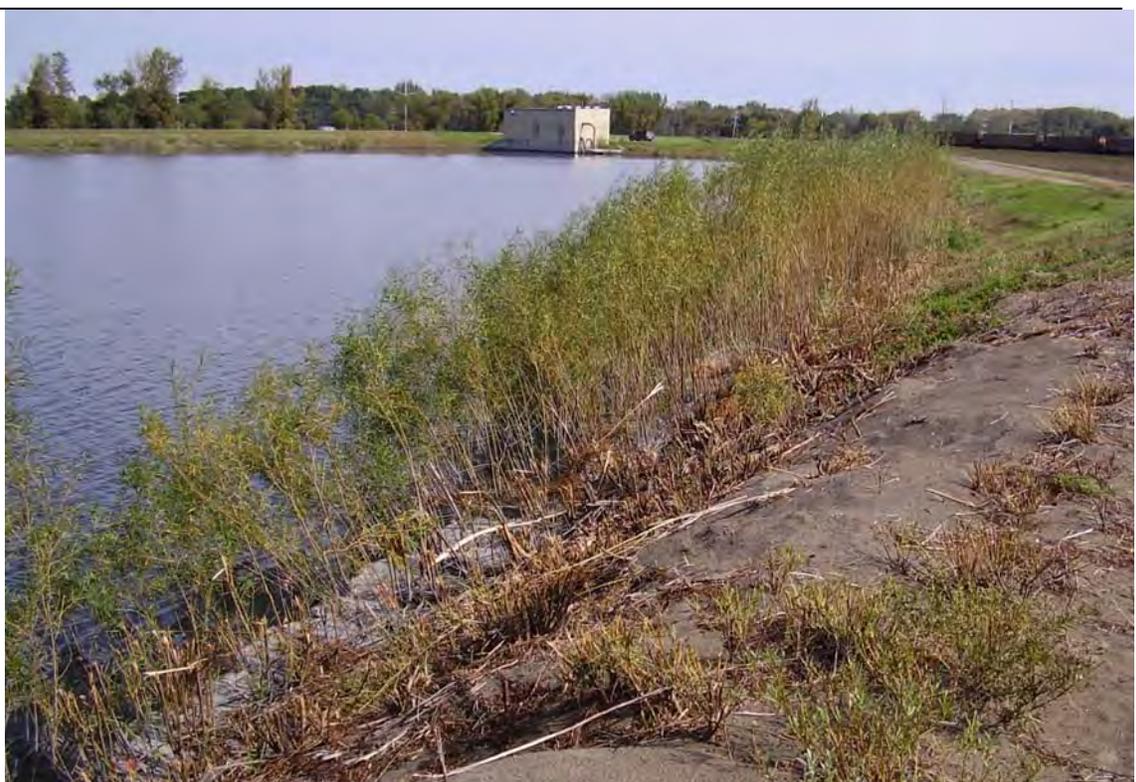
Photo No. 14	Date: 9/28/10
Direction Photo Taken: Northeast

Description:
Upstream slope of PAP, downstream slope of SAP and PAP pump house.

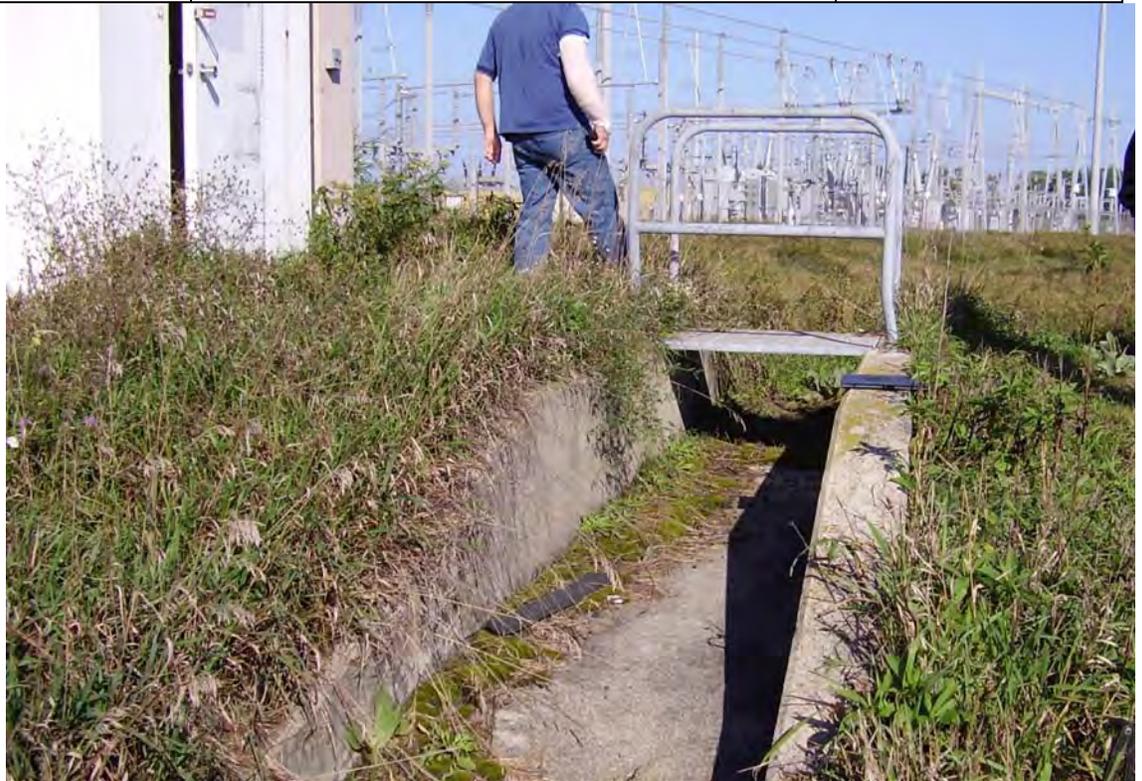
Description:
PP emergency spillway.

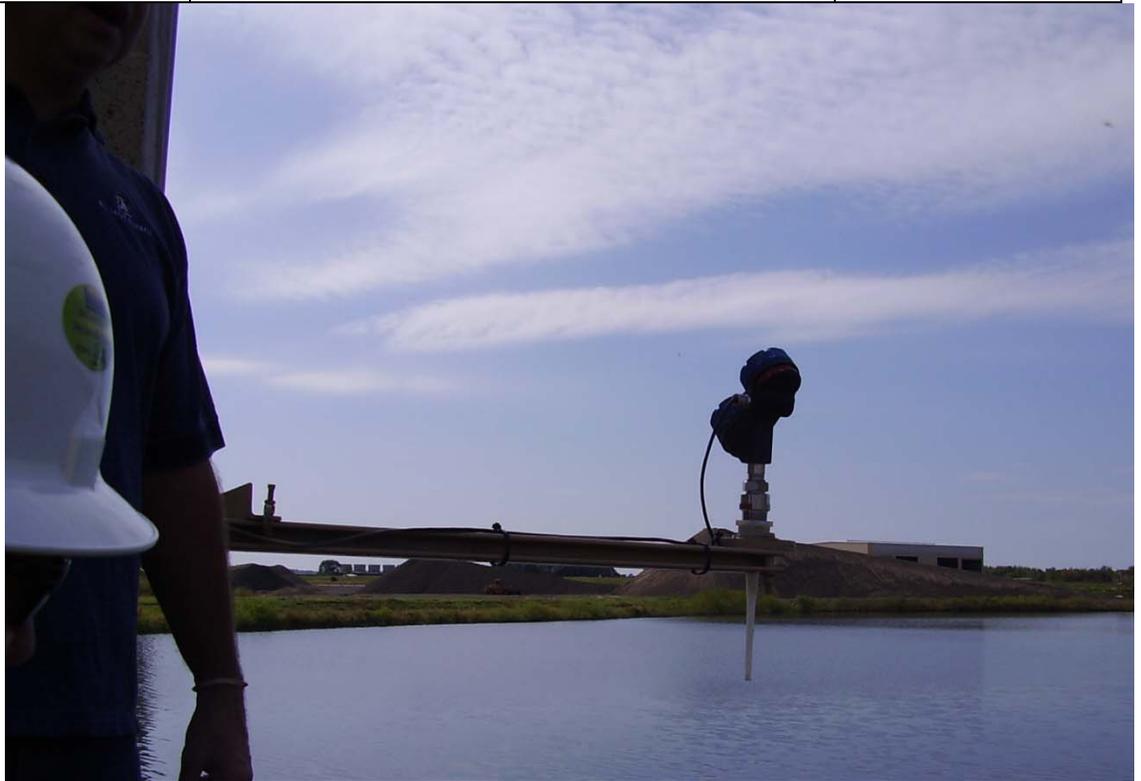
Electronic Water Level monitor on the PAP Pump house.
