Report of Dam Safety Assessment of Coal Combustion
Surface Impoundments
Interstate Power and Light Company
M.L. Kapp Generating Station
Clinton, IA

AMEC Project No. 3-2106-0183.0002

May 2011

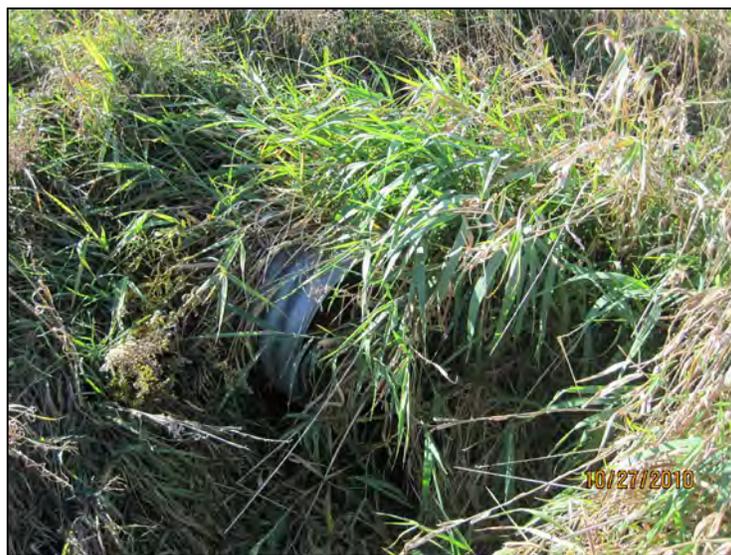
Flow is discharged from the northwest corner Primary Pond into the southwest corner of the Secondary Pond through a drop inlet (Photos MP-5 and MP-8)). The drop inlet was noted to be adjustable using extension pieces located nearby (Photo MP-7). The southwest corner of the Secondary Pond, where flow from the Primary Pond enters, was overgrown with grass and weeds and did not appear to have been active in some time (Photo MP-8).

MP-8
VEGETATION SURROUNDING PIPE DISCHARGE FROM
MAIN ASH PRIMARY POND INTO SECONDARY POND

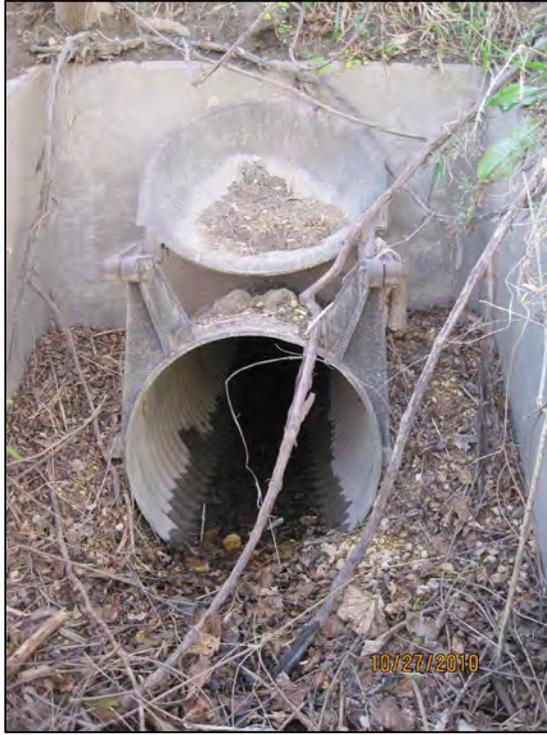
MP-13
DOWNSTREAM END OF ABANDONED MAIN POND OUTLET
STRUCTURE AT TOE OF SLOPE OF ORIGINAL EMBANKMENT

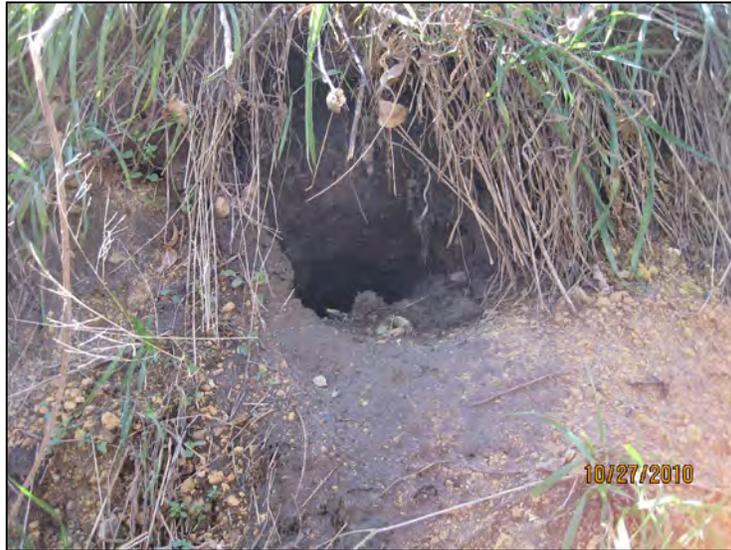
The original pond embankment remains in-place; however, it does not directly support the ash ponds since the ponds themselves are situated well inside this original embankment. The narrowest distance between a pond boundary and the original downstream embankment face appears to be at the Secondary Pond discharge pump house, which is located at the eastern end of the pond. The original embankment has not been maintained and is covered in trees and vegetation (MP-15 through MP-18). An animal burrow was noted at the top of the northeastern embankment (Photo MP-14).

MP-14
ANIMAL BURROW LOCATED AT NORTHEAST
CORNER OF ORIGINAL POND EMBANKMENT

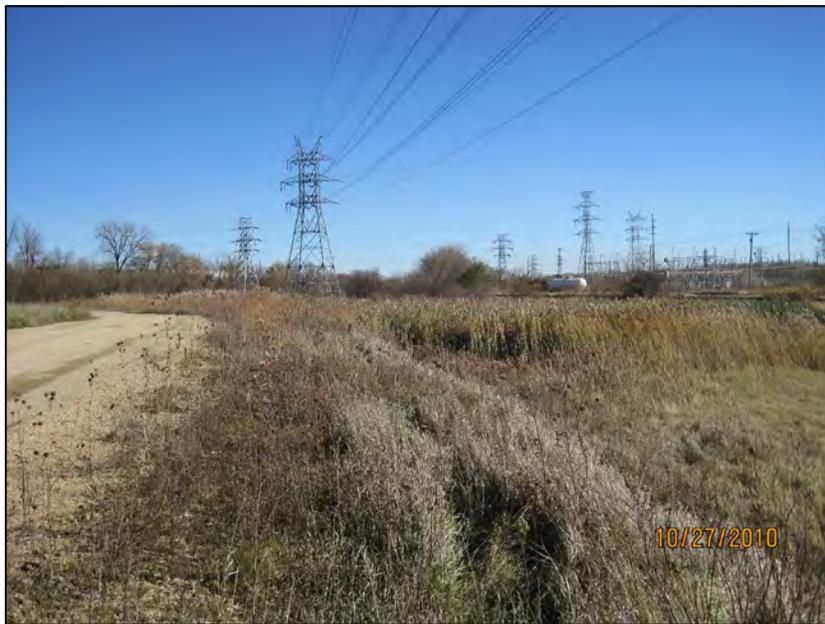
MP-18
LOOKING NORTHEAST ALONG SOUTHERN
PORTION OF ORIGINAL EMBANKMENT
