Site Name: Progress Energy Asheville Date: 29 MAY 2009
 Unit Name: 1964 POND Operator's Name: Progress ENERGY
 Unit I.D.: Hazard Potential Classification: High Significant Low

Site Name: Progress Energy Asheville Date: 29 May 2009
 Unit Name: 1982 PdND Operator's Name: Progress ENERGY
 Unit I.D.: Hazard Potential Classification High Significant Low

1982 Ash Pond - Photo Log

May 29, 2009

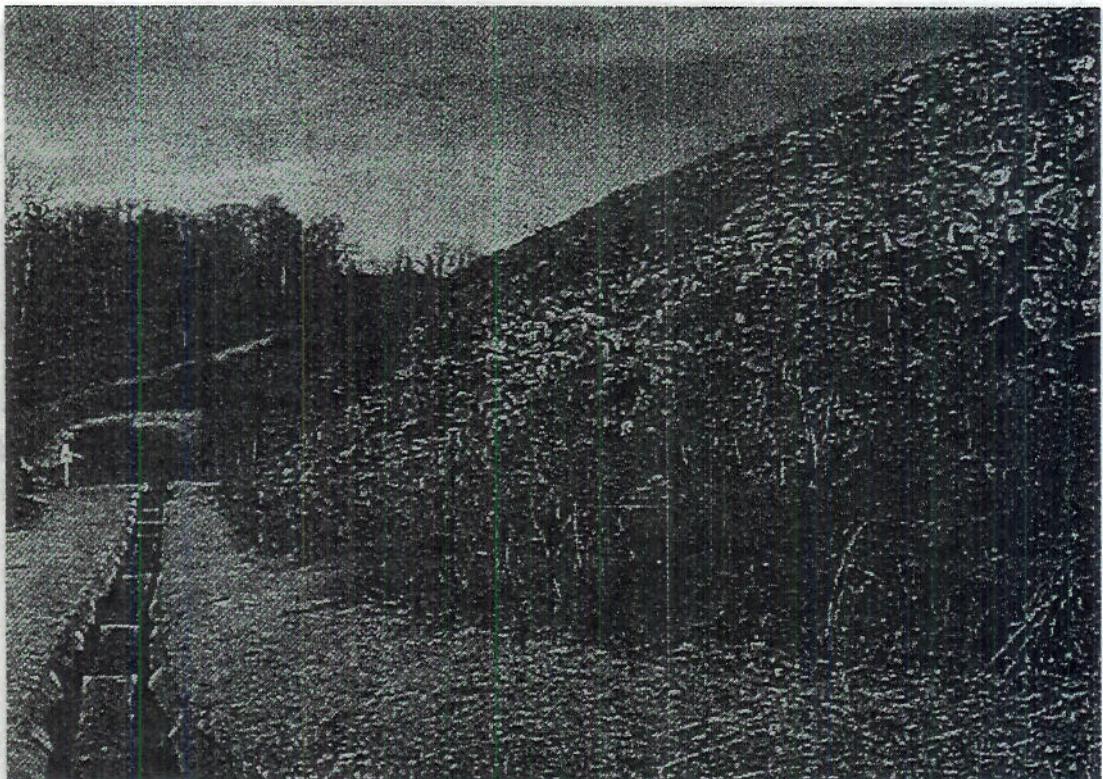
Photograph 13: 1964 Ash Pond – downstream slope looking northwest along toe of slope, note bushes growing in riprap.

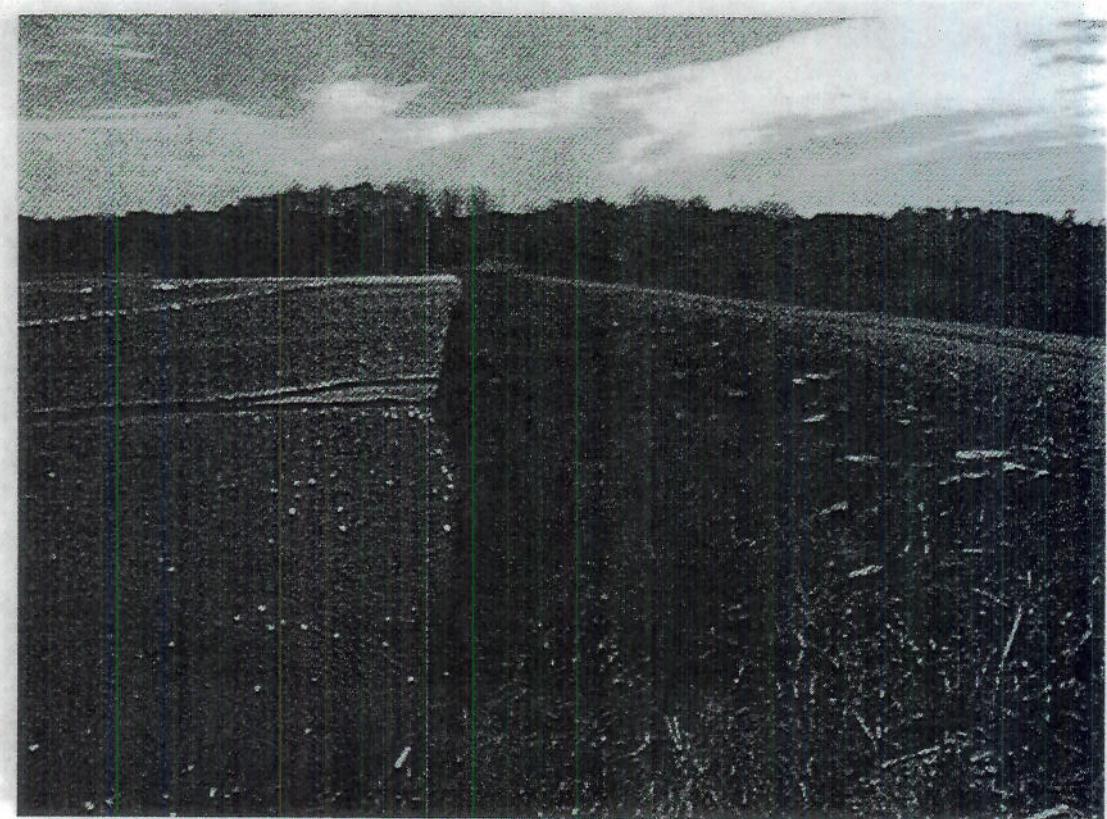
Photograph 15: 1982 Ash Pond, interior slope looking east, note vegetation in riprap.

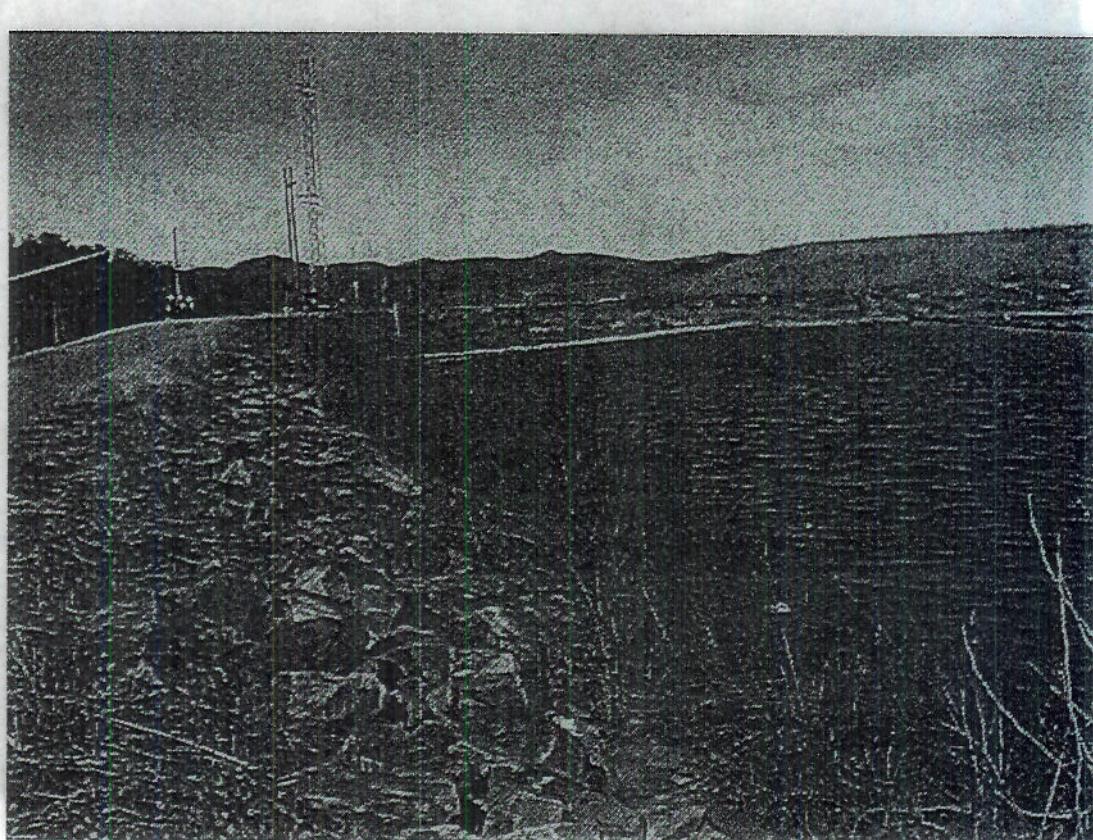
Photograph 16: 1982 Ash Pond - interior slope looking west, note vegetation in rip rap.

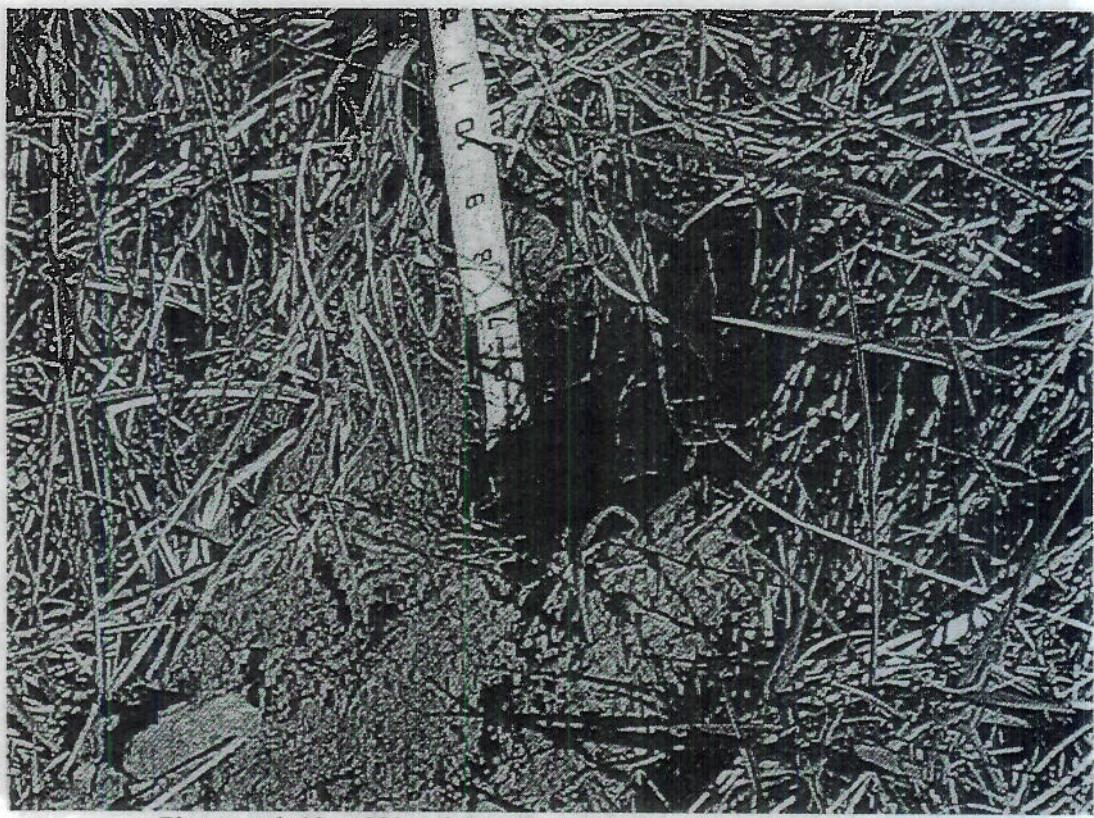
Photograph 19: 1982 Ash Pond – rodent holes in downstream slope.

Attached is the most recent annual inspection report summary. Actions taken or planned: Animal burrows noted on western portion of embankment. Animals should be removed and the burrows backfilled with tamped earth.

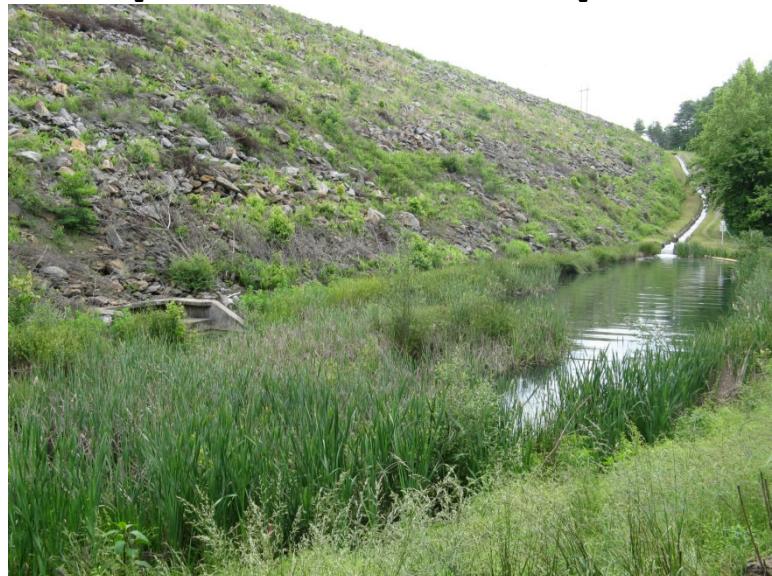
| 3. BROKEN ARCH OF CONCRETE ALONG FLUME. | |

Photo 6: 1964 Dam - Concrete Flume Deterioration, Right Groin, Photo: 090, 5/29/09
(note: right and left are based on the observer facing downstream)

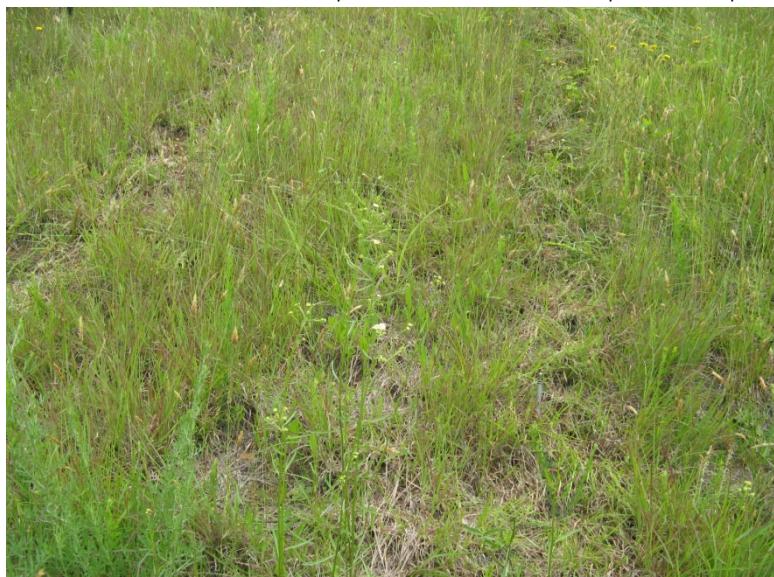
Photo 18: 1982 Dam – Minor Rill Erosion, Downstream Embankment, Photo: 033, 5/29/09
