**DRAFT REPORT
ROUND 7 DAM ASSESSMENT
CONSUMERS ENERGY COMPANY - D.E. KARN PLANT
1 & 2 SOLID WASTE DISPOSAL AREA
ESSEXVILLE, MICHIGAN**

January 12, 2011

**GZA GeoEnvironmental, Inc.
19500 Victor Parkway, Suite 300
Livonia, MI 48152
GZA File No. 01.0170142.20**

Re: Round 7 Dam Assessment - Draft Report
EPA Contract No. EP10W001313
Consumers Energy Company D.E. Karn Plant
DE Karn 1 & 2 Solid Waste Disposal Area
Essexville, Michigan

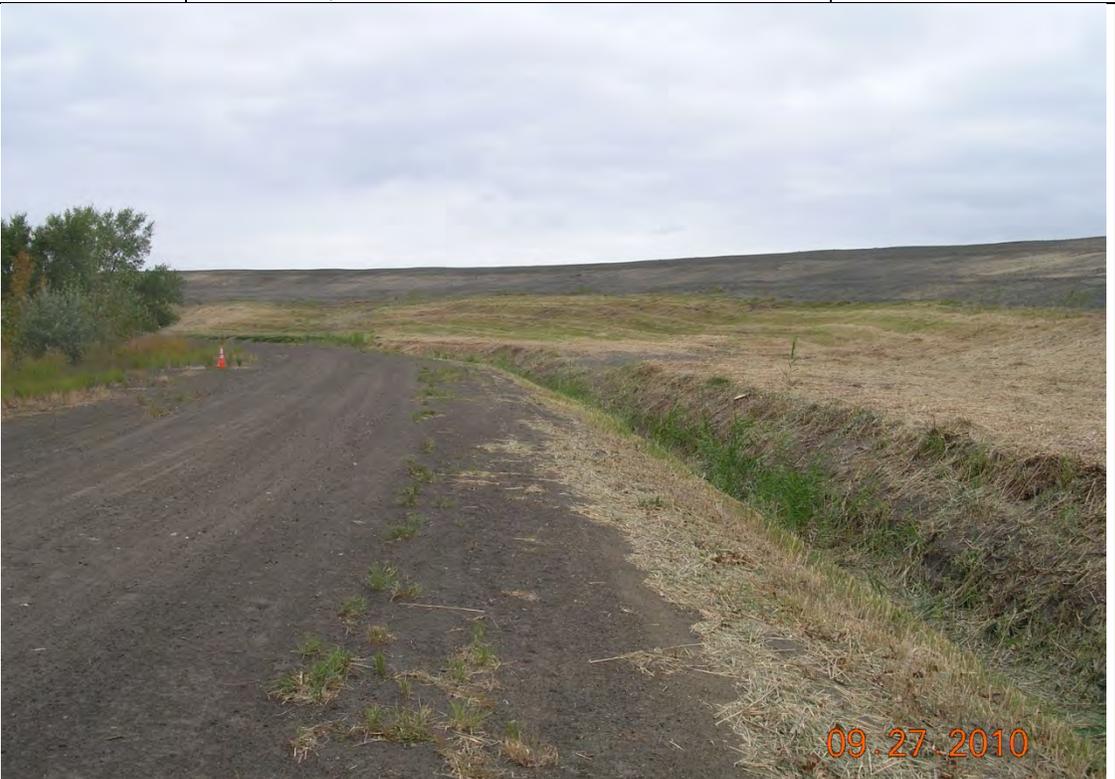
Description:
Toe of the inner slope of the dike, the stormwater collection ditch, and dry storage of compacted coal ash.

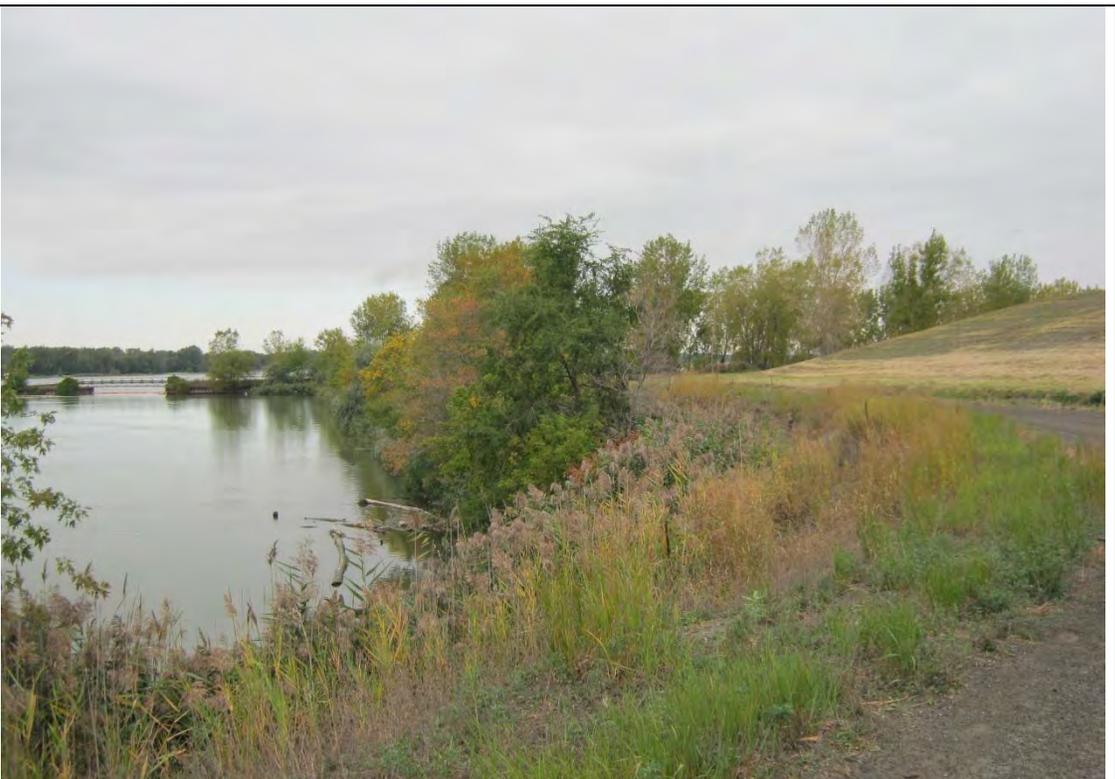
Photo No. 2	Date: 9/27/10
Direction Photo Taken: West

Description:
The dike abuts the D.E. Karn Plant's Intake Channel.

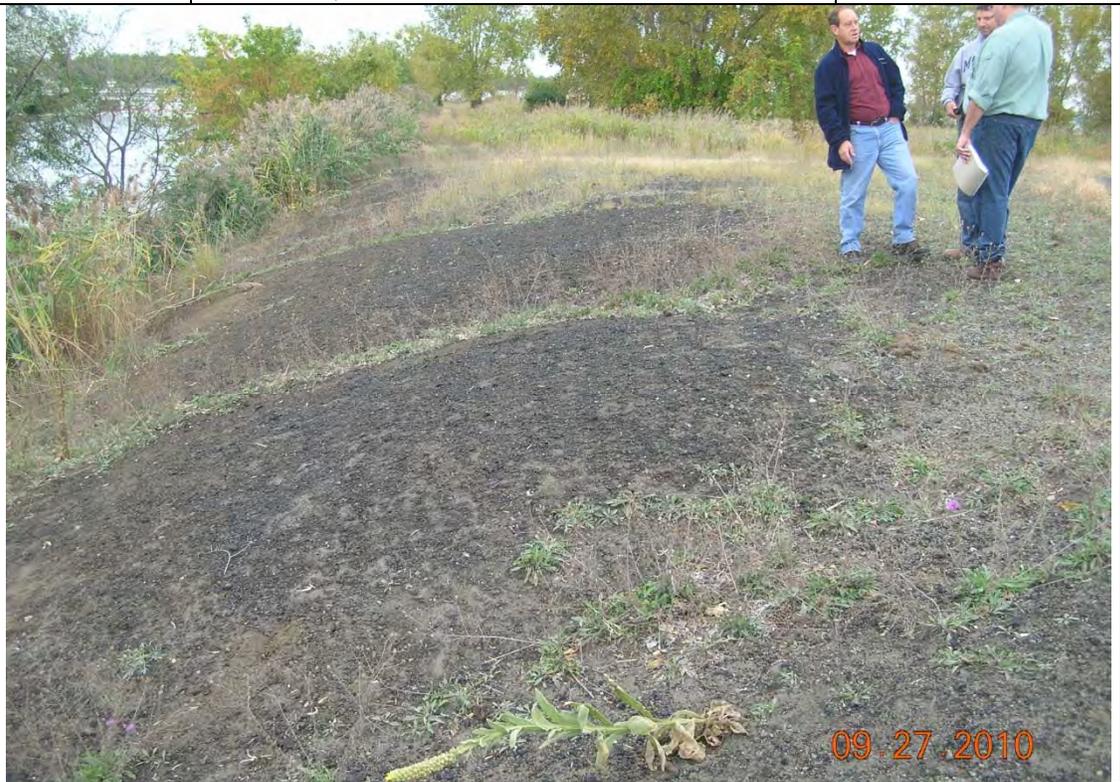
Description:
Erosion channels in the dike near the Intake Channel.

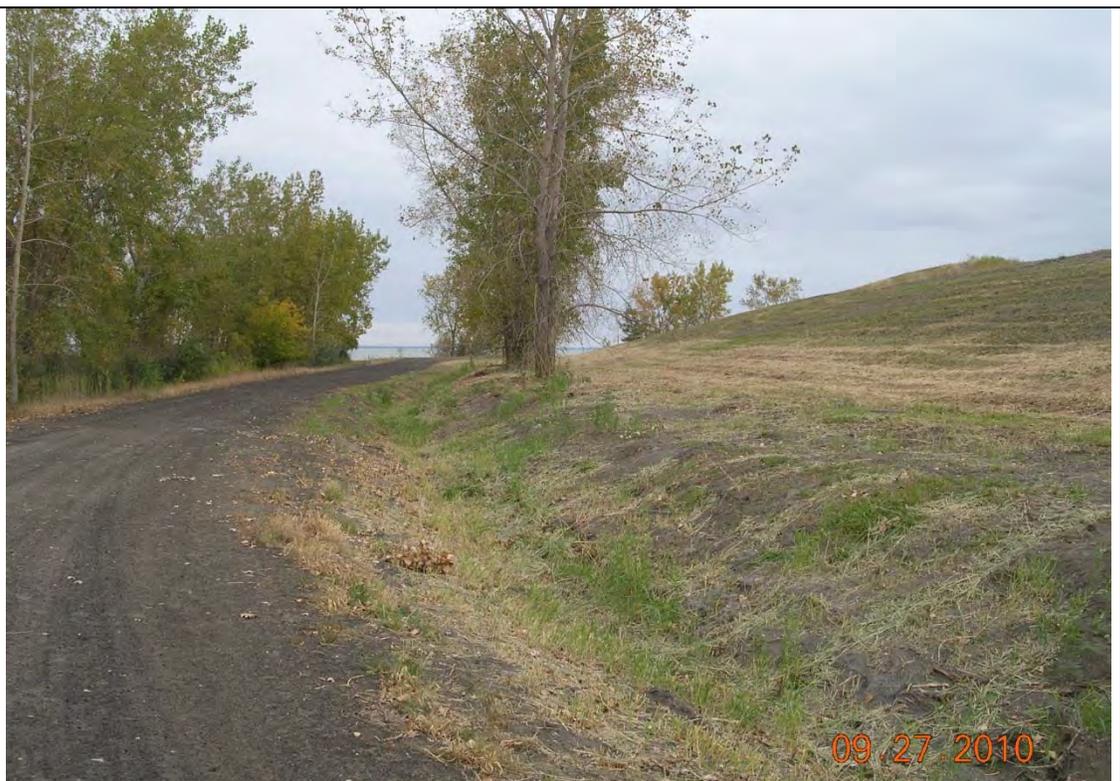
Photo No. 4	Date: 9/27/10
Direction Photo Taken: Northwest

Description:
The crest and inner slope of the dike near the northwestern portion of the impoundment. Note the trees growing on the exterior and interior slopes.

1. Clear vegetation, including small brush and grass, from the heavily vegetated areas to increase visibility of the slopes for monitoring purposes;
2. Develop a maintenance plan for monitoring of the large trees along the downstream slope. Trees that are damaged or uprooted by storm events should be removed and the dike area repaired;
3. Install riprap or other stabilizing material on the outer slope near the Intake Channel to reduce surface erosion. Similarly, CEC should consider flattening the dike slope along the Discharge Canal as recommended by AECOM; and,
4. Complete and/or analyze other embankment stability and seepage improvements recommended by AECOM.

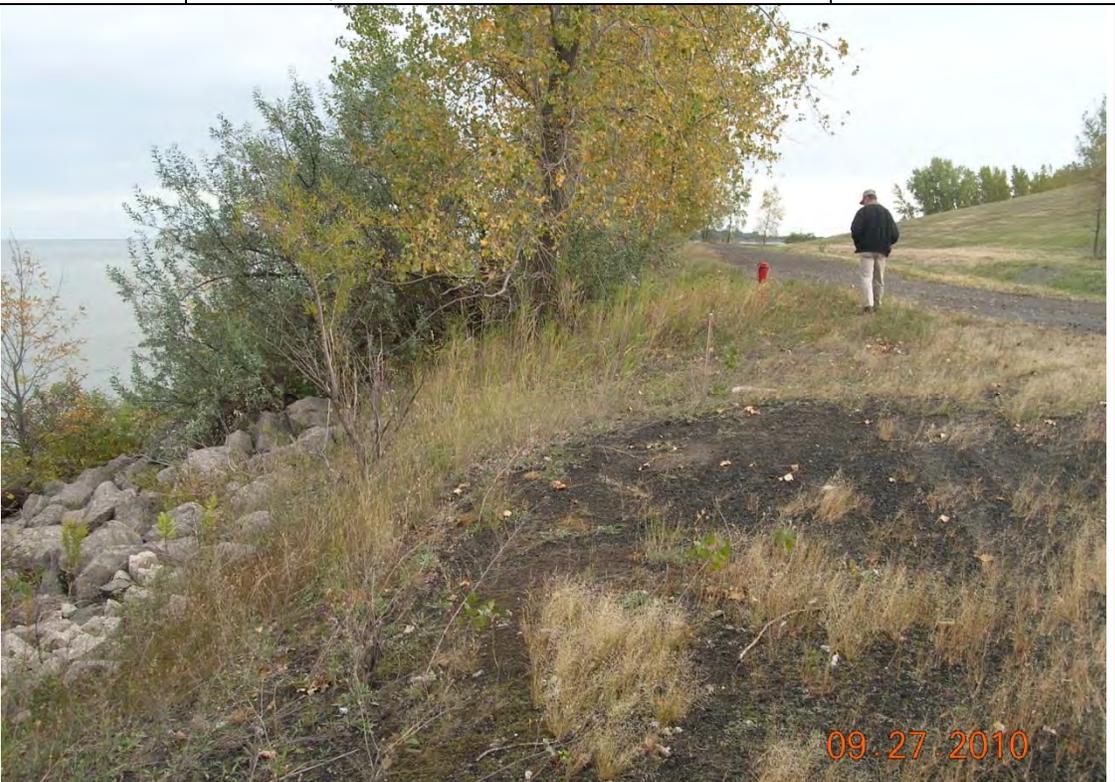
Description:
Vegetation growing on the outer slope of the dike near the northwestern corner of the impoundment. Rip rap is also present at this location.

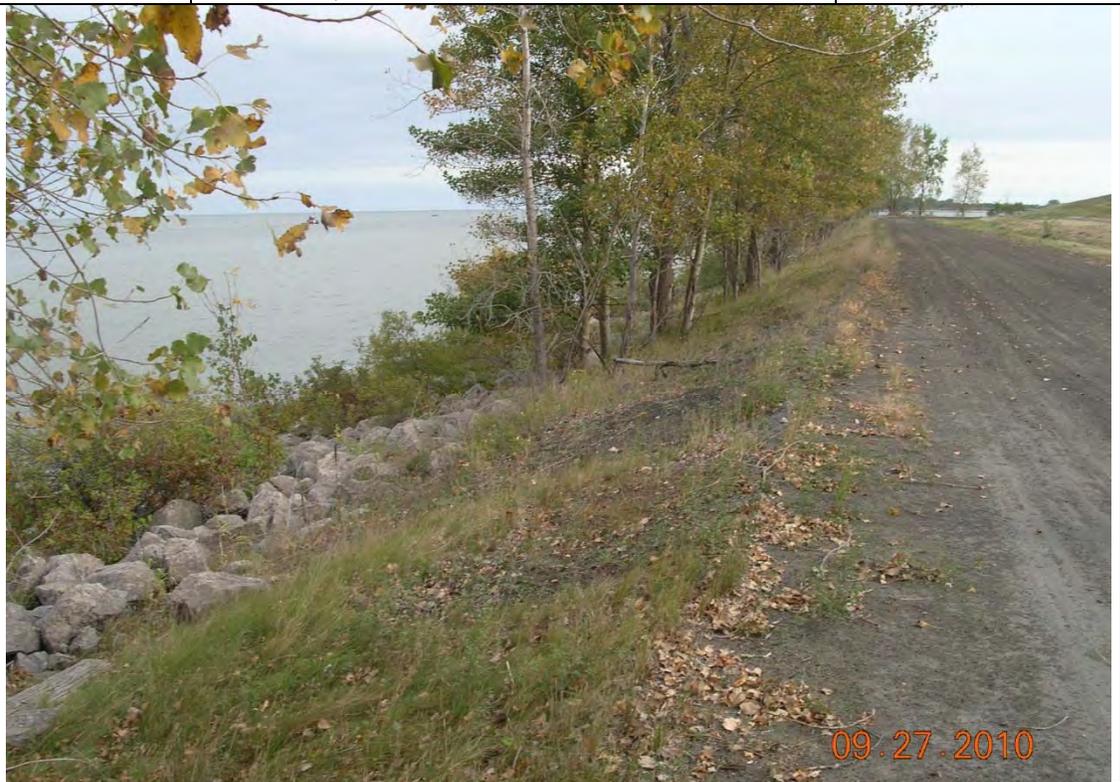
Description:
 Rip rap and trees on the outer dike slope. Saginaw Bay abuts the dike at this location.

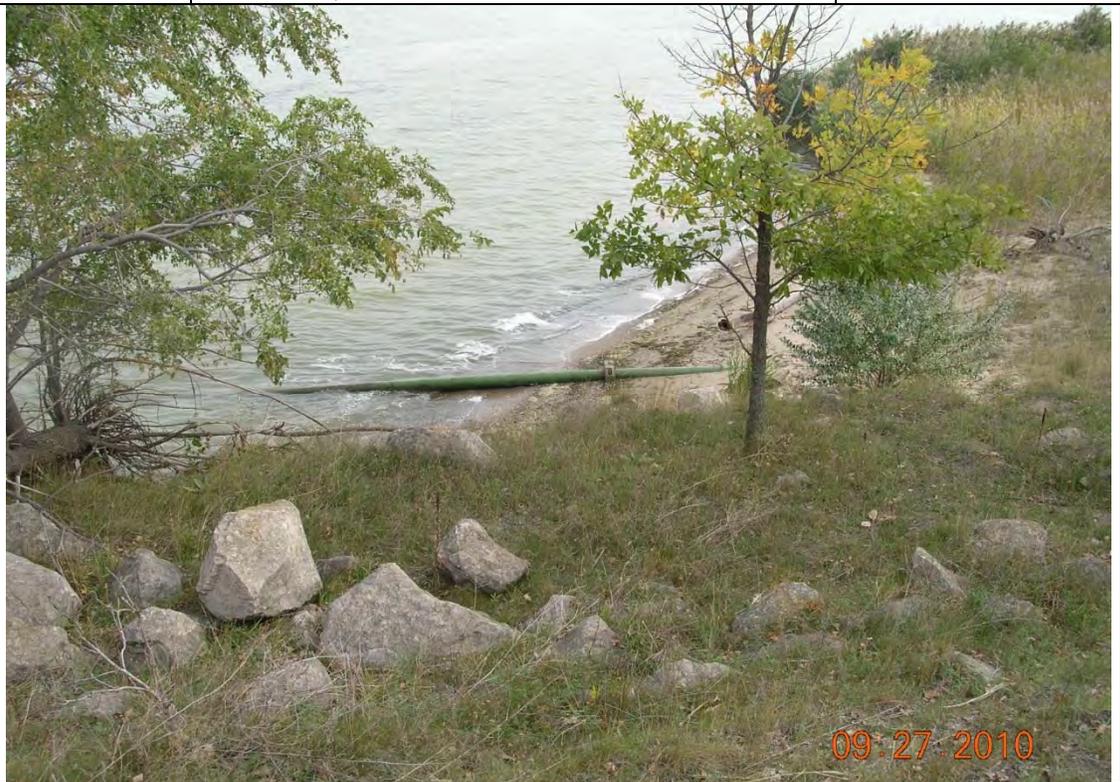
Photo No. 9	Date: 9/27/2010
Direction Photo Taken: Northeast	
Description: Pipe of unknown origin or purpose that does not appear to penetrate the dike.

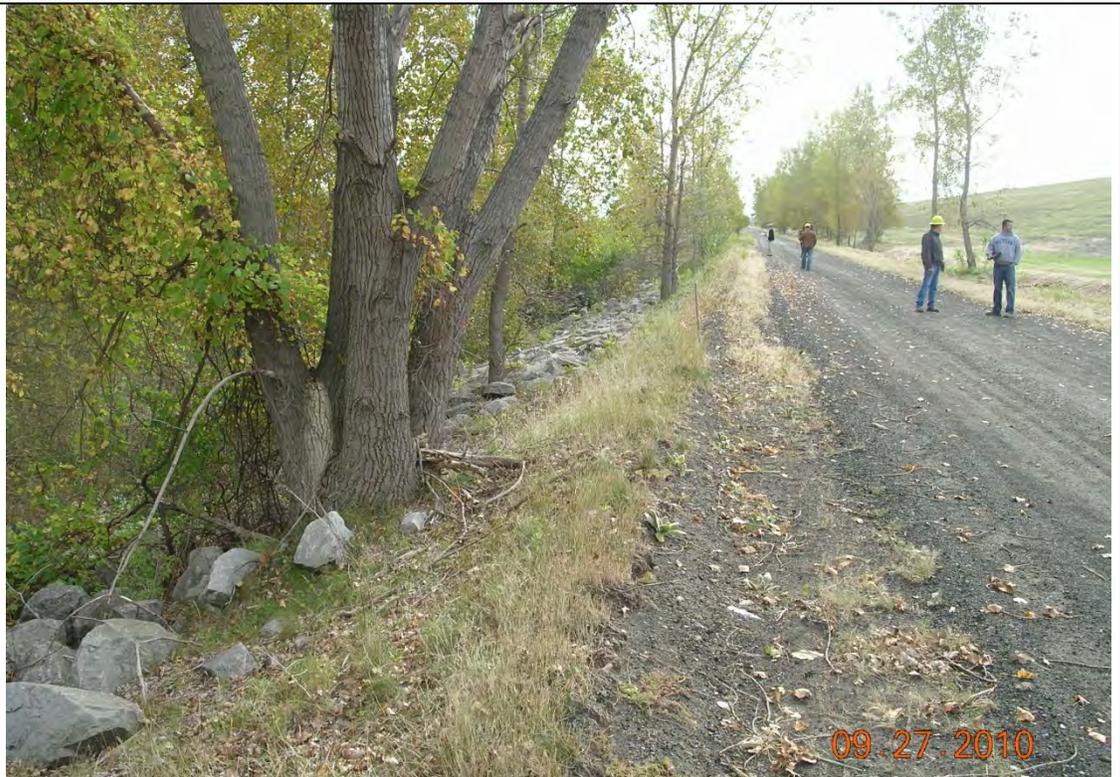
Photo No. 10	Date: 9/27/2010
Direction Photo Taken: Southeast	
Description: Vegetation and rip rap along the outer slope of the dike.

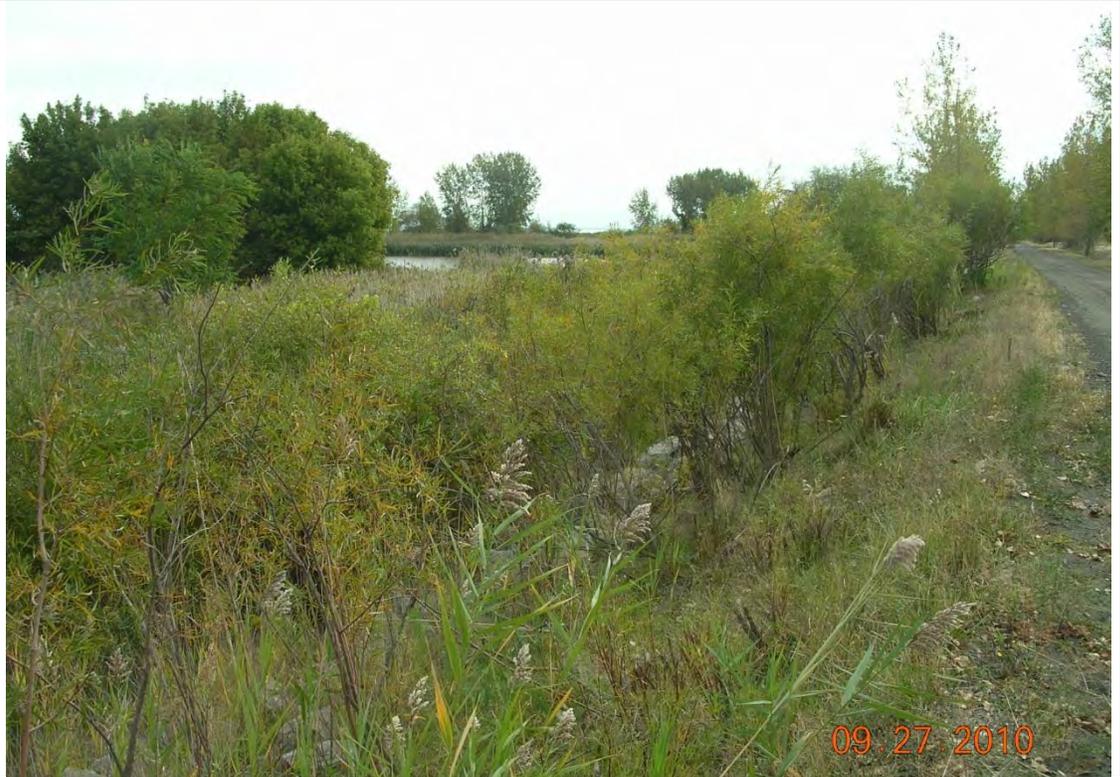
Description:
Vegetation on the outer slope of the dike.

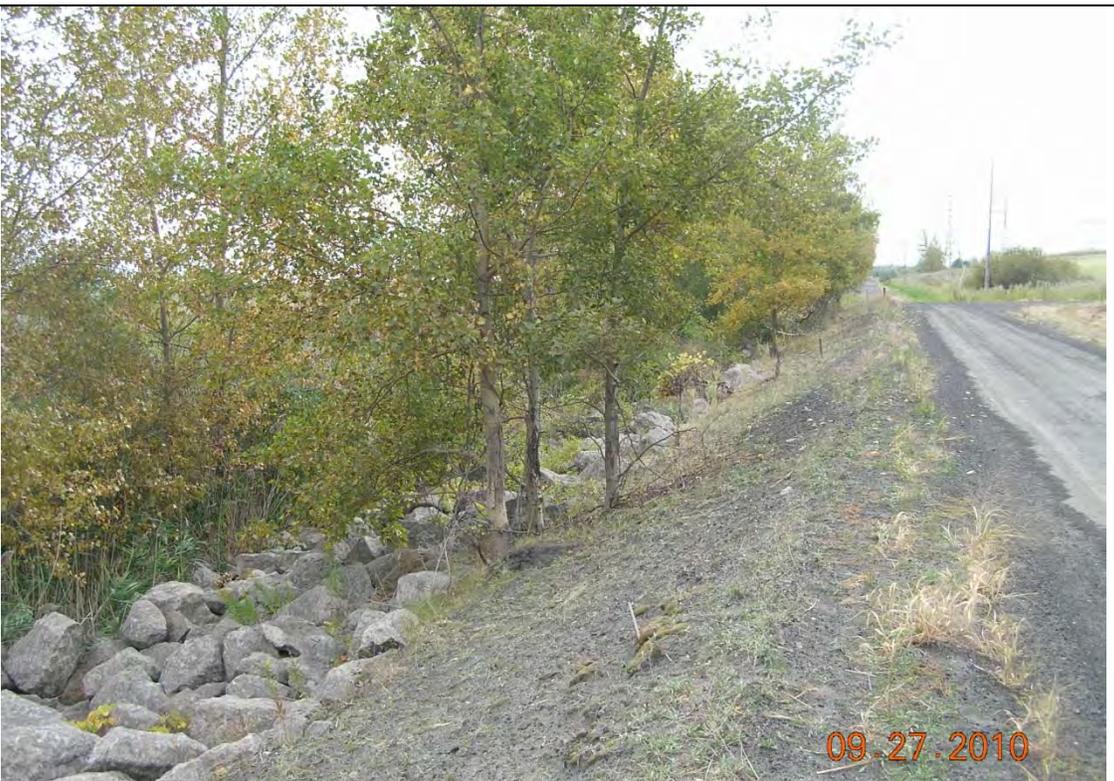
Photo No. 16	Date: 9/27/2010
Direction Photo Taken: Southeast

Description:
Vegetation and rip rap on the outer slope of the dike. Note the bottom ash that was used to build up the crest.

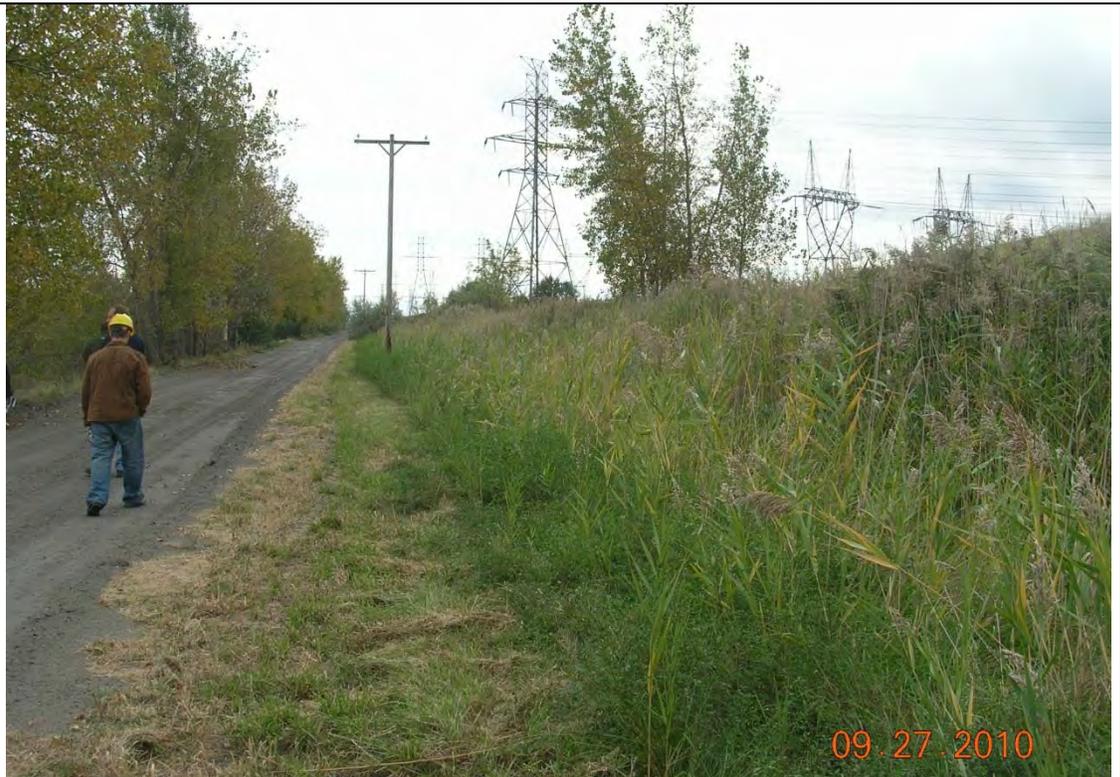
Description:
Vegetation on the inner dike slope in the storm water drainage ditch.

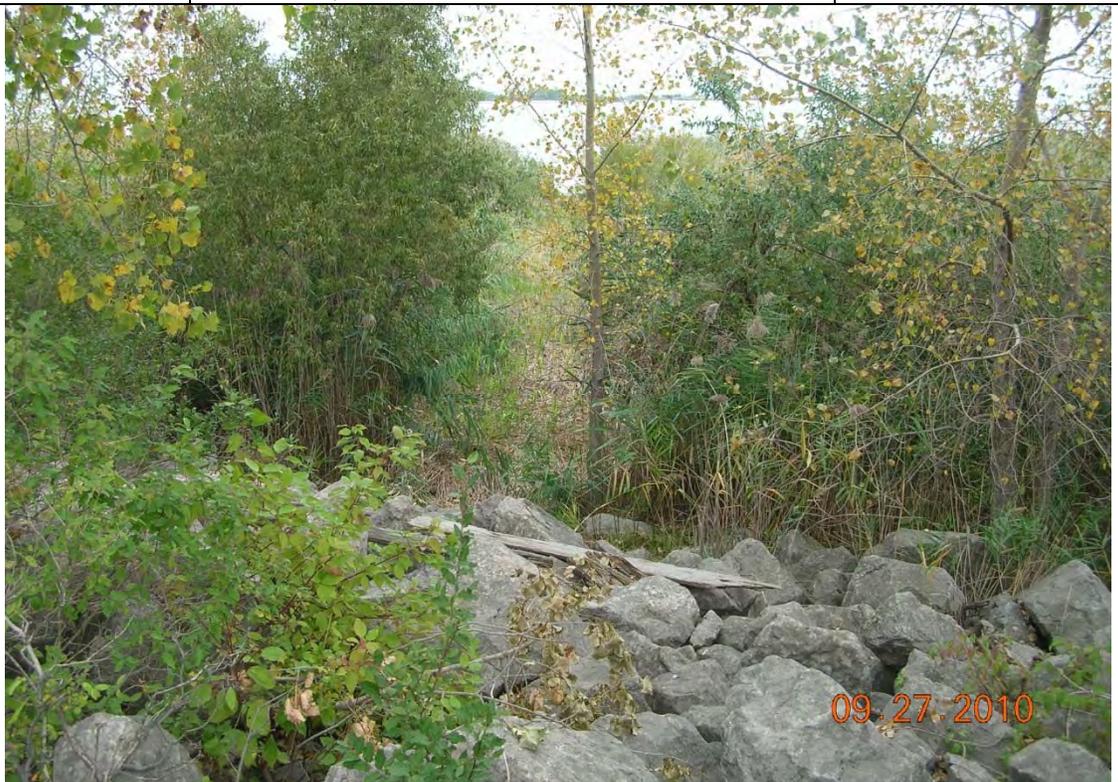
Description:
Drift wood on top of the outer dike slope, indicating that the water level in Lake Huron has been as high as the rip rap.

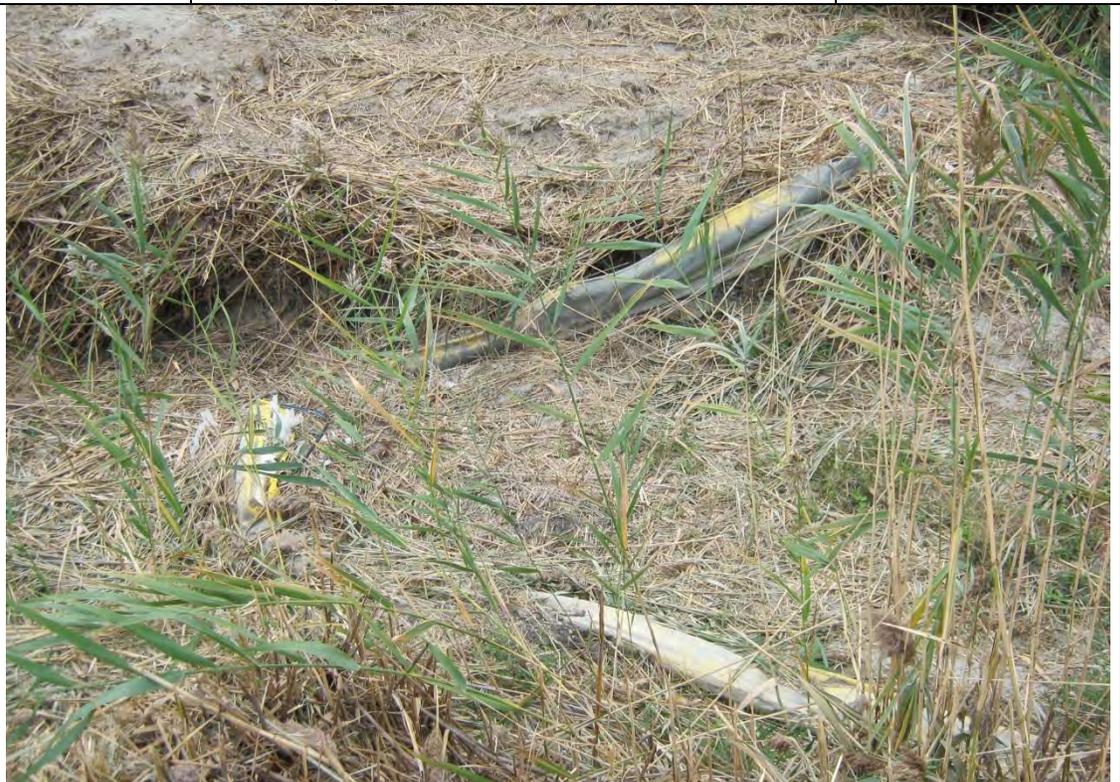
Description:
Trash in the stormwater drainage ditch.

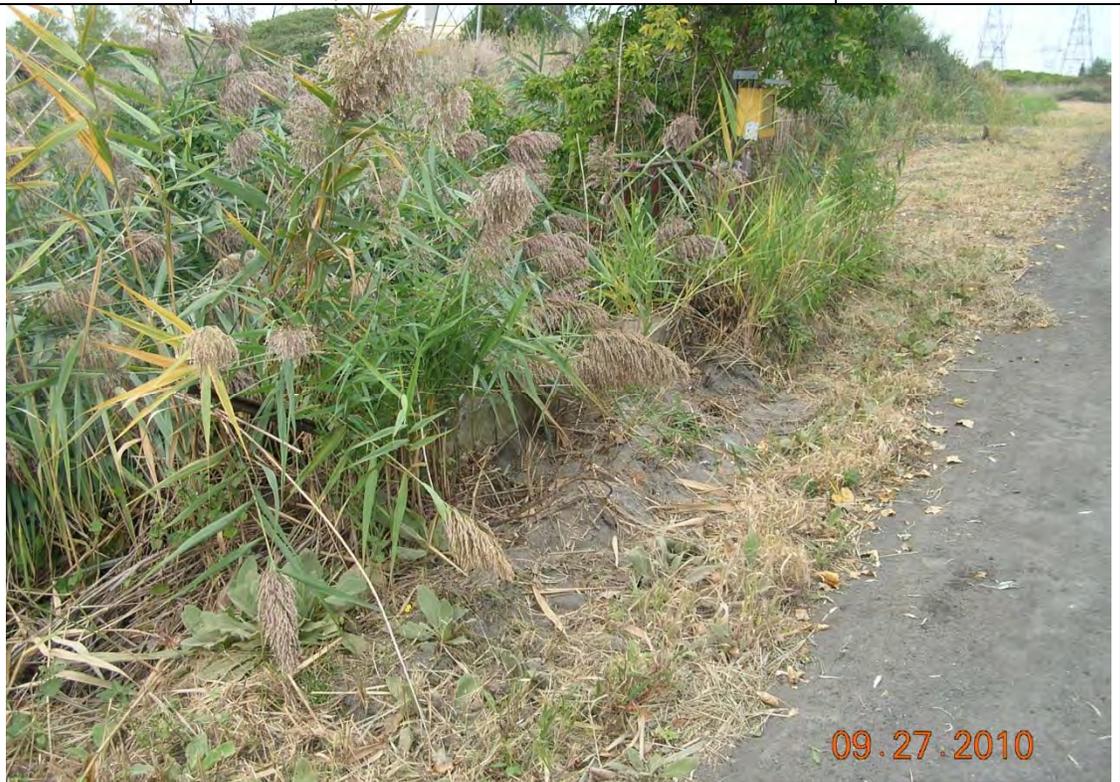
Description:
The former NPDES discharge outlet equipment is still in place.

1. Remove the former NPDES discharge structure, including excavating and removing the former pipes, and replace with compacted fill.

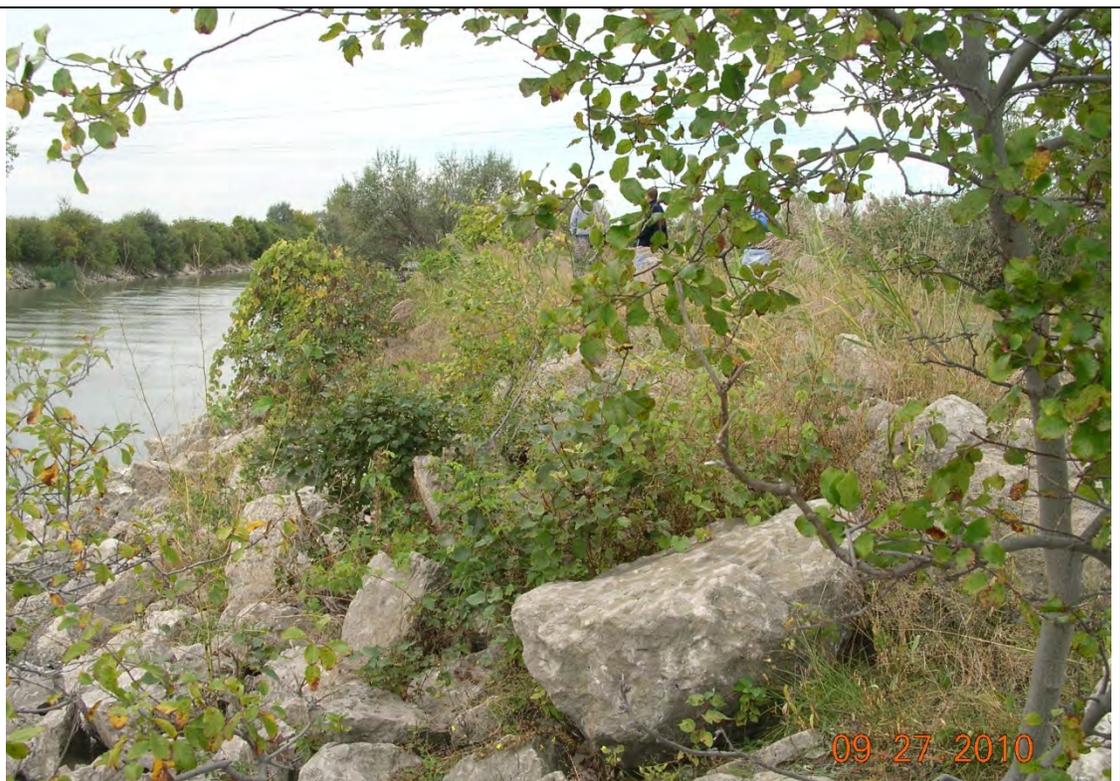
Photo No. 26	Date: 9/27/10
Direction Photo Taken: Southwest

Description:
Vegetation and rip rap on the outer dike slope at the Discharge Canal.

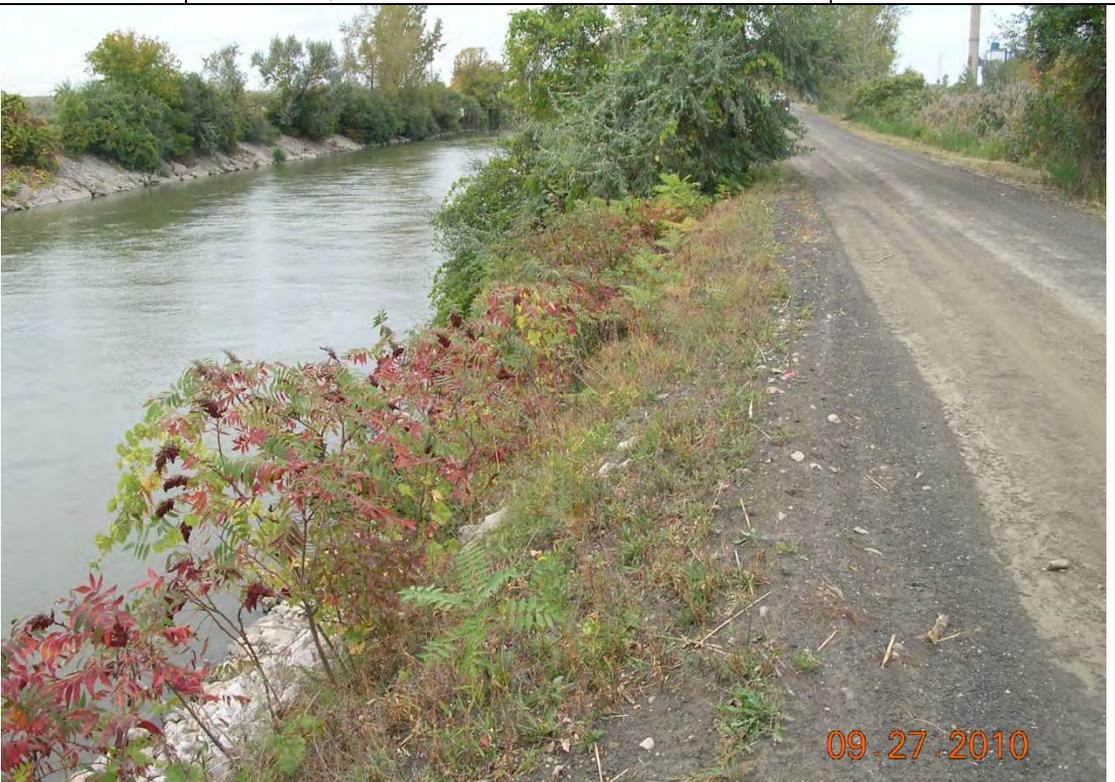
Photo No. 27	Date: 9/27/2010
Direction Photo Taken: Southwest

Description:
Vegetation and rip rap on the outer dike slope at the Discharge Canal.

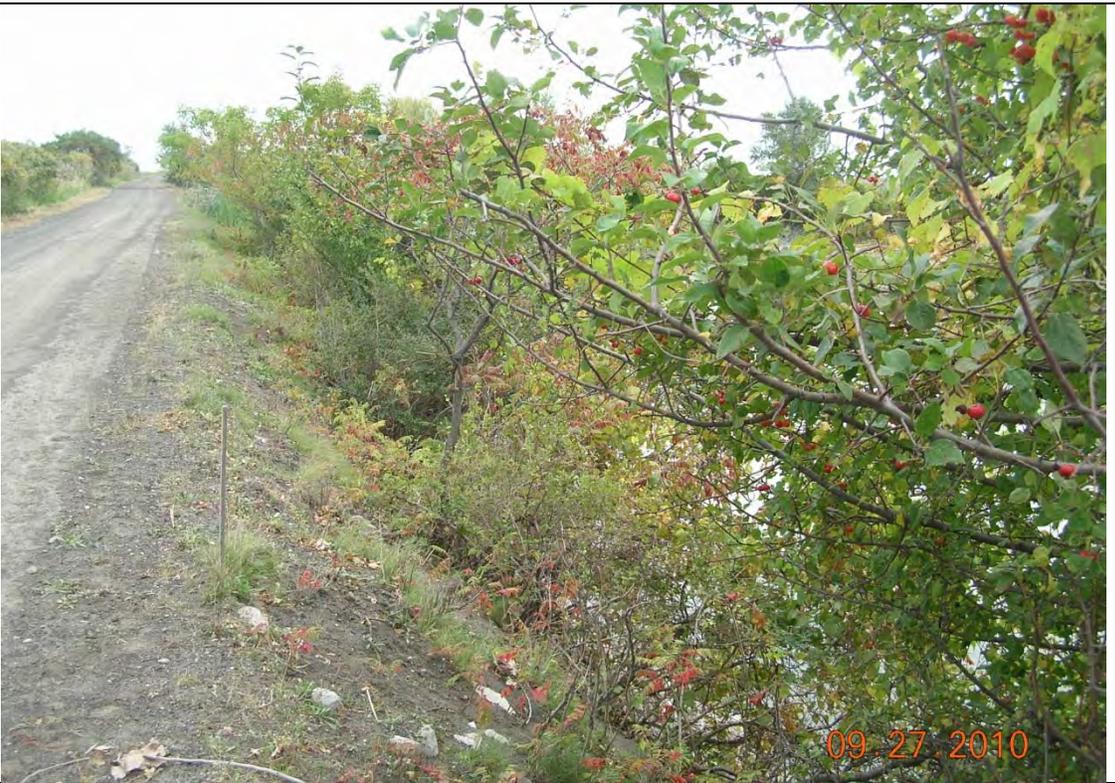
Photo No. 28	Date: 9/27/10
Direction Photo Taken: Northeast

Description:
Vegetation on the outer dike slope at the Discharge Canal.

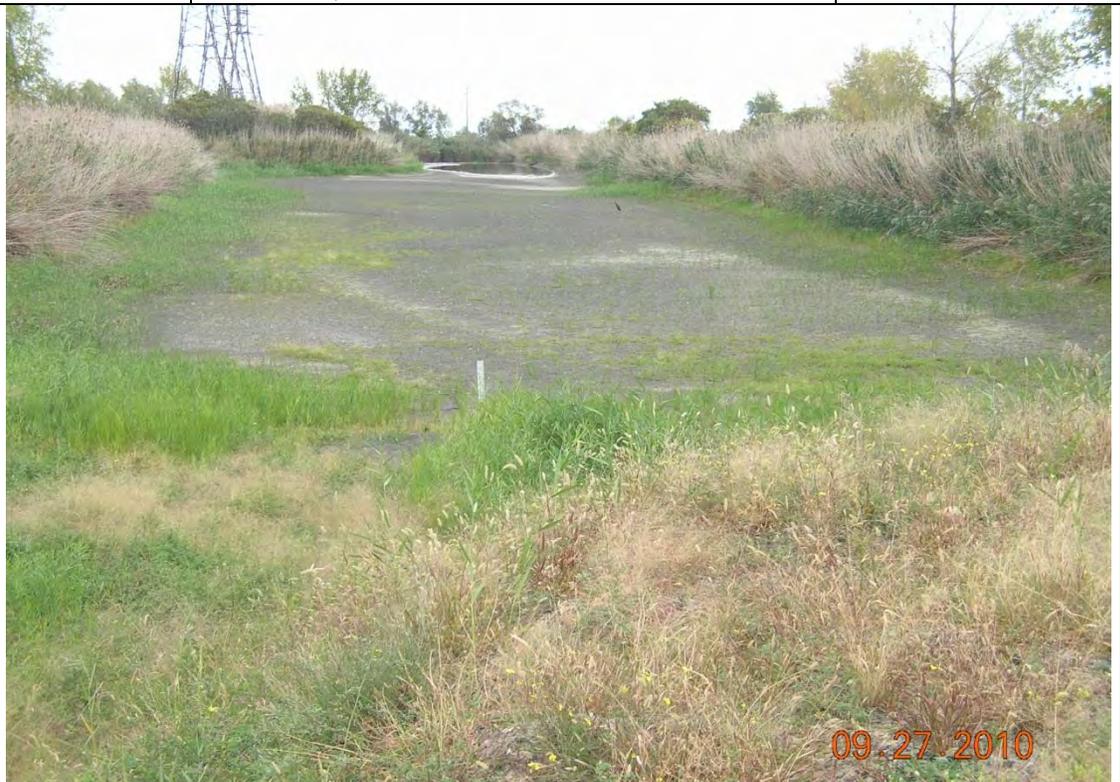
Description:
Pond E has been significantly drained within the last year.

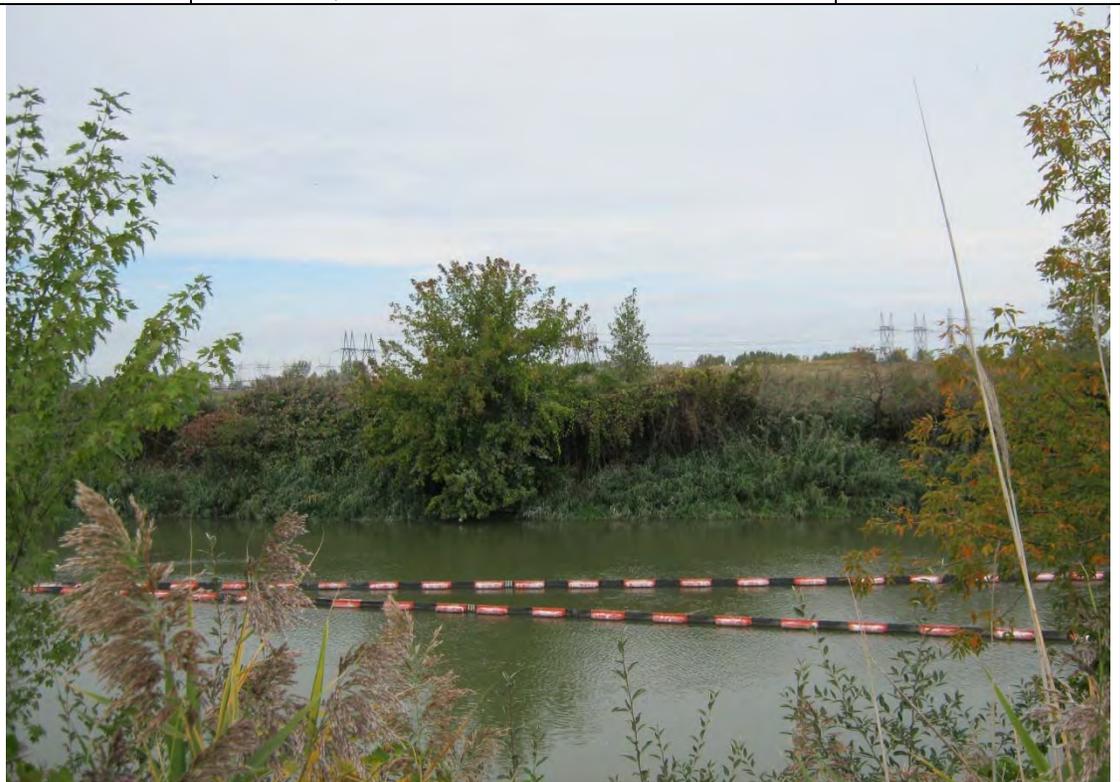
Description:
 View of the NPDES outlet into the Discharge Canal from the opposite side of the Karn Disposal Area. Note the heavy vegetation.

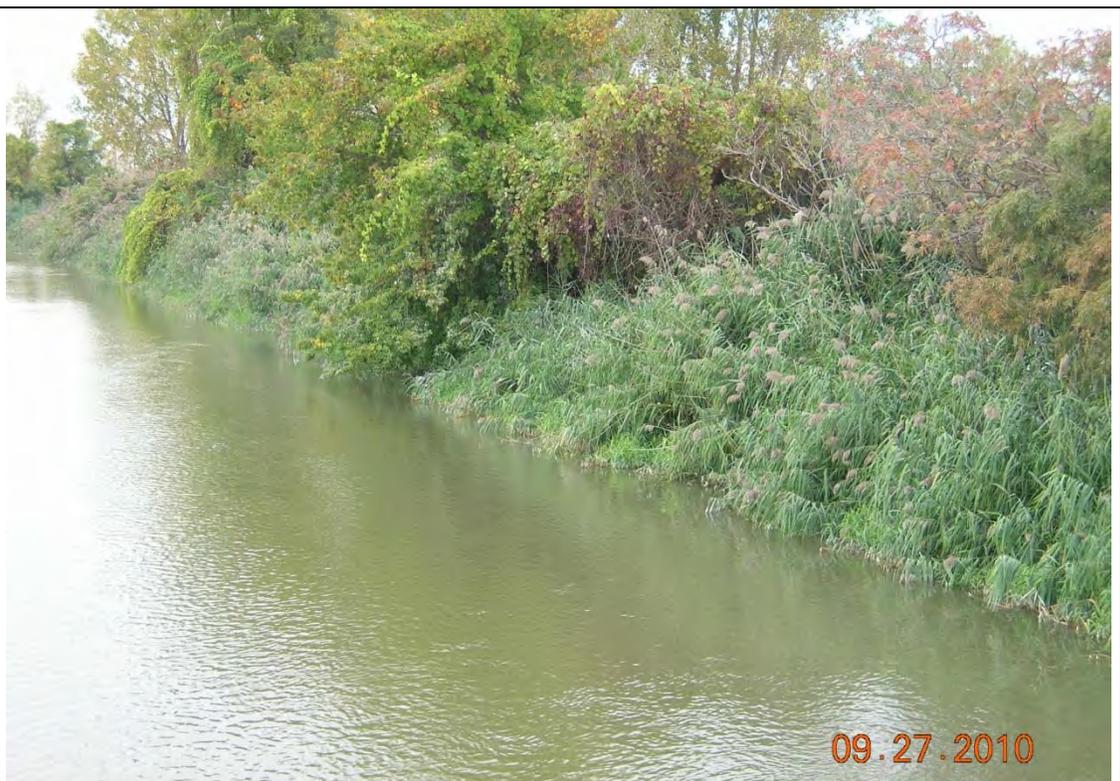
Photo No. 34	Date: 9/27/10
Direction Photo Taken: Southwest

Description:
 Vegetation growing on the outer dike slope at the Discharge Canal.
