Assessment of Dam Safety Coal Combustion Surface Impoundments (Task 3) Final Report

Duke Energy

W.C. Beckjord Station
New Richmond, Ohio

March 22, 2010

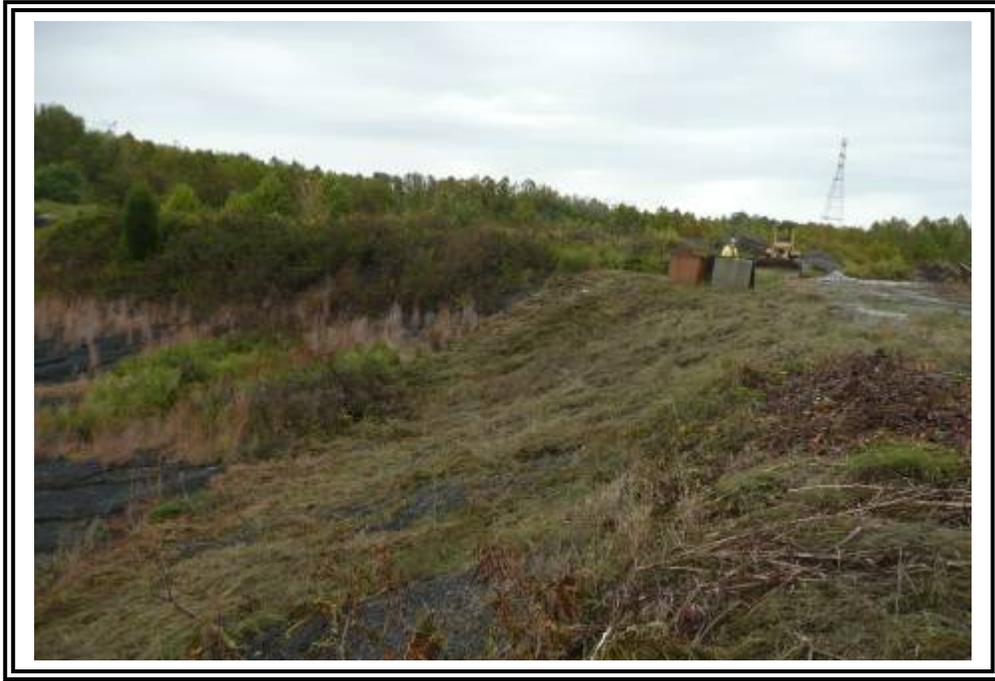
45

Exterior slope of west dike at contact with the Ash Pond A south dike, looking north.
Note exposed bottom ash and slag on slope surface where vegetation is missing.

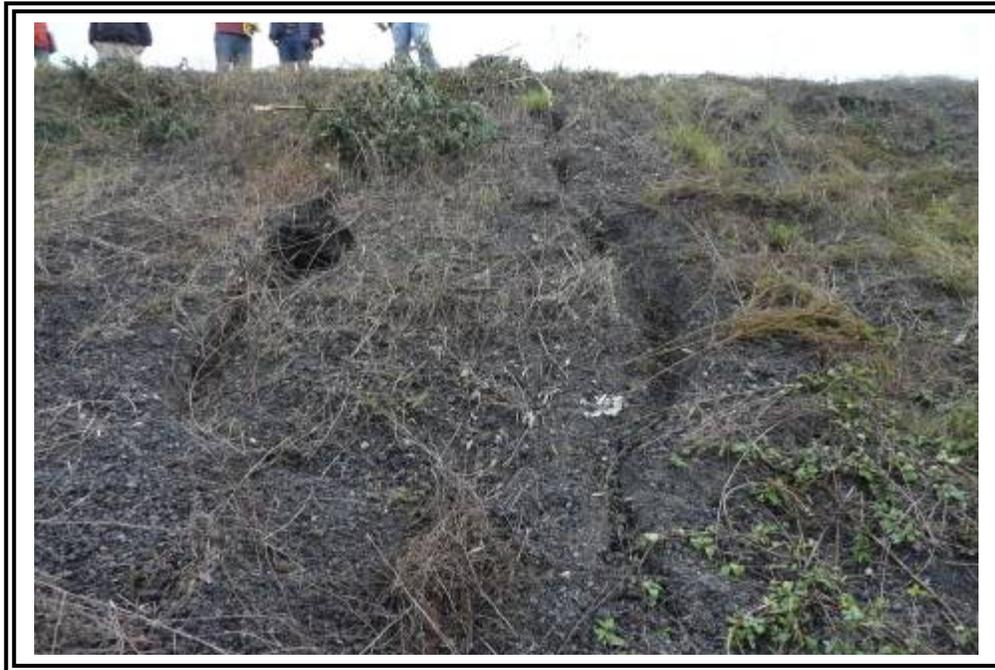
46

Erosion rills on west dike exterior slope where vegetation is sparse in bottom ash/slag surface material.

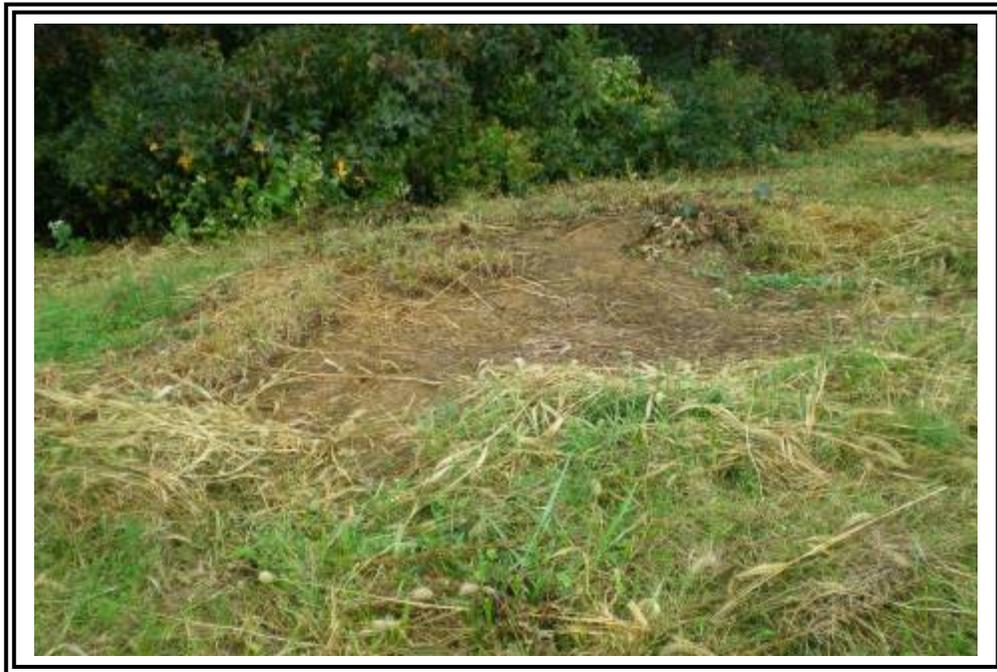
56

Looking east at downstream slope, missing ground cover and slough.

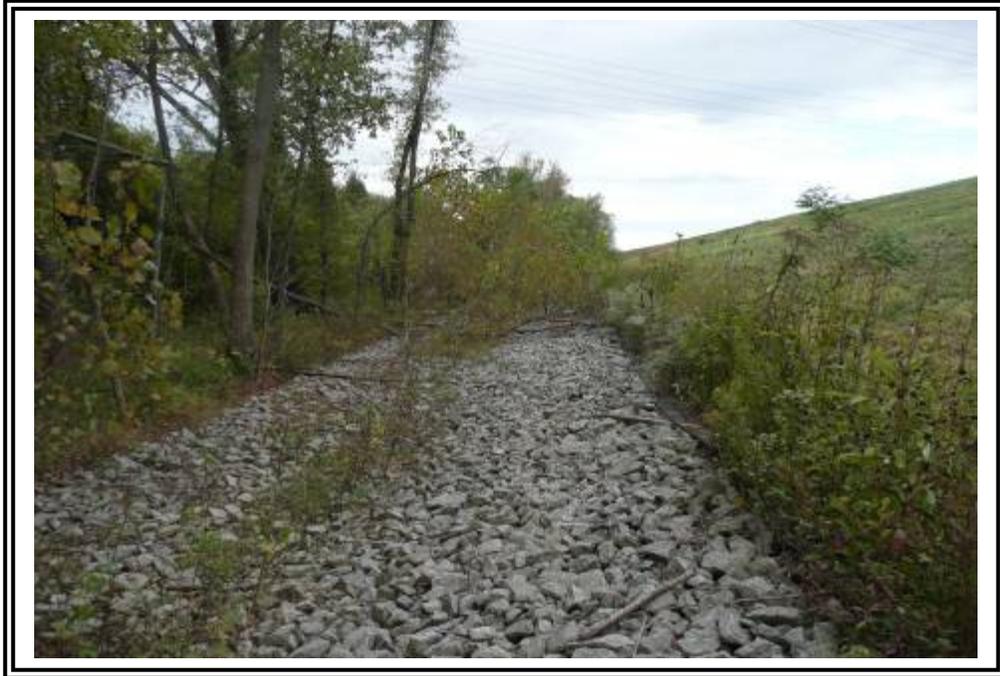
61

Vegetated rock toe drain/ditch placed as part of 2003 slide repair.

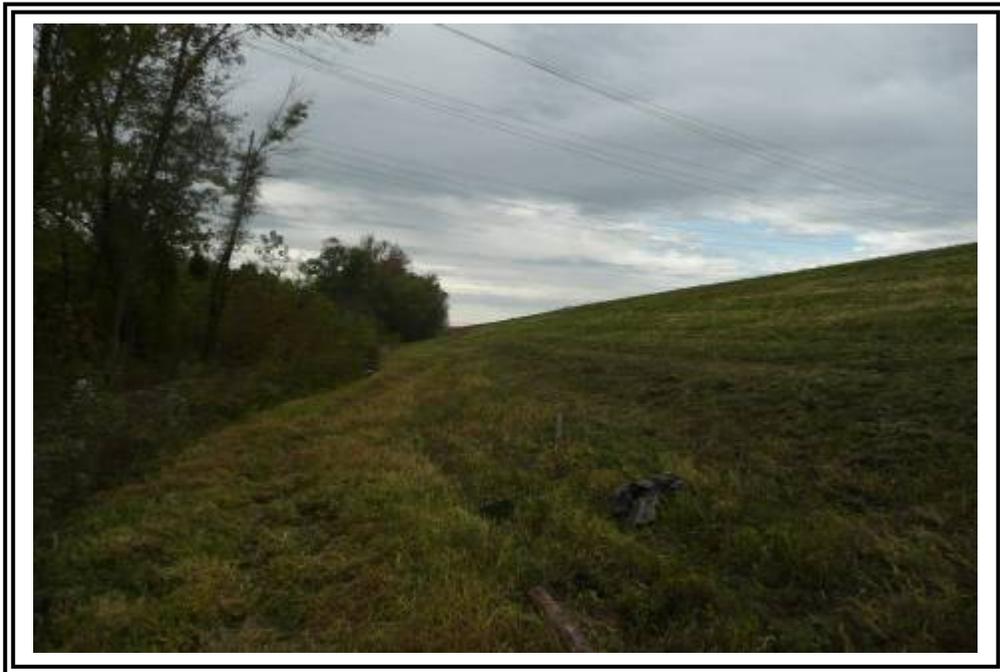
62

Exterior slope of east dike where the toe was extended out as a part of the 2003 slide repair, looking south.

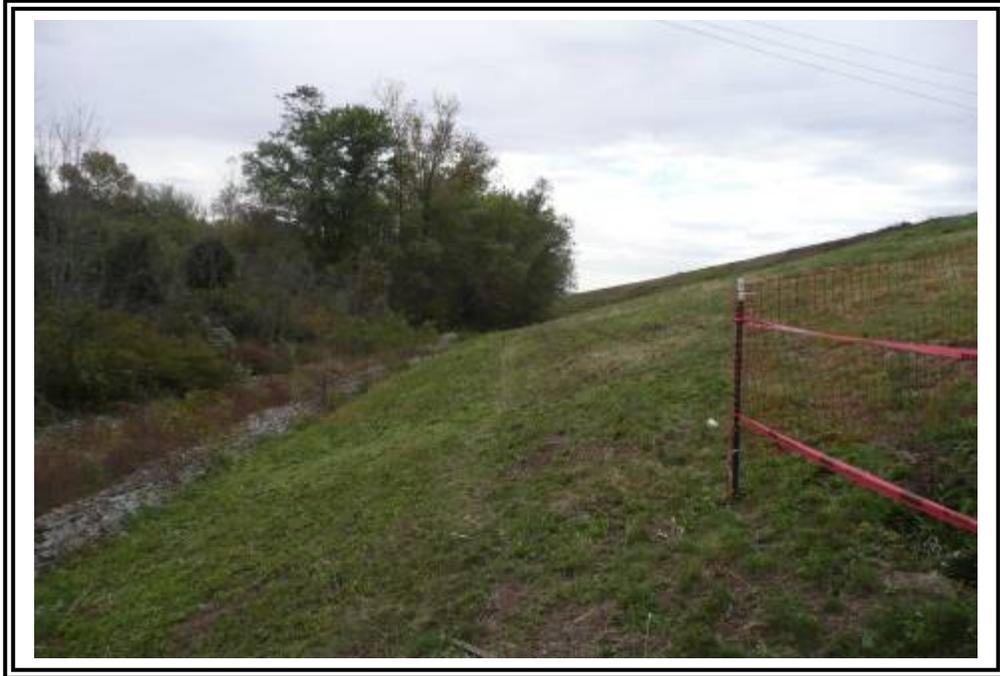
63

Slope repair area on east dike showing rock toe drain and location of sinkhole (right). Southern extent of repair in background where trees are prevalent.

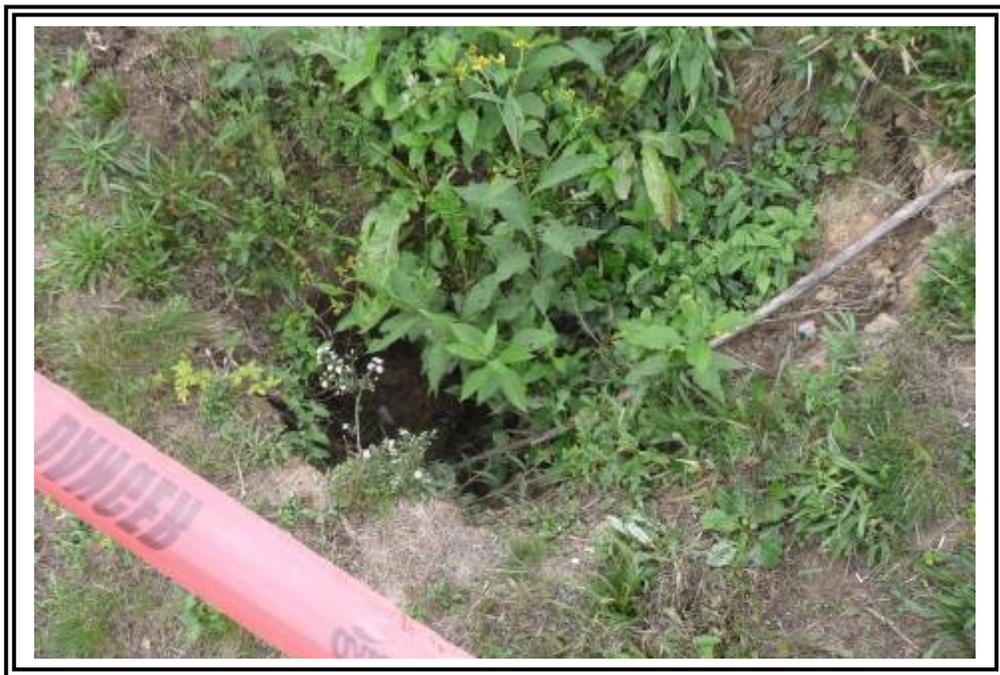
64

About mid-way along the east dike a sink hole, approximately 3 feet deep by 5 feet wide by 5 feet long was observed on the exterior slope (Photo 64). In this location, slope repair work was conducted and the toe of the slope was extended approximately 51 feet beyond the original toe (Photo 62). At the toe of the slope the ditch line conveys water flow which includes effluent from Ash Pond B (Photo 65). The ditch line is located approximately 8 to 9 feet from the toe of the slope. On the interior and exterior slopes of the east dike superficial, grassed-over sloughs were observed. At the mid-point of the exterior slope a possible animal burrow was noted and in the same location an old slide area was observed which measured approximately 20 feet wide (Photo 68). Slightly south of the mid-point of the dike an active area of slough was observed and was measured to be approximately 22 to 23 feet wide. An 8-inch wide animal burrow was noted on the exterior slope just south of the active slough area. Another area of active slough was observed to the south of the animal burrow. The area is approximately 22 feet wide. South of this active area of slough an area of old sloughing was noted which is heavily vegetated and approximately 60 to 70 feet long (Photo 71). An erosion rill and/or animal burrow, approximately 4 feet deep and 2 feet wide, was observed behind the headwall in the slope (Photo 74). South of the headwall, slope repair was performed and continuing south. The repair work included adding a bench and rock at the toe. The bottom 20 to 30 feet of the slope and toe are armored with rock to the creek level. At the south end of the dike there is an older scarp in the original slope above the repair bench. The scarp is approximately 15 to 16 feet wide.

Close-up of sinkhole in 2003 slide repair area. Appears to be above pipe for seepage collection system.

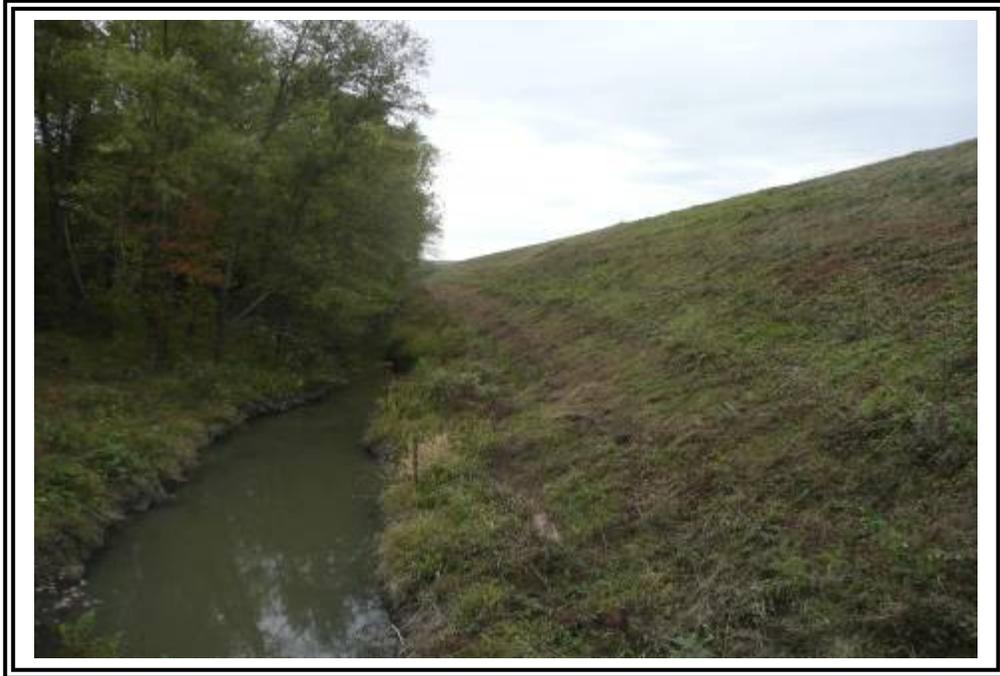
65

Looking south beyond 2003 slide repair area. Water in ditch is predominantly effluent from Ash Pond B.

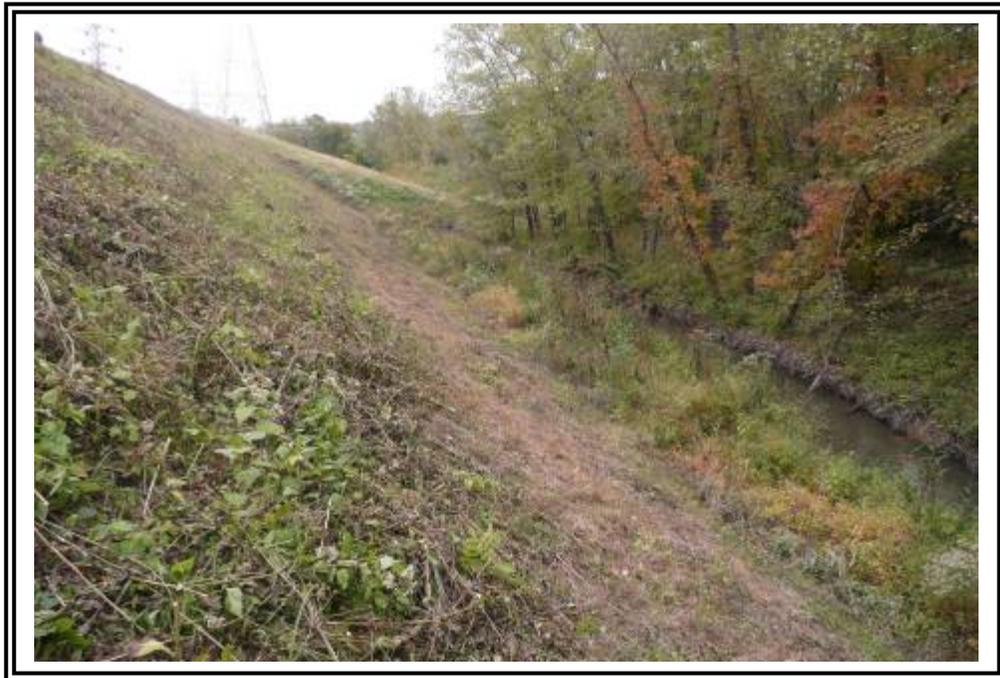
66

East dike, exterior slope, looking north at end of slide repair area. Note steeper slope beyond repair area.

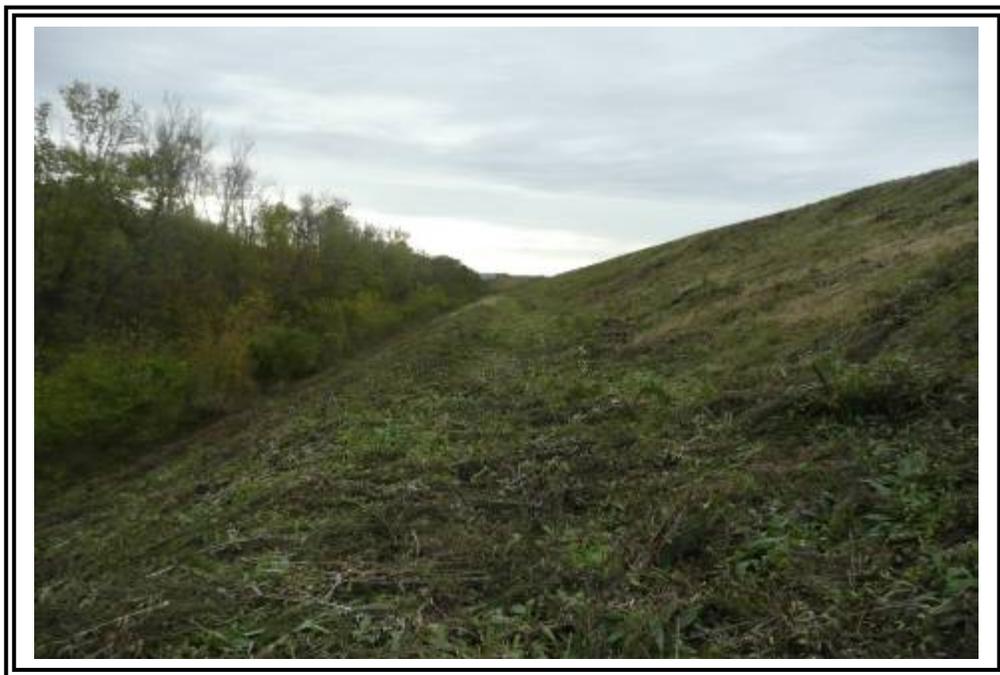
76

East dike exterior slope in area of 1991-1992 slope repair, looking south. Note bench and broad leafy vegetation.

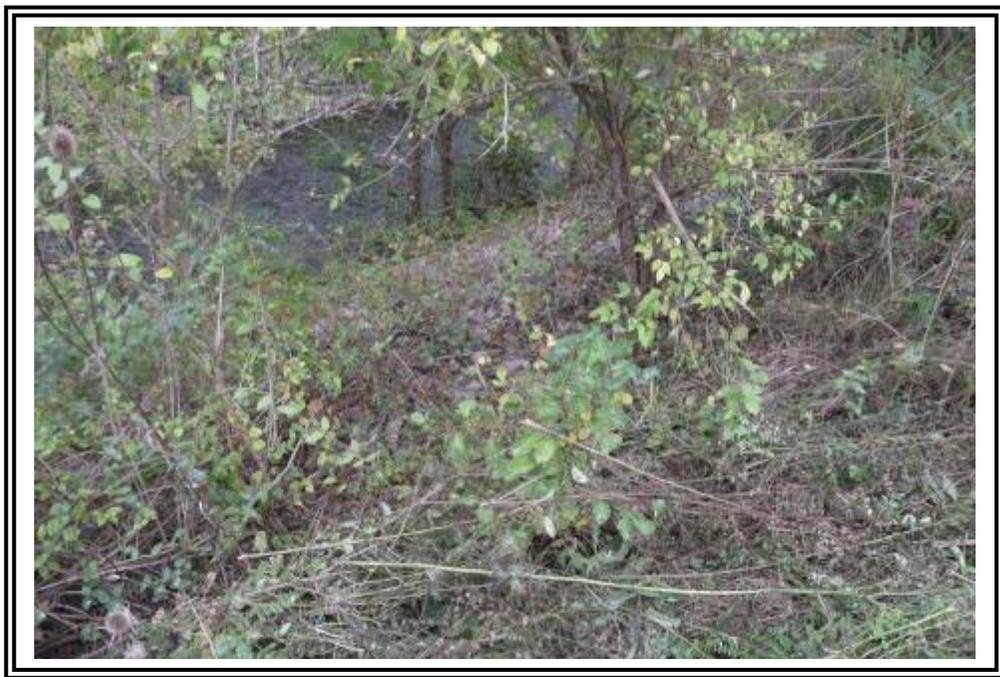
78

Rock slope protection installed as a part of the 1991-1992 slope repair work. Note saplings and brush.

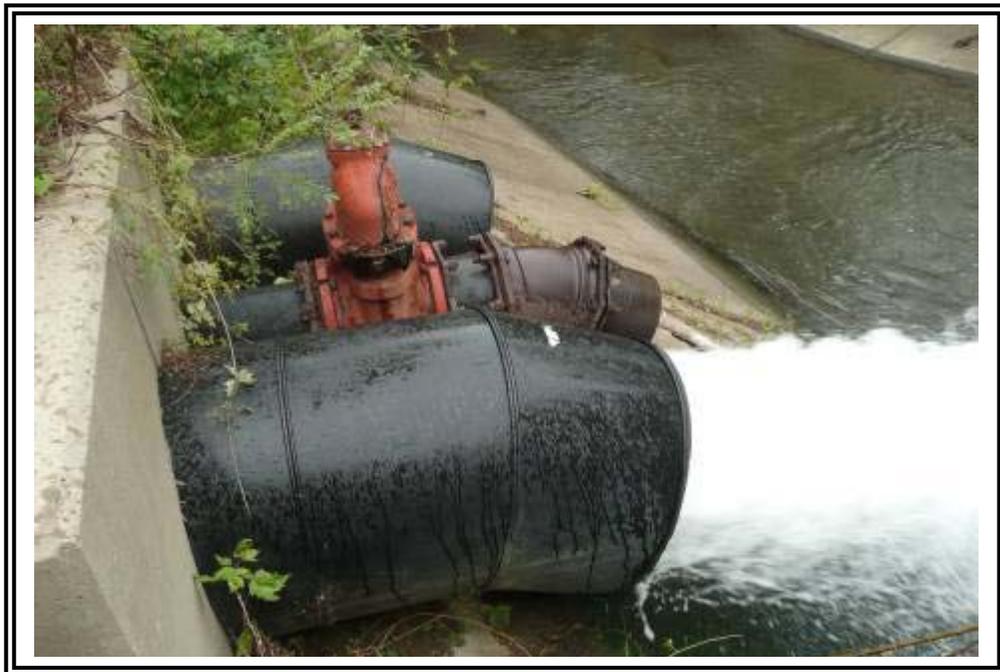
82

The Ash Pond C outlet consists of a 24-inch diameter smooth-walled HPDE slant pipe. There is a 12-inch diameter ductile iron siphon. The valve for the siphon is cracked. There is also a 24-inch diameter smooth-walled HDPE pipe (Photo 82).

Ash Pond C outlet (near), siphon pipe (middle, note cracked valve), and high water over flow outlet (far).

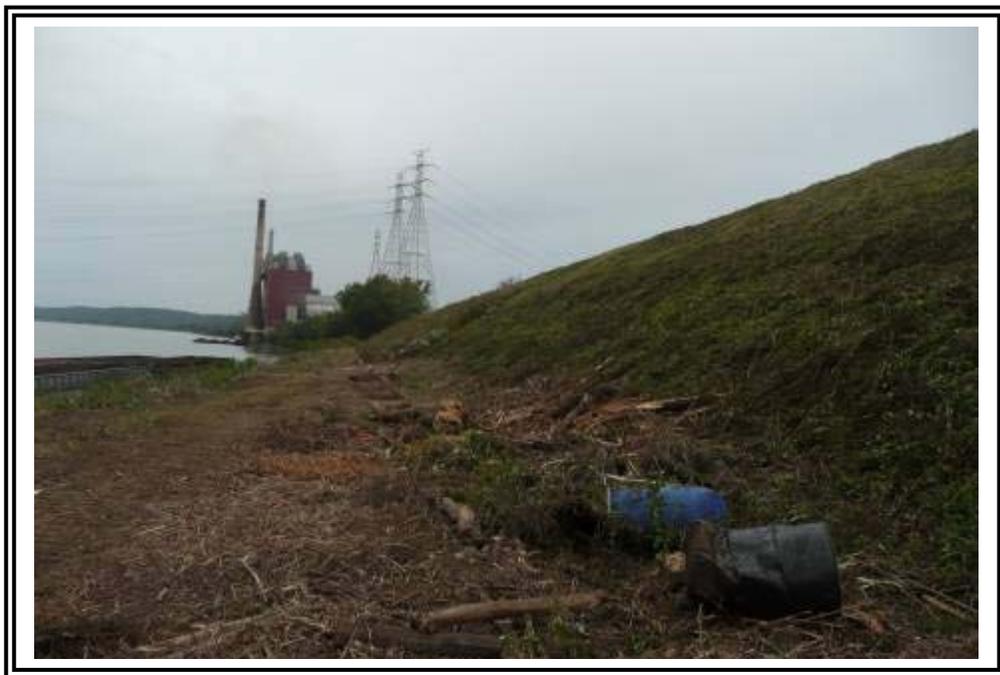
88

West dike exterior slope adjacent to the Ohio River, looking north, showing flood deposited debris on river terrace and beginning of 1998 rip-rap buttress slope repair in background.

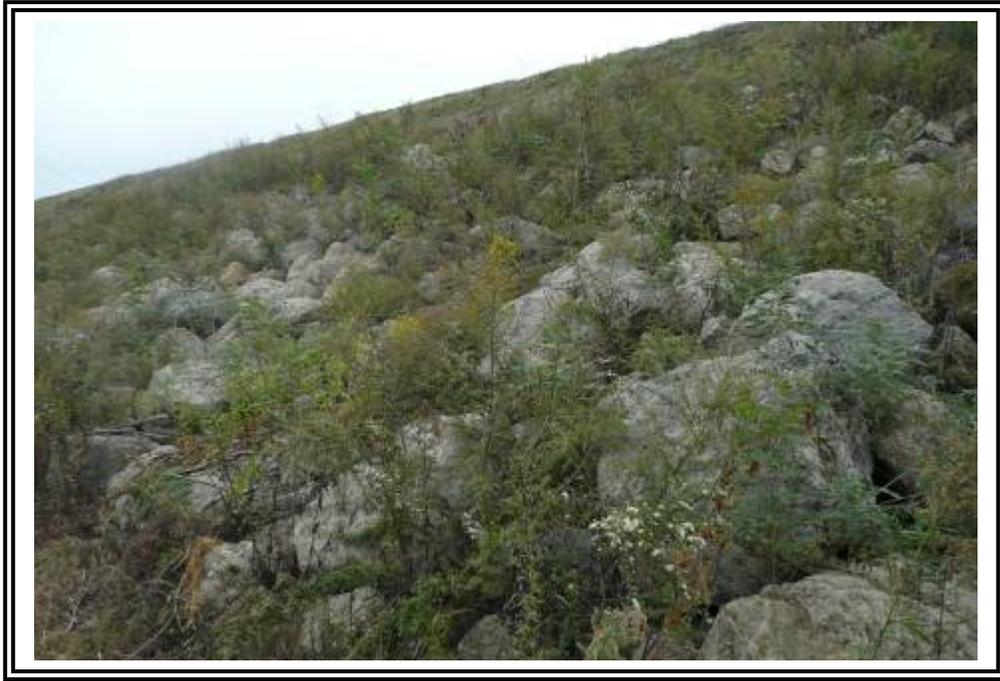
89

On the west exterior slope slightly north of the south end of the dike, repair work was performed with large rip rap (approximately 3 to 4 feet in diameter) being placed (Photo 89). North of this repaired area a vegetated area of slough approximately 42 feet wide was observed. The vegetation on the west dike exterior slope changes from brushy/broad-leaf vegetation to weeds/grass at about the mid-point of the dike. North of the change in vegetation is an area where reinforced slope repair work was performed in 2002. North of the repaired area an area of slope repair/disturbance was observed during the site visit. The erosion control matting was observed to be shredded (Photo 94). At the north end of the west dike the stockpile areas at the toe of the exterior slope have allowed surface water (runoff) to pool (Photo 98).

Close-up of rip-rap buttress slope repair. Note vegetation in rip-rap.

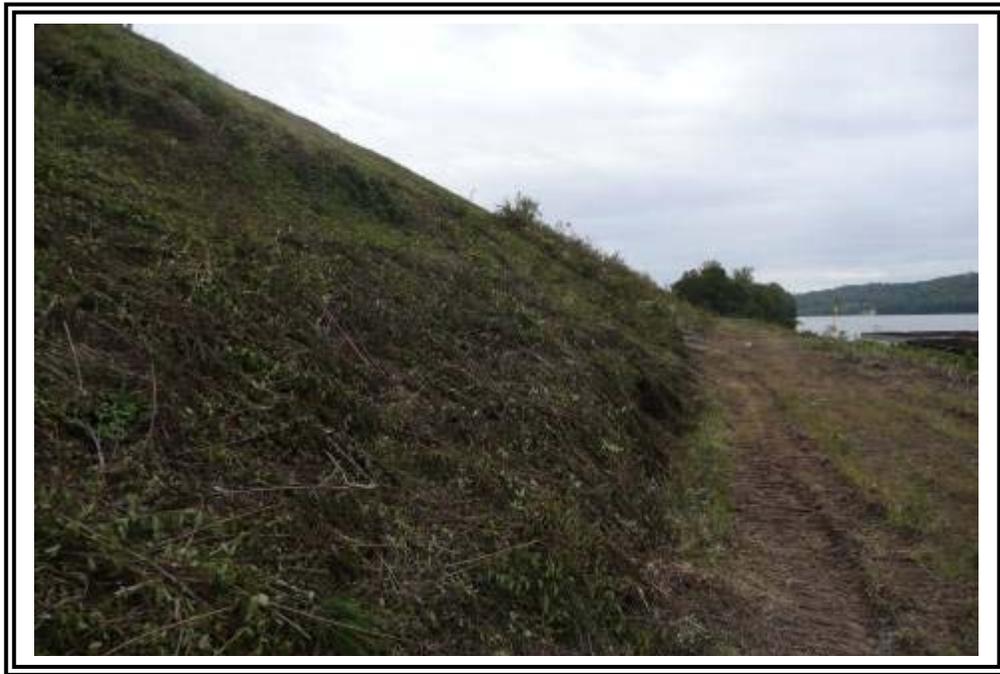
90

West dike showing the northern extent of rip-rap slope repair, looking south.

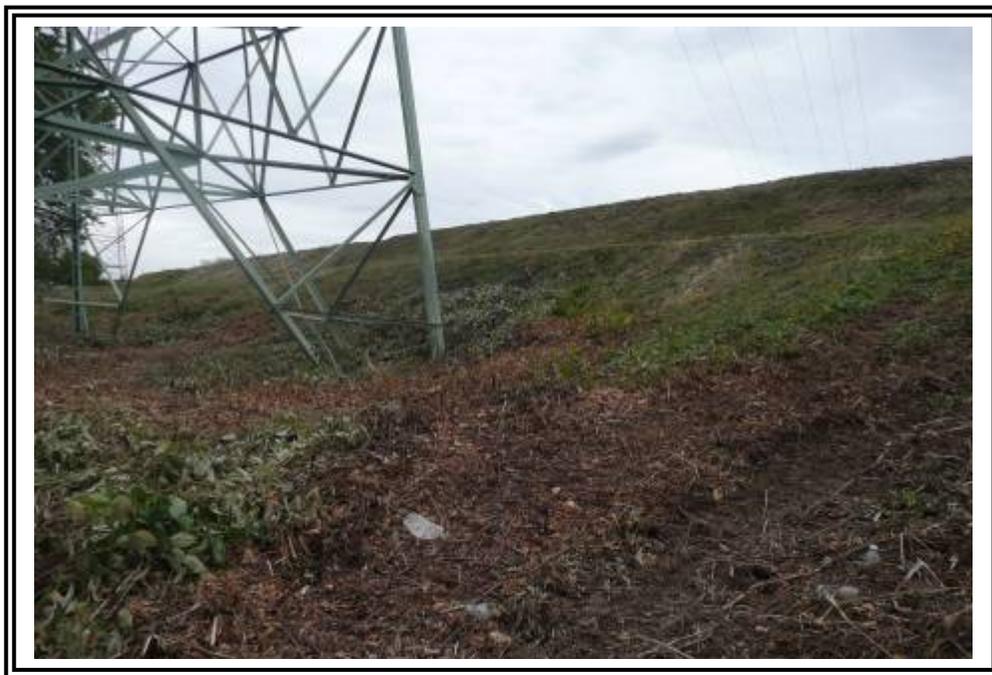
92

West dike slope in area of 2002 slope repair where soil buttress and toe was constructed, looking northeast. Bench can be seen near middle of slope.

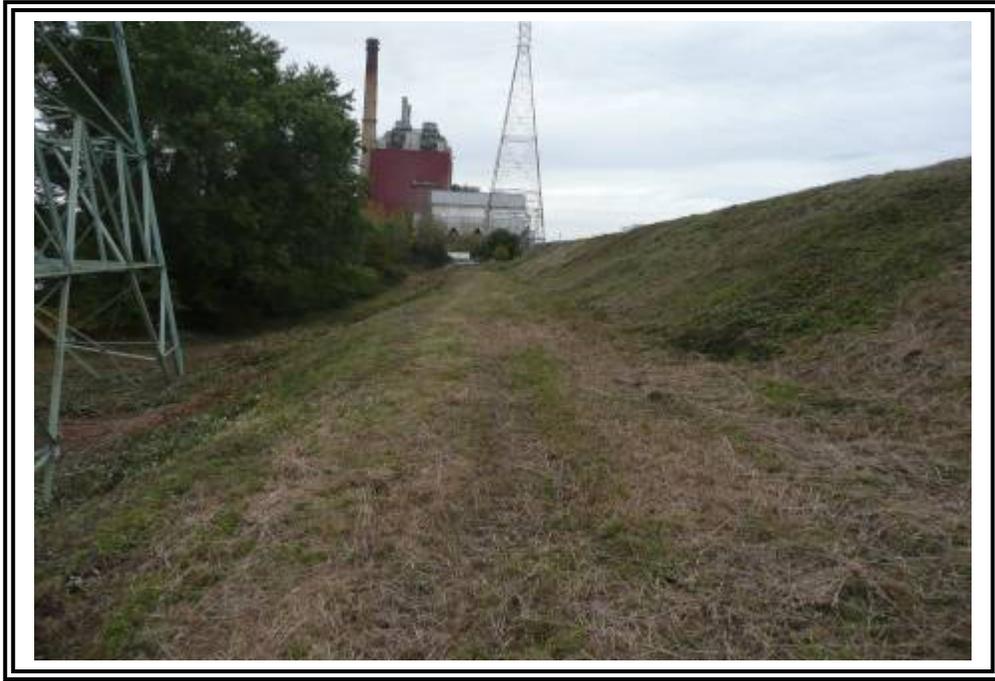
93

West dike exterior slope in area of 2002 slope repair, looking south.

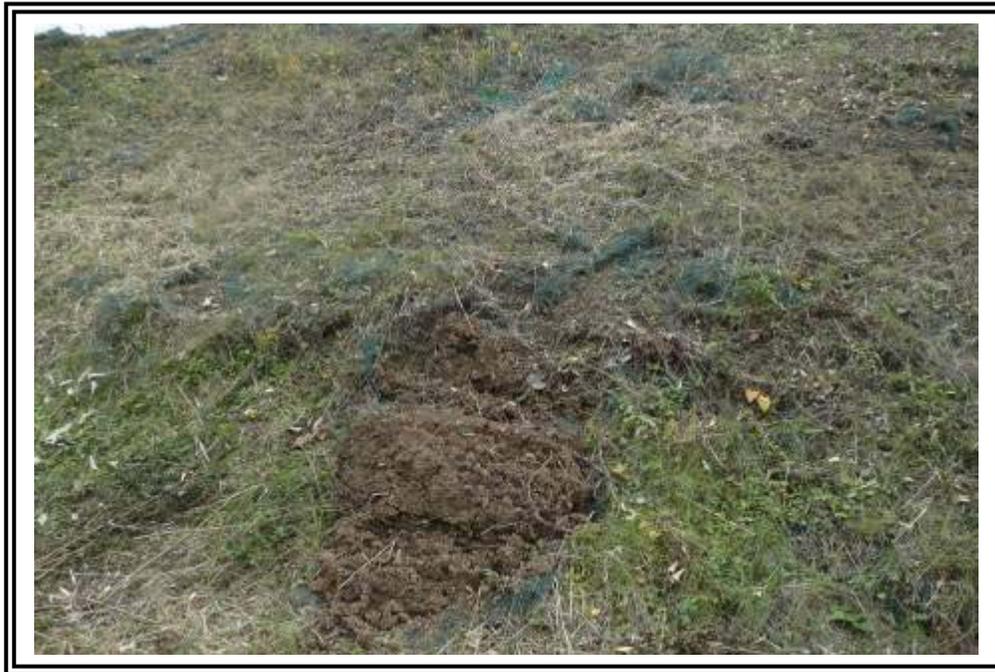
94

Area of exposed and disturbed erosion matting adjacent to 2002 slope repair area.

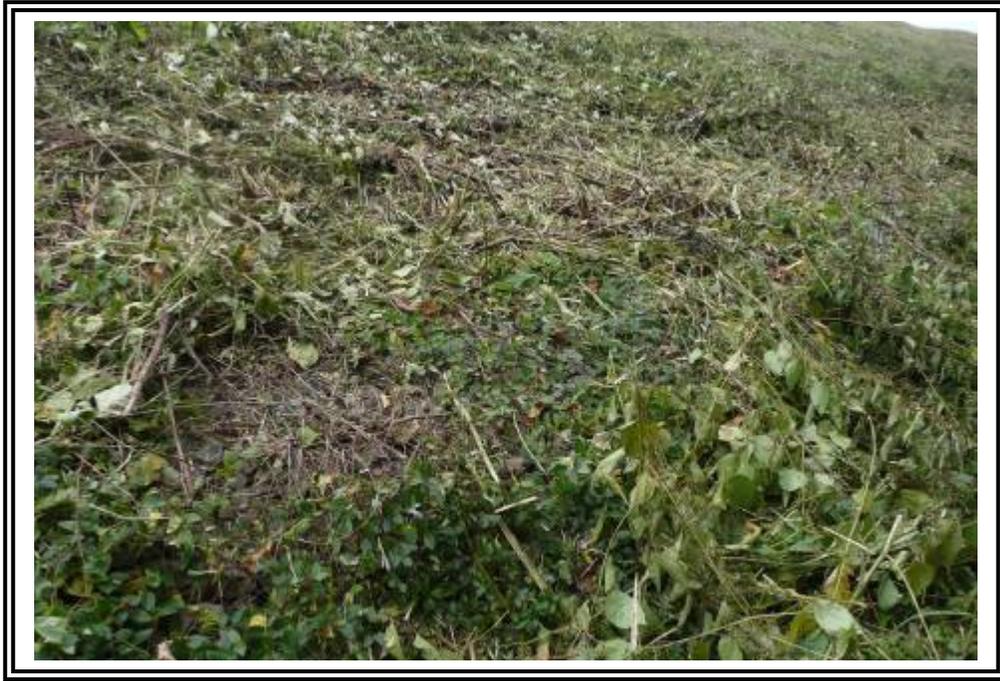
95

Rock toe drain of 2002 repair area of west dike. Barely visible due to vegetation in toe drain.

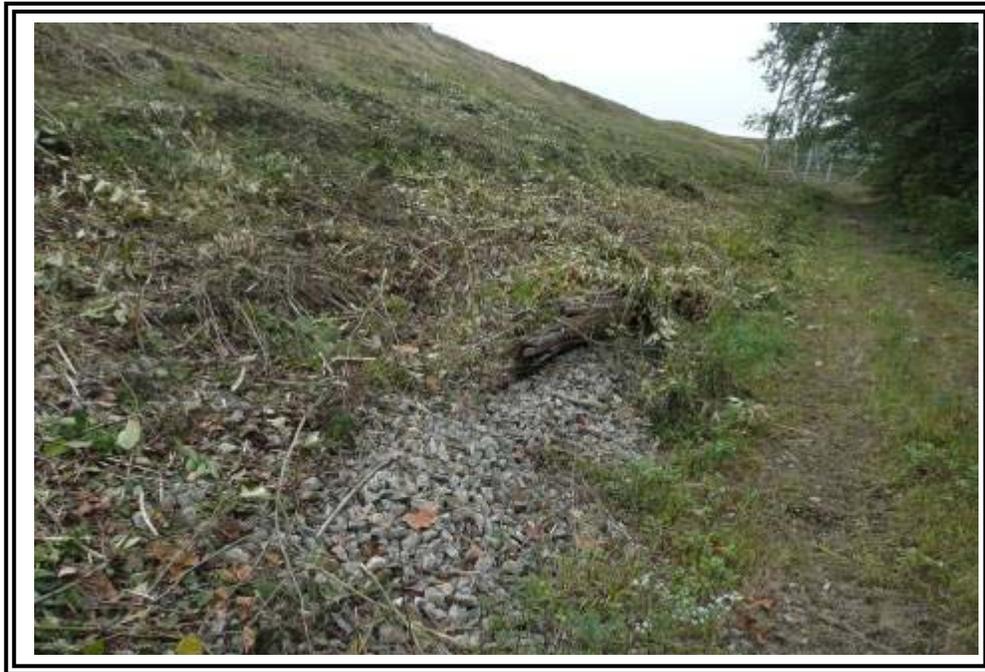
96

Rock toe drain on west dike exterior slope, looking south.

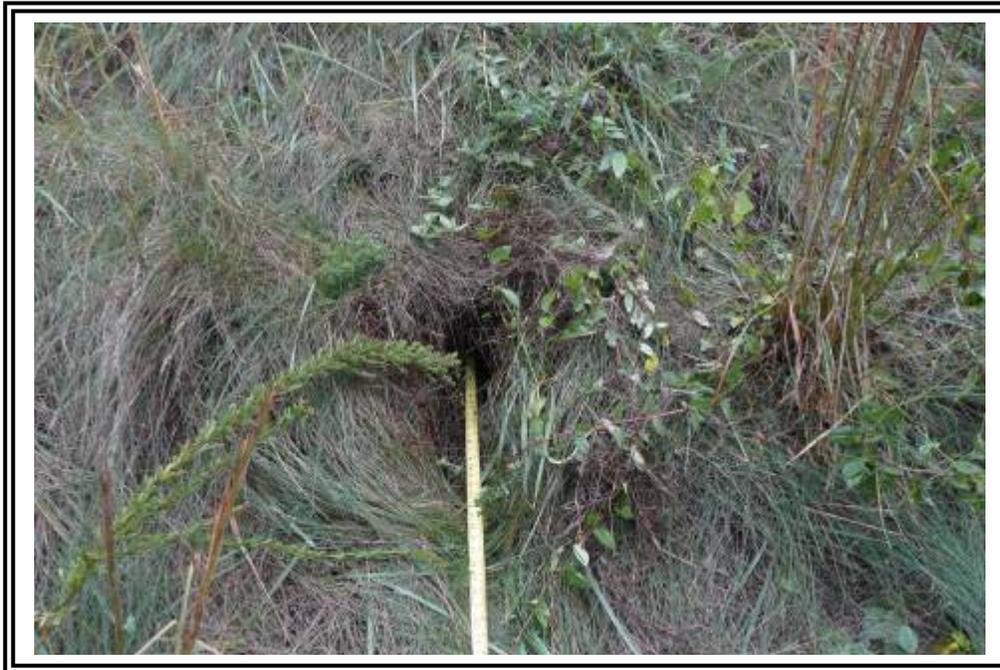
135

Example of the holes and depressions noted in this area of the east dike.

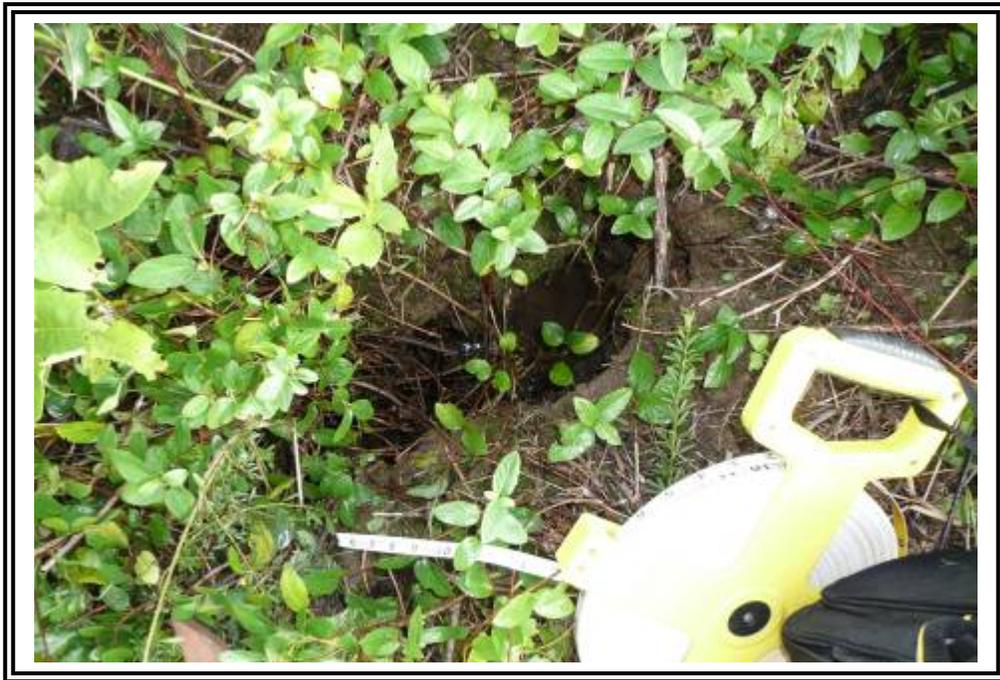
150

Vertical crack/sinkhole holding water approximately 24" long, 10" wide, and 12" deep on west dike, exterior slope.

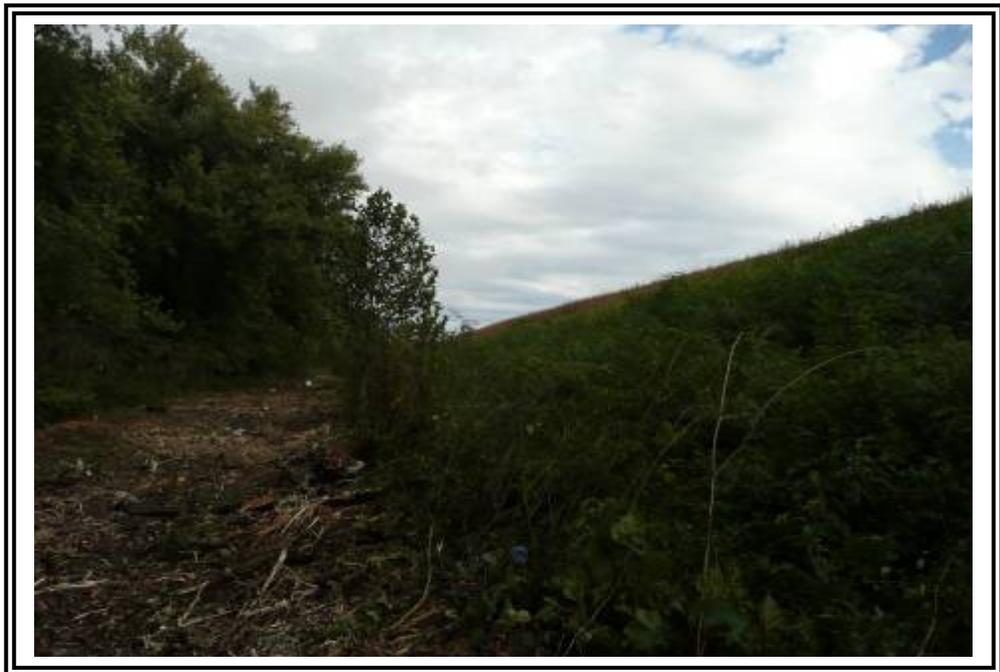
151

Toe of west dike where clearing activities have partially exposed rock toe drain, facing north.
