# Assessment of Dam Safety Coal Combustion Surface Impoundments (Task 3) Final Report

Georgia Power  
Company

Plant Branch

CHA Project No. 20085.2060.1510

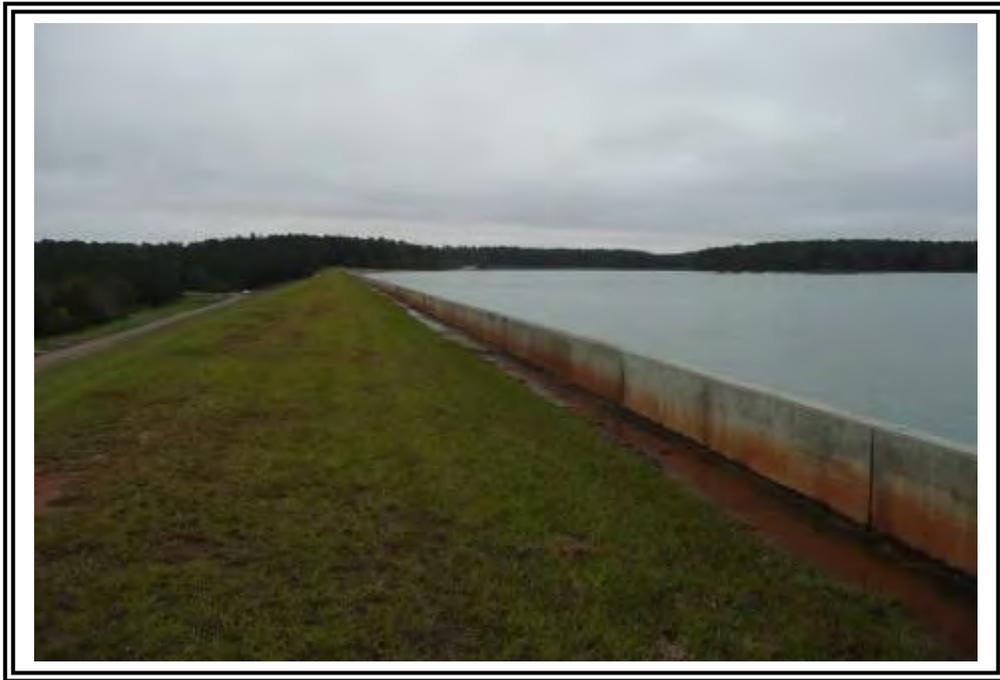
1

Northern end of Ash Pond E dike crest, facing south.

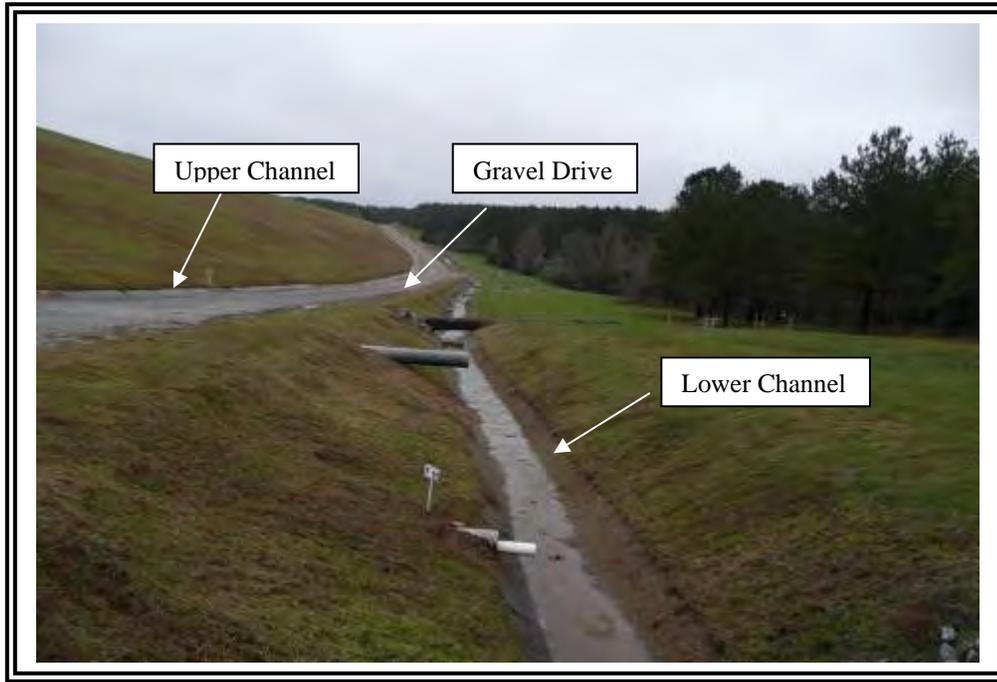
3

Ash Pond E, south dike toe, facing north. Drainage system shown. Upper and lower drainage channels are constructed of a concrete lined channel.

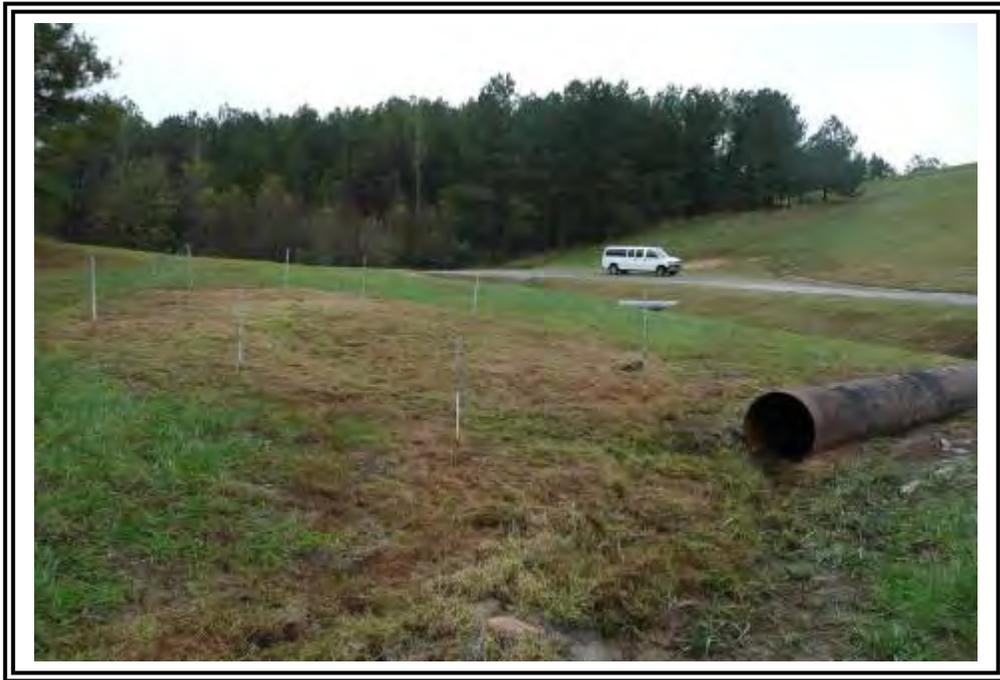
5

Ash Pond E, “soft spot” located south of emergency overflow drain (1 of 3 observed near Ash Pond E). This area has been monitored for nine years by Georgia Power with no additional expansion observed. Perimeter stakes have been placed to aid in monitoring.

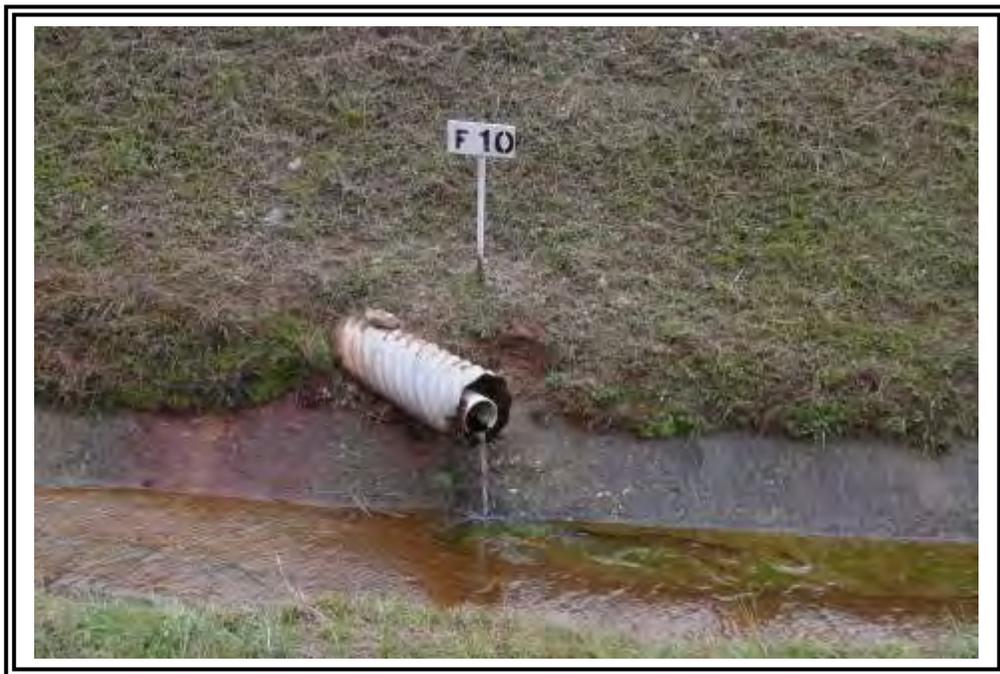
6

Ash Pond E finger drain #10. Drainage from finger drains observed to be clear.

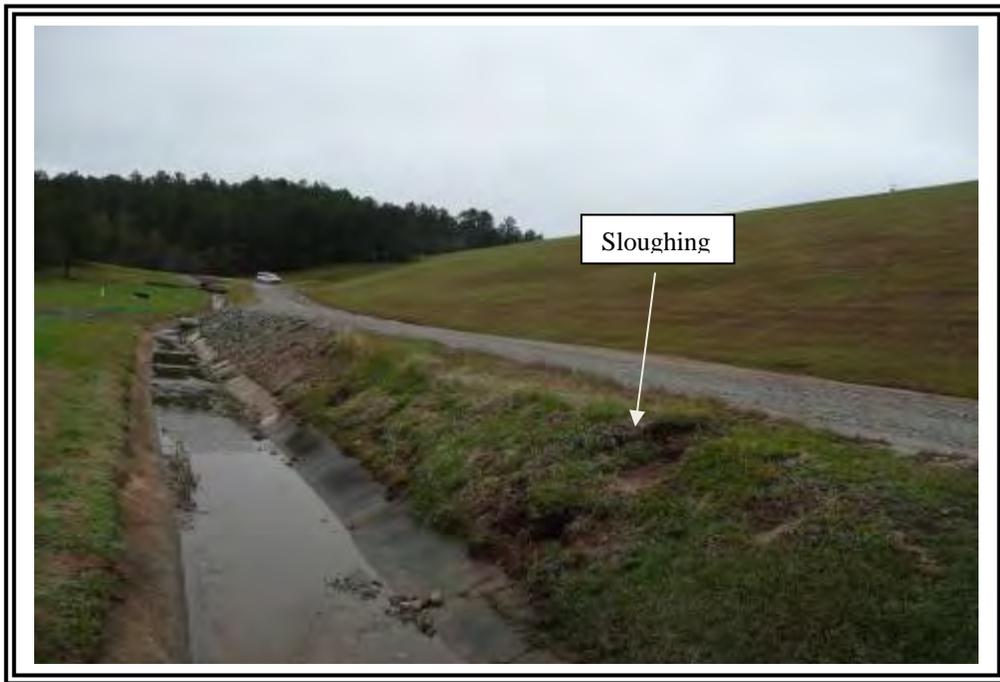
8

Ash Pond E, sloughing observed along west edge concrete line channel at the base of the toe, central portion of the dike.

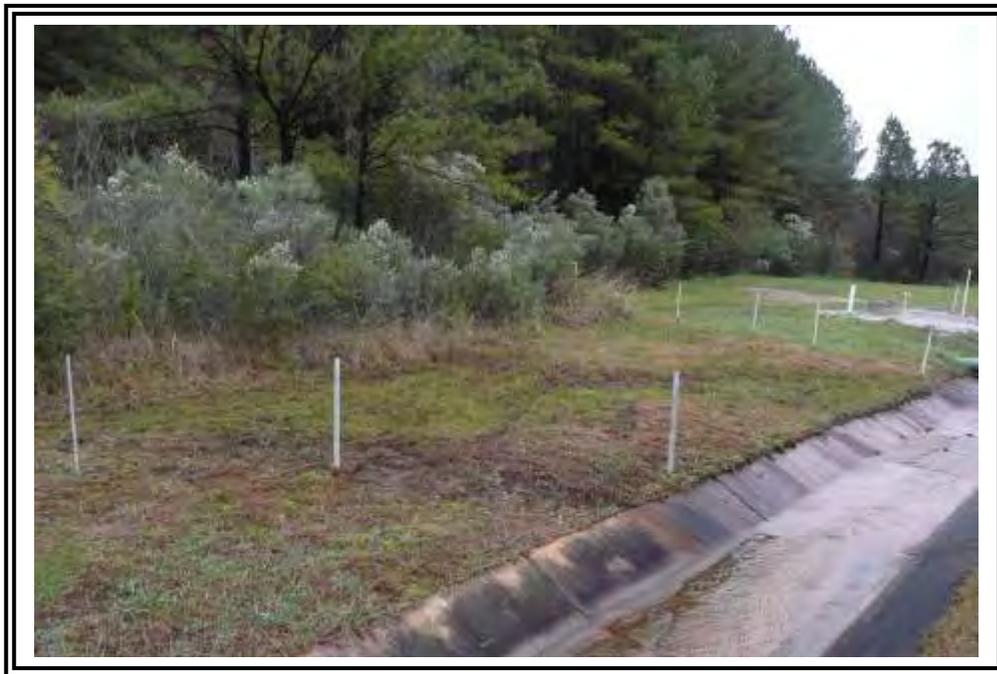
10

Ash Pond E, 3<sup>rd</sup> observed “soft spot” located east of finger drain #5. Perimeter stakes installed for all soft spots in effort to monitor expansion. No observed expansion for any of the three soft spots in at least nine years, as indicated by Georgia Power.

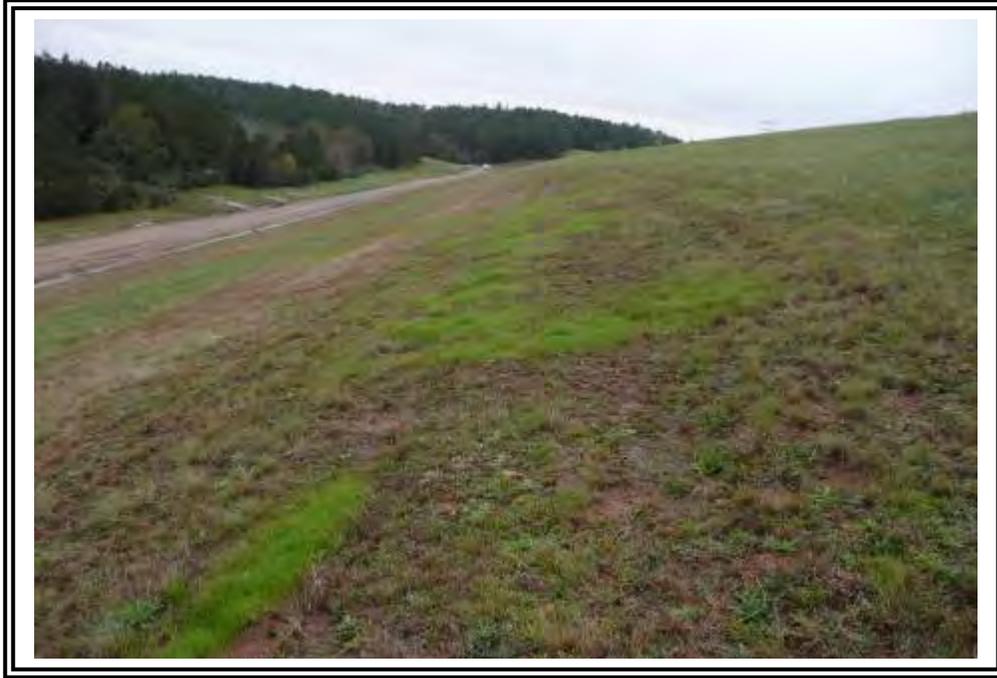
13

Ash Pond E, mid-height of dike, northern end of dam facing south. Mower-rutting observed throughout portions of the dike. Rye grass patching observed and indicated to be seasonal grass cover in effort to minimize sparse vegetation.

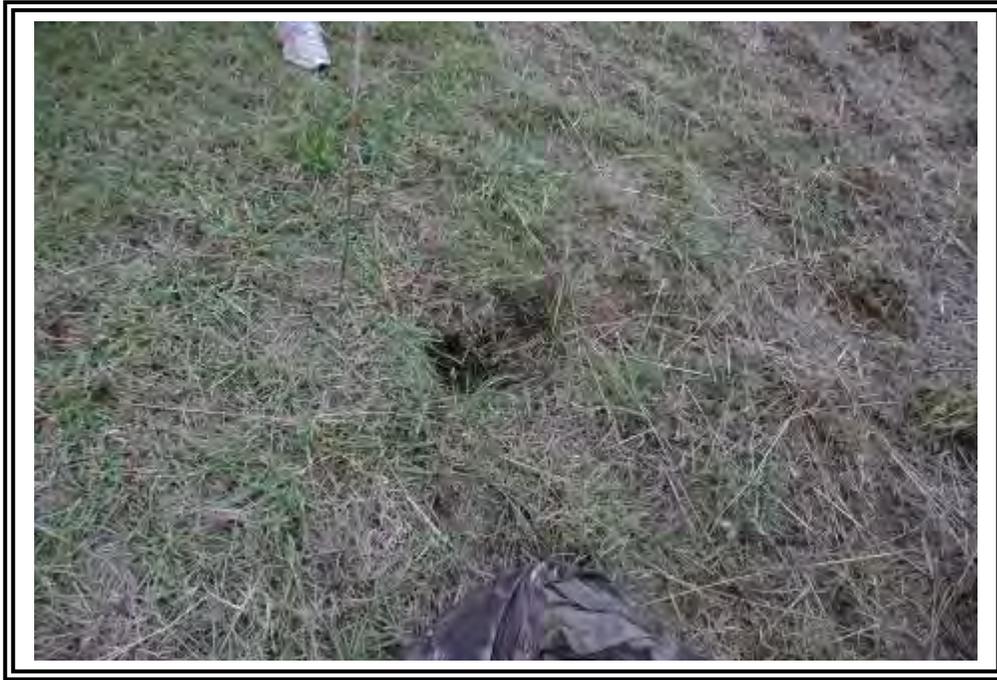
19

Ash Pond D, animal burrow located along central portion of the dike along the interior edge.  
One of several found throughout the length of the dike.

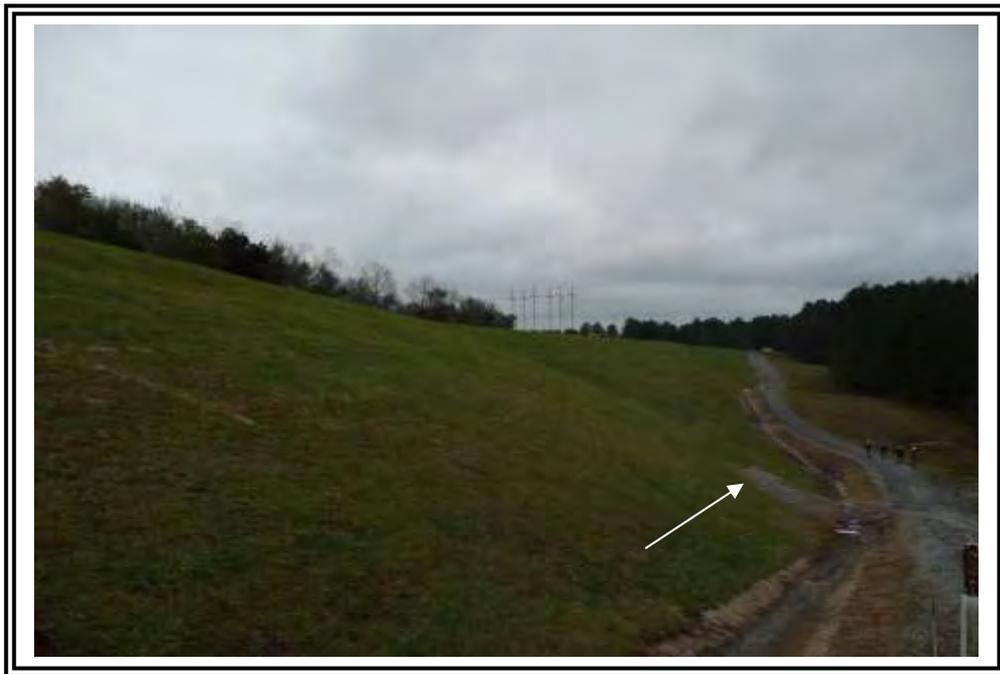
24

Ash Pond D, south central portion of dike facing south east at edge of toe. Dike seepage remediation shown by arrow.

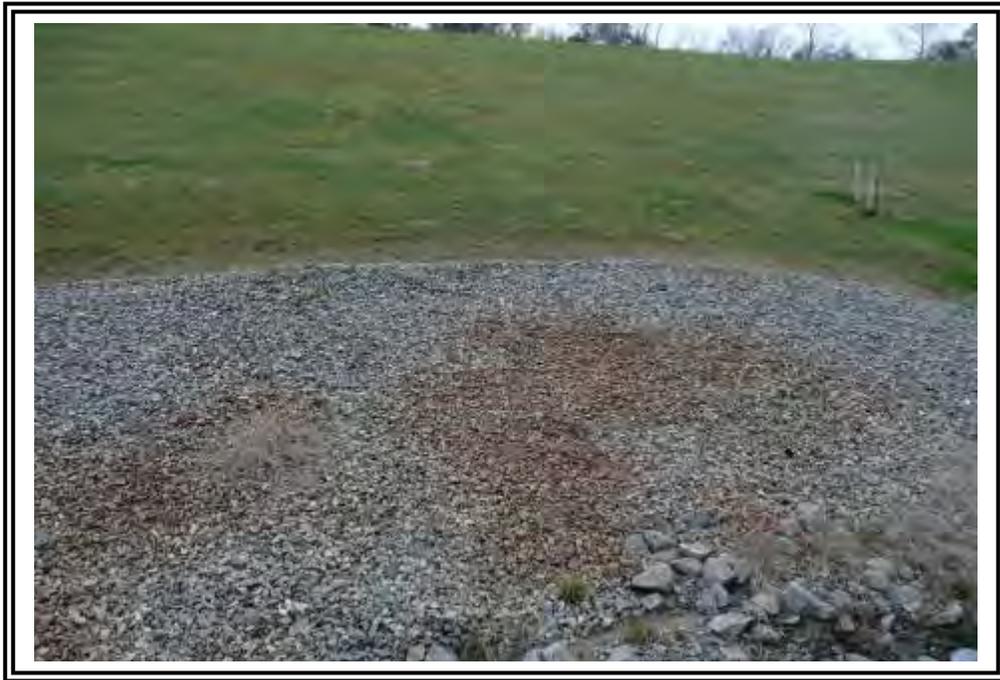
25

Ash Pond D, central portion of dike at edge of toe. Seepage remediation area shown. Georgia Power personnel indicated that this area was previously remediated and the concrete lined channel was inadvertently razed during remediation

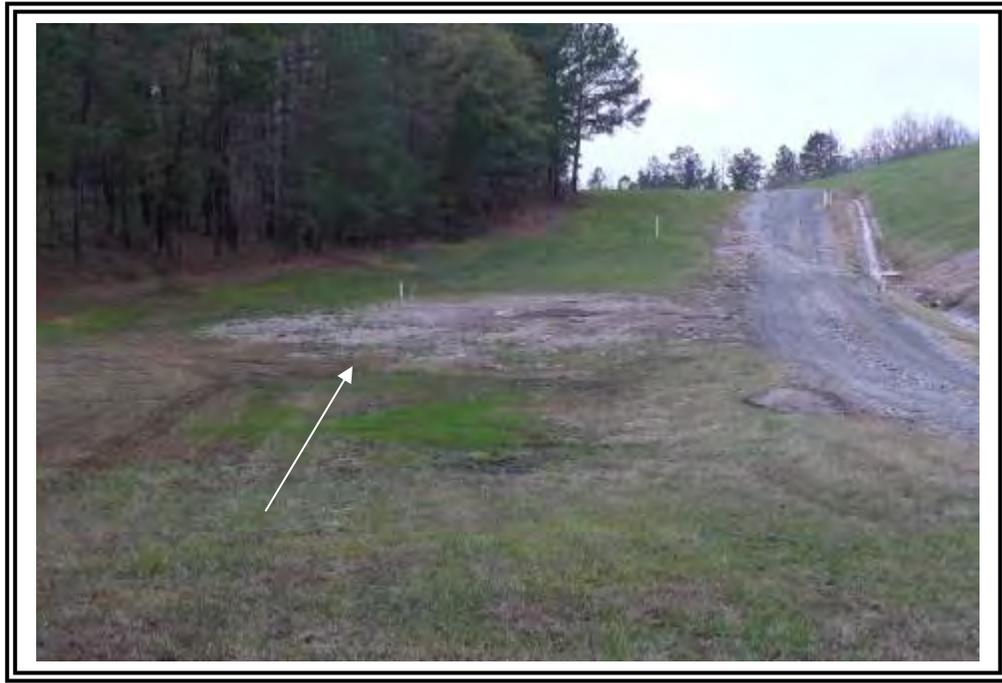
27

Ash Pond D, central portion of dike, west of toe facing north west.  
“Soft area” covered with rock indicated by arrow.

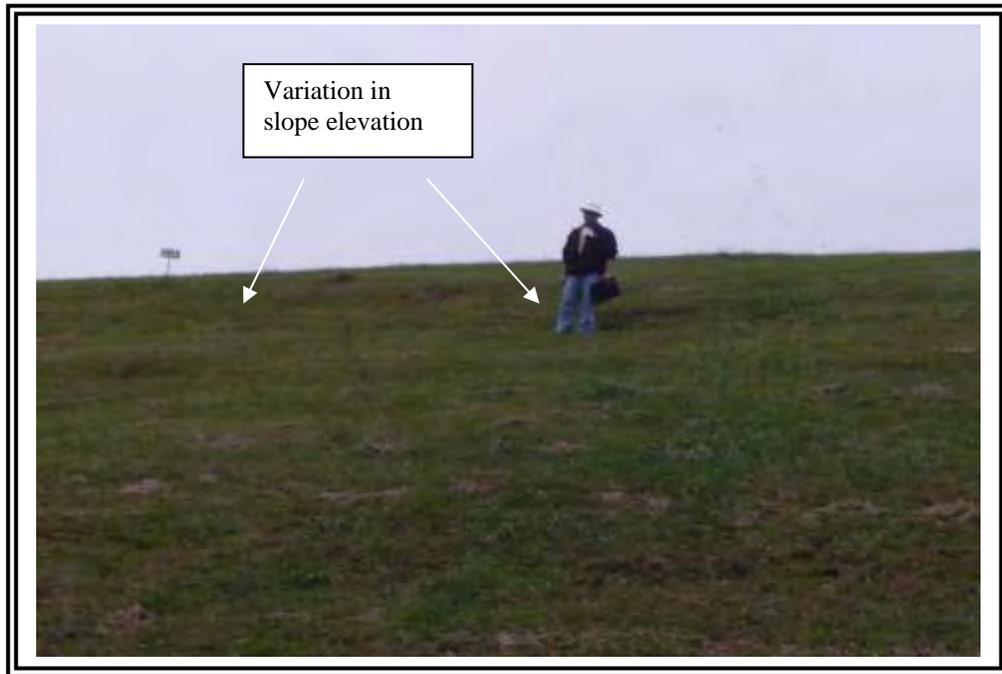
28

Ash Pond D, central portion of dike at edge of toe, facing east into the dike.  
Note dike variation in slope elevation possibly due to scarping or sloughing due to mowing patterns.

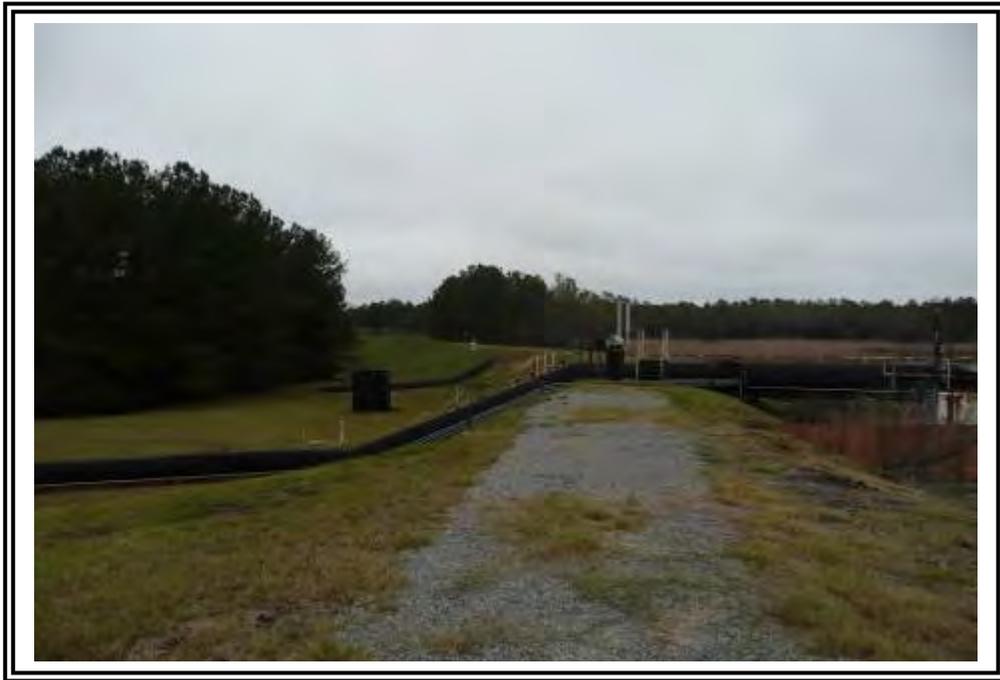
During the site reconnaissance of the west dike, a historic discharge system was observed at the south end (Photos 31 and 32). This was originally constructed as the primary outfall via a gravity feed to a treatment facility before the water was recycled or discharged to the lake. It was later replaced with two emergency overflow pipes at this location to provide an emergency outlet should the need arise. This was done around the same time the siphon system conveying water to the plant was installed. Georgia Power indicated that the historic discharge system facility has been decommissioned; however the plant maintains an NPDES discharge permit at this location.

Southwest edge of Ash Pond C along west dike crest, facing north. Historic discharge facility shown frame right is no longer in use per Georgia Power personnel.

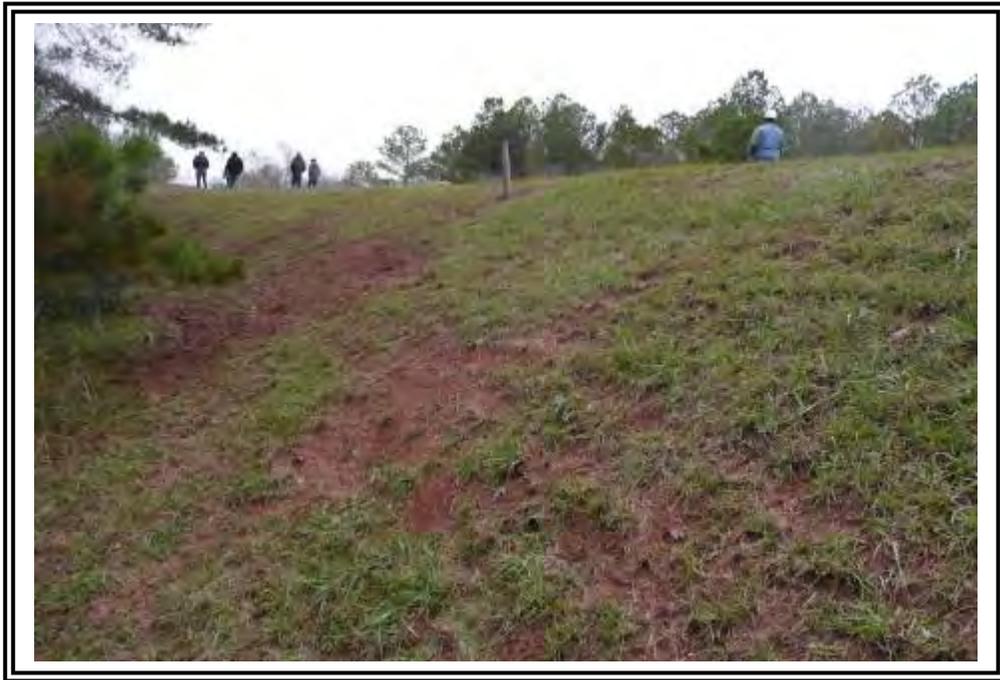
35

Several apparent areas of sparse vegetation were noted along the central and northern exterior portion of the west dike (Photo 35). These areas appeared to be caused by mowers slipping down the exterior face of the dike. Additionally, a few rodent burrows were observed along the length of the dike (Photo 37). After noting these burrow locations during the site visit, Georgia Power/Southern Company personnel were observed actively filling these areas.

Sparse grass cover on north central portion of Ash Pond C west dike toe, facing north.

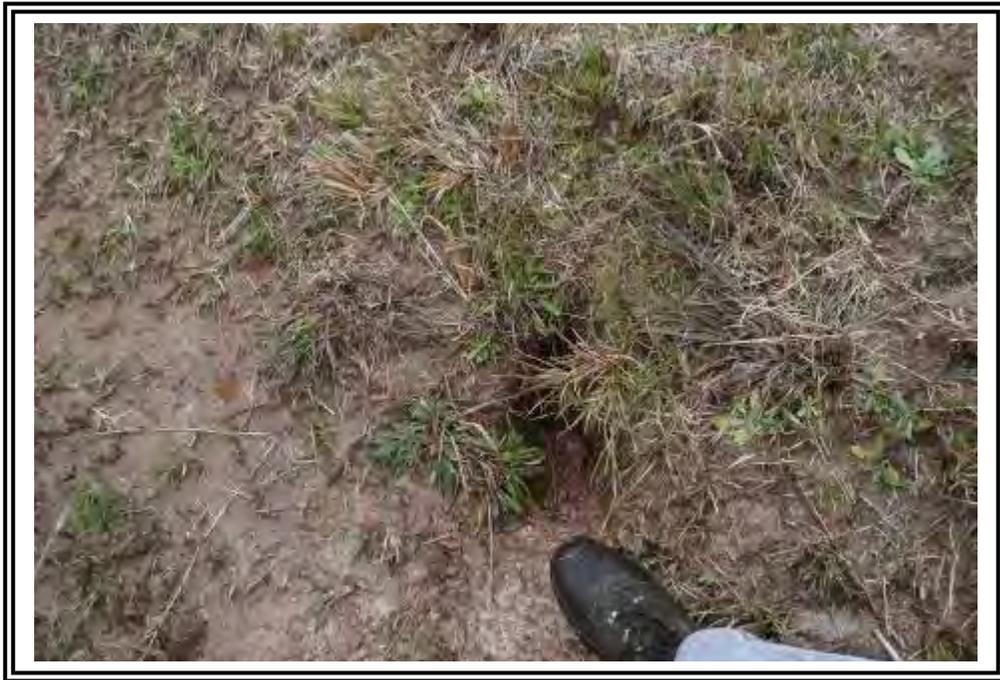
37

Ash Pond C, north portion of west dike, rodent burrow observed on upstream side of dike.

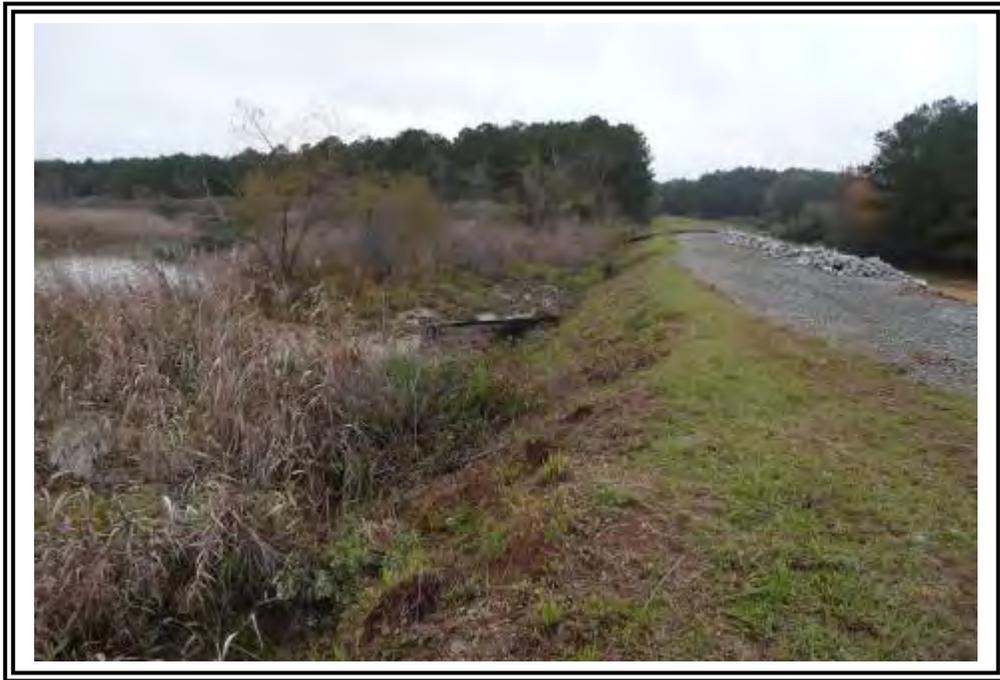
49

“Re-facing” was being performed in a section of the downstream face of the south portion of the east dike as shown in Photo 46. This area is located south of the “recycle water” station, located near the center of the dike. The re-facing of the section on the east dike entailed the same procedures used along the south dike exterior facing. Tall grass was observed along the upstream side of the dike as shown in Photo 49.

Central portion of Ash Pond C east dike facing north.  
Interior pond edge shown with thick and tall vegetative growth in the ash.

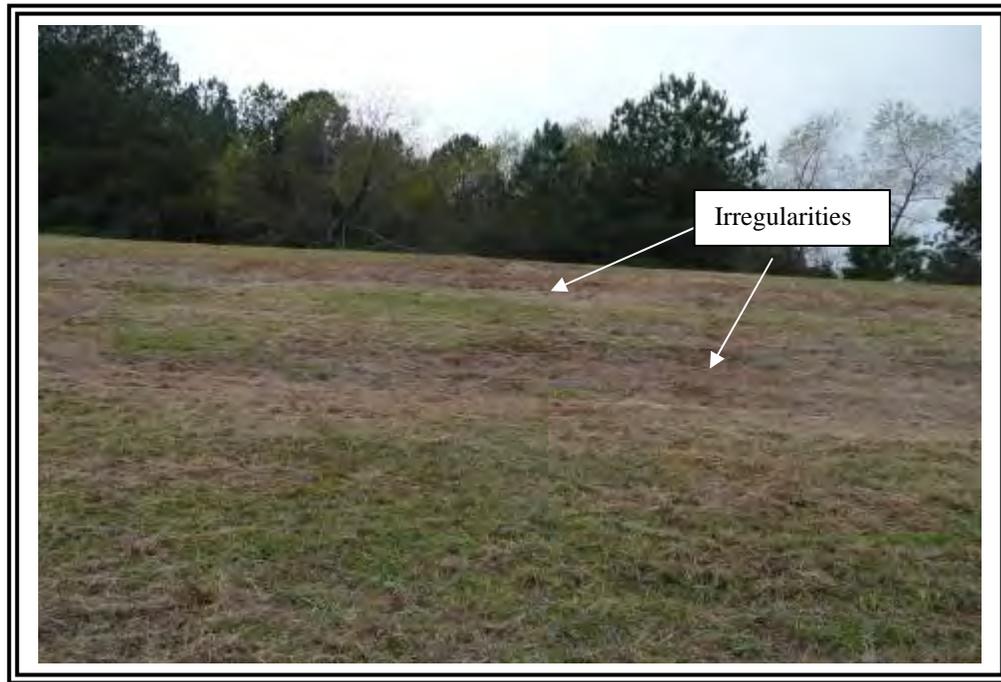
53

Ash Pond C, north end of east dike along dike toe, facing west. Dike irregularity due to mowing indicated.

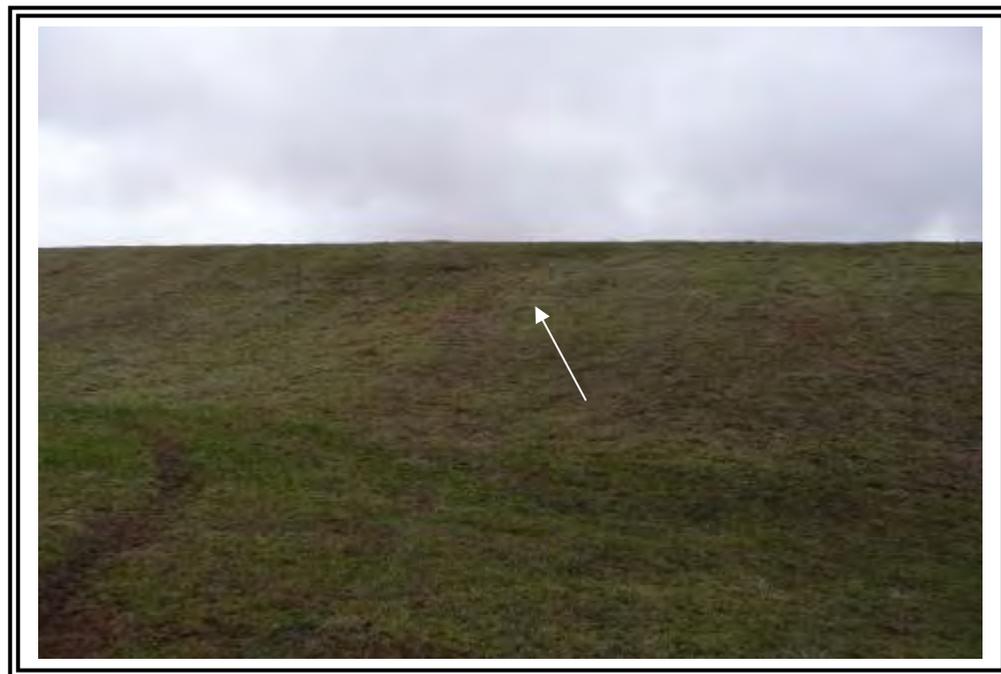
54

Inconsistencies in the dike’s downstream face were also noted along the south end as shown in Photo 54. These variations in the face of the slope appeared to be either the remnants or initial formation of erosion rills beneath the vegetation currently present on the slope.

Downstream slope of Ash Pond C east dike near the south end showing variations in elevation.

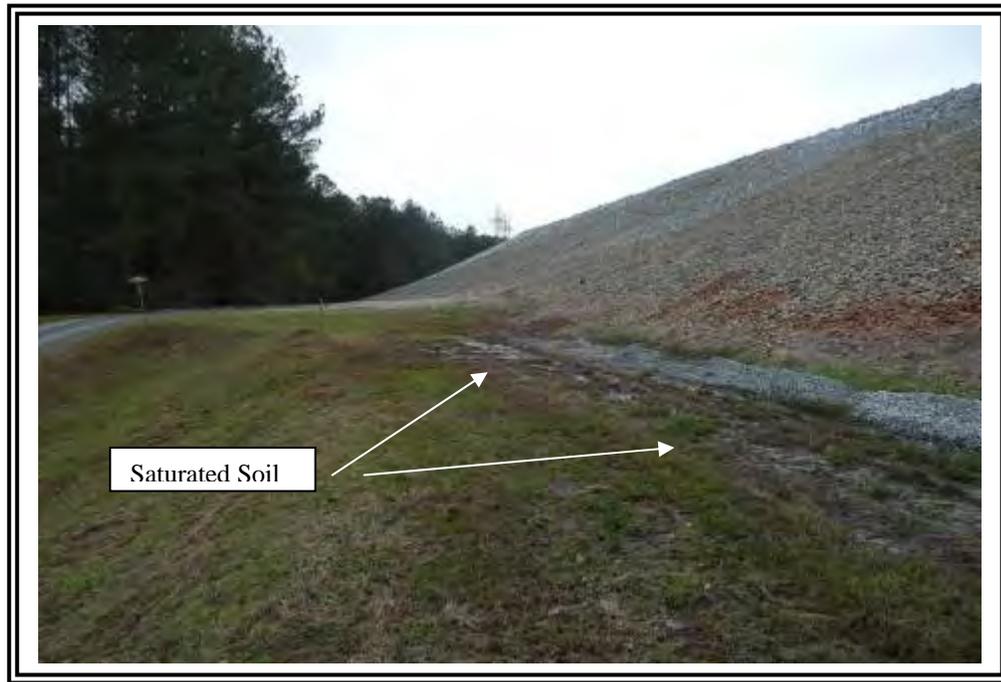
59

Ash Pond C, western central portion of south dike facing west. Saturated soil shown.

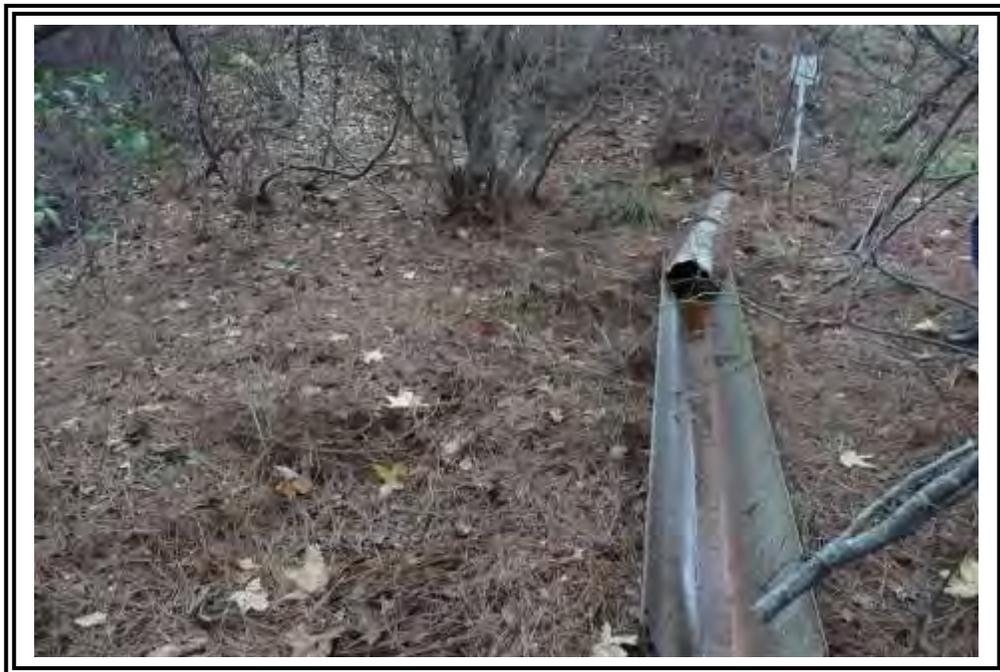
Seepage drains SD1-SD3 were observed to produce clear water as shown in Photos 62 and 63. This water was released directly onto the native soils north of Lake Sinclair

Ash Pond C seepage drain No. 3 shown. Draining water was observed to be clear.

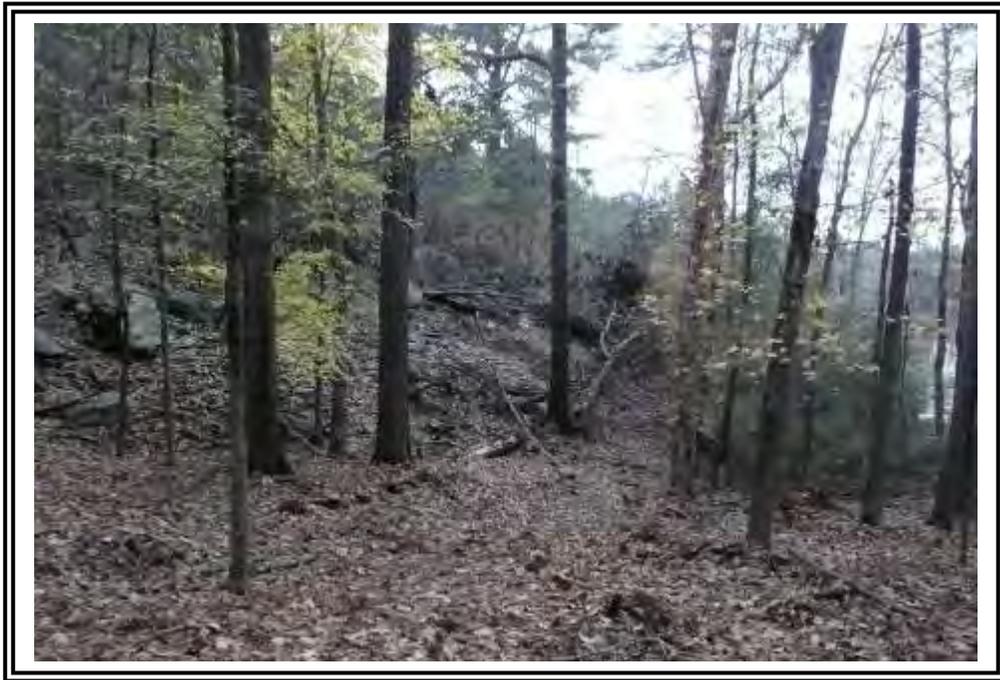
67

During the site visit, heavy vegetative cover including large trees and large boulders were noted as being present along the downstream edge of the dike and along the toe as shown in Photos 66 through 68. Heavy tree cover was also observed along the east end of the upstream edge of the dike and on top of the filled in area of the pond. Representatives of Georgia Power stated that it was their opinion that due to an “over” constructed dike and the southern portion of the pond being filled with ash and capped, the trees along the edge of the crest would not pose any impact to the stability of the existing dike.

Ash Pond B, central portion of dike along the toe facing east. Heavy vegetative growth present and large boulders present throughout. Lake Sinclair shown frame right.
