**Coal Combustion Residue Impoundment**

**Round 9 - Dam Assessment Report**

*H. B. Robinson Steam Electric Plant*

*Progress Energy Carolinas, Inc.*

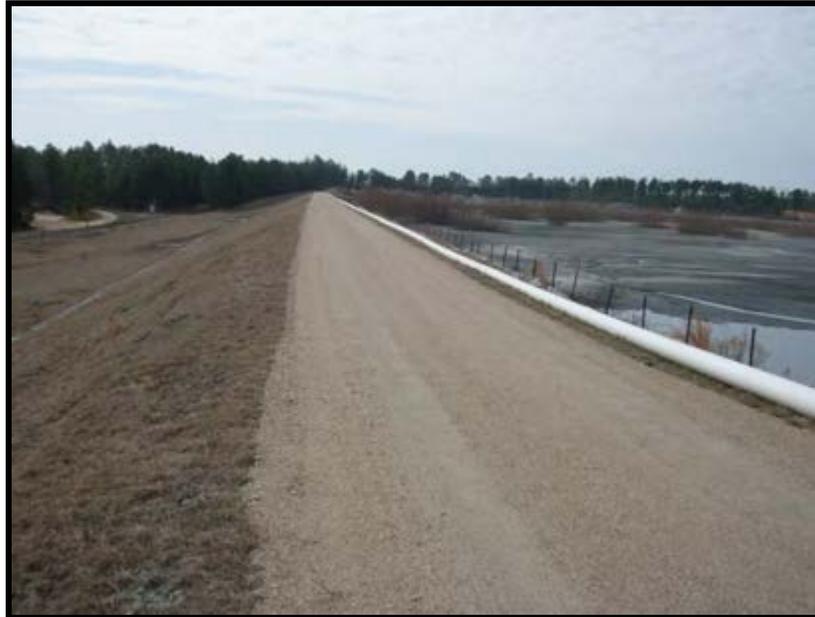
**Photograph 5.1. Typical view of crest, looking south.**

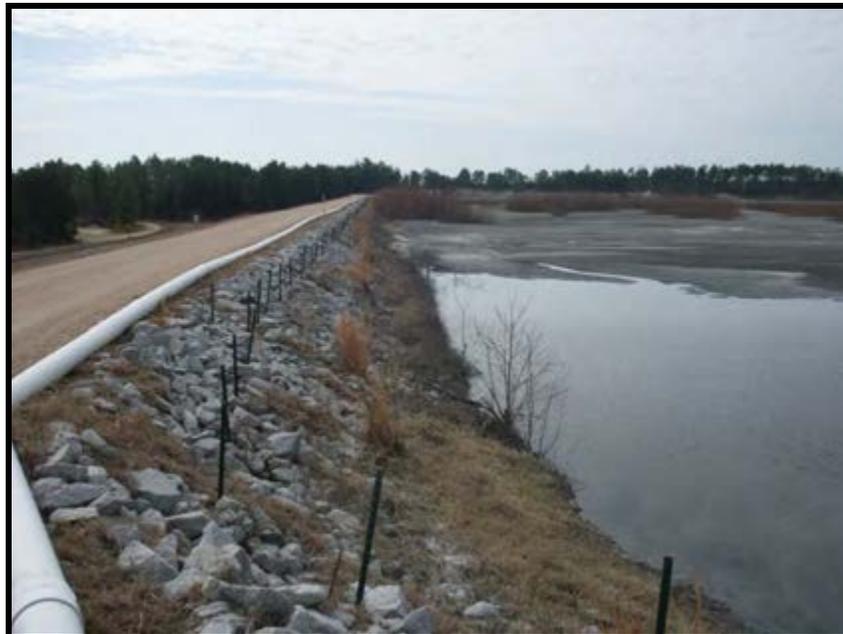
The upstream slope of the north portion of the dike embankment (north of the finger dike) was observed to be lined with riprap with a minor amount of dormant vegetation, including woody vegetation, growing in it, as shown in Photograph 5.3a. The upstream slope of the embankment south of the finger dike was observed to have a dormant cover of grass and weeds (see Photograph 5.2). A small-diameter metal pipe from the Darlington County Plant on the north side of the pond conveys discharge from an oil-water separator through the north side dike embankment extension and into the pond, as shown in Photograph 5.3b. Former erosion at the discharge location had been repaired with the riprap shown in the photograph. The upstream toe and much of the upstream slope is buried with ash, particularly along the south portion of the dike, as shown in Photograph 5.3c; this photograph also shows where the ash is sluiced into the pond and the dust-control sprinkler system in operation in the background. Only a small amount of water was observed in the pond, mostly at the north end next to the dike (see Photograph 5.3a). No slumps, slides, or other signs of shear failure were observed in the visible parts of the slope above the ash and water levels. No significant erosion was noted.

**Photograph 5.3a. Upstream slope of north portion of dike, looking south.**

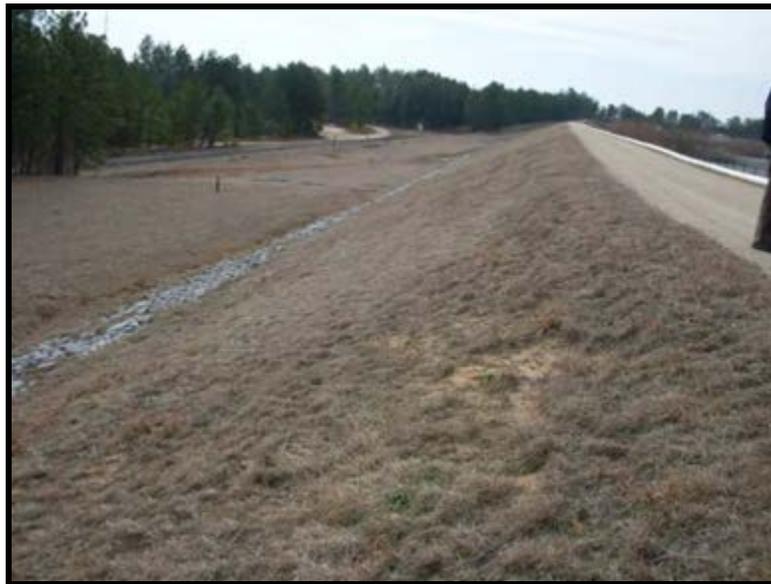
maintained, as shown in Photographs 5.4a, 5.4b, and 5.4c. Minor erosion from mowing equipment was observed on the slope. A portion of the buried sluice line along the downstream slope face was observed to be exposed due to erosion, and minor erosion was observed elsewhere along the soil-covered sluice line, as shown in Photograph 5.5. Progress Energy personnel indicated that the soil cover over the sluice line was not compacted. Local embankment soil material loss due to erosion into the riprap and minor depressions were observed at a number of locations on the downstream slope above the riprap; one of the worst of these is shown in Photograph 5.6a. It was noted that in a number of locations soil had eroded (or moved by creep) onto the surface of the riprap. Some areas of sparse grass growth on the outside slope were also observed (see Photograph 5.4a), but no major areas of erosion were noted. No slumps, slides, bulges, tension cracks, or other obvious signs of shear failure were observed on the downstream slope. No seepage or active animal holes were observed. Wet soils were observed in the shallow swale along the right (south) toe of the dike, but no seepage or flowing water appeared to be associated with this wet area, as shown in Photograph 5.6b. It appeared to be due to poor drainage. The catch basin at the low point of the toe (see Photograph 5.8) was observed to be surrounded with stone and a fine filter that apparently tends to easily clog with vegetation and grass clippings, which retards flow from the toe swale into the catch basin.

**Photograph 5.4a. Downstream slope and toe of north portion of dike, looking south.**

- a. Re-establishing good grass cover in areas of sparse grass growth and in areas damaged by mowers;
- b. Filling holes in the embankment slope just above the downstream toe riprap with suitable filter materials to minimize continuing erosion of embankment soil into the voids of the riprap; lining the larger holes with filter fabric before filling them with coarse filter stone may be beneficial;

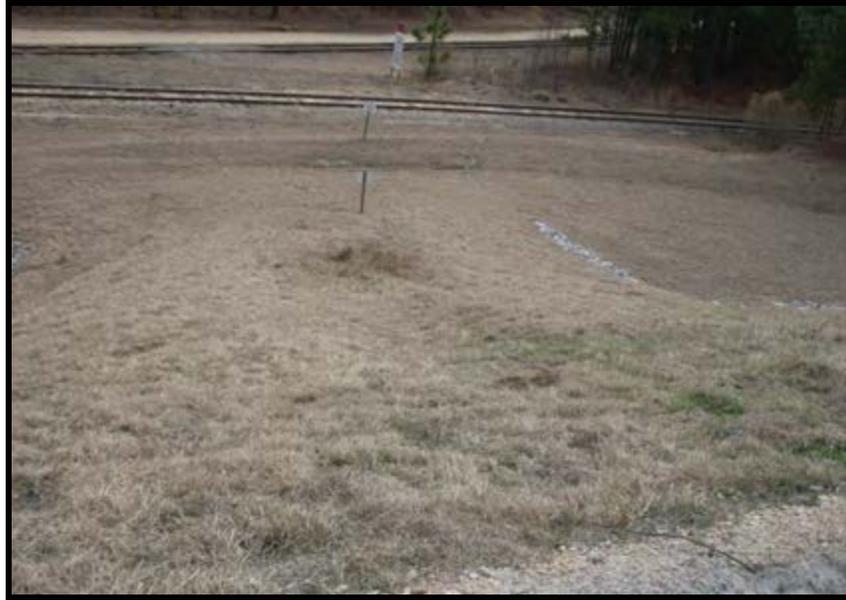
**Photograph 5.5. Minor erosion observed along buried sluice line on the downstream slope, looking east.**

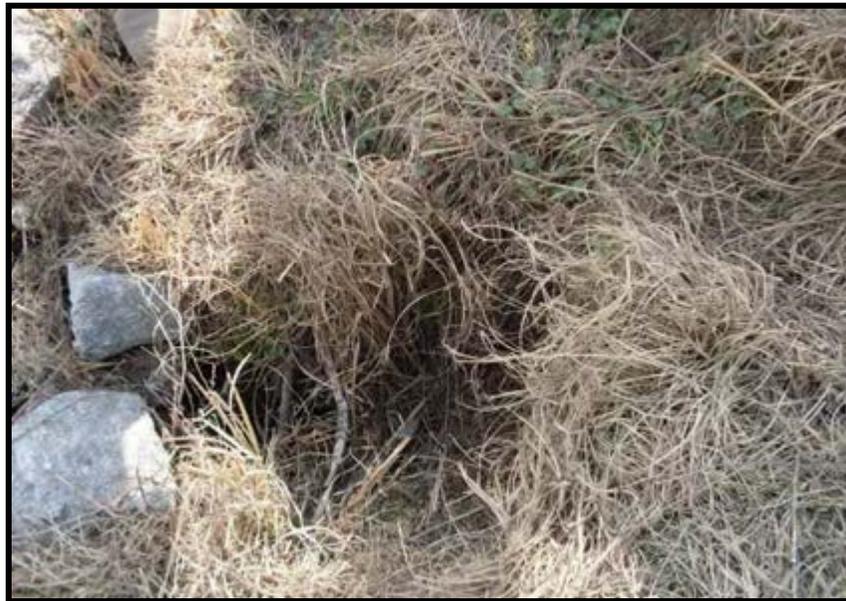
**Photograph 5.6a. Hole due to soil material loss into riprap voids, observed on downstream slope above riprap at toe.**

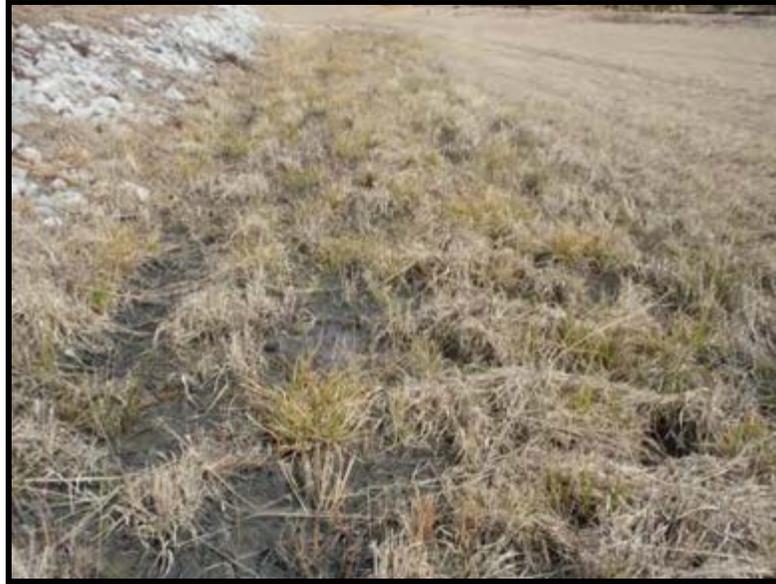
**Photograph 5.6b. Wet soils in shallow swale along right (south) toe of dike embankment, looking north.**

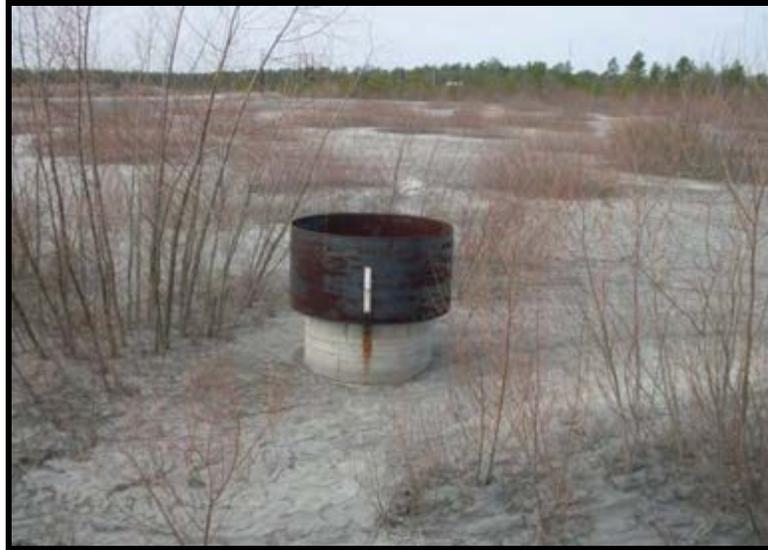
The Ash Pond overflow structure was observed on the northeast side of the pond just upstream of the dike. The 48-inch diameter RCP overflow structure with a metal skimmer was observed to be in good condition. The skimmer had rust on its surface, but it appeared sound. No water was flowing into the structure and was not even impounded around the structure at the time of the visit, as shown in Photograph 5.7.

**Photograph 5.7. Ash Pond overflow structure, looking west.**

It is recommended that record drawings be corrected or amended, as appropriate, to eliminate confusion as to the size of the buried portion of the overflow riser at the Ash Pond. PEC has indicated that the existing riser pipe size will be verified in the field and any necessary changes will be made to the as-built drawings.

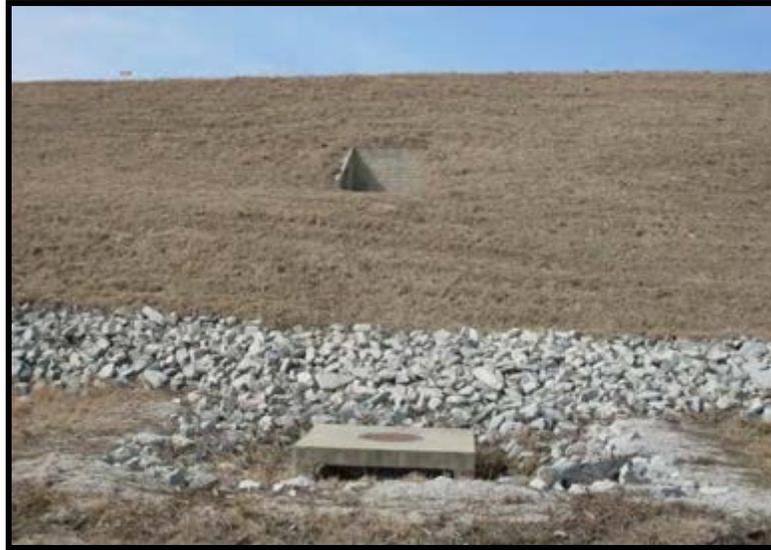
**Photograph 5.8. Showing manhole access to outlet conduit on the slope, and covered catch basin at the downstream toe of the embankment of the ash pond dike, looking west.**

It is recommended that periodic interior inspection of the outlet structure with a “borehole” video camera be included as part of PEC’s inspection program for the ash pond dike (see Subsection 9.3.1 for discussion).

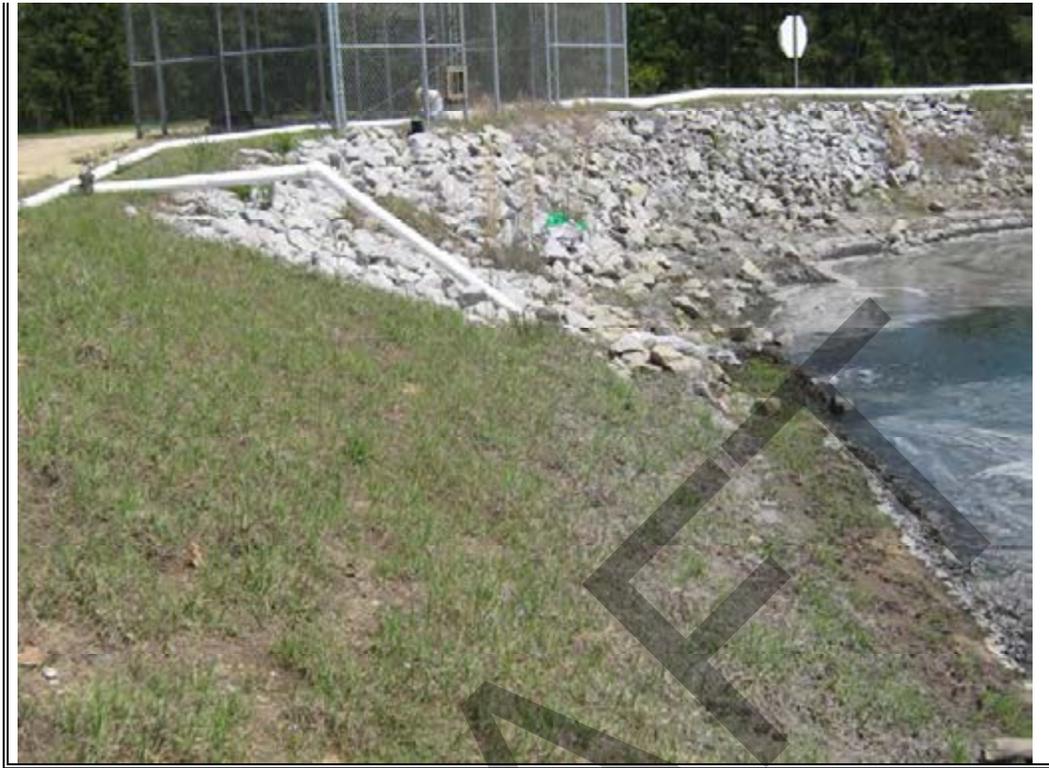
**Photograph 50:** Rip rap in good condition at junction of North Pond dike and northern extension dike.

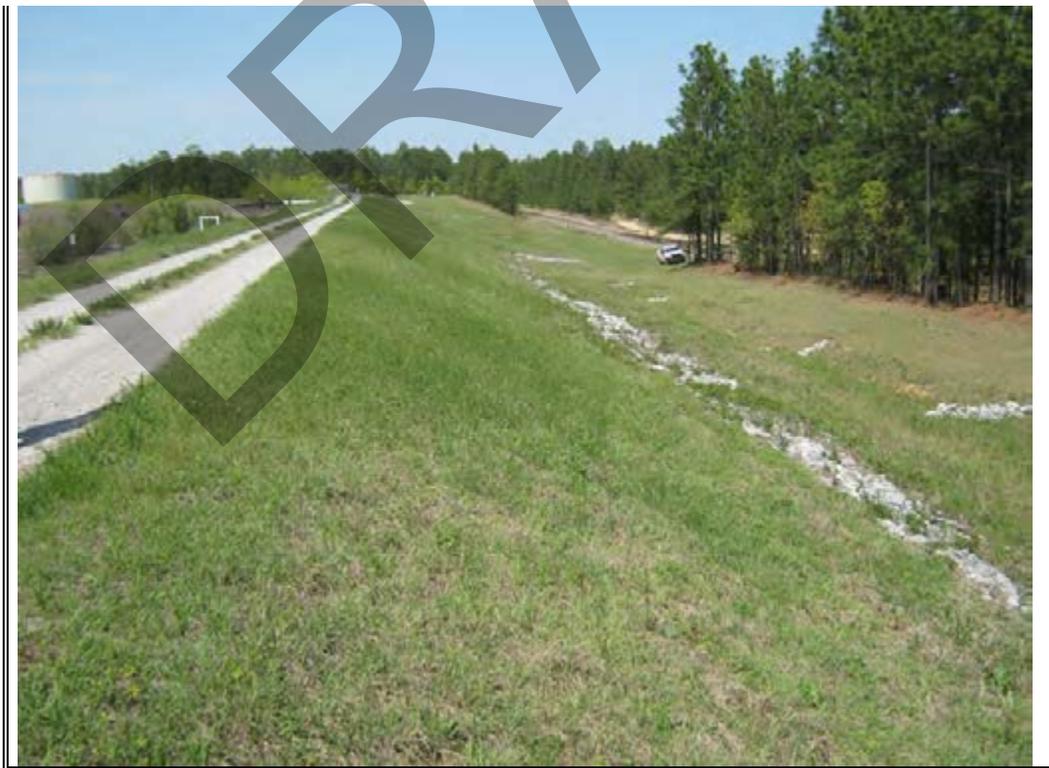
**Photograph 51:** Exterior of South Pond dike. Note good vegetative cover of slope and drainage ditch adjacent to dike toe.

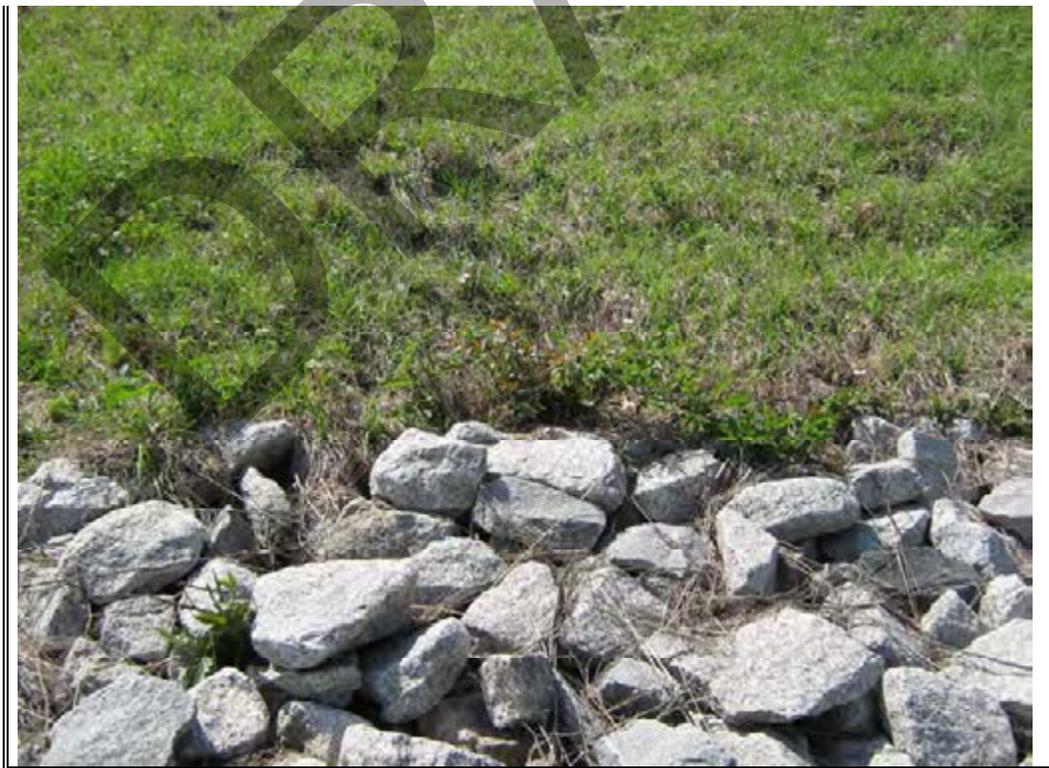
**Photograph 55:** Local spot in North Pond dike rock toe – soil slope where slight loss of material. Typical of conditions addressed as necessary by Plant.

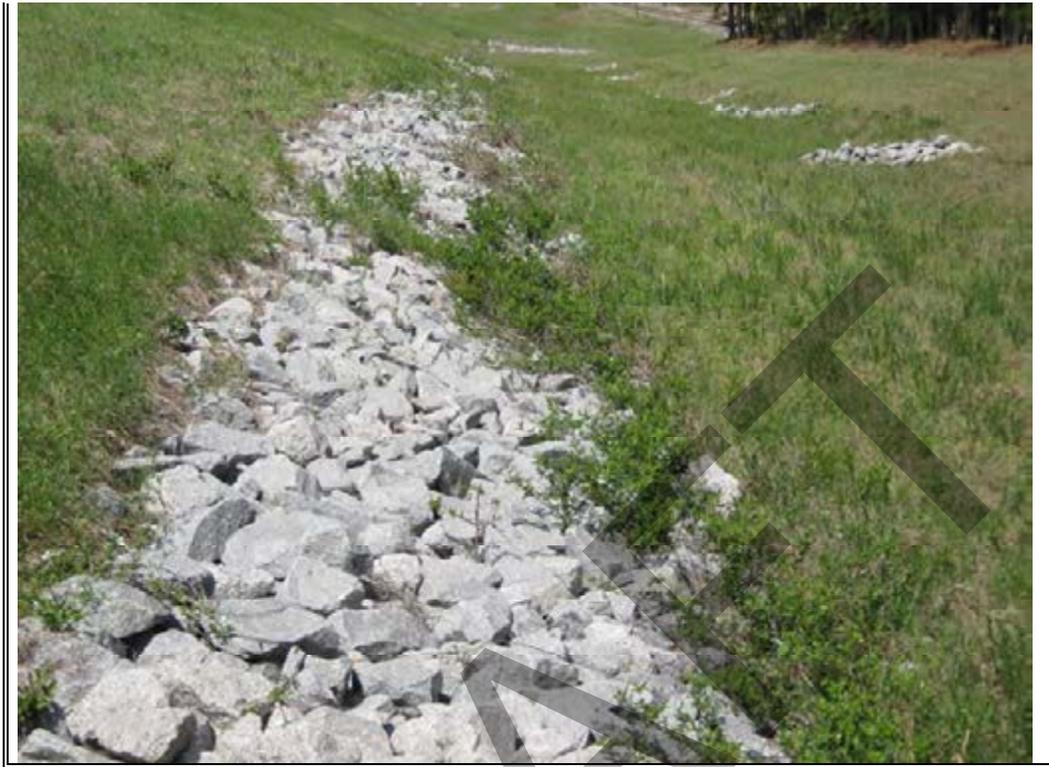
**Photograph 56:** Rock toe and rock check dams at toe of North Pond dike.

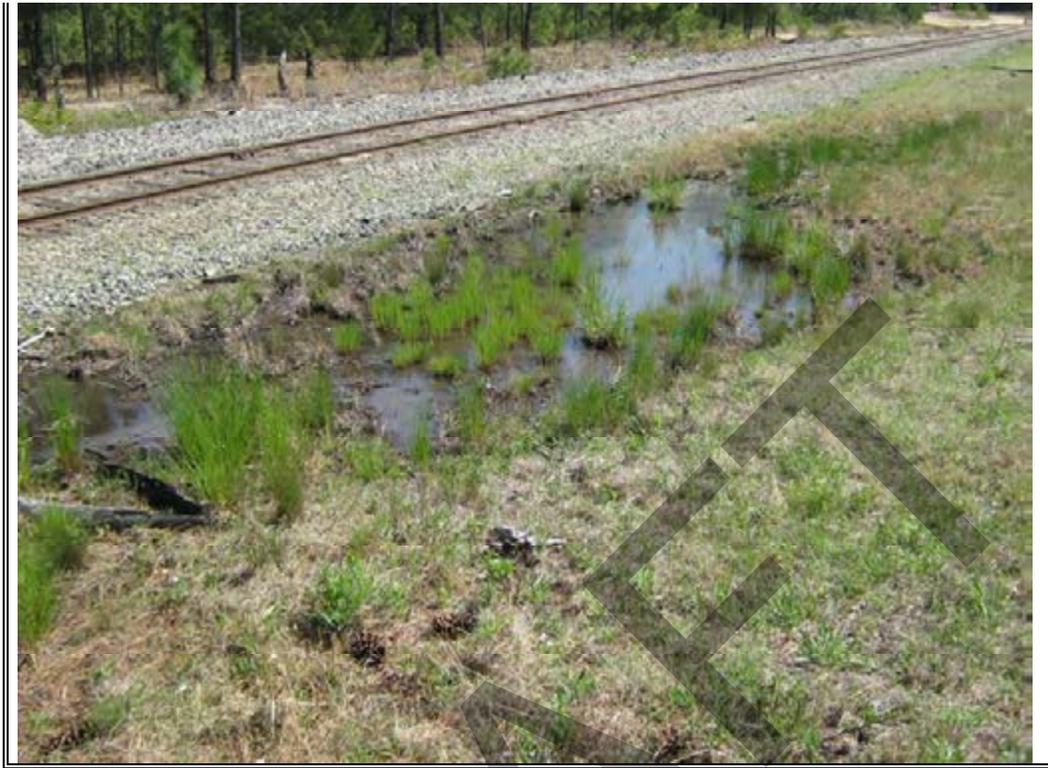
**Photograph 58:** Standing water adjacent to railroad in topographic low area. A normal condition not related to seepage.

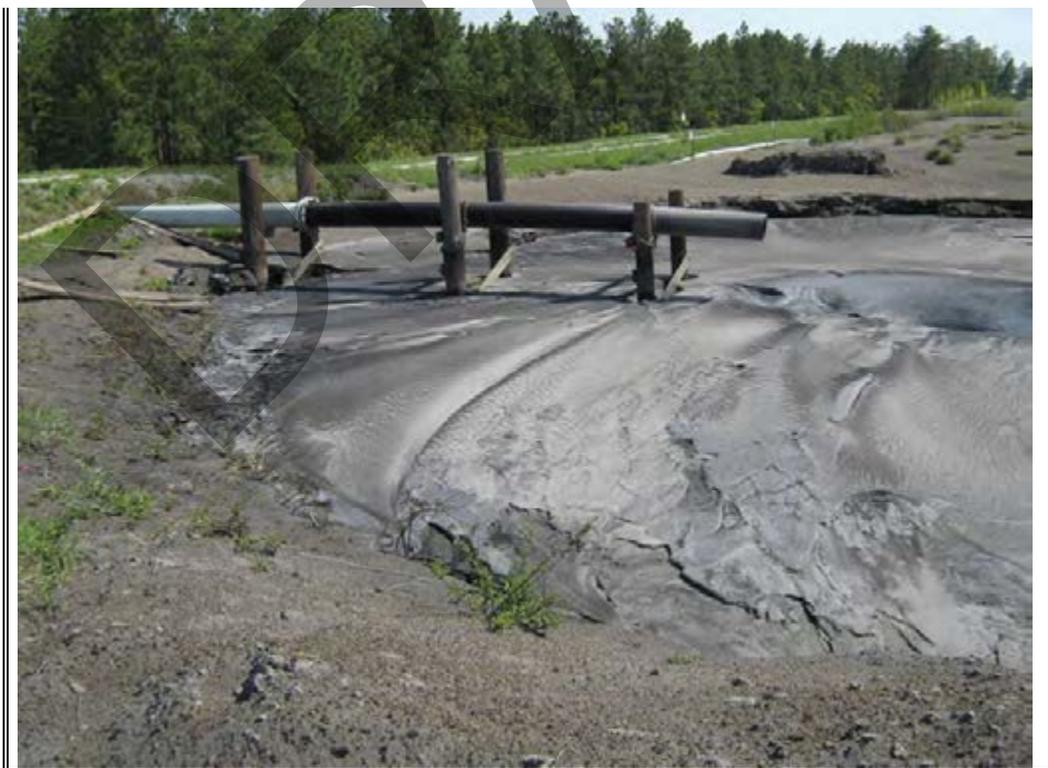
**Photograph 59:** Ash discharge line.
