# **Assessment of Dam Safety of Coal Combustion Surface Impoundments**

**PowerSouth Energy Cooperative**

**Charles R. Lowman Power Plant**

**August 6, 2010**

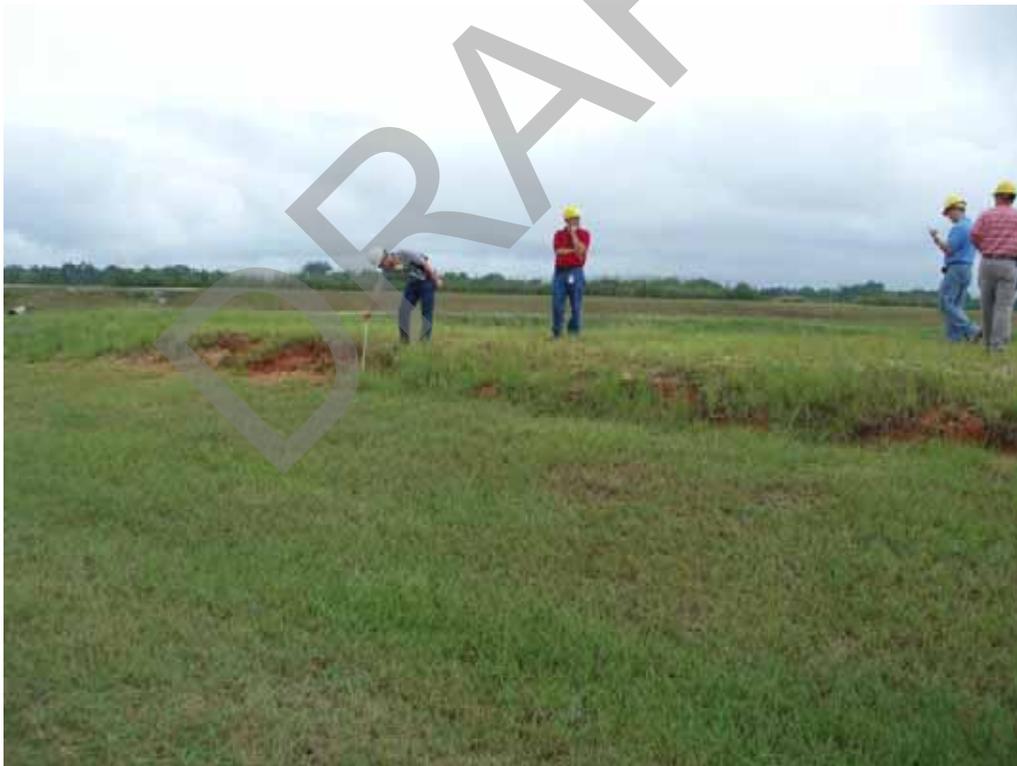
**Photo No. 14: #1 Bottom Ash Pond – South embankment exterior slope, looking north. Note surface erosion.**

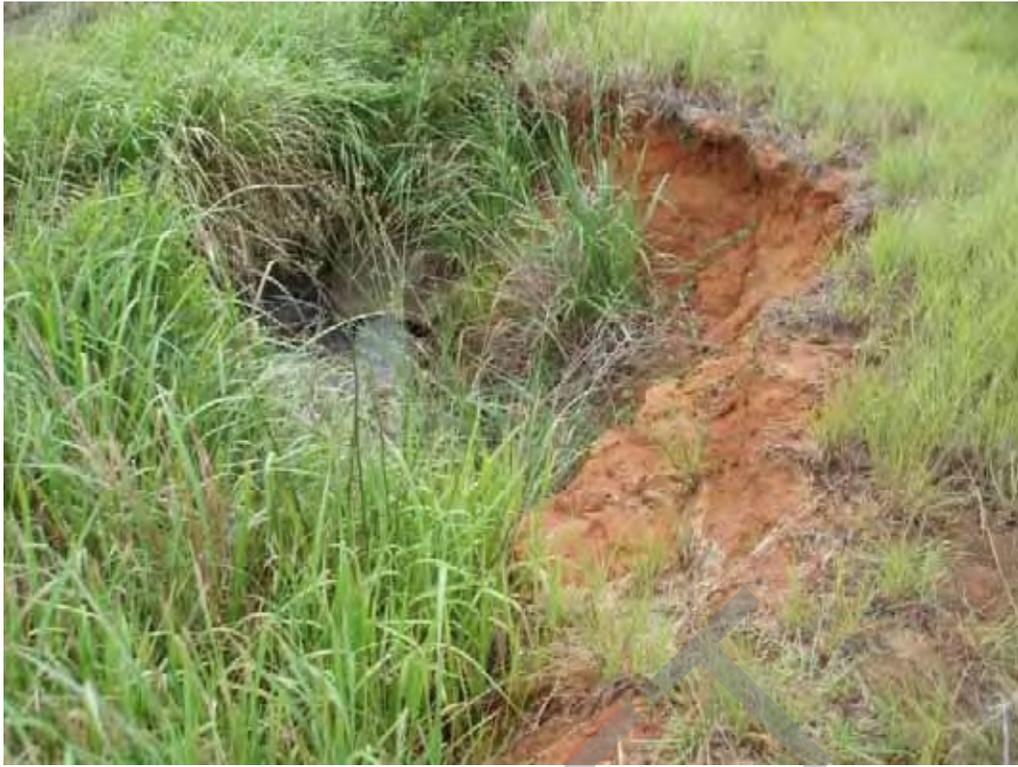
A section of the crest and interior slope of the south embankment has been excavated and remains open, apparently to facilitate the repair of the discharge pipe (Photograph 19). This created a localized area of erosion that has cut into the crest's width by approximately 3 feet.

A section of the interior slope of the south embankment has been excavated and remains open, apparently to facilitate the repair of the discharge pipe (Photograph 19). Erosion features, including minor sloughing and erosion rills, were observed on portions of the interior slopes (Photographs 22, 24, 25, 28, 31, 47, and 48).

**Photo No. 19: #1 Bottom Ash Pond – South embankment interior slope. Location of excavation into slope/crest and subsequent erosion.**

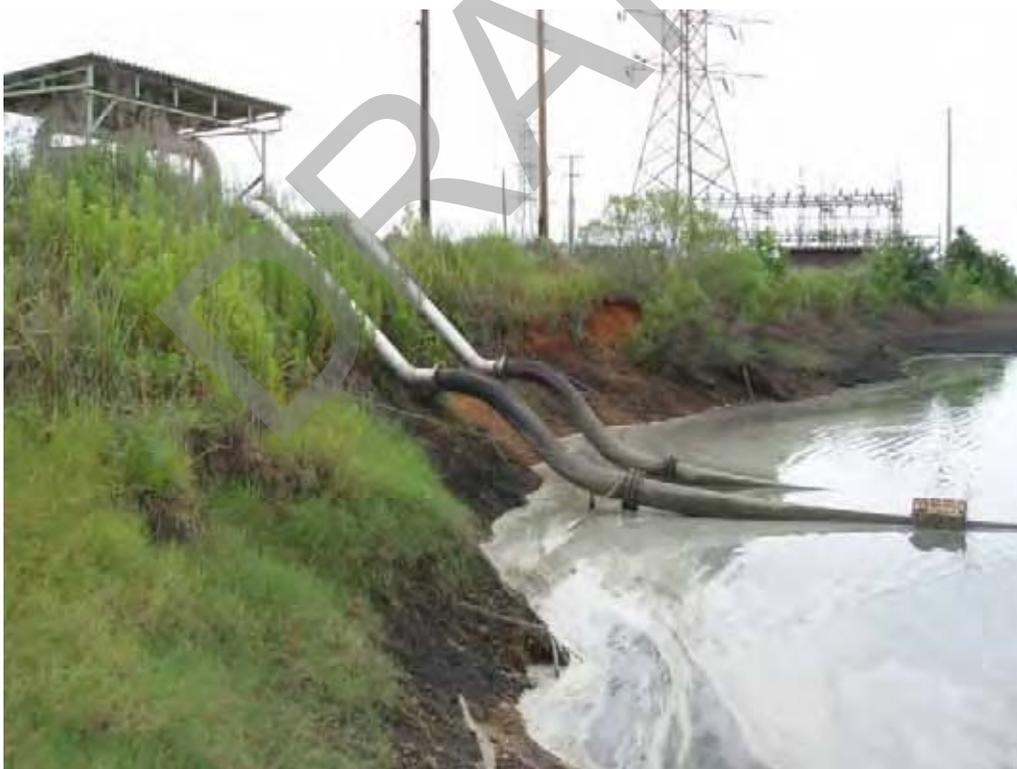
The outlet pipes in the #1 Bottom Ash Pond appear to be in good condition. Two, 10-inch-diameter pipes, located at the southwestern end of the pond, intake water that is pumped to the #2/#3 Bottom Ash Pond through one 14-inch-diameter HDPE pipe (Photographs 23 and 24). No unusual movement was observed around the pumps or piping.

**Photo No. 24: #1 Bottom Ash Pond – South embankment interior slope, looking southwest.  
Looking at outlet pipes.**

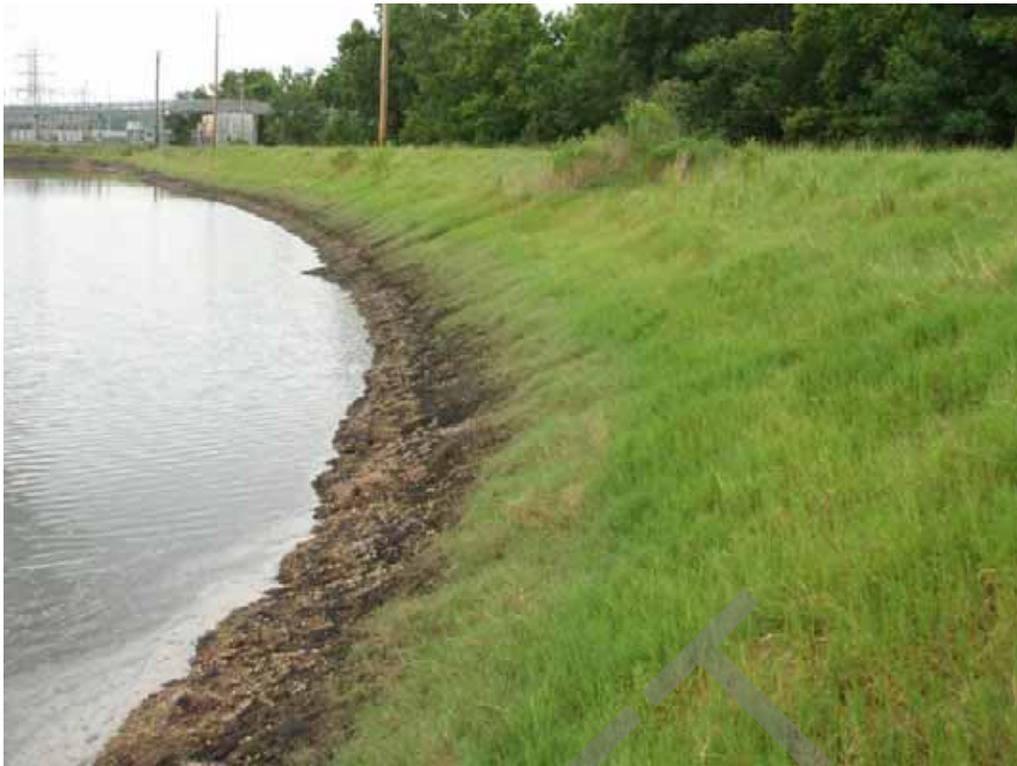
**Photo No. 25: #1 Bottom Ash Pond – East embankment interior slope, looking north. Note surface erosion near water line.**

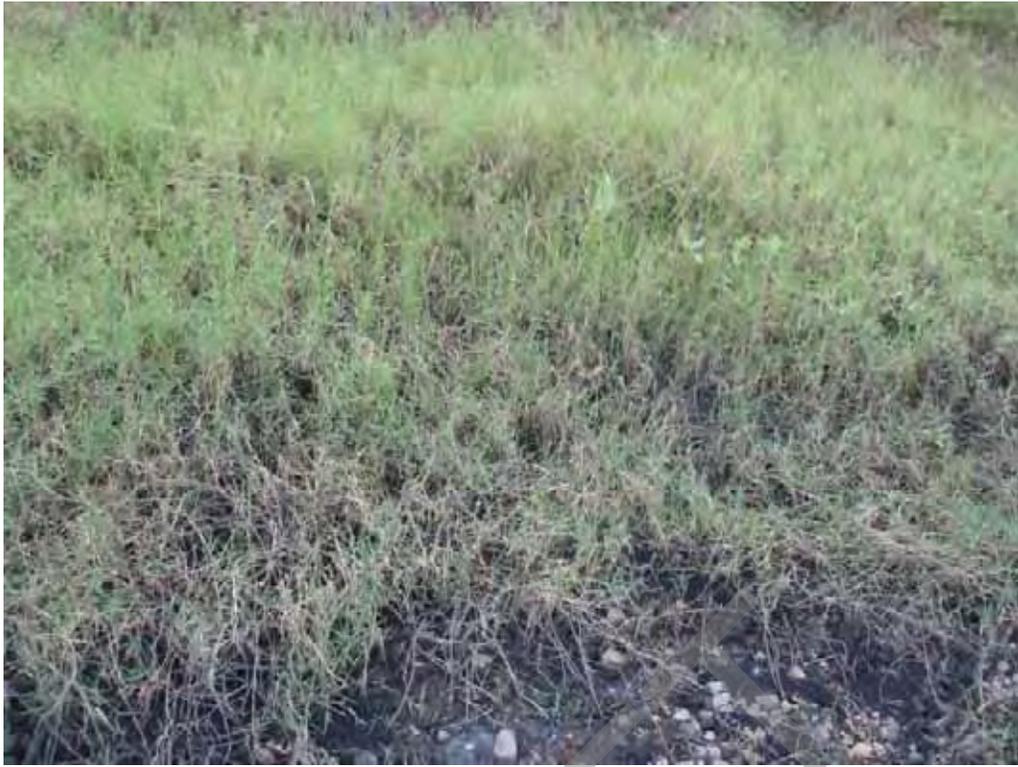
**Photo No. 31: #1 Bottom Ash Pond – East embankment interior slope. Note vegetation and surface erosion.**

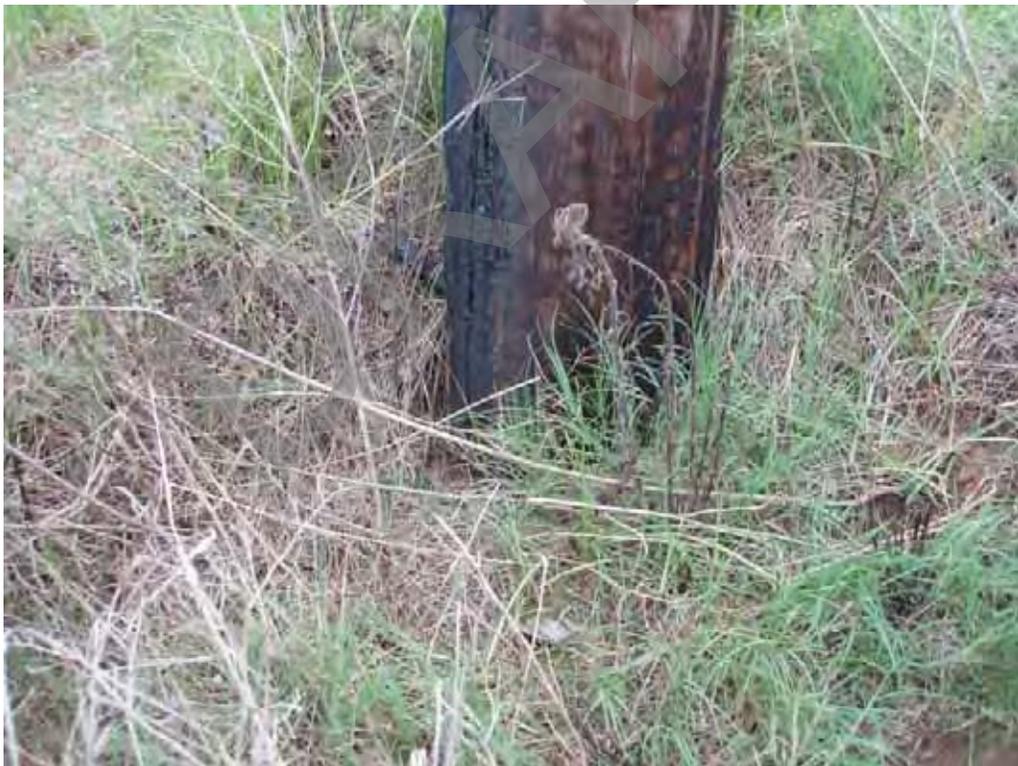
**Photo No. 38: #1 Bottom Ash Pond – East embankment interior slope. Looking at eroded or missing soils near utility pole.**

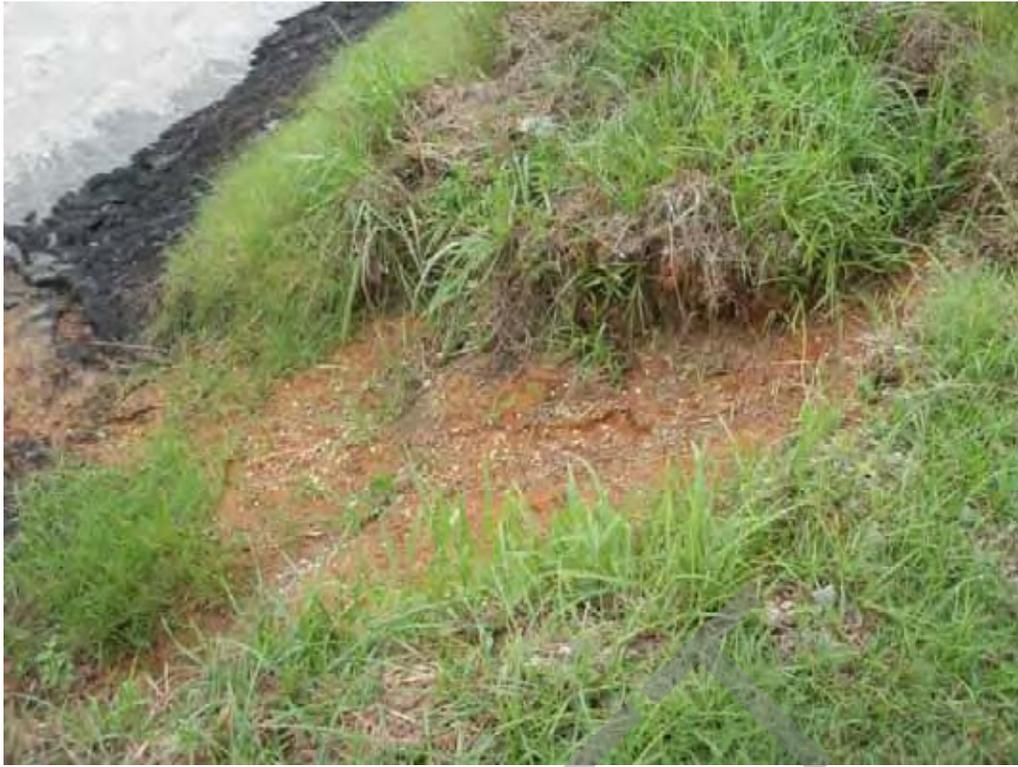
**Photo No. 41: #1 Bottom Ash Pond – North embankment interior slope. Looking at erosion rill.**

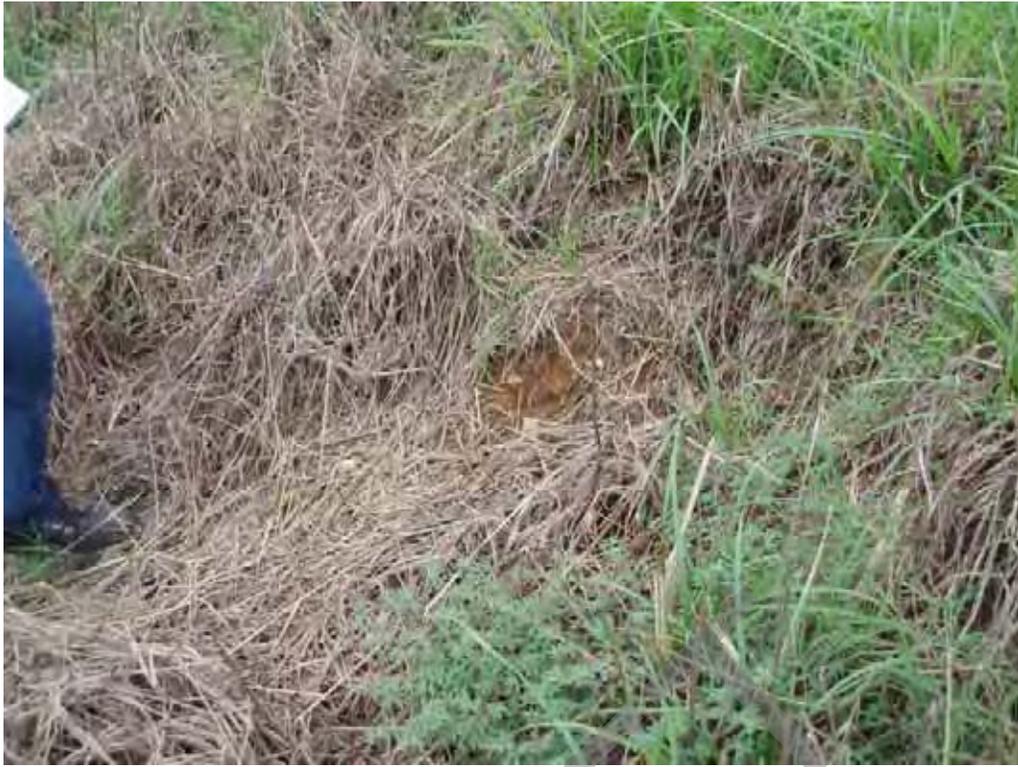
Minor surface erosion was observed along portions of the exterior slope of the north and east embankments (Photographs 22 and 43).

**Photo No. 43: #1 Bottom Ash Pond – North embankment interior slope. Looking at surface erosion.**

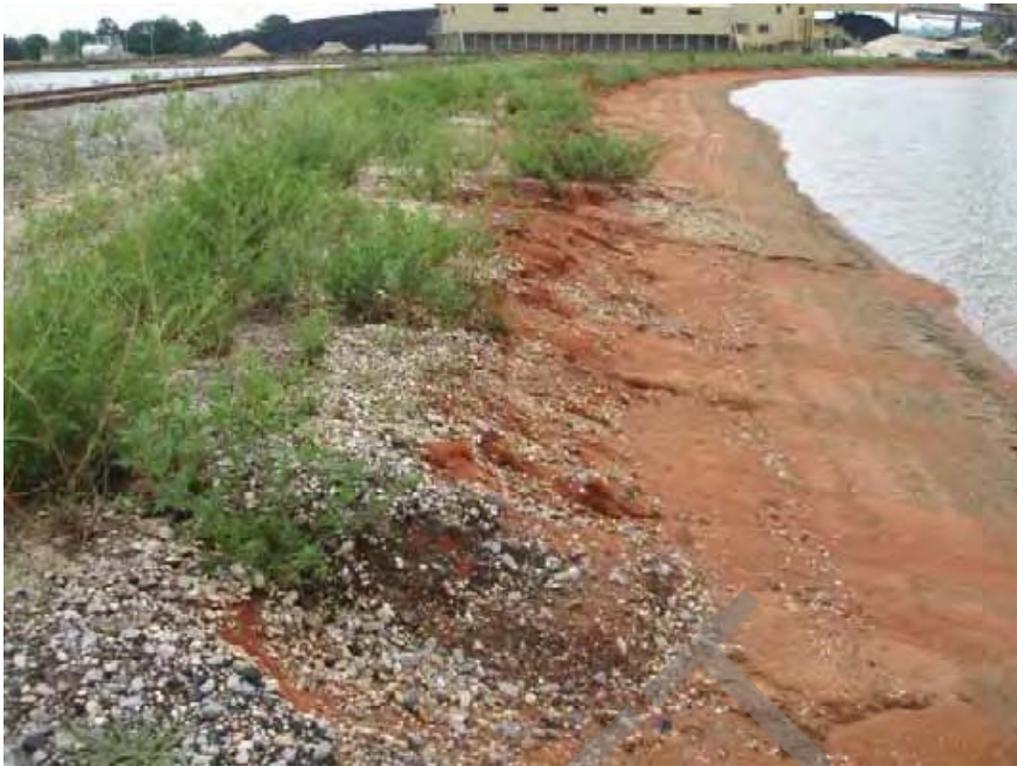
**Photo No. 57: Process Waste Pond – South (divider) embankment exterior slope, looking east. Note erosion rills in fill material, placed in the past for construction access road.**

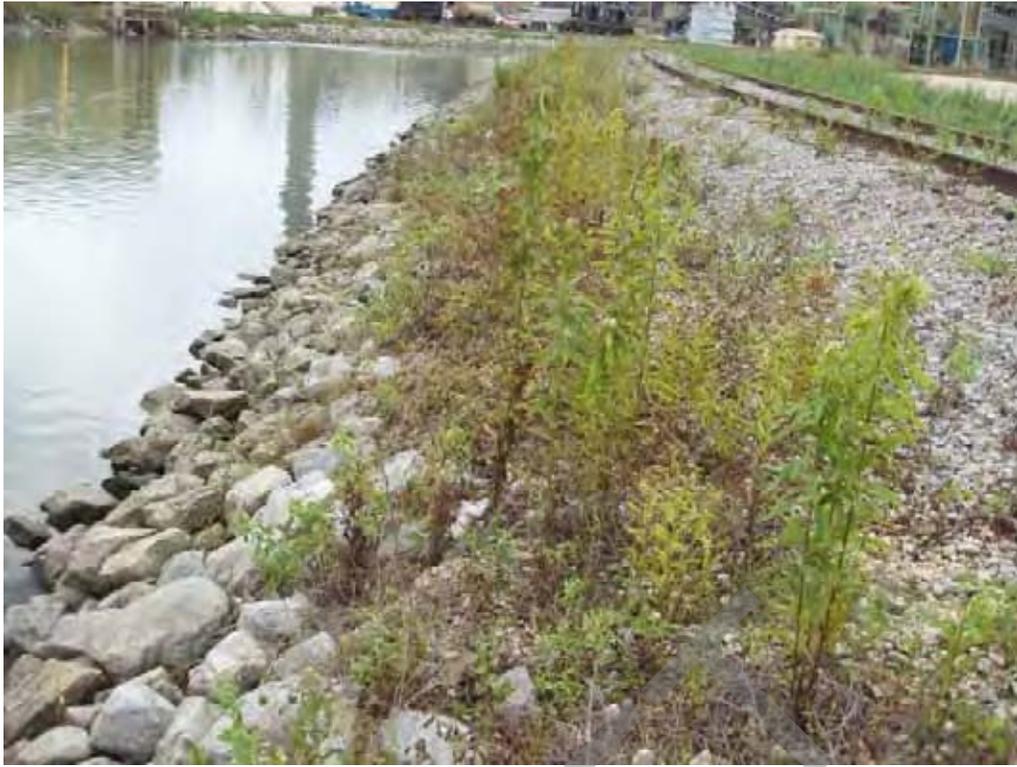
The west embankment exterior slope appears to be in poor condition. The north and south embankment exterior slopes appear to be in fair condition. The north and south embankment exterior slopes are approximately 2H:1V. The east embankment is incised, with the crest extending into the generating facility, so there is effectively no east embankment exterior slope (Photograph 89). Heavy vegetation with trees up to 18 inches in diameter covers the exterior slope of the west embankment (Photograph 161). The exterior slopes of the north and south (divider) embankments, are armored with riprap (Photograph 61 and 133).

**Photo No. 61: Process Waste Pond – South embankment interior slope, looking east. Note vegetation growing within riprap**

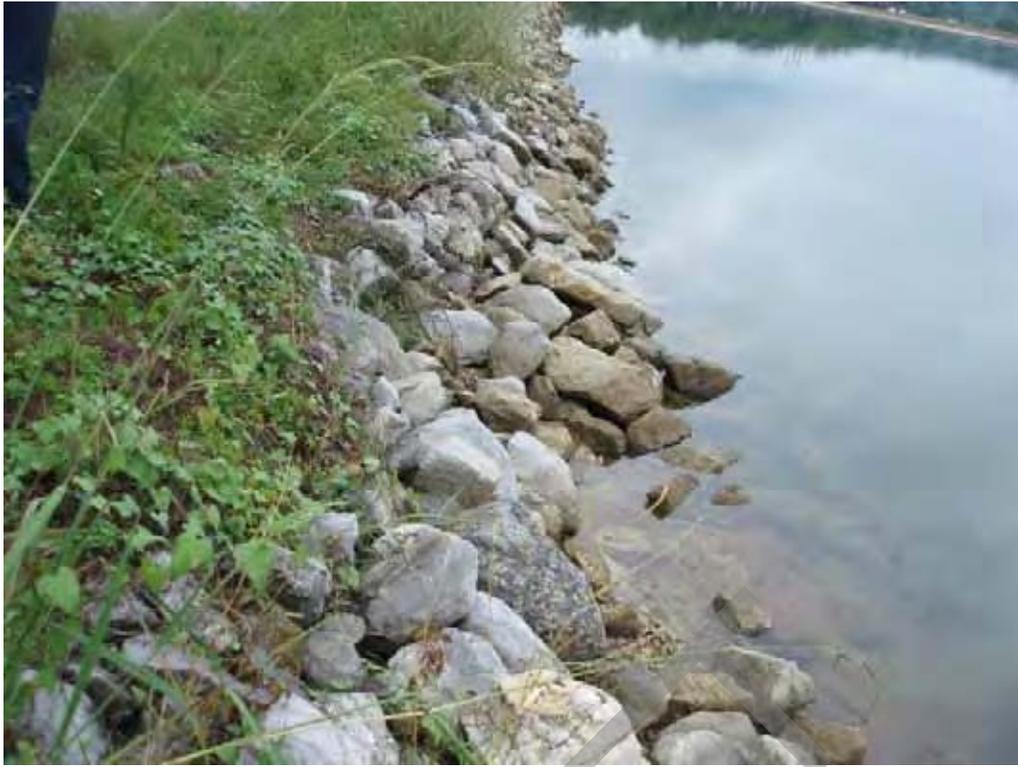
**Photo No. 73: Scrubber Waste Pond – West embankment interior slope, looking north. Note erosion of riprap.**

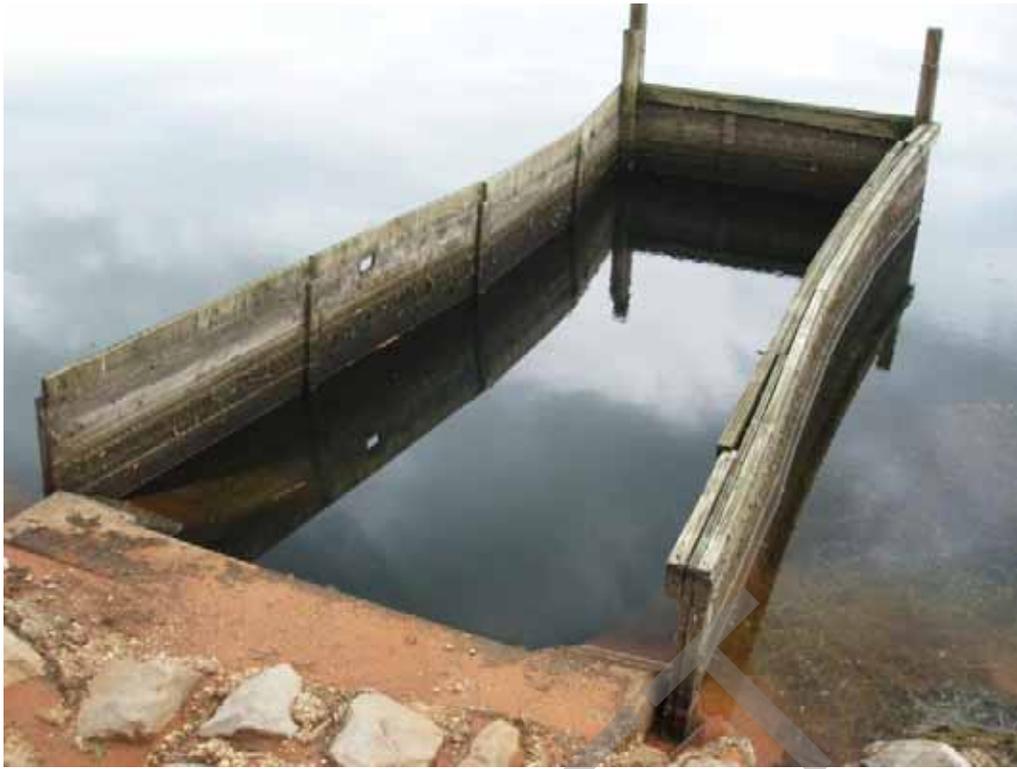
The outlet pipe in the #2/#3 Bottom Ash Pond was kept free of debris by a wood framed structure and was submerged at the time of the assessment (Photograph 103). Based on drawings provided by PSEC, a 36-inch-diameter cast or ductile iron pipe, with invert elevation El. 35.5, is the intake for the pump house located on the crest at the northwest corner of the pond. From the limited view, the outlet appeared to be free of debris. No unusual movement was observed around the pipe penetrations.

**Photo No. 103: #2/#3 Bottom Ash Pond – North embankment interior slope. Looking at outlet structure.**

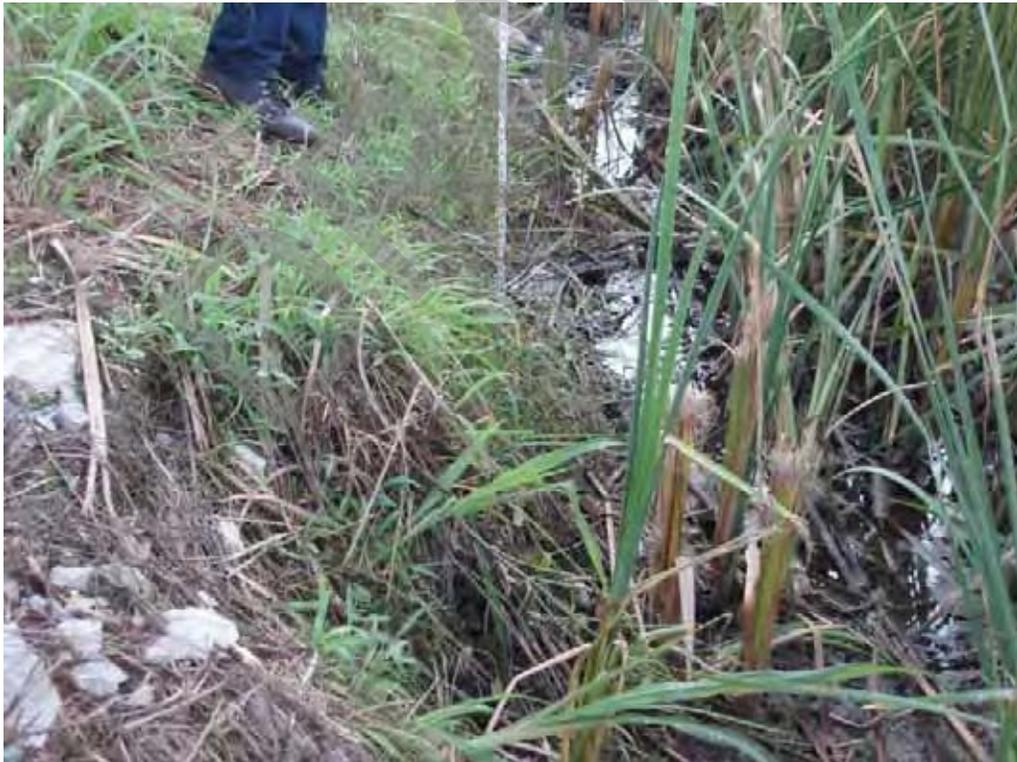
Locations of erosion due to missing riprap, vegetation growing within riprap, and possible localized settlement were observed at various locations on the interior slopes (Photographs 108, 114, 129 and 132).

**Photo No. 114: #2/#3 Bottom Ash Pond – South embankment interior slope, looking southwest. Looking at erosion and missing riprap.**

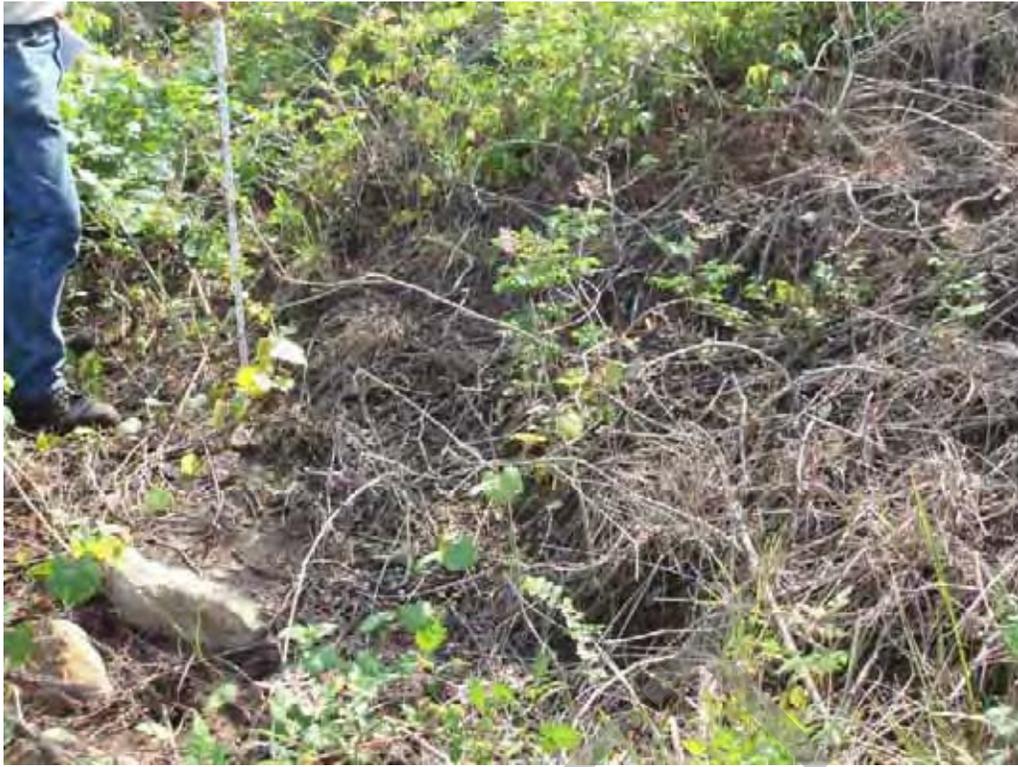
Minor surface erosion, sloughing, and scarps, as well as several animal burrow holes, were observed on the exterior slope of the west embankment within the dense vegetation (Photographs 153, 149, and 150).

**Photo No. 149: Scrubber Waste Pond – West embankment exterior slope. Looking at surface erosion.**

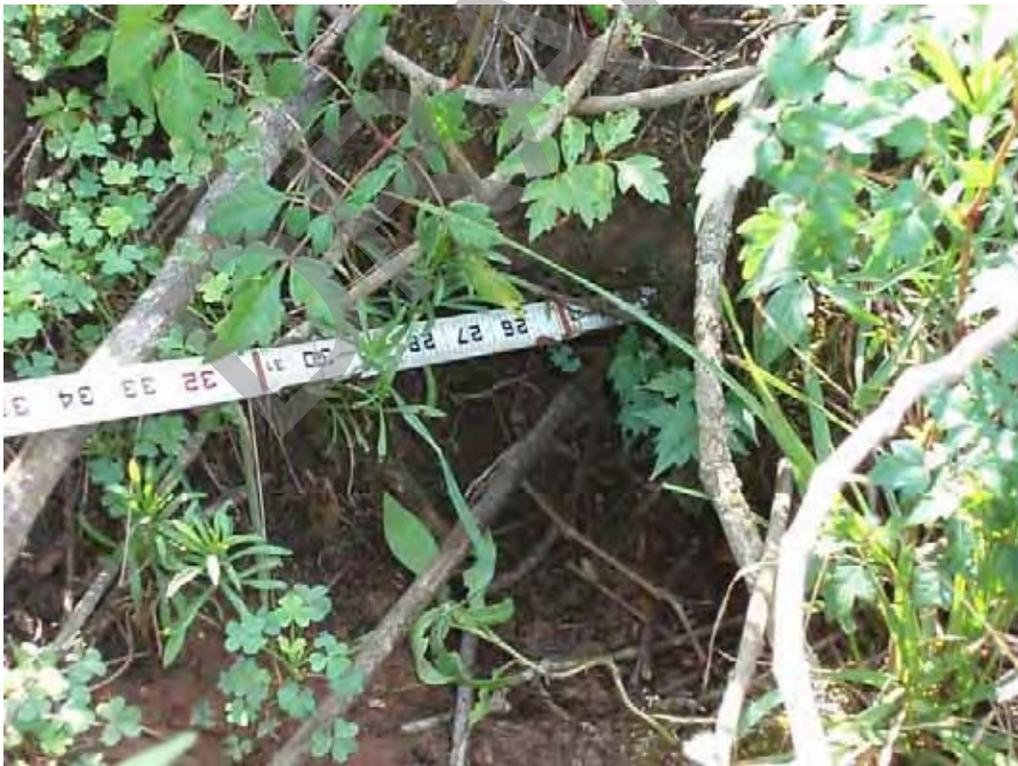
**Photo No. 150: Scrubber Waste Pond – West embankment exterior slope. Looking at rodent burrow (4 inches in diameter, 26 inches deep).**

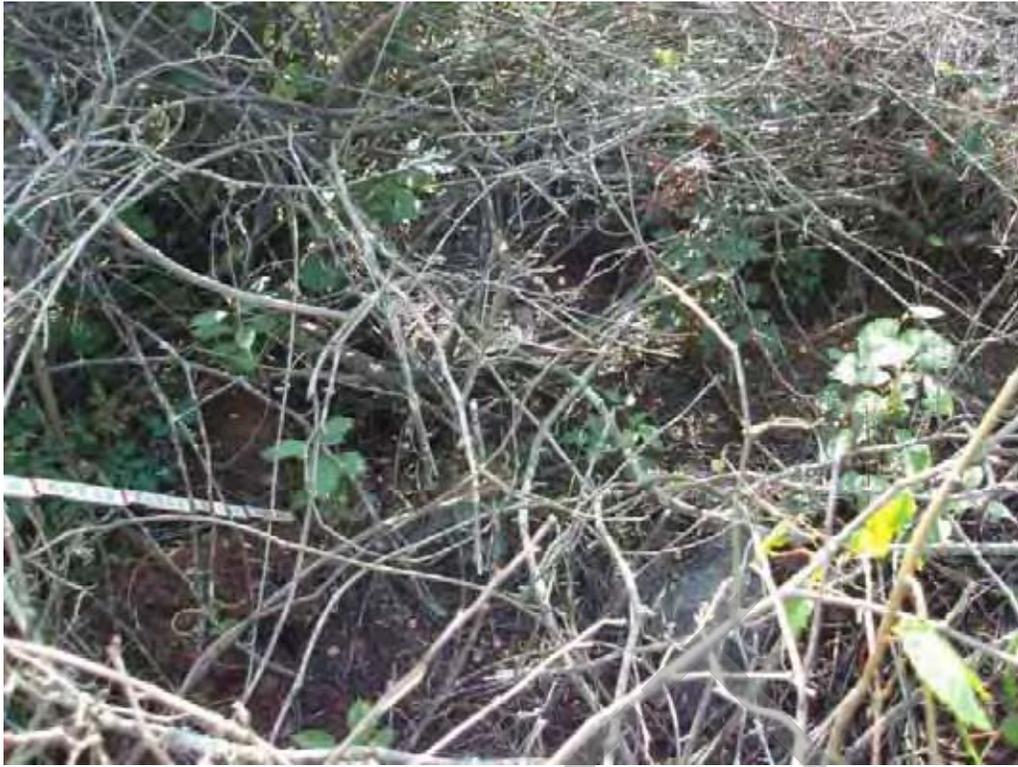
**Photo No. 153: Scrubber Waste Pond – West embankment exterior slope. Looking at minor slough.**

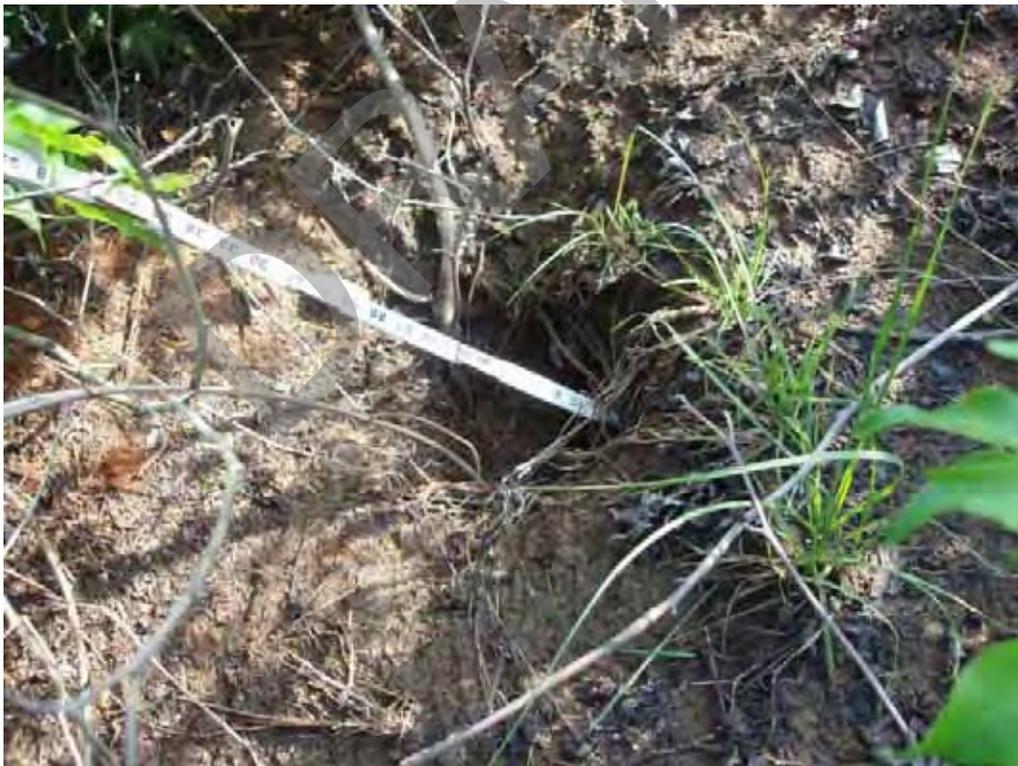
**Photo No. 154: Scrubber Waste Pond – West embankment exterior slope. Looking at rodent burrow (4 inches in diameter, 20 inches deep).**

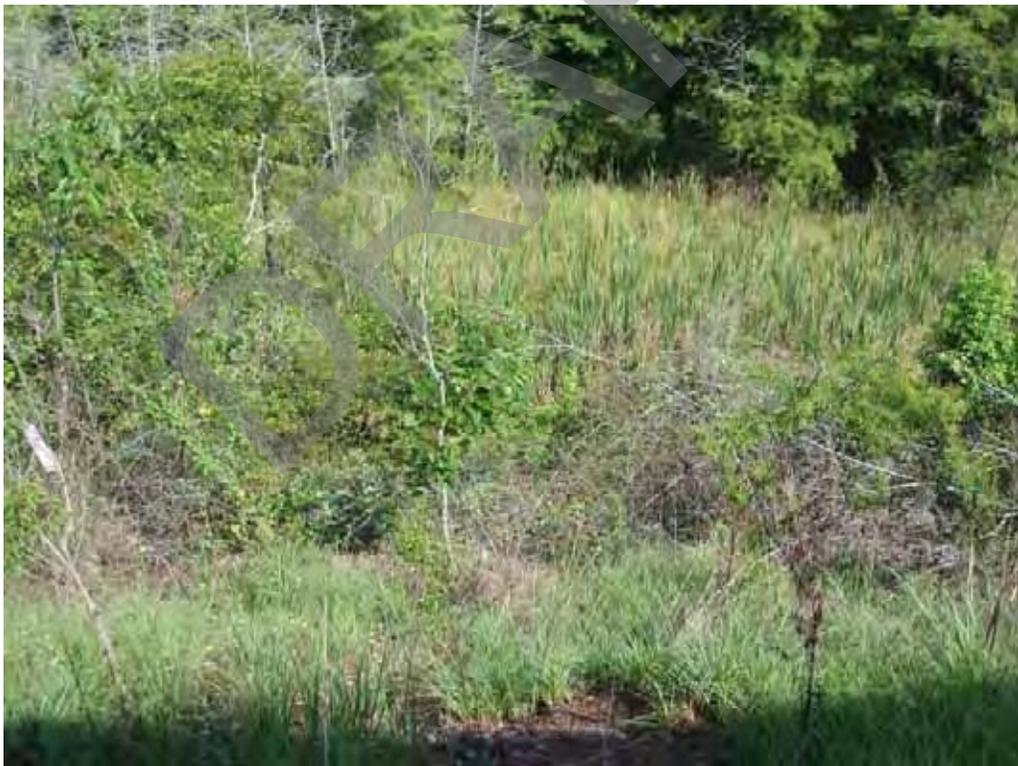
**Photo No. 156: Scrubber Waste Pond – West embankment exterior slope, looking west.  
Looking at cattails near toe.**

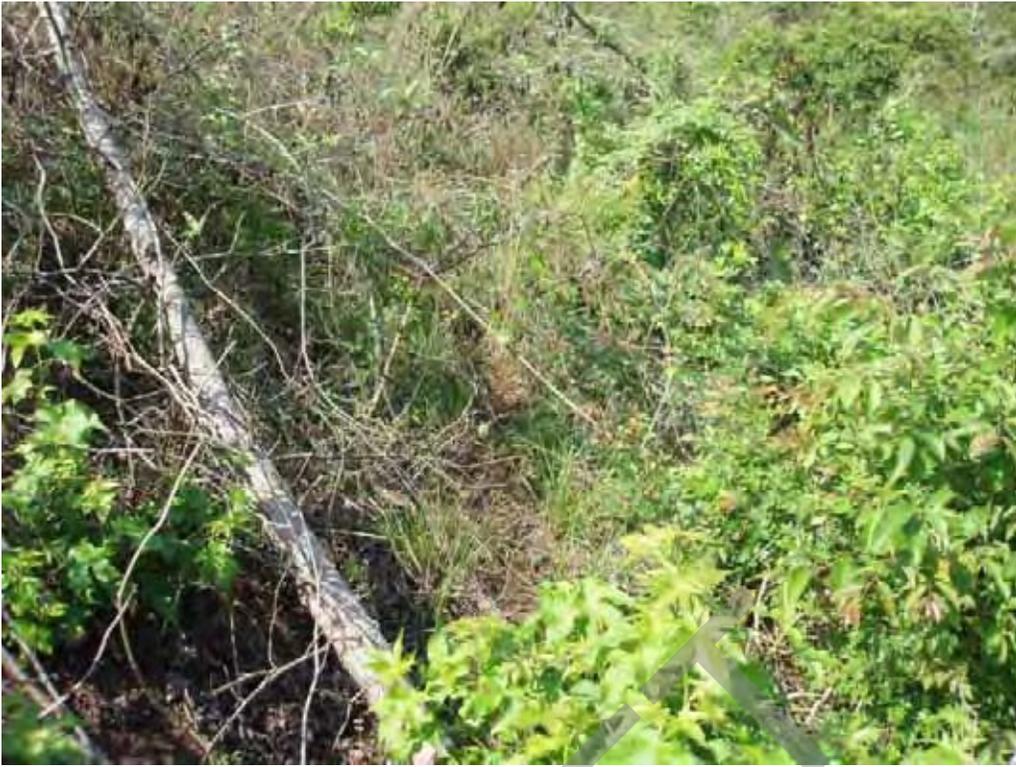
**Photo No. 157: Scrubber Waste Pond – West embankment exterior slope. Looking at surface erosion or possible animal trail.**

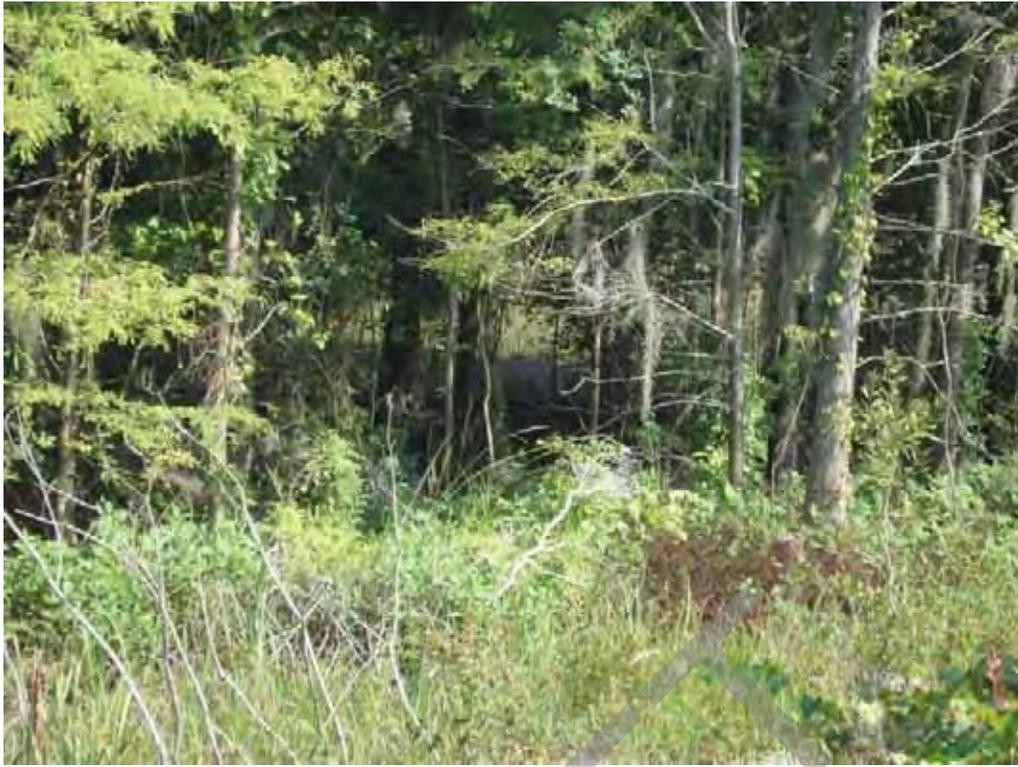
**Photo No. 159: Scrubber Waste Pond – West embankment exterior slope, looking west.  
Looking at standing water outside toe.**

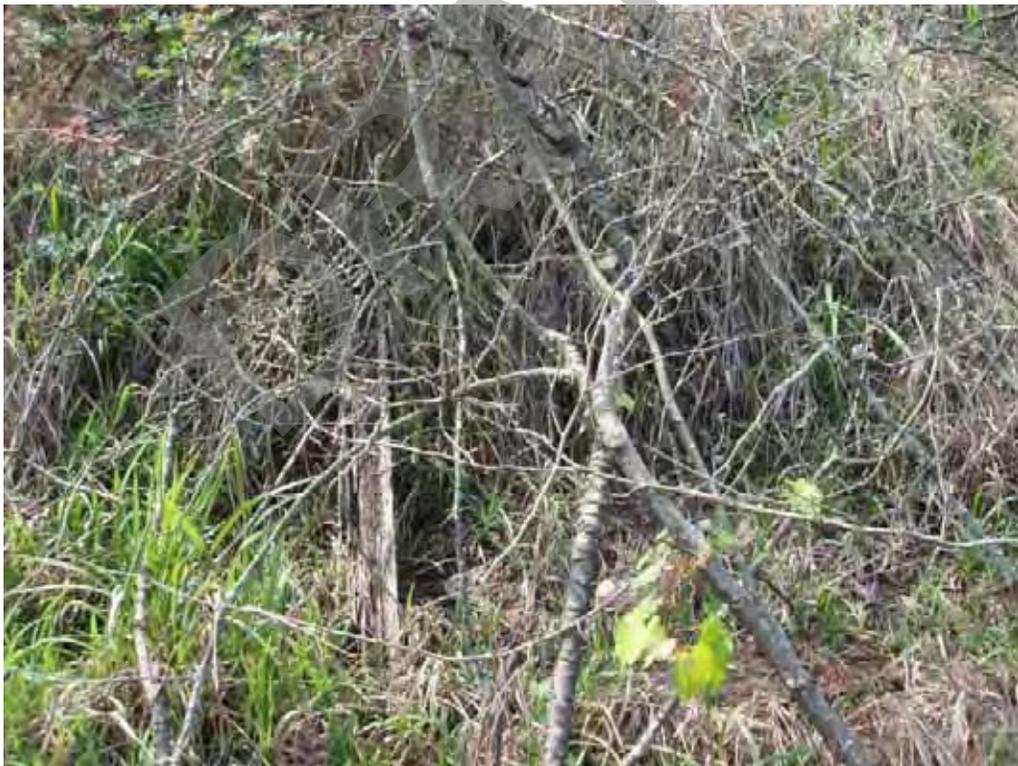
**Photo No. 160: Scrubber Waste Pond – West embankment exterior slope. Looking at minor scarp.**
