Assessment of Dam Safety of Coal Combustion Surface Impoundments

Hugo Power Plant

Western Farmers Electric Cooperative
U.S. Highway 70
Fort Towson, Oklahoma

Draft Report

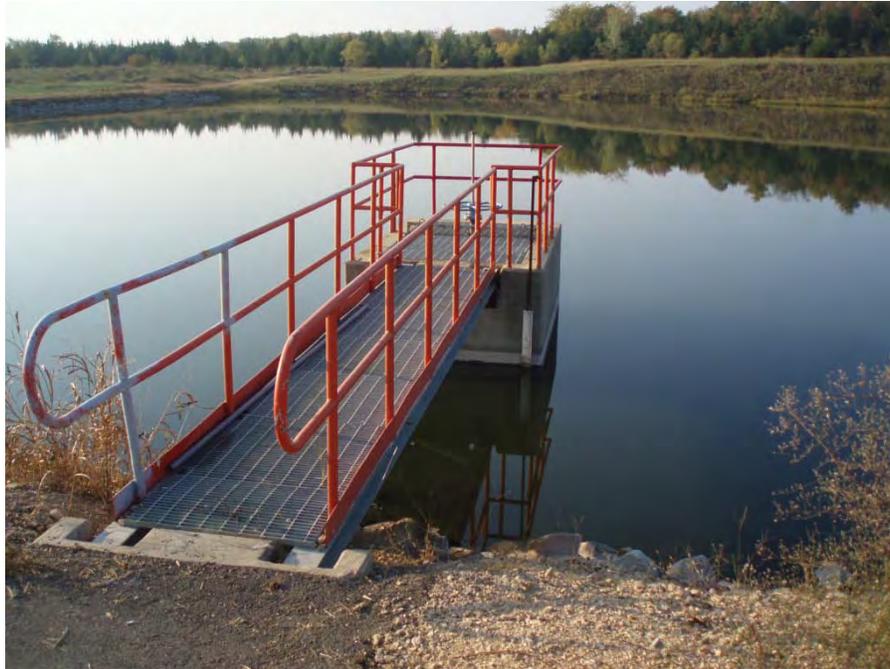
A concrete riser and outlet pipe is located at the eastern end of the pond. The outlet structure discharges to the Bottom Ash Recycle Structure, eventually discharging to the Process Waste Pond. The outlet structure appeared to be in good condition. No unusual movement was observed around the structure.

1. South Bottom Ash Pond -Outlet Structure, looking south

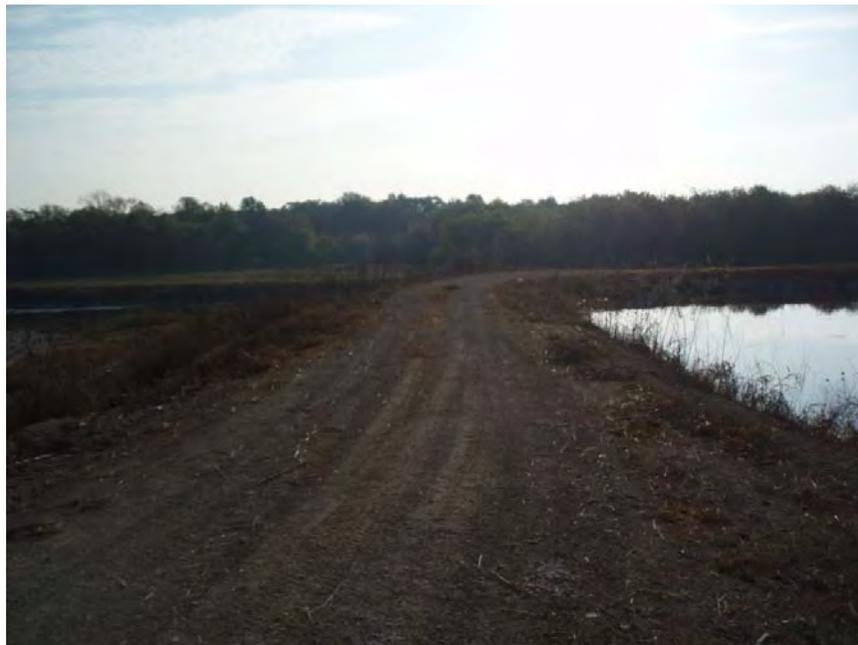
The crest width is about 10 feet on the east, south, and west sides, and 25 feet on the north side. The entire crest is subjected to vehicle traffic, though the majority is restricted to the north and east embankments. The crest surface appeared to mainly consist of compacted granular material and vegetation. The crest appeared to be in satisfactory condition (Photographs 2 and 7).

2. South Bottom Ash Pond - Looking toward east embankment
crest embankment?

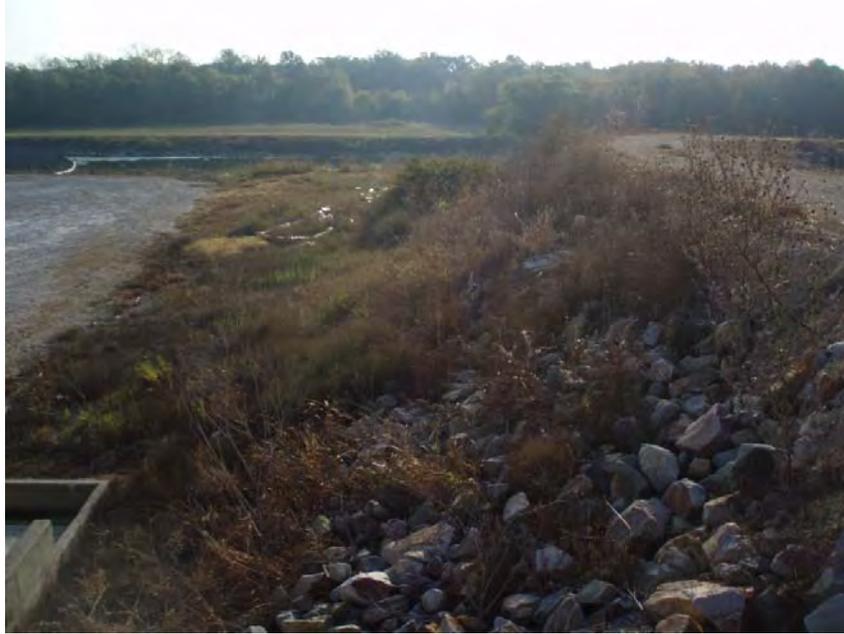
3. South Bottom Ash Pond – East embankment exterior slope,
looking south

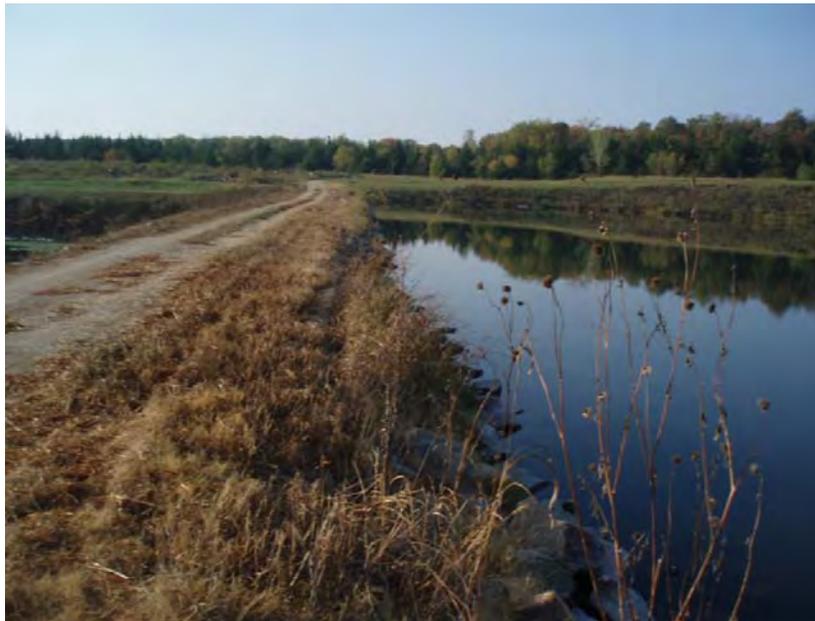
The interior slopes were approximately 2H: 1V. Riprap armoring of the interior slope is present on the east embankment (Photographs 4 and 6). Some small desiccation cracks were observed near the southeast corner of the interior slope. There were also some small sloughs observed well above the crest elevation on the excavated portion of the south embankment interior slope. On the south embankment, it appeared that the water level was below the natural ground surface elevation. The interior slopes appeared to be in generally good condition (Photographs 6, 9 and 10).

4. South Bottom Ash Pond - East embankment interior slope,
looking south

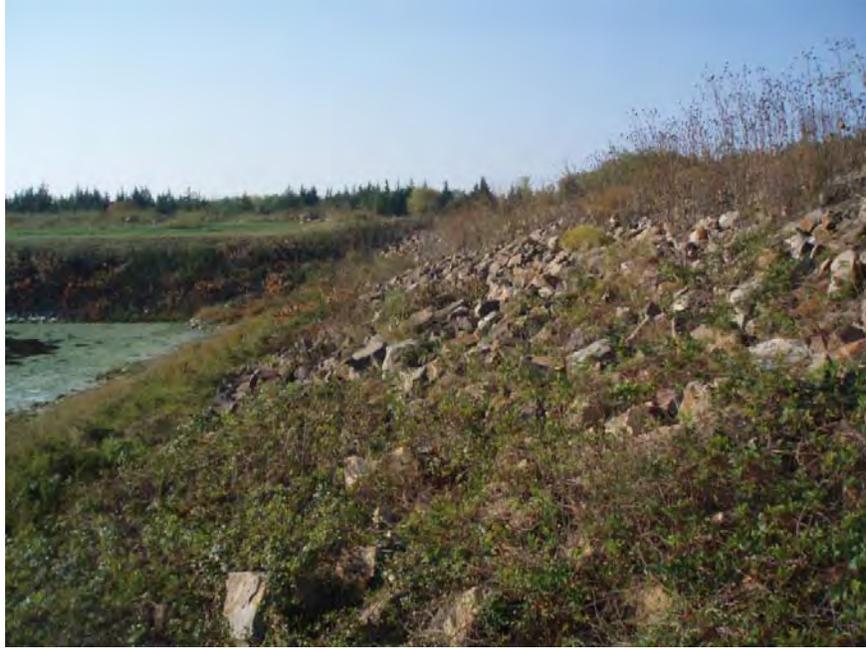
The exterior slopes of the embankments were inclined at approximately 2H: 1V. Large riprap, approximately 2 feet in largest dimension, was observed on the face of the east embankment (Photograph 5). The slopes appeared to be in good condition.

5. South Bottom Ash Pond - East embankment slope, looking south

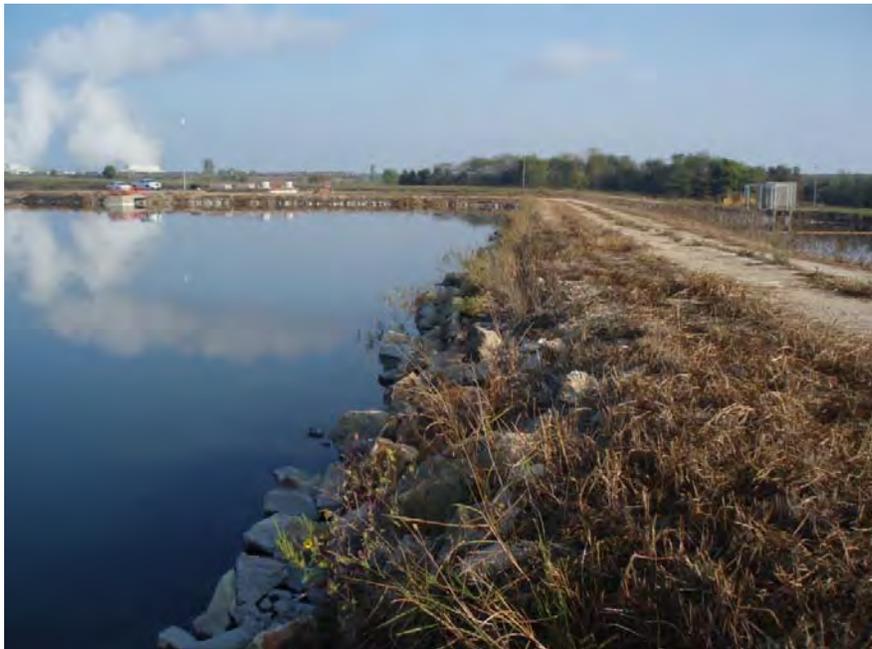
6. South Bottom Ash Pond - East embankment interior slope,
looking north

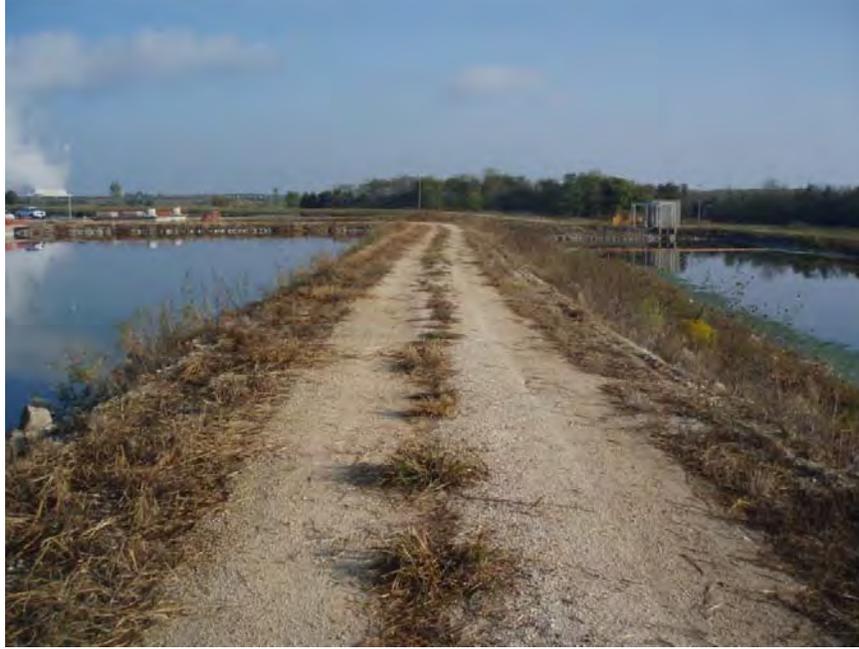
7. South Bottom Ash Pond – East embankment crest, looking north

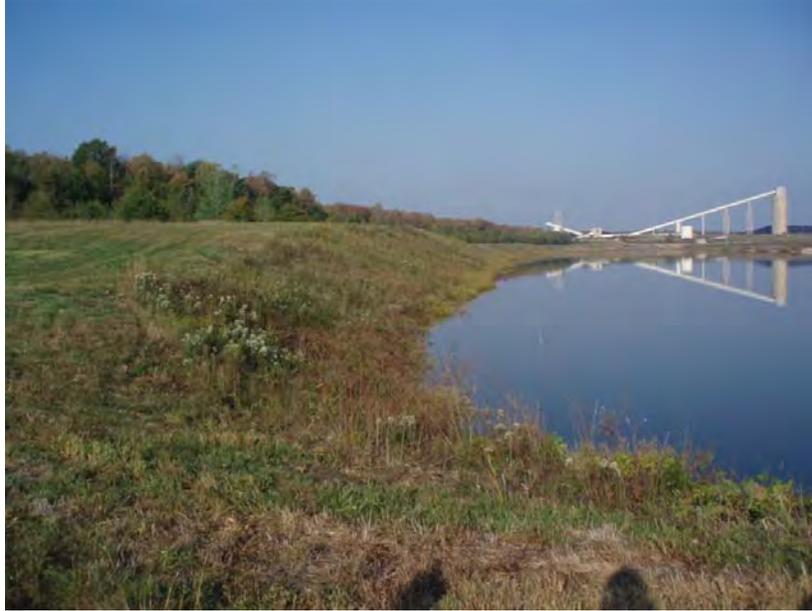
9. South Bottom Ash Pond – Southeast embankment interior slope, looking west

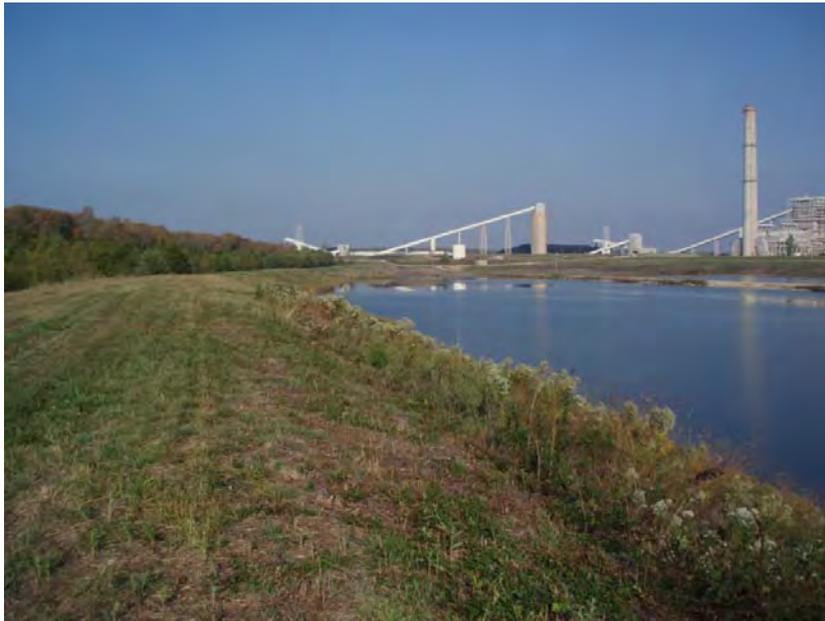
10. South Bottom Ash Pond – South embankment crest, looking west

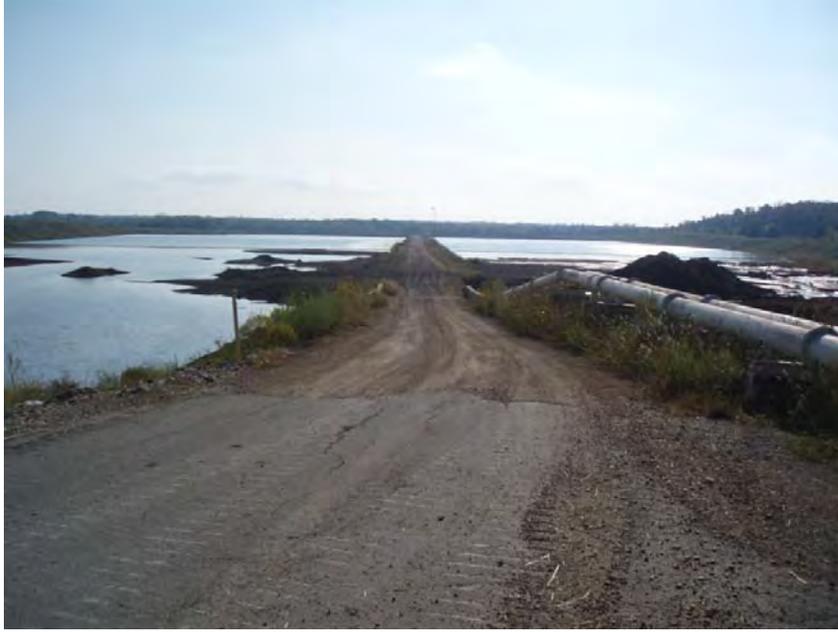
The crest of the North Bottom Ash Pond appeared to be in good condition (Photographs 13, 14, and 16). A small 3-foot by 3-foot rut was observed on the east embankment crest. The crest width ranged from about 10 feet wide along the west, north, and east embankments, and 25 feet for the south embankment. The entire crest is subjected to vehicle traffic, but most of the traffic occurs along the north and south embankment crests. The crest surface appeared to mainly consist of compacted granular material and grass.

The south embankment of the North Bottom Ash Pond is the divider between the North and South Bottom Ash Ponds. The embankment was in satisfactory condition and was covered in light vegetation (Photographs 13, 21, and 22). The vegetation was about 6 to 12 inches high. The embankment slopes appeared to be 2H: 1V. Minor sloughing, cracks approximately 15 feet long (Photograph 21), and ruts were observed in some localized areas of the divider embankment. The sloughs observed did not

13. North and South Bottom Ash Pond Divider Embankment- West end of crest, looking east

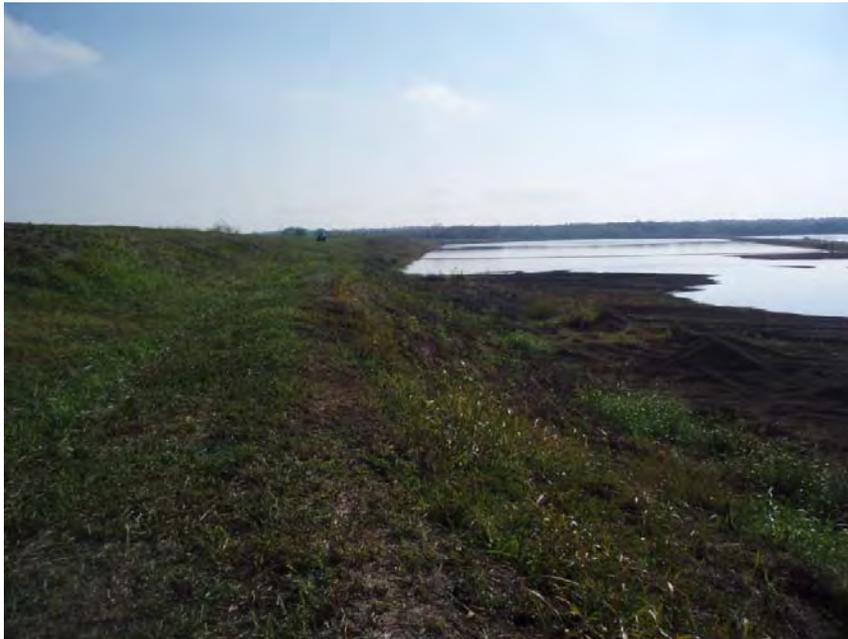
The interior slopes appeared to be in good condition. Light vegetation covered the embankment interior slopes (Photographs 14, 15 and 16). The interior slopes appeared to be approximately 2H: 1V. No armoring of the interior slope was observed, and no significant erosion or slumping was observed.

14. North Bottom Ash Pond - North embankment interior slope, looking east

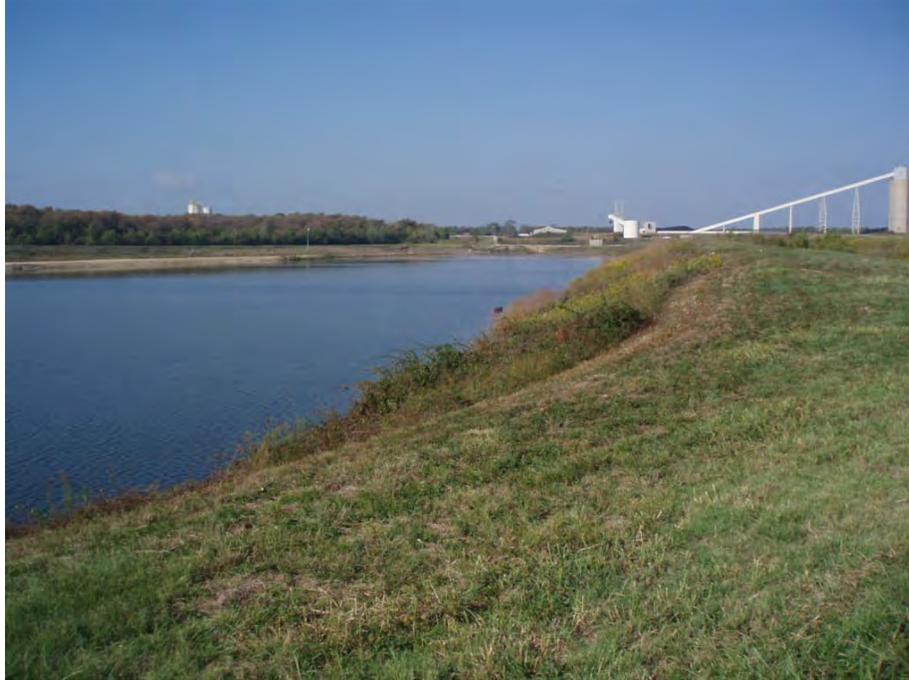
15. North Bottom Ash Pond – North embankment interior slope, looking west

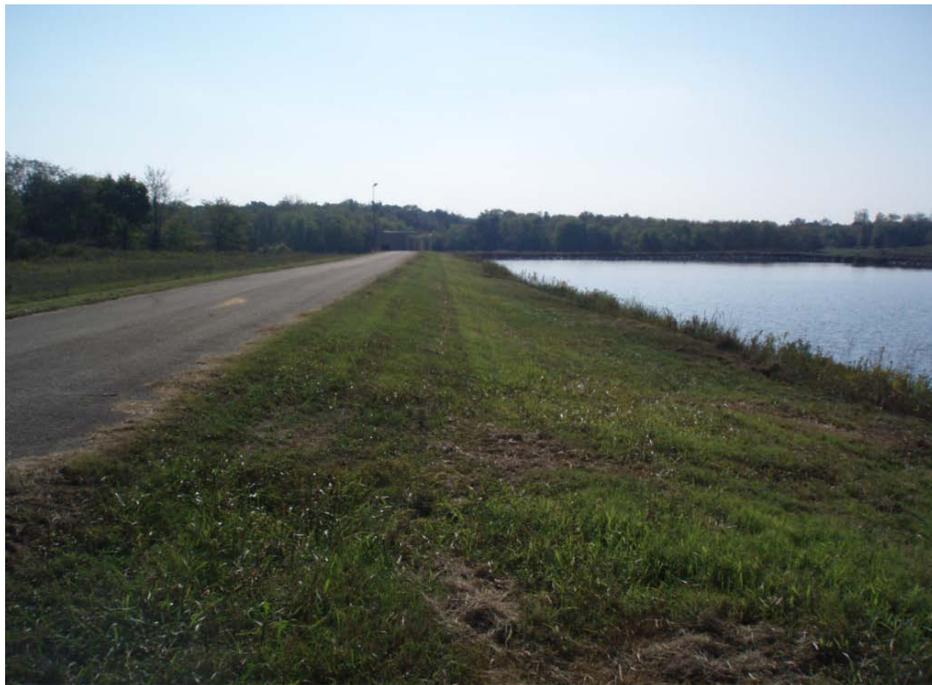
16. North Bottom Ash Pond – East embankment crest and interior slope, looking southeast

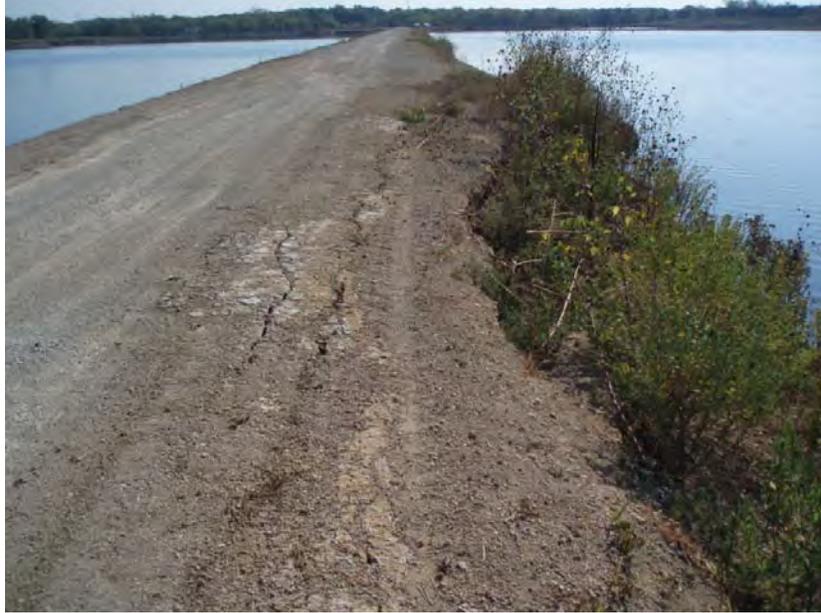
21. Bottom Ash Ponds - Longitudinal cracks along divider embankment, looking east

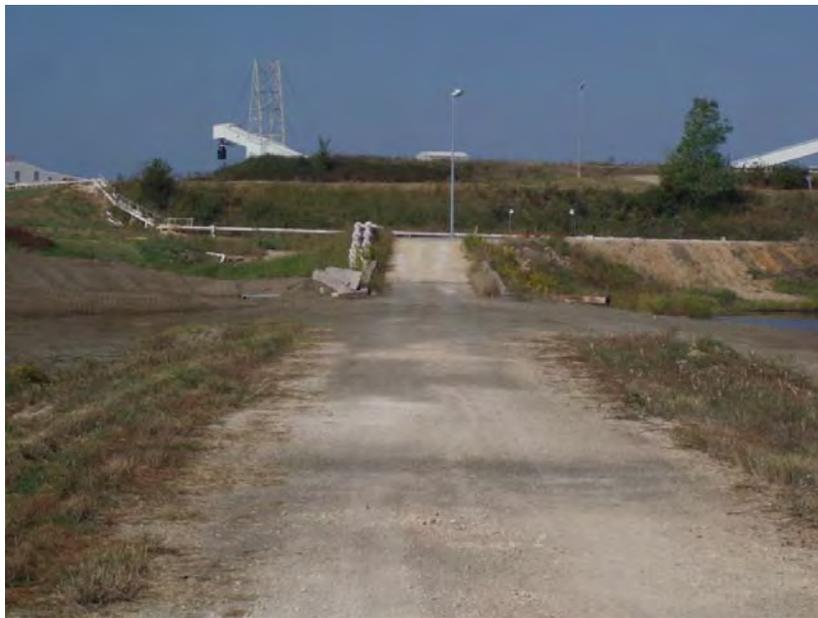
22. Bottom Ash Ponds - Discharge outlets on either side of the divider embankment, looking west

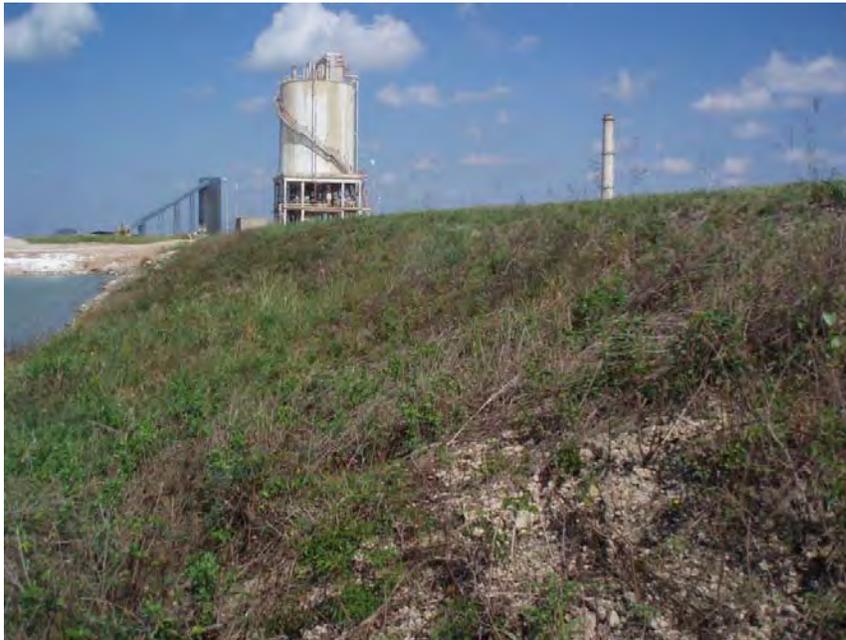
The slopes were 2H: 1V, except in the areas where sloughing and resulting over steepening of the interior face occurred. Sloughing was observed on the southern portion of the east embankment (Photograph 26) and at the western end of the south embankment interior slope (Photograph 34). In those areas slopes appear to be approximately 1H: 1V. Vegetation, consisting primarily of grass and brush less than 6 inches tall was observed on the interior slopes of the west, east and north embankments. There were also some small areas where vegetation was observed to be sparse. The interior slopes appeared to be generally in fair condition (Photograph 46).

26. South Fly Ash Pond – Sloughing on east embankment interior slope, looking north

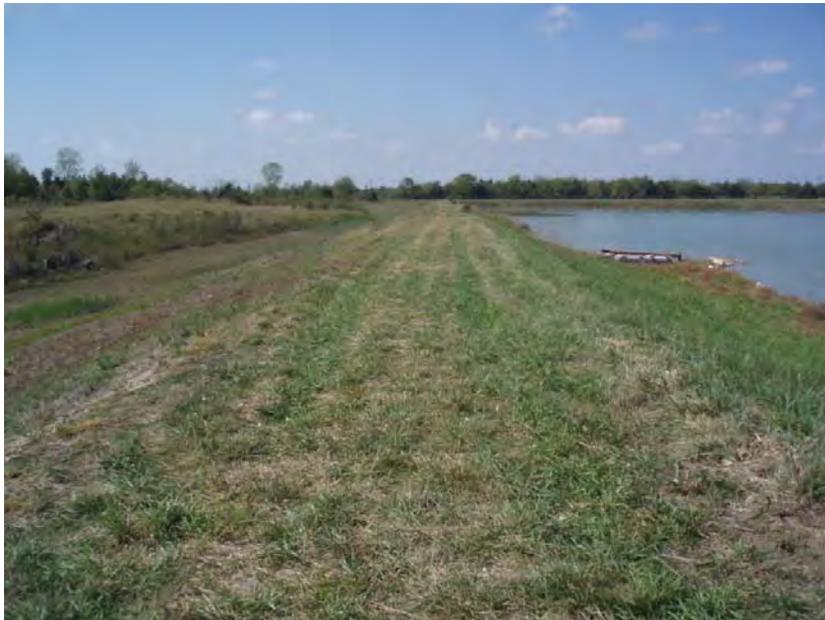
The average crest width of the north embankment is approximately 25 feet. The average crest width of the west, south and east embankment was approximately 10 feet. The crest surface consisted of compacted granular fill materials or was vegetated. A minor depression approximately 30 feet long by 12 feet wide was observed on the south embankment crest (Photograph 32). The crest generally appeared to be in good condition (Photograph 28) with the exception of rutting.

28. South Fly Ash Pond – South embankment exterior of southeast corner, looking west

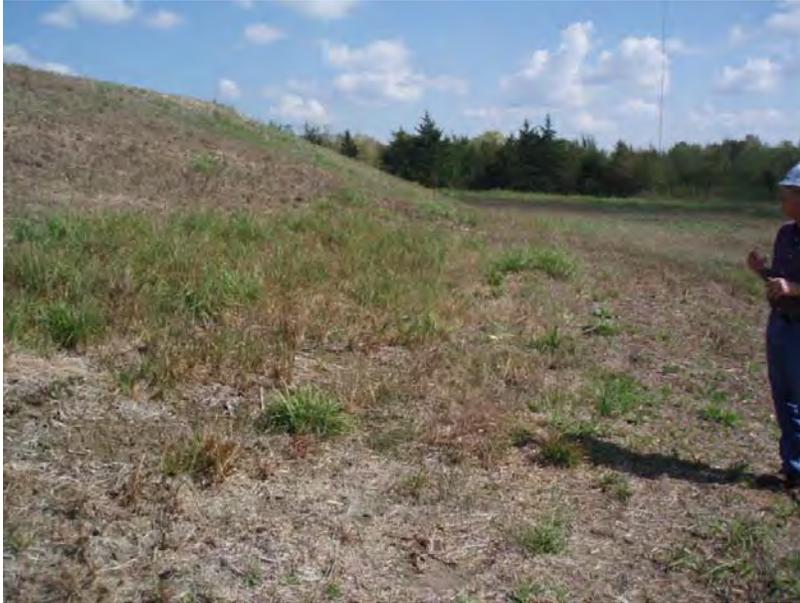
The west, north, and east exterior slopes appeared to be in good condition. The south exterior slope appeared to be in poor condition. An approximate 15-foot by 90-foot wet area was observed on the south embankment (Photograph 29). Near the south east corner of the embankment, an approximate 24-foot by 60-foot area of cattails was observed (Photograph 30). A 75-foot-long portion of the south embankment slope appeared to be over steepened and eroded, with some signs of possible slope movement (Photograph 31). Another 75-foot-long slough was observed on the south embankment (Photograph 33).

29. South Fly Ash Pond - Wet area on south embankment exterior slope, looking east

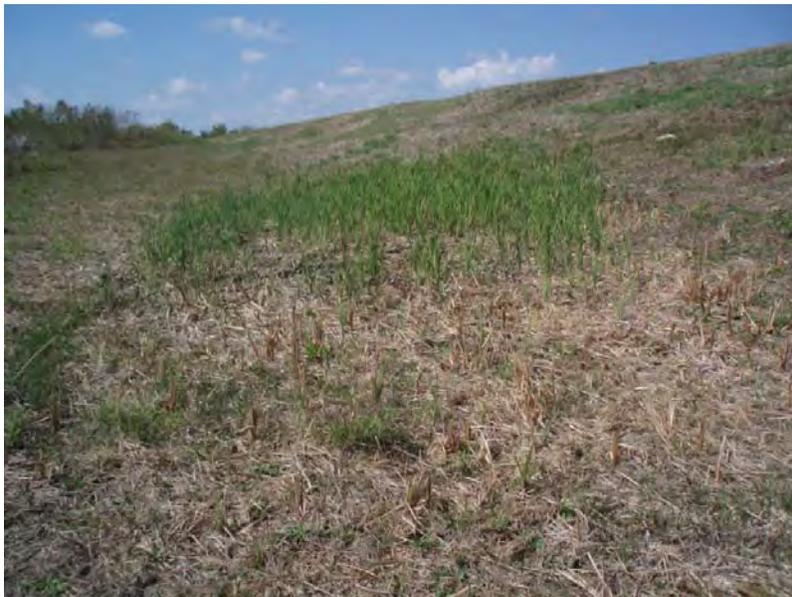
30. South Fly Ash Pond - Cattails growing on south embankment exterior face, looking west

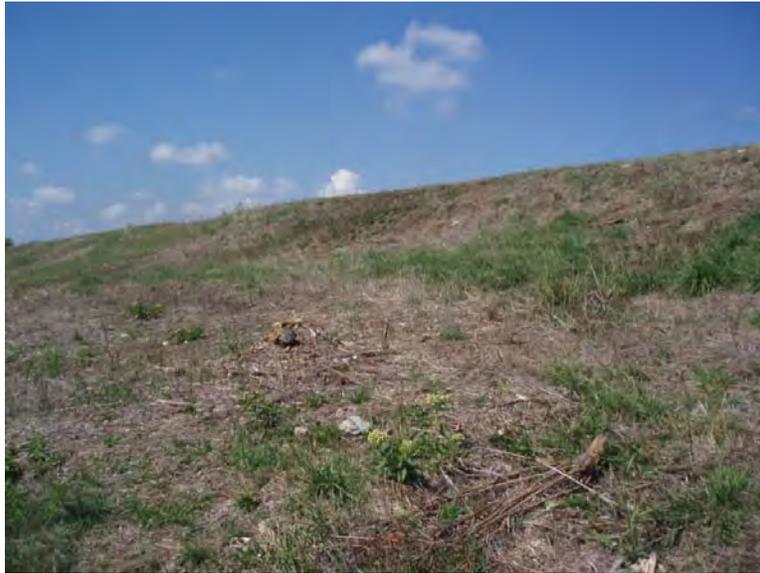
31. South Fly Ash Pond – South embankment exterior face slough, looking northwest

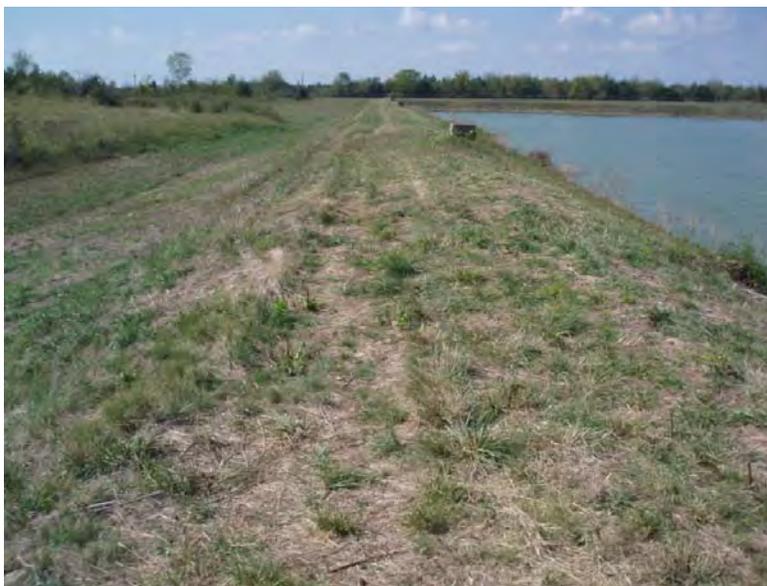
32. South Fly Ash Pond – South embankment crest depression, looking west

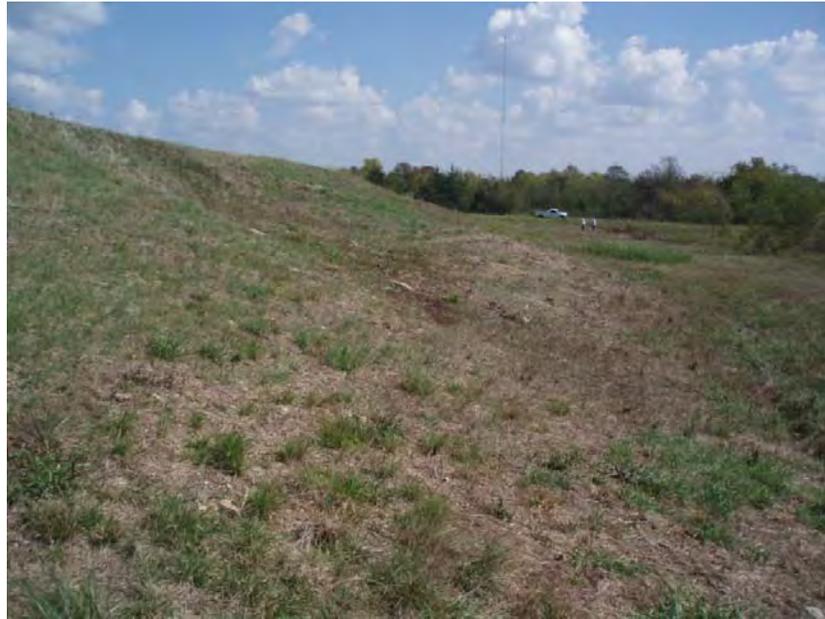
33. South Fly Ash Pond – South embankment exterior slope slough, looking east

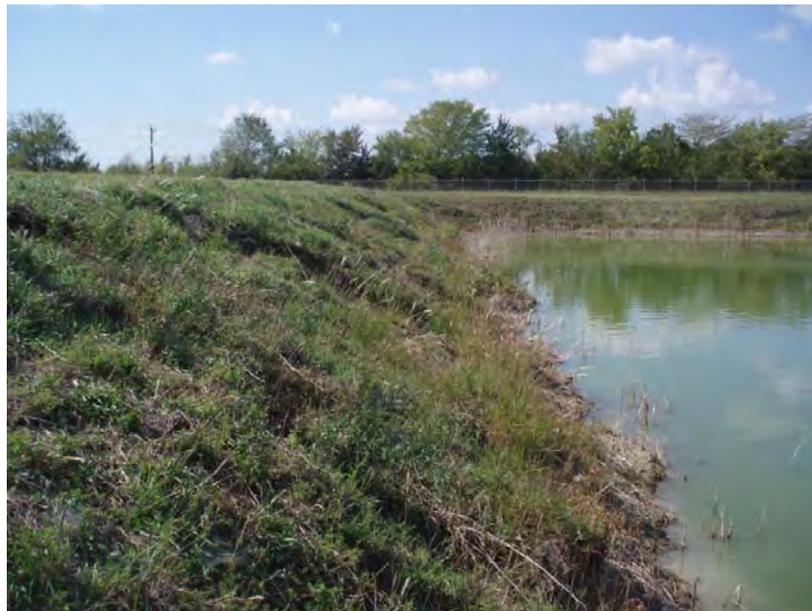
34. South Fly Ash Pond – South embankment interior slope slough, looking west

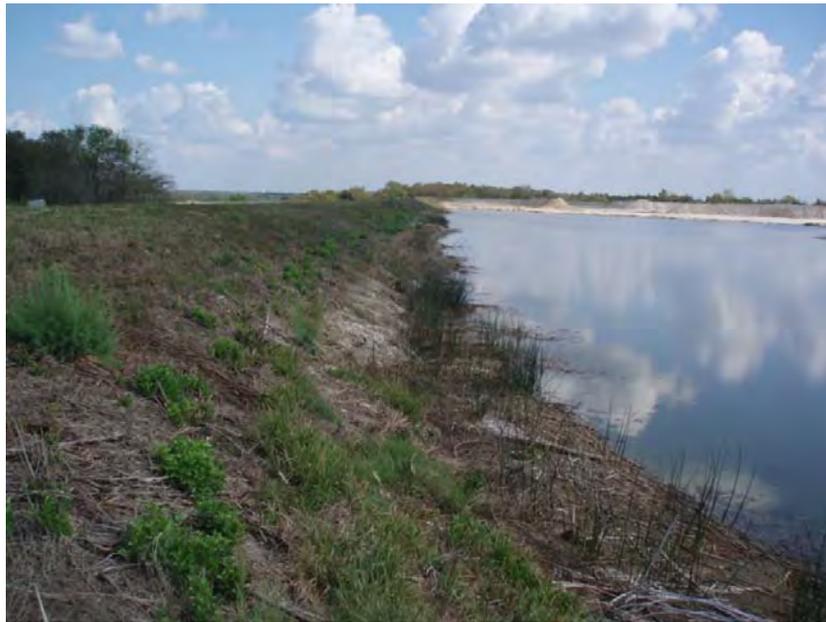
The interior slopes were generally inclined at 2H: 1V. In general the surface of the interior slopes had areas of sparse and light vegetation up to one foot high (Photograph 38). Some small stumps, small-diameter woody growth, and minor surface erosion were observed on the west embankment interior slope. Minor over-steepening of the interior slope was observed in some areas, apparently the result of erosion. Vegetation had been removed from portions of the north and south interior slopes, most likely due to ash excavation (Photographs 42 and 48). Several sloughs (Photographs 40 and 41) were observed along the north embankment. On the north embankment slope, four sloughs were estimated to be 75, 35, 65, and 60 feet long, respectively. In the slough areas, the upper portion of the embankment appeared to be over steepened to about approximately 1H: 1V. The interior slopes appeared to be in fair condition.

38. North Fly Ash Pond - Northwest embankment corner interior slope, looking east

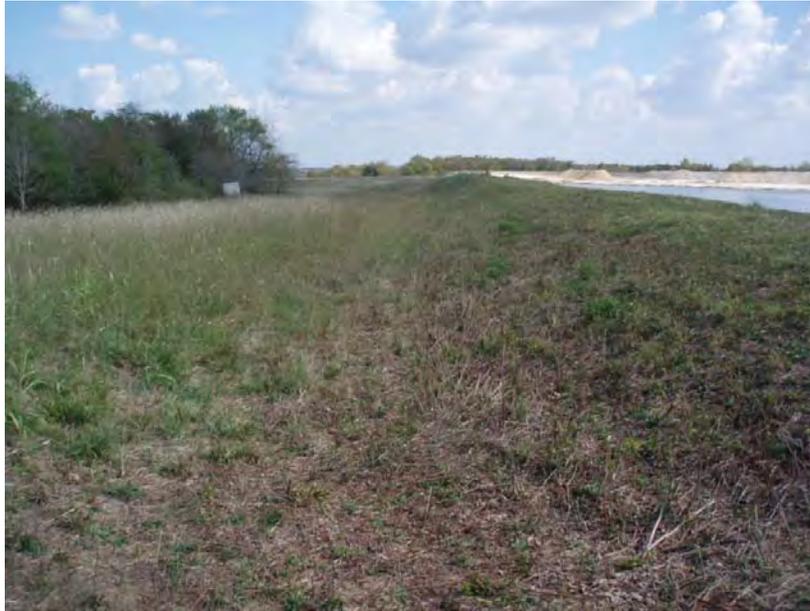
The embankment exterior slopes were approximately 2H: 1V. The slopes were covered with light vegetation about 6 to 8 inches high (Photograph 39) with the exception of the east embankment. On the east embankment there were some areas of Johnson grass that was about 3 feet high. An area that was identified by plant personnel as being seasonally wet that was dry at the time of the site visit and some sparse vegetation were observed on the northeast corner of the embankment (Photograph 43). No significant erosion features were observed on the slopes. The exterior slopes appeared to be in good to fair condition.

39. North Fly Ash Pond – Northwest embankment corner exterior slope, looking east

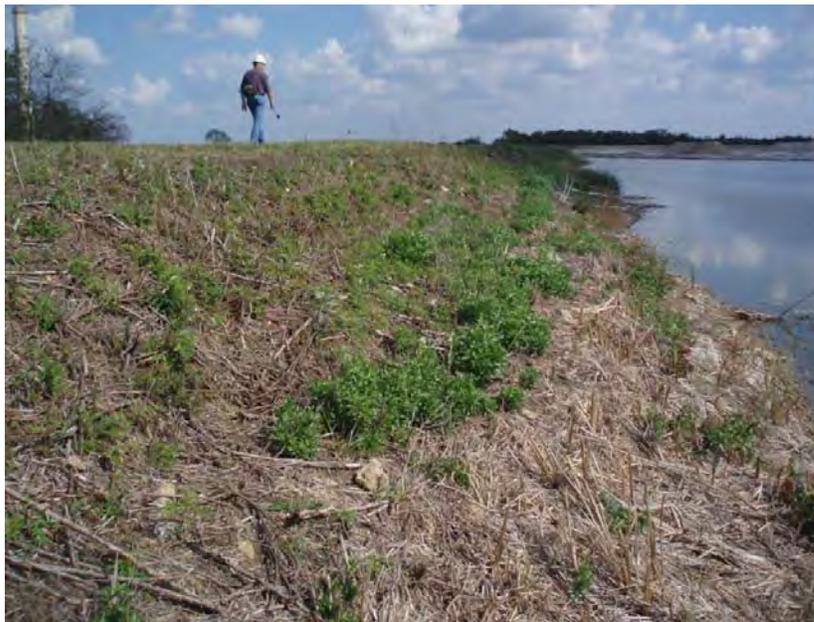
40. North Fly Ash Pond – North embankment interior slope slough, looking east

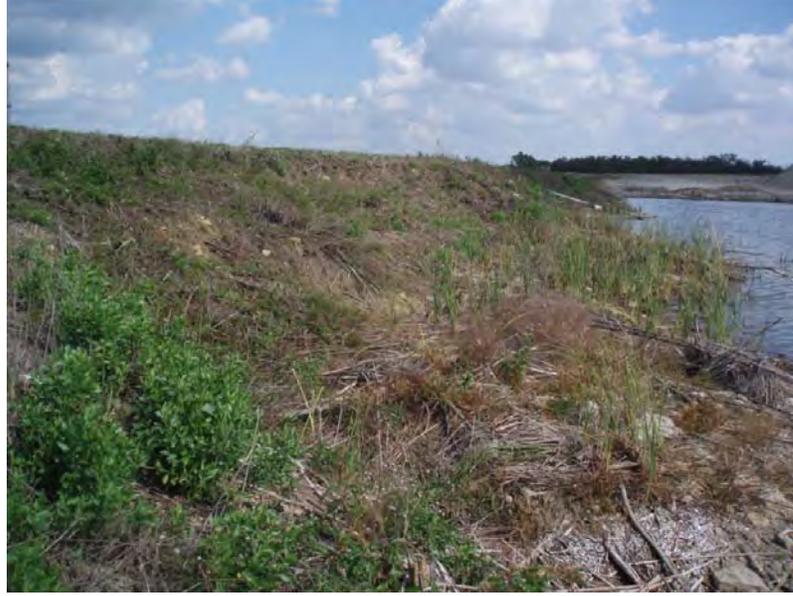
41. North Fly Ash Pond - North embankment interior slope slough, looking east

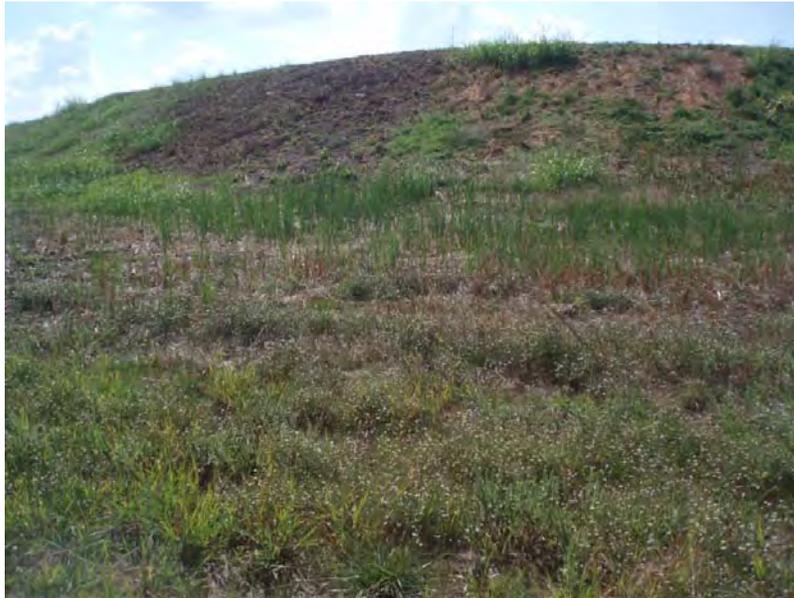
43. North Fly Ash Pond – Northeast embankment corner exterior slope seasonal wet area

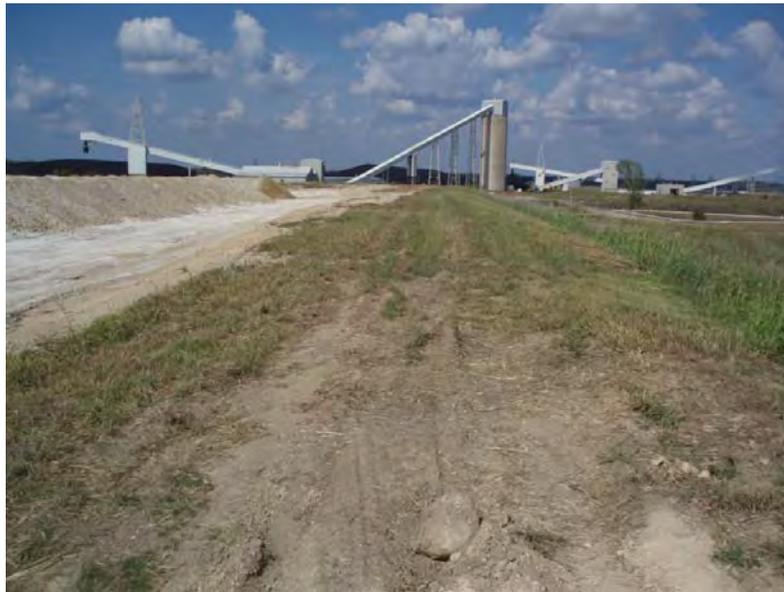
The average width of the embankment crest was 10 feet, with the south embankment crest being up to about 25 feet wide. In general, there were no signs of misalignment. The crest is utilized for vehicle access. A portion of the east embankment crest, near the northeast corner, had rutting from vehicle traffic (Photograph 44). The crest appeared to be in fair condition.

44. North Fly Ash Pond – West embankment crest vehicle ruts, looking north

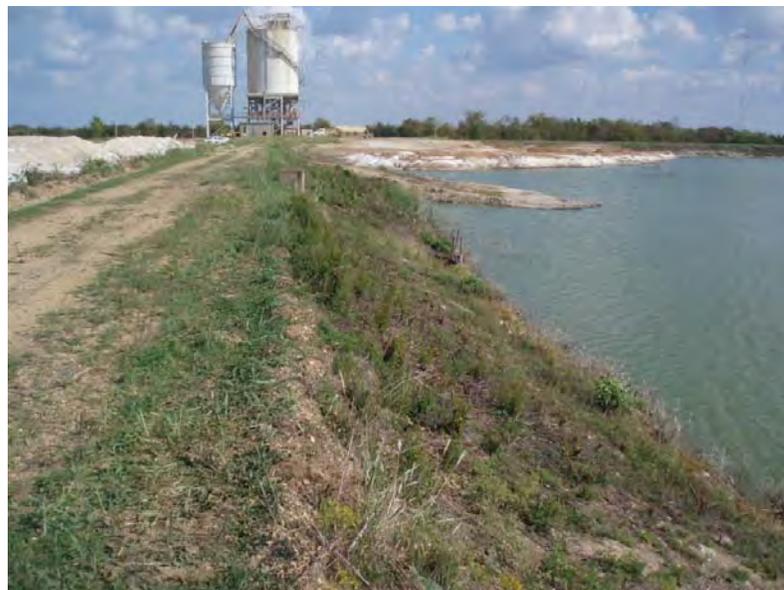
46. Fly Ash Pond Divider Embankment- Central portion of south interior slope, looking east

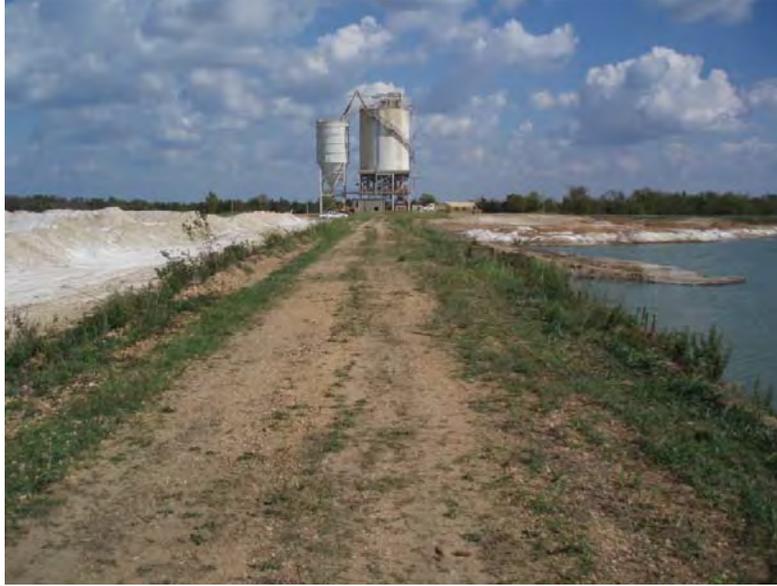
The south embankment serves as the divider embankment between the north and south fly ash ponds. In general, there were no signs of misalignment (Photographs 47 and 48). The divider embankment crest is utilized for vehicle access. An apparent slough approximately 130-foot-long that extended from the crest to the water level was observed on the south side of the divider embankment. The interior slopes appeared to be in fair condition.

47. Fly Ash Pond Divider Embankment- Central portion of crest and interior slope, looking east

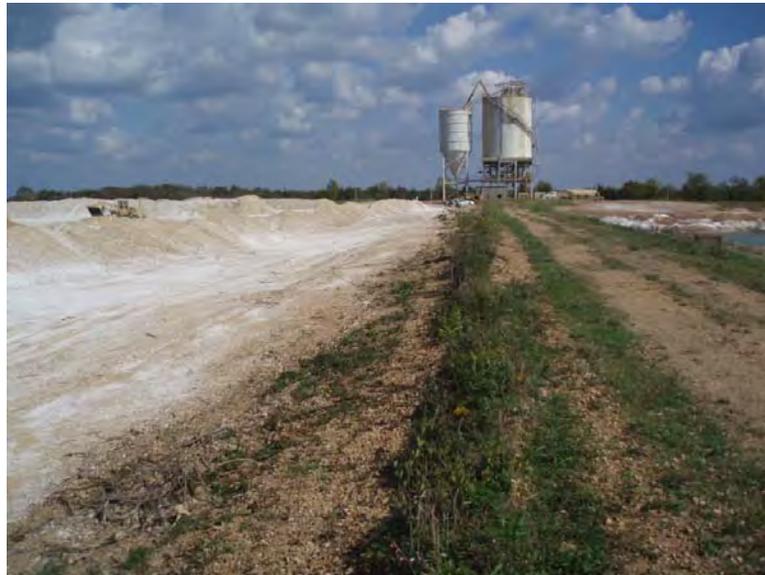
48. Fly Ash Pond Divider Embankment- Central portion of north exterior slope, looking east
