Semi-Annual Inspection

Building Demolition Barrier Areas

20s and 30s Complexes

William Stanley Business Park

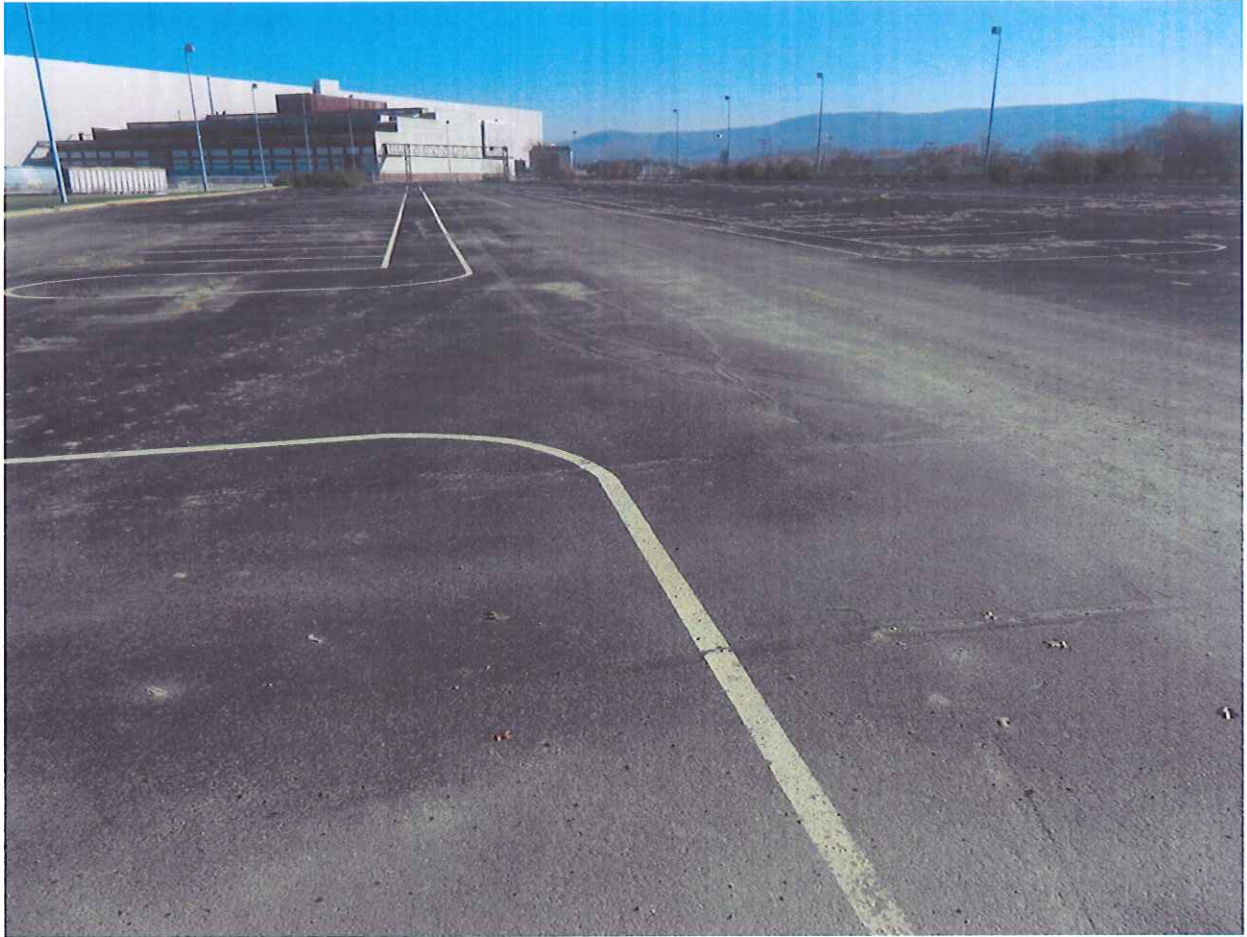
20s Building Demolition Barrier Area #1
View Looking East
11/9/11

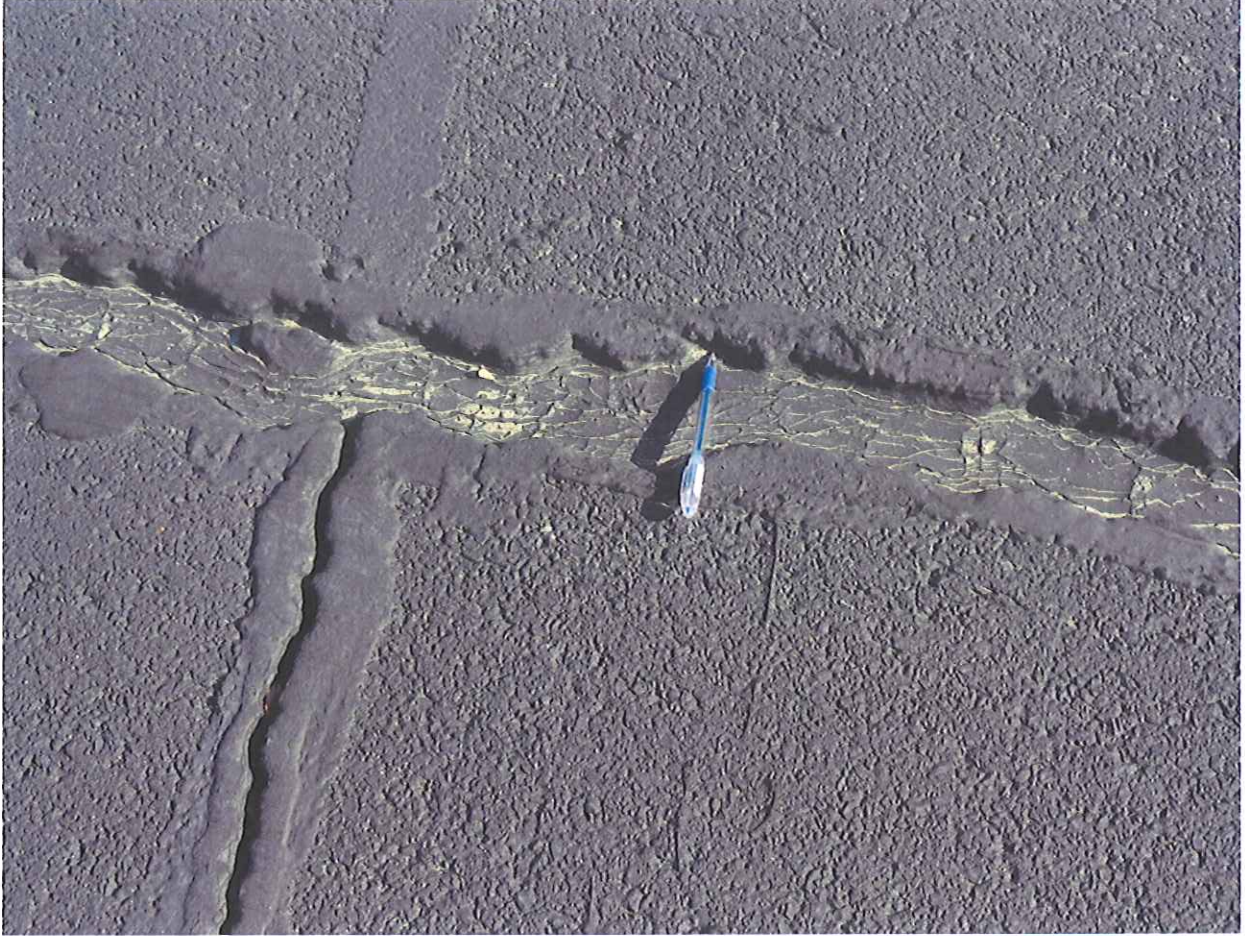
- Description of any conditions or problems noted during the inspection which are or may be affecting the performance of the engineered barrier:
No conditions were observed which are or may be affecting the performance of the engineered barrier. Minor vegetative growth and cracking were observed. The cracks, which were repaired/sealed in 2009, do not appear to be affecting the performance of the barrier. Evidence of water ponding was observed in the north western portion of the barrier area. The ponding is not the result of settlement of the barrier area but rather appears to result from restricted drainage of precipitation off the barrier area. The grassed area adjacent to the barrier area appears to inhibit free flow of precipitation run-off.

20s Building Demolition Barrier Area #1
Typical Crack Sealed in 2009
11/9/11

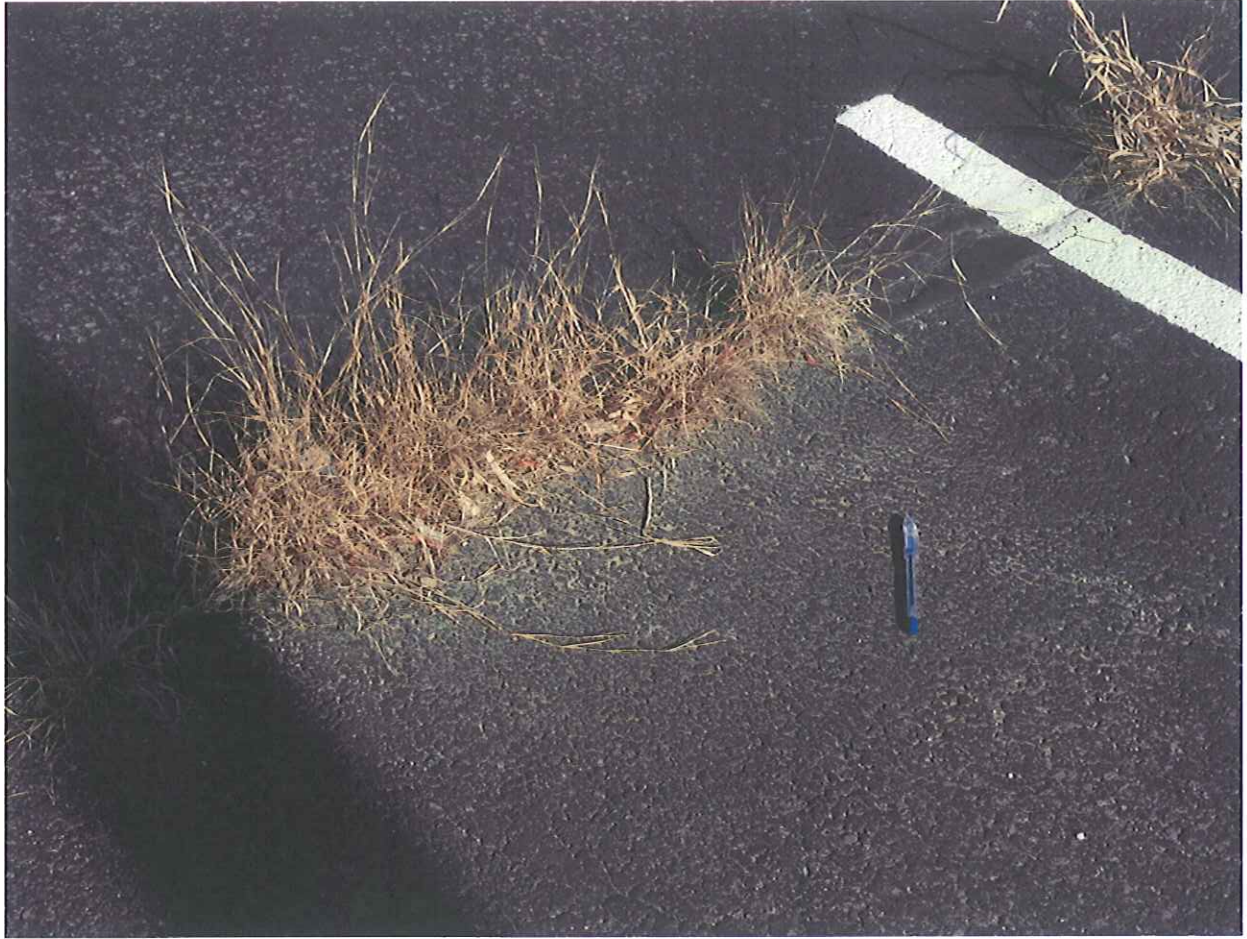
20s Building Demolition Barrier Area #1
Typical Vegetation Growth
11/9/11

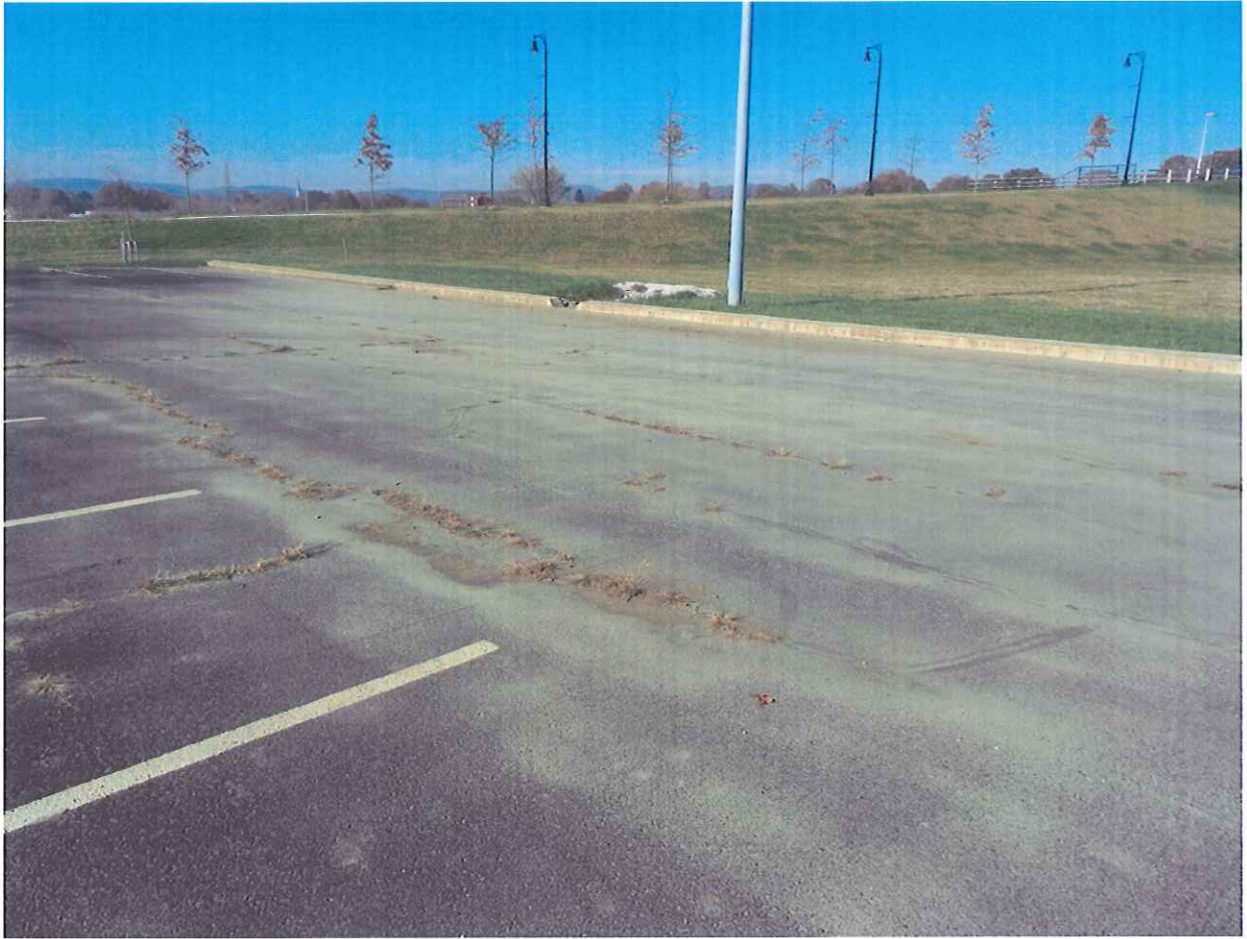
The overall condition of the barrier area can be described as very good. No conditions were observed on the barrier or on areas adjacent to the barrier that would currently compromise the integrity of the barrier surface area. The cause of the water ponding in the northwest corner of the barrier area should be reviewed by PEDDA's civil engineer to determine if corrective actions are necessary.

20s Building Demolition Barrier Area #1
Sign of Restricted Drainage
11/9/11

- Description of any measures that may need to be performed to correct any conditions affecting the performance of the barriers:
The cause of the water ponding should be reviewed by PEDDA's civil engineer to determine if corrective actions are necessary.

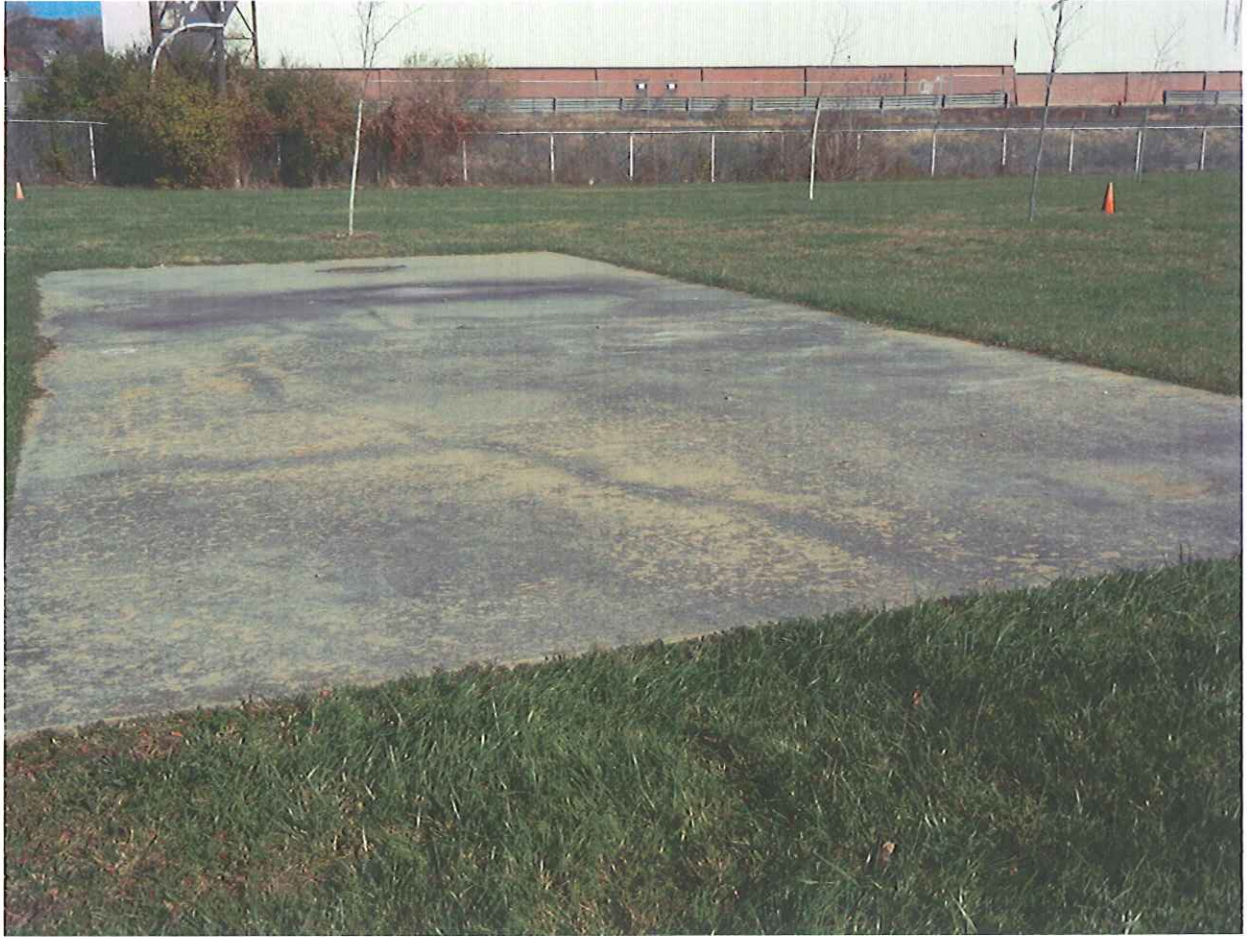
20s Building Demolition Barrier Area #2
View Looking North
11/9/11

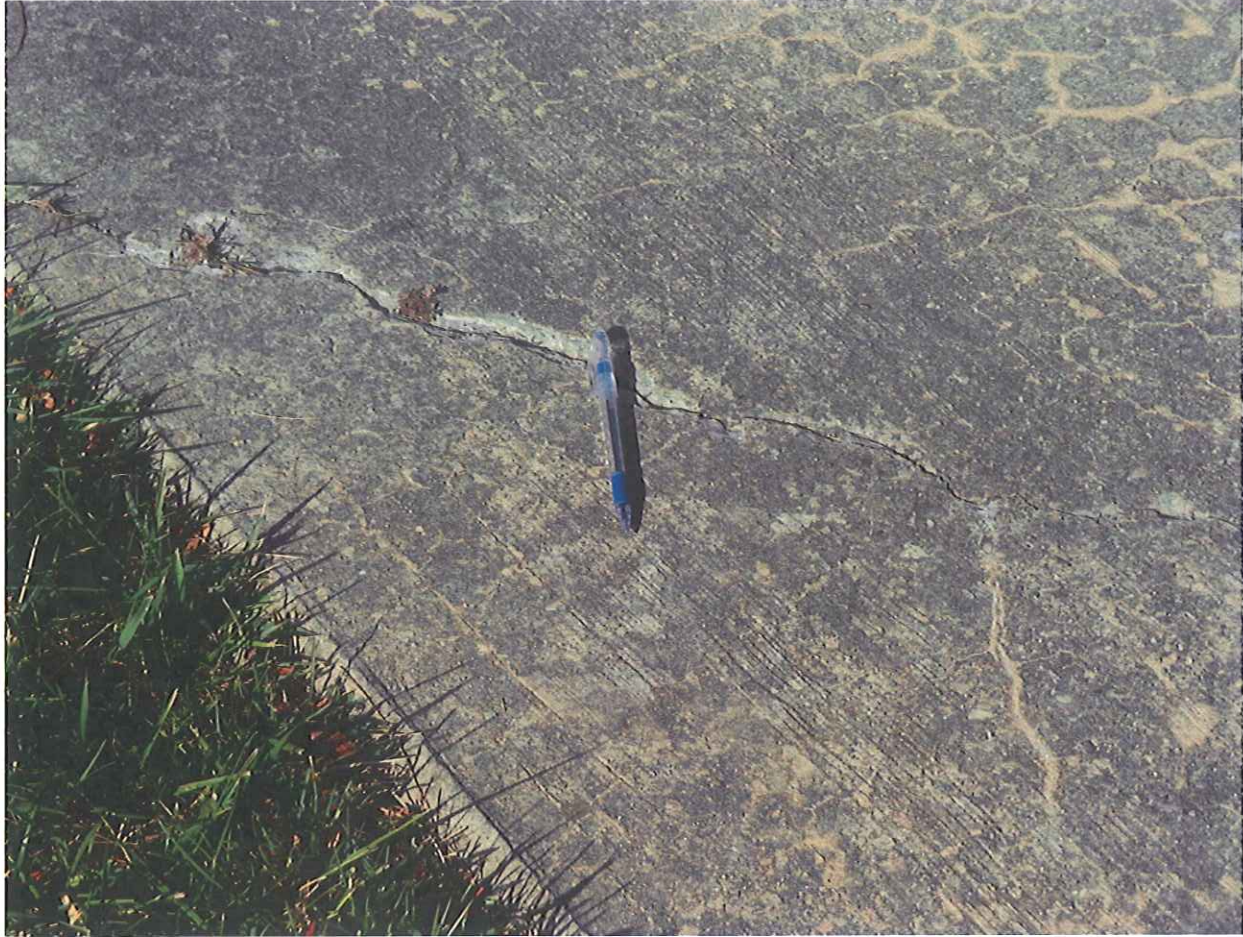
20s Building Demolition Barrier Area #2
Typical Crack
11/9/11

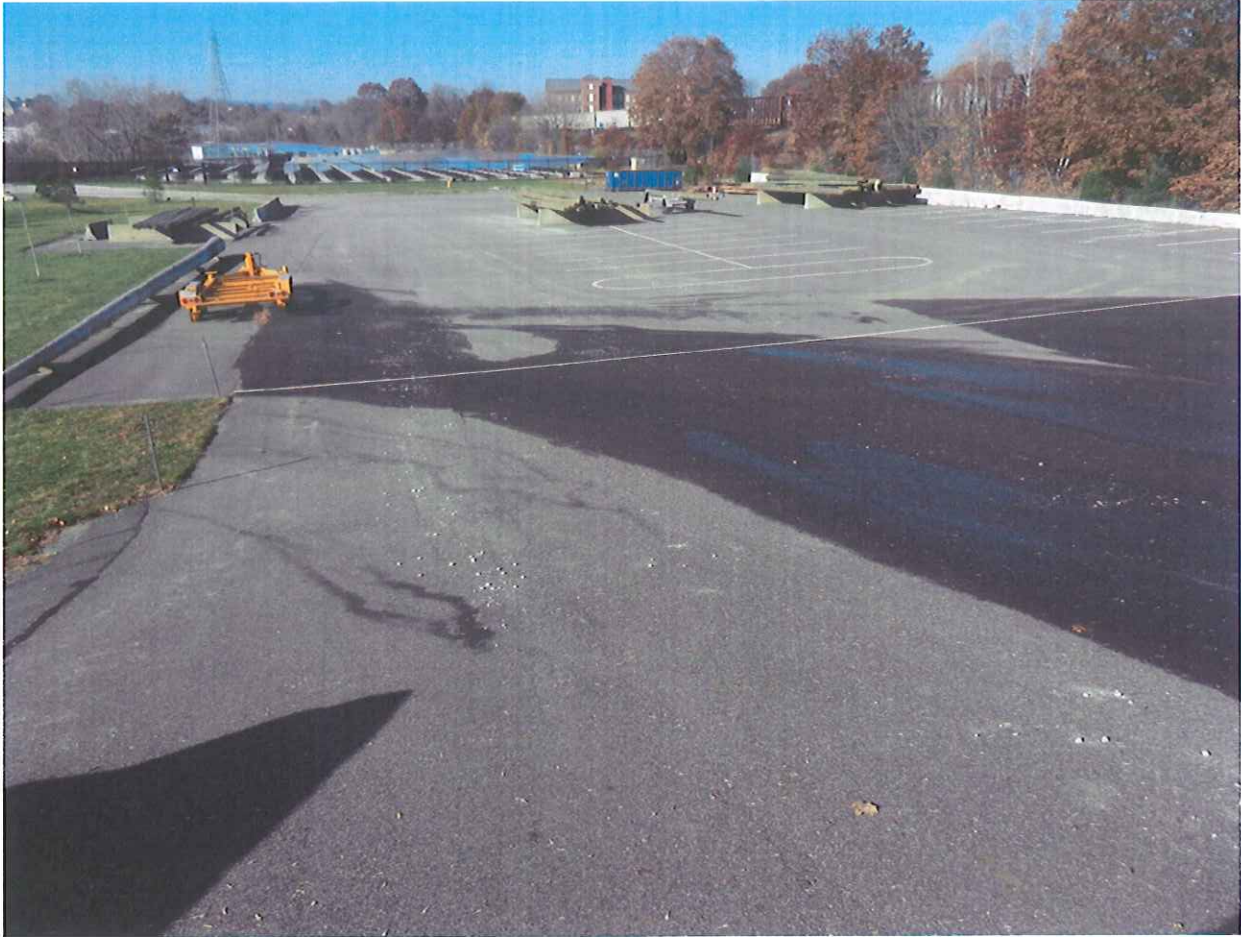
30s Building Demolition Barrier Area
View Looking West
11/9/11

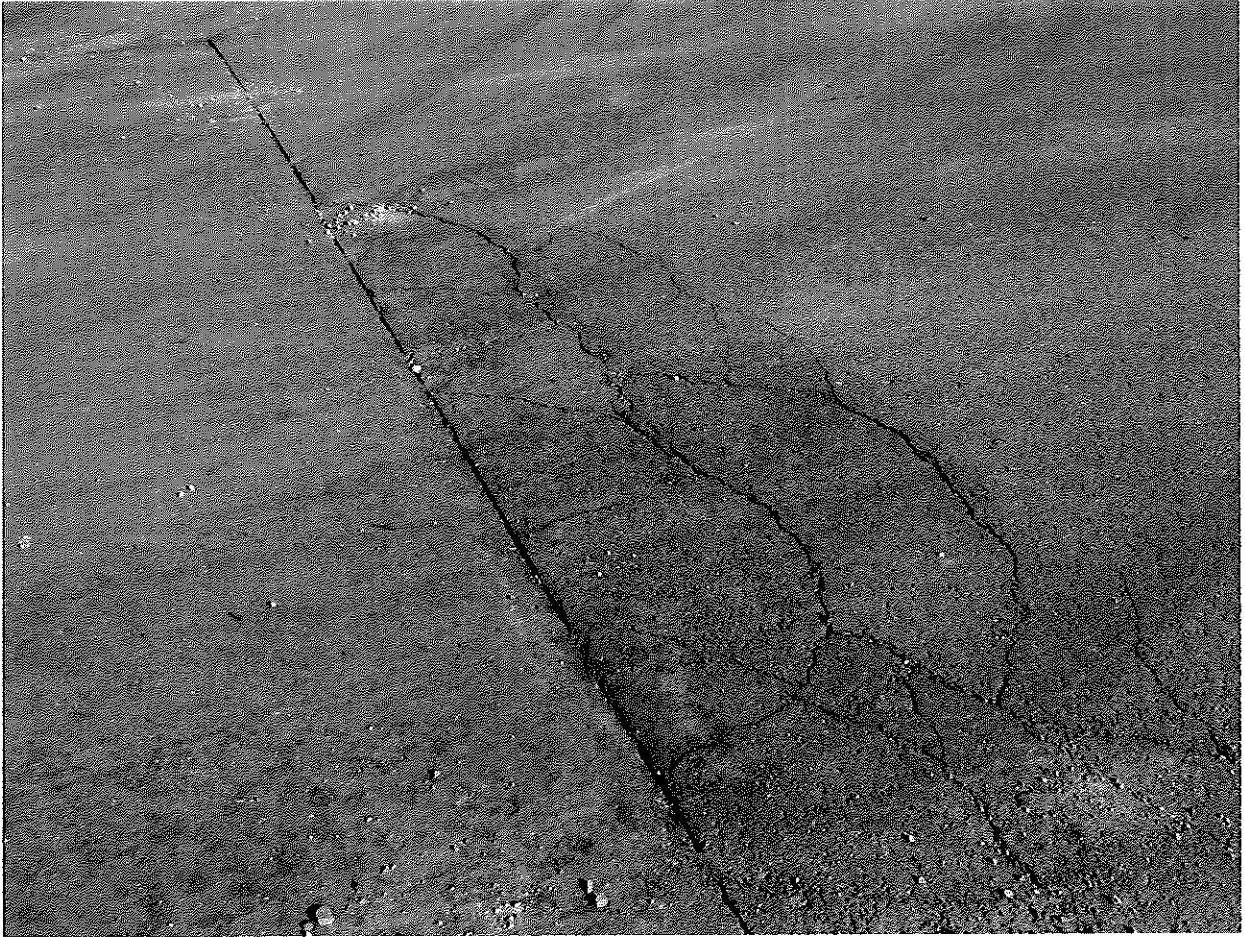
30s Building Demolition Barrier Area
Minor Cracking
11/9/11

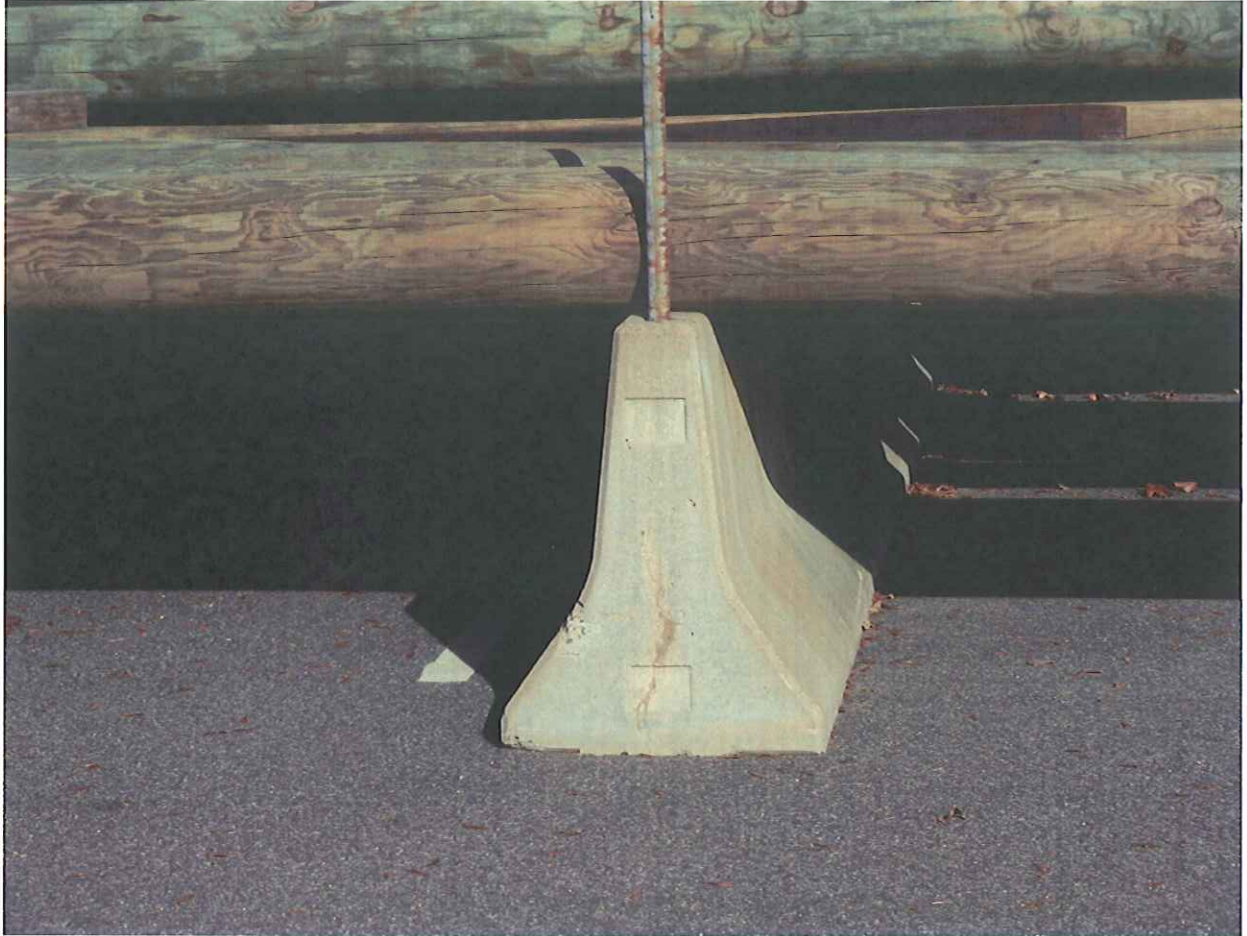
New and used utility poles are currently stored on the barrier area. Jersey Barriers are used to distribute the weight of the utility poles. This activity has not impacted the barrier area.

30s Building Demolition Barrier Area
Support for Utility Pole Storage
11/9/11
