**Re: GE-Pittsfield/Housatonic River Site
East Street Area 2-South (GEC150)
Summary of September 2010 Inspection Activities – City Recreational Area**

**INSPECTION SUMMARY AND CHECKLIST
CITY RECREATIONAL AREA**

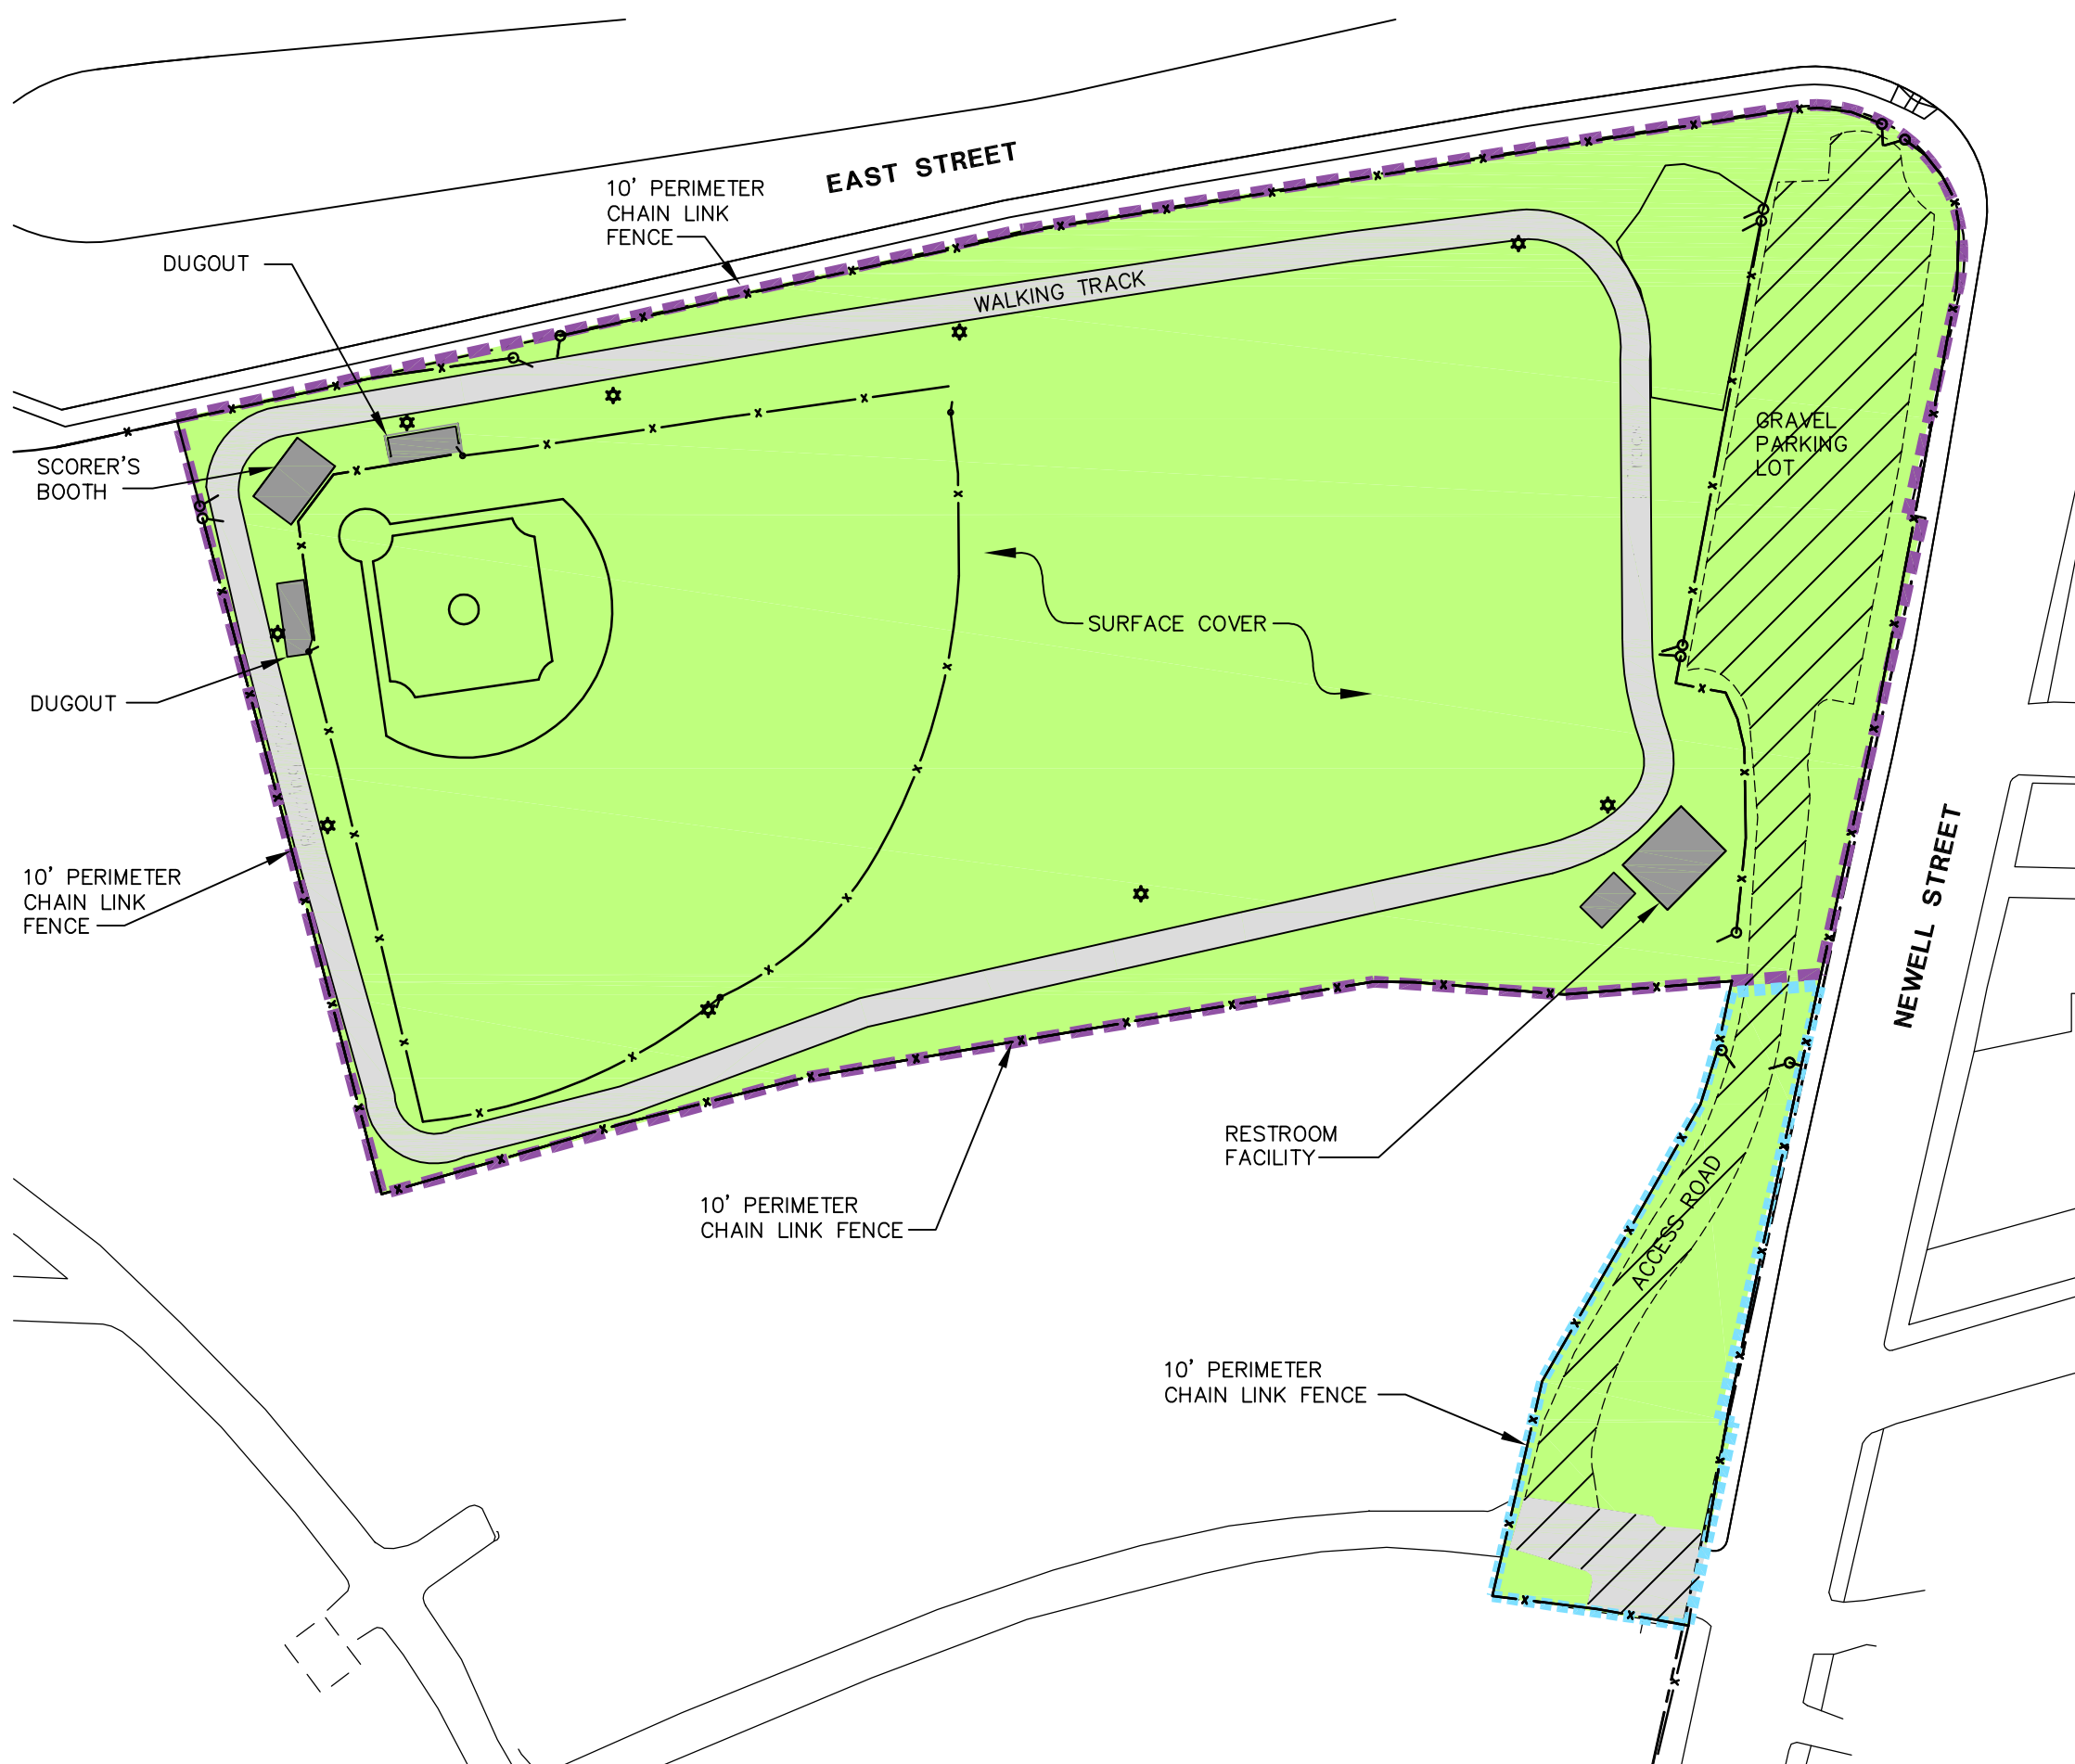
FIGURE
3

The September 2010 inspection indicated that the inspected areas within the City Recreational Area were in good overall condition with the exception of the pedestrian gate in the northwest corner. The gate was broken open, allowing unauthorized access to the GE facility from the City Recreational Area. Subsequent to the inspection, a chain was purchased and installed with a lock to prevent unauthorized access to the GE facility. No further maintenance or repair activities were identified.

- Pedestrian gate at the northwest corner of the site was broken open, allowing pedestrians to access the GE facility. Subsequent to the inspection, a new chain was purchased and installed with a GE lock to stop unauthorized access to the GE facility.
