GE
159 Plastics Avenue
Pittsfield, MA 01201
USA

**Re: GE-Pittsfield/Housatonic River Site
Hill 78 Area-Remainder (GEC160)
Summary of September 2011 Inspection Activities**

INSPECTION SUMMARY AND CHECKLIST

HILL 78 AREA-REMAINDER

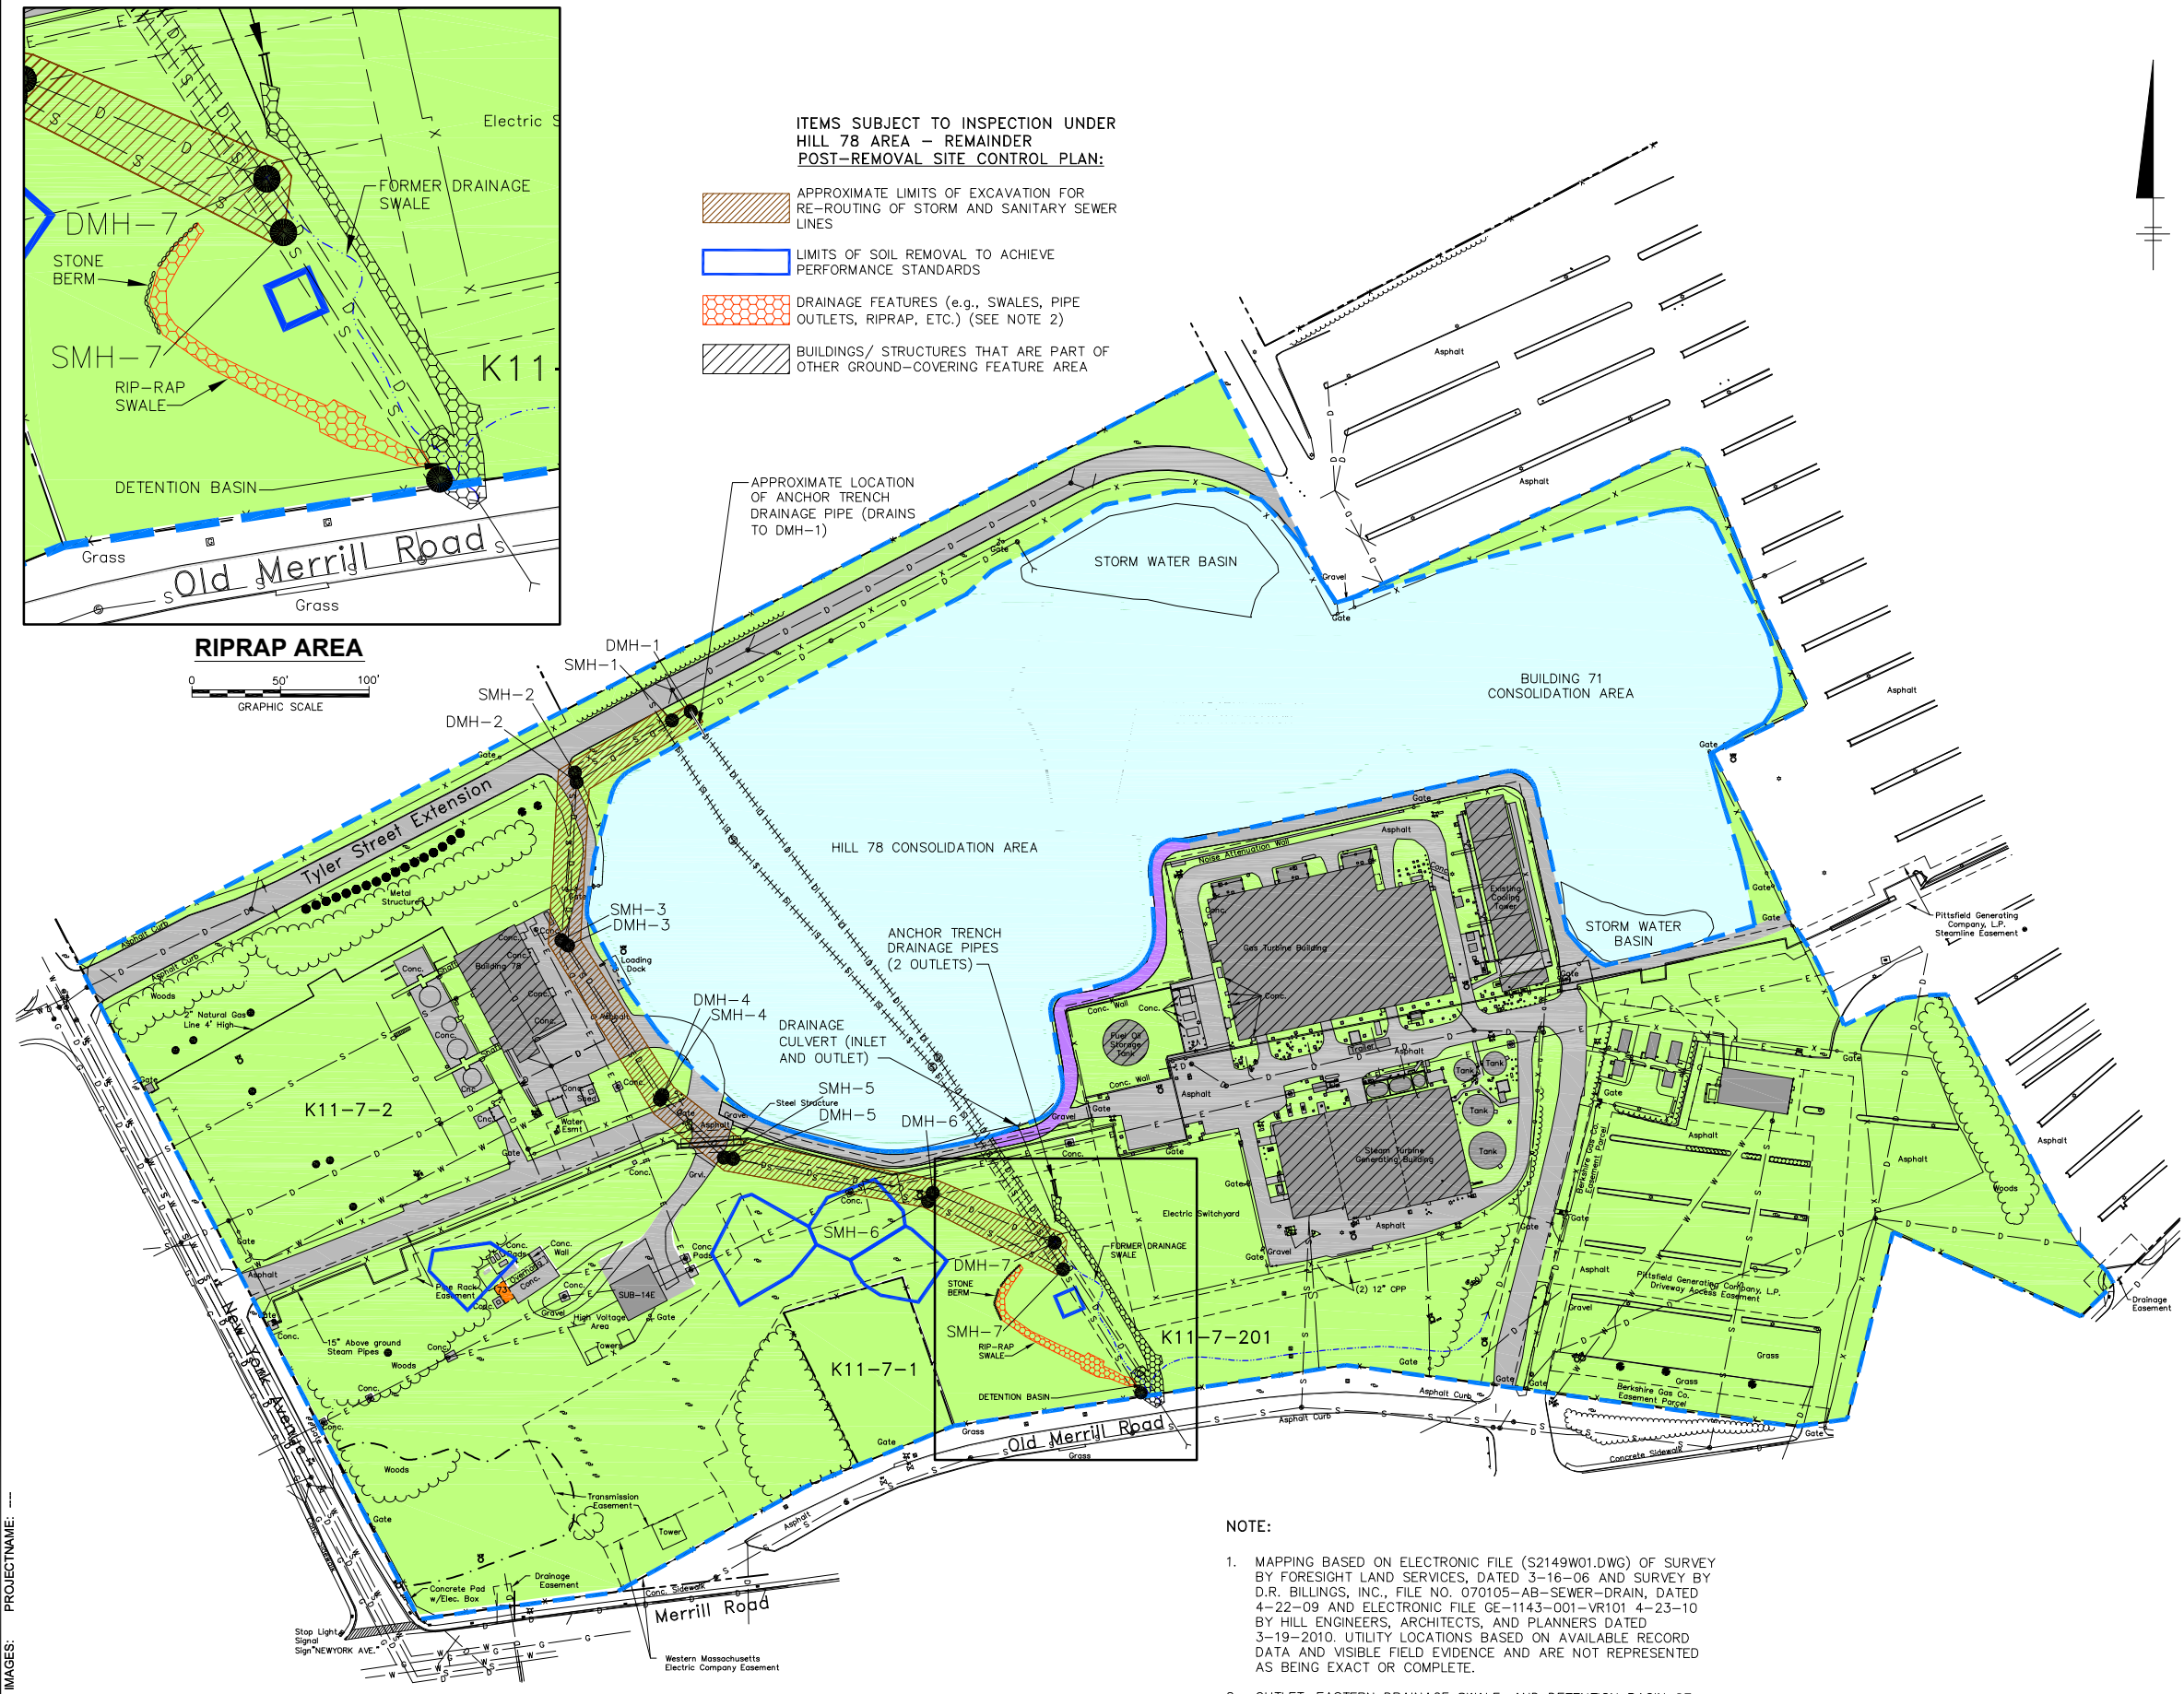
FIGURE
4

The results of the September 2011 inspection are provided in the attached Inspection Summary and Checklist form. As noted in that attached form, the September 2011 inspection indicated that the areas inspected at Hill 78 Area-Remainder were in good overall condition with the exception of the presence of vehicle ruts observed at four locations in the vicinity of the backfilled/restored areas north of Parcel K11-7-1. There was no observed evidence of erosion and no evidence of damage from the above-referenced tropical storm. The inspection also showed that existing structures that are part of the Other Ground-Covering Feature Area under the ERE for this RAA remain in place and intact.

- Vehicle ruts were observed at four locations in the vicinity of the backfilled/restored areas north of Parcel K11-7-1.

The areas of vehicle ruts in the vicinity of the backfilled/restored areas north of Parcel K11-7-1 will be repaired this fall. No need for other maintenance or repair activities was identified.

- Repair vehicle ruts observed in the vicinity of the backfilled/restored areas north of Parcel K11-7-1.
