Fourth Five-Year Review Report

**For Monticello Radioactively
Contaminated Properties
Superfund Site San Juan County
Monticello, Utah**

June 2012

**Prepared by
U.S. Department of Energy
Office of Legacy Management
Grand Junction, Colorado**

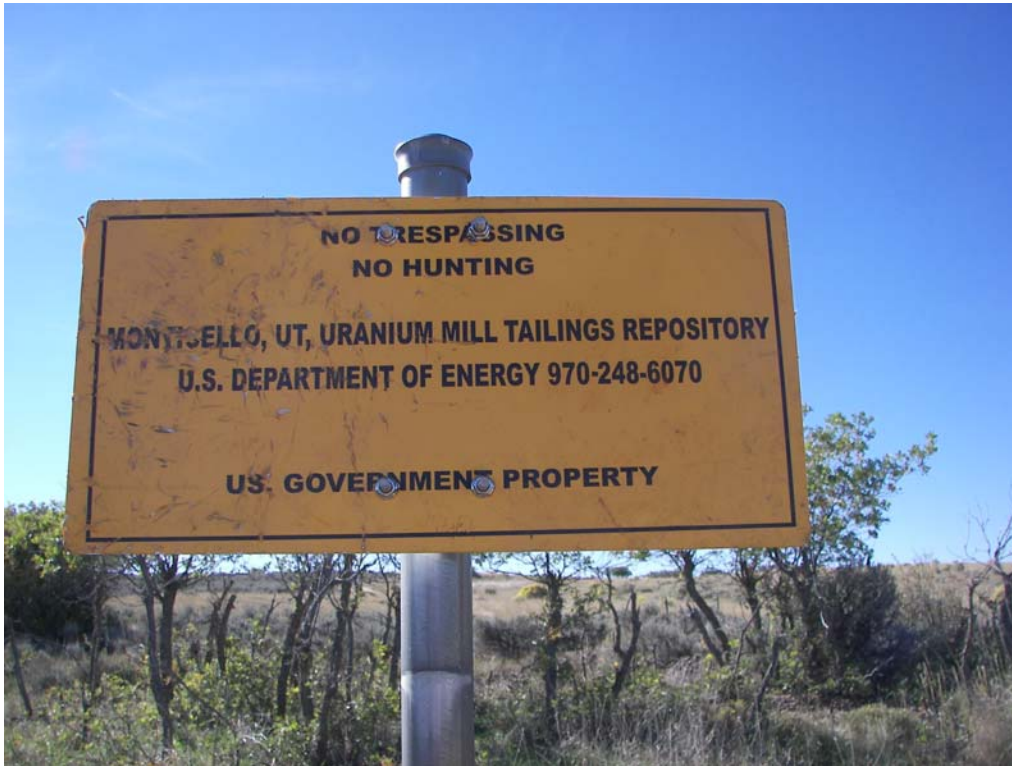
All perimeter signs were legible and in good condition, although perimeter signs P12 and P15 (Photo 1) were scratched. "No Hunting" signs, posted at all gates along the perimeter fence, were weathered and largely illegible. "No Hunting" signs may be particularly important along the eastern site boundary, where land use changes are likely to occur with the recent sale of the property. No evidence of bullet holes or other vandalism was present.

1. Perimeter sign P15, scratched but legible.

Maintenance Item: Replace “No Hunting” signs at all gates in the perimeter fence with sturdy metal signs.

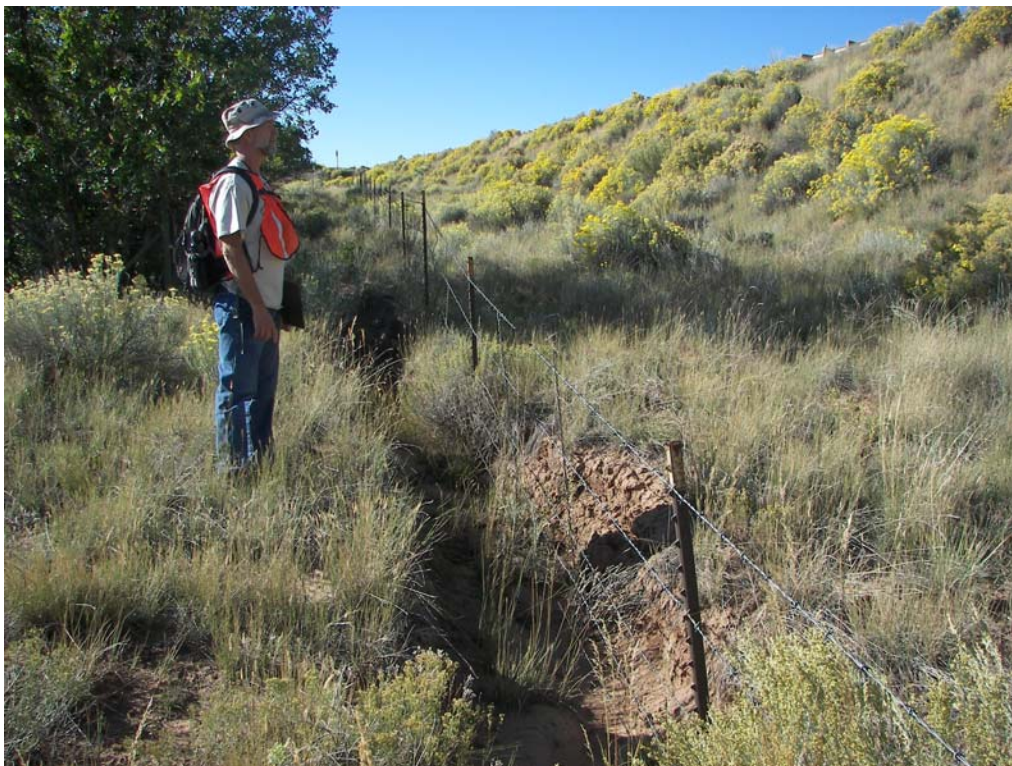
No new erosion was apparent during the 2011 inspection. Previous inspection reports describe a gully between perimeter signs E and P2, which threatened portions of the fence line along the west boundary of the site. Because sources of water to the gully have been rerouted or repaired by UDOT, no action was taken by DOE to fill the gully or to move the perimeter fence. As in 2010, the gully was still present in 2011. Deposition has continued, slowly filling in washout areas (Photo 2). This process will likely continue to fill the gully over time.

2. Gully along western perimeter fence.

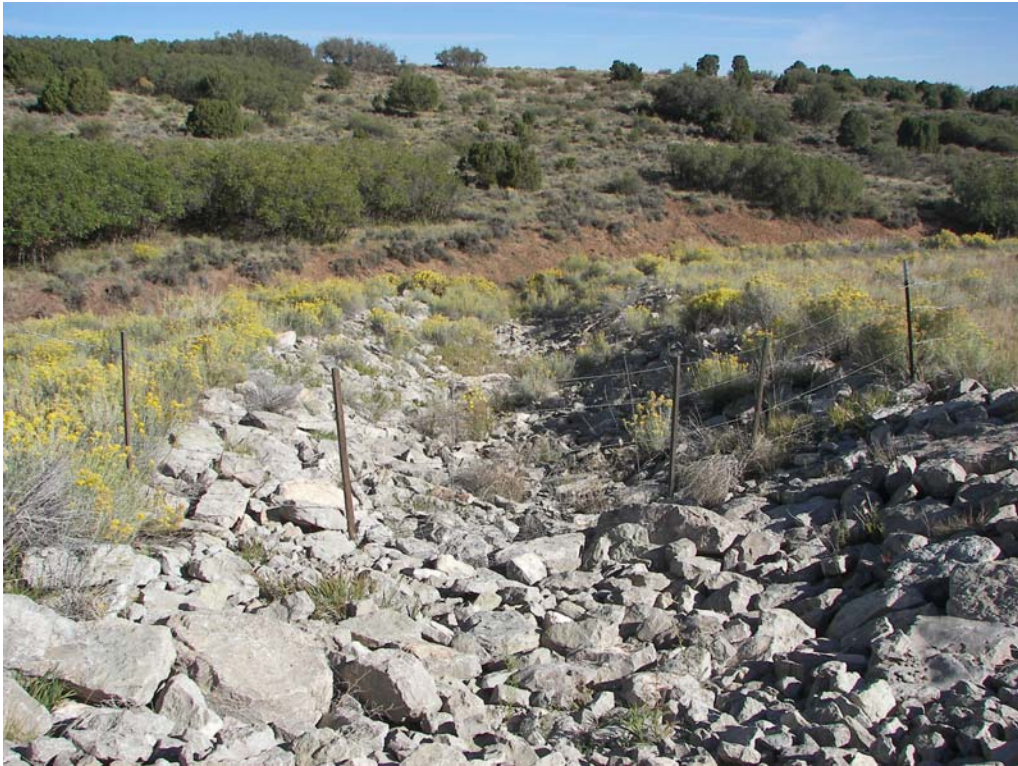
In 2002, eroded areas in the West Drain Ditch channel immediately north of the inner fence were repaired, and the channel was lined with rock all the way to North Draw. Erosion was also observed in a small gully connected to the West Drain Ditch during the 2008 inspection. No evidence of additional erosion in either area was apparent in 2011 (Photos 3 and 4). One small

3. Rock-lined drainage between the West Drain Ditch and North Draw.

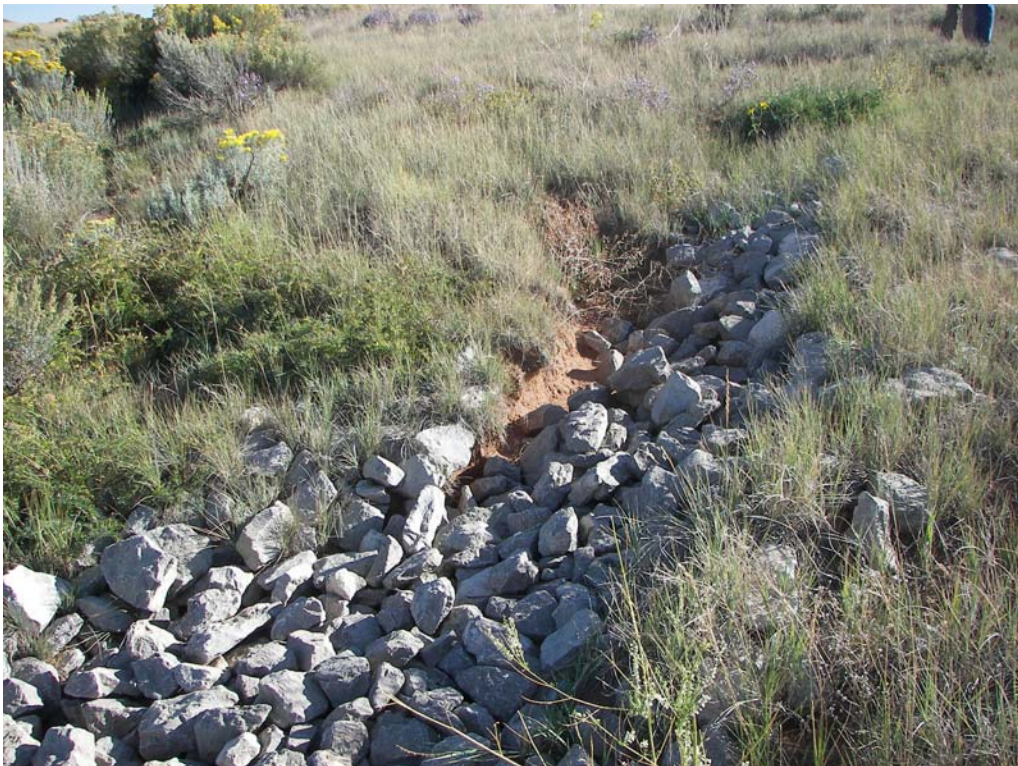
4. Stabilized erosion area near the West Drain Ditch.

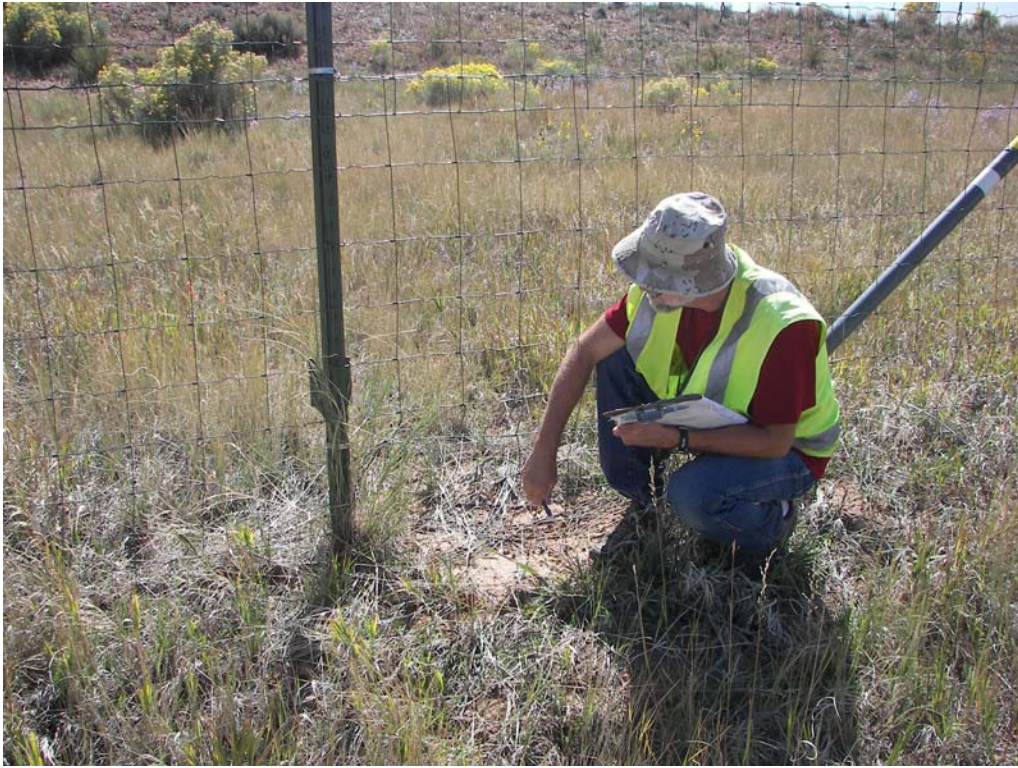
All gates were in good working condition. Warning signs on the perimeter fence were easily visible and legible. The following warning signs were posted on the perimeter fence: "Danger Do Not Enter," "Controlled Area, Enter at Designated Access Only," "Contaminated Water, Do Not Discharge," and a sign posting current contact information, which included a "No Trespassing" warning. There was no evidence of vandalism or trespass, but damage to the security fence from snowmelt was apparent. Most damaged sections have been repaired by on-site personnel, but two additional holes, large enough to allow human or animal access, were discovered during the inspection (Photo 5). These holes require repair.

5. One of two holes discovered in the Pond 4 security fence.

Maintenance Item: Repair holes in the security fence around Pond 4.

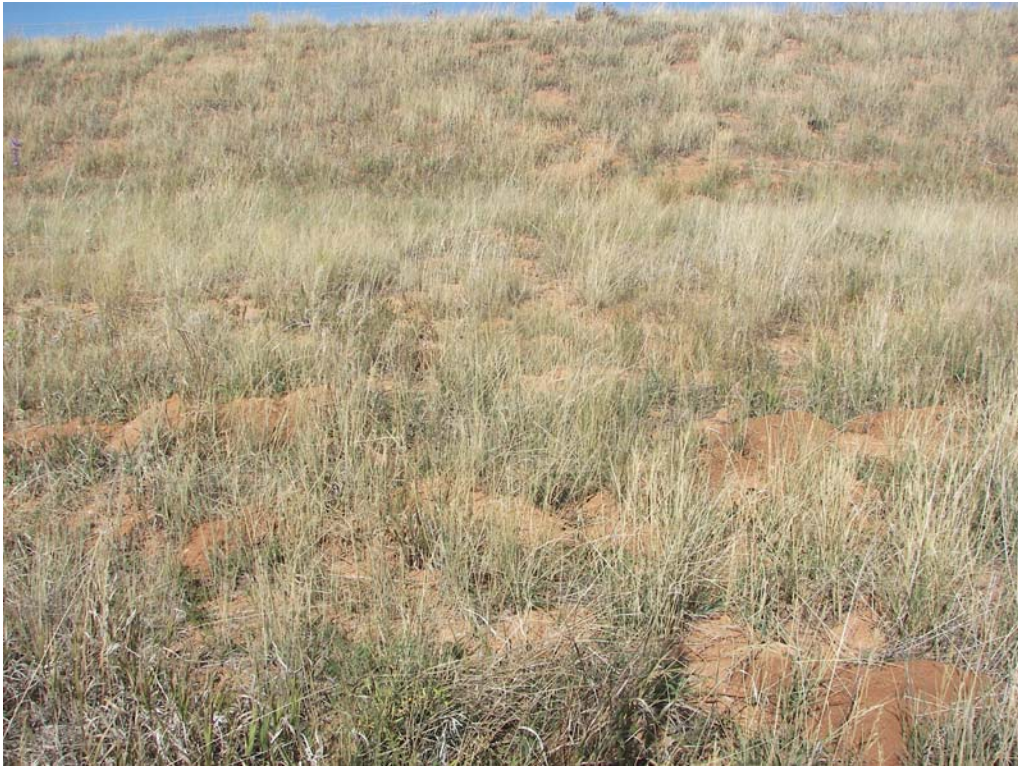
The pond's rope barrier was intact, and warning signs—"Contamination Area" postings and notices that life jackets are required—were visible and legible. Animal burrows, primarily made by voles, were visible on and below the pond berm on all sides (Photo 6). No large burrows, which might threaten the berm's integrity, were found. Animal burrows will continue to be monitored during routine Pond 4 inspections. Vegetation on the slopes of the berm was well established and primarily composed of non-weedy species.

6. Animal burrows on and below the Pond 4 berm.

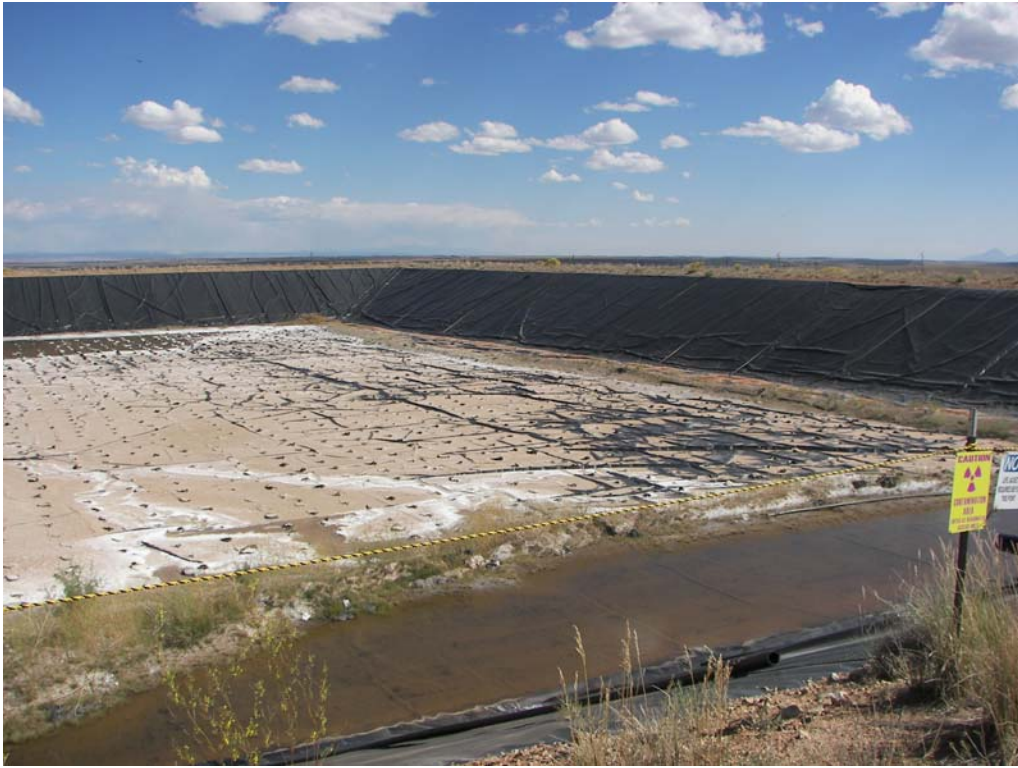
Although no visible evidence of holes in the pond liner was observed, repairs to known holes in the pond liner are planned in October 2011. Liner anchors, consisting of sand-filled polyethylene pipe installed in 2007, were in good condition. Less than 1 foot of water was standing in the northeast corner of the pond. The pond contained silt and vegetation, including saltcedar (*Tamarisk ramosissima*, a noxious species), but this vegetation was later removed during liner repairs (Photo 7).

7. Pond 4 showing siltation, vegetation, and standing water.

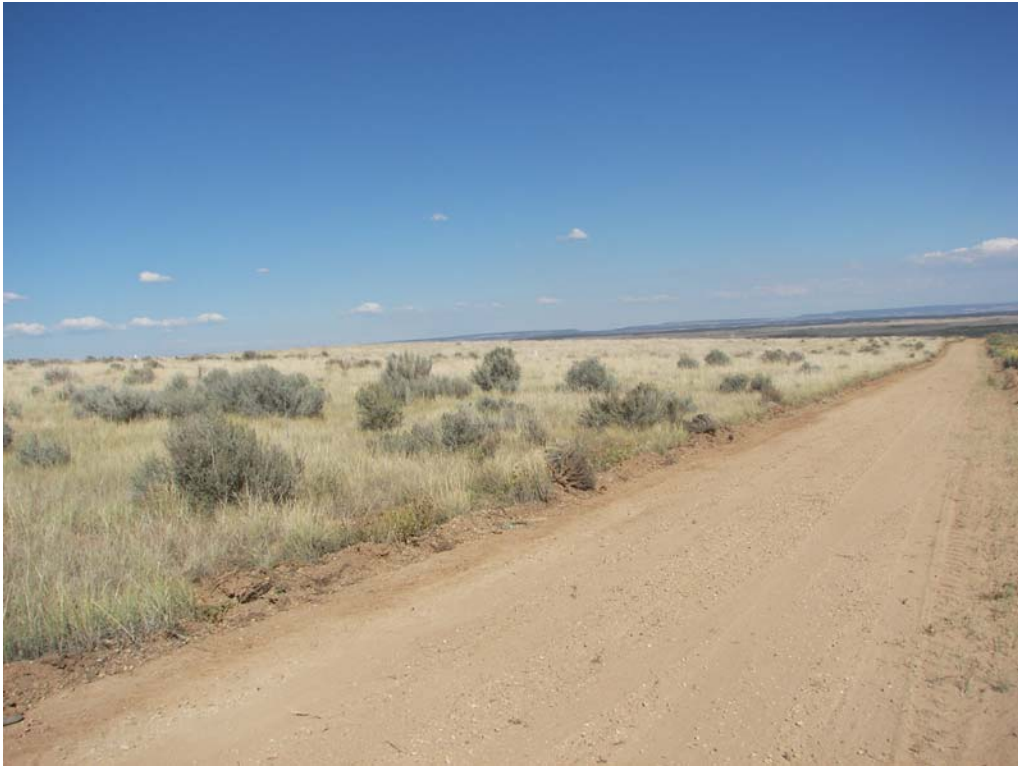
8. Repository cover and recently graded perimeter road.

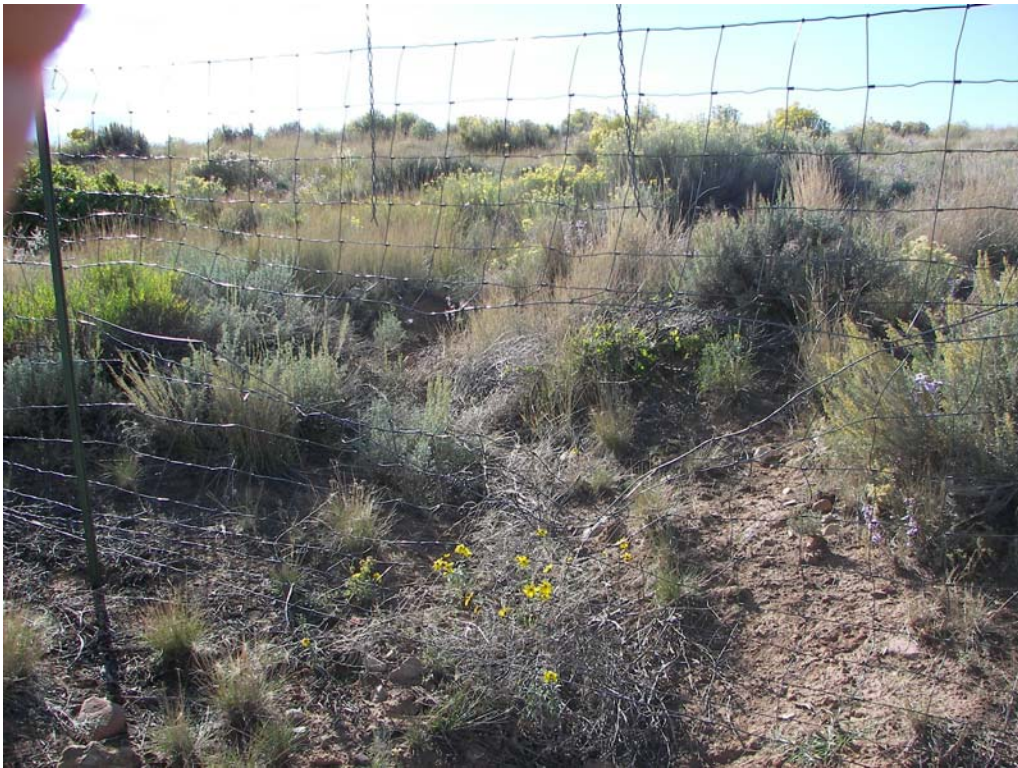
The unpaved road surrounding the disposal cell and the road to Pond 4 was recently graded and in very good condition (Photo 8). One hole was discovered in the wildlife fence in its northeast section (Photo 9). The hole, probably caused by snow damage, may present a hazard to wildlife and will be repaired. Other sections of the wildlife fence and gates, open at the time of the inspection, were in acceptable condition and showed no evidence of vandalism. Both site monuments, one at the west access gate through the wildlife fence (Photo 10) and one at the apex of the repository, were present and intact. Six raptor perches, installed near the disposal cell cover in 2007, were in good condition.

9. Hole in northeast section of wildlife fence.

Maintenance Item: Repair the hole in the wildlife fence in its northeast section.

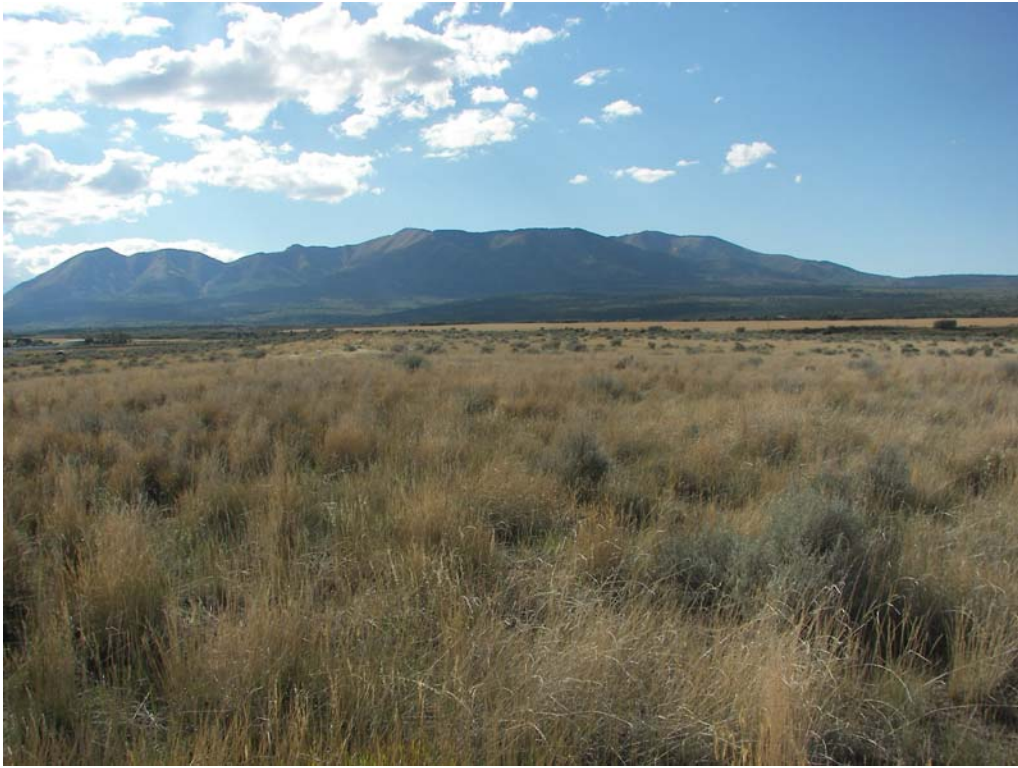
Desirable plants remained well established on the cover, and no significant barren areas, eroded areas, or phreatophyte shrubs were identified (Photo 11). Some dead sagebrush (*Artemisia tridentata*) and rabbitbrush (*Ericameria nauseosa*) plants—killed from a 2006 vole infestation—were still scattered across the cover. As in 2010, a large number of healthy, desirable shrub seedlings were apparent. Small quantities of field bindweed were found on the cover; because it is not spreading, control is not necessary.

11. Vegetated disposal cell cover, view to the west from center monument.

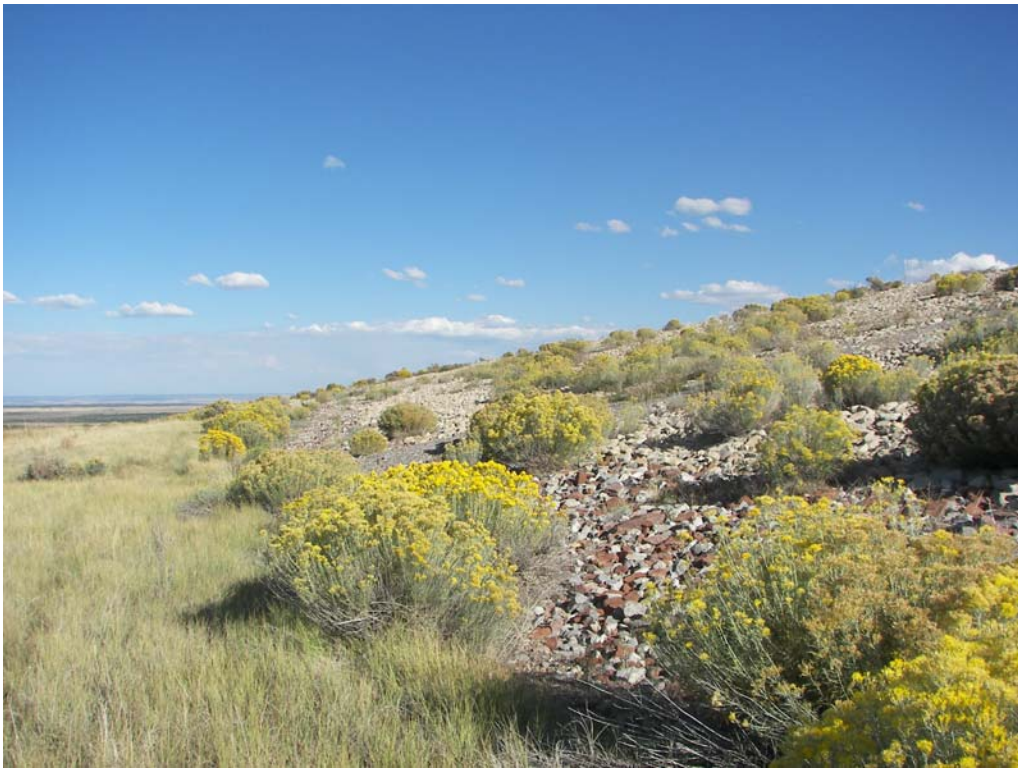
Vegetation on the repository's soil-covered side slopes and outlying areas is also in good condition. Plants also have established on portions of the rock riprap armoring (Photo 12), mainly rabbitbrush, yarrow (*Achillea millefolium*), and grass species with occasional patches of oak brush (*Quercus gambelii*). Because none of this vegetation overlies tailings or threatens the integrity of the side slopes, it is not of concern.

12. Vegetation on rock side slope of repository.

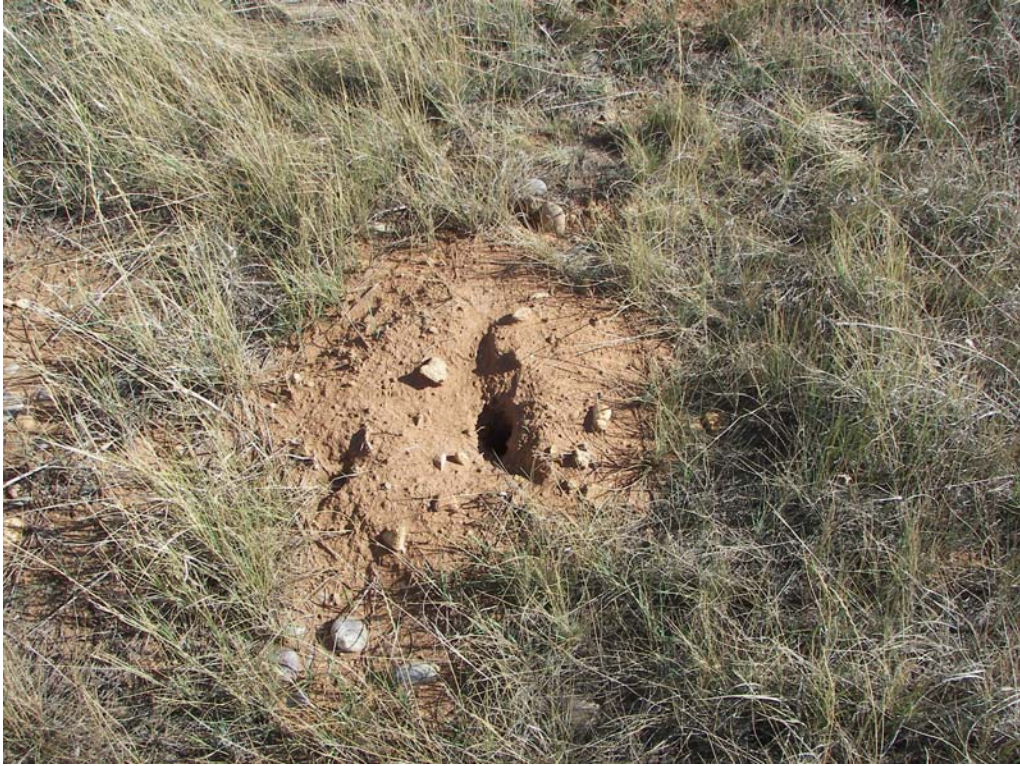
More active burrows (Photo 13) were observed during the 2011 inspection than in 2010, indicating that vole populations may be cyclically increasing at the site. However, the increased presence of raptors and recent decreases in standing dead vegetation due to heavy snowfall are expected to prevent widespread damage to the cover shrubs in 2011. There is no evidence that burrows penetrate beneath the cover's biointrusion layer.

13. Animal burrow on repository cover.

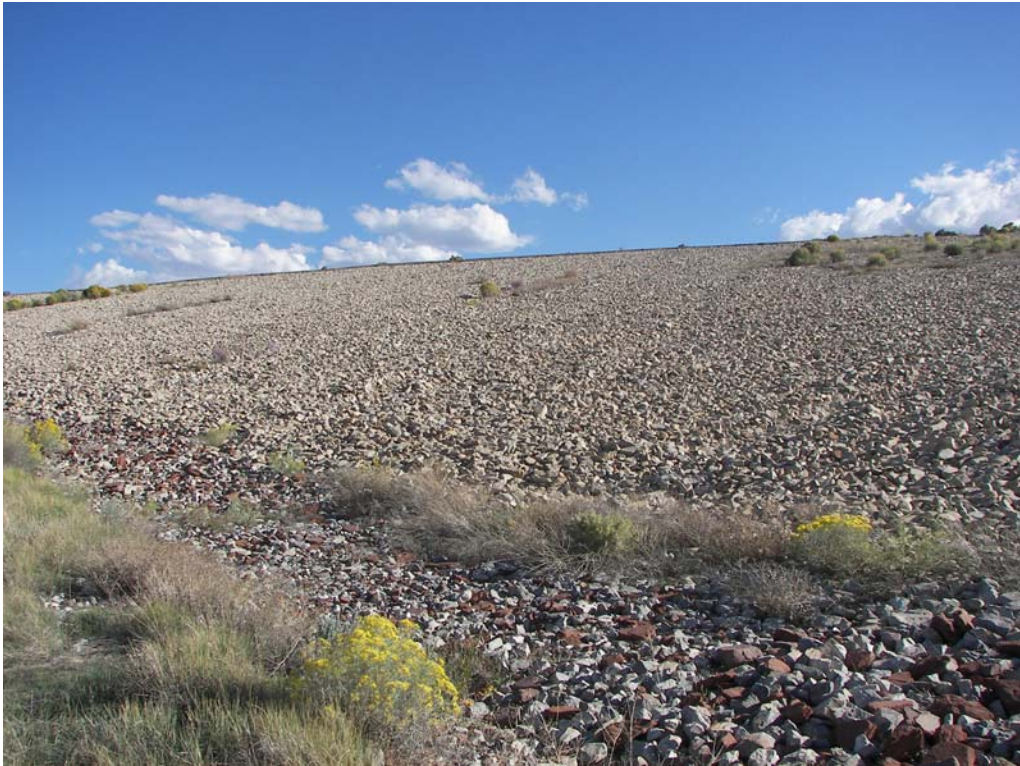
No area of the cover indicated settling, slumping, fracturing, seepage, ponding, or significant erosion. The steep, rock-lined slopes showed no evidence of rock movement or degradation, settling, slumping, or erosion (Photo 14).

14. Rock side slope of repository and North Toe Trench.

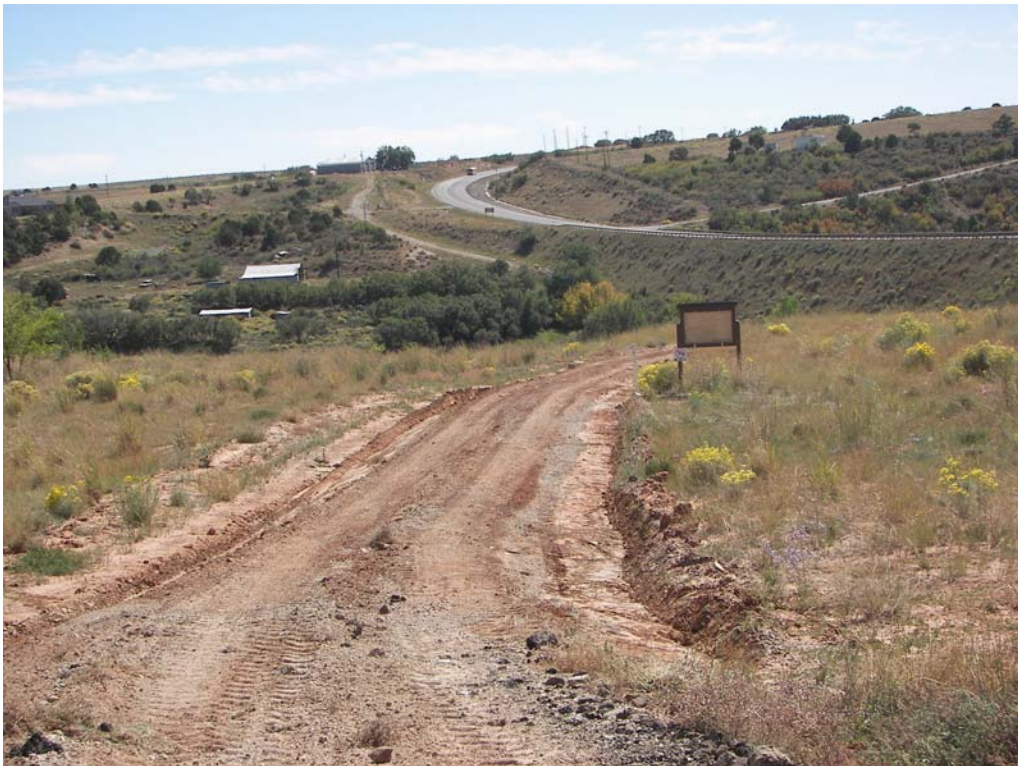
18. Recently graded bike path at former mill site.

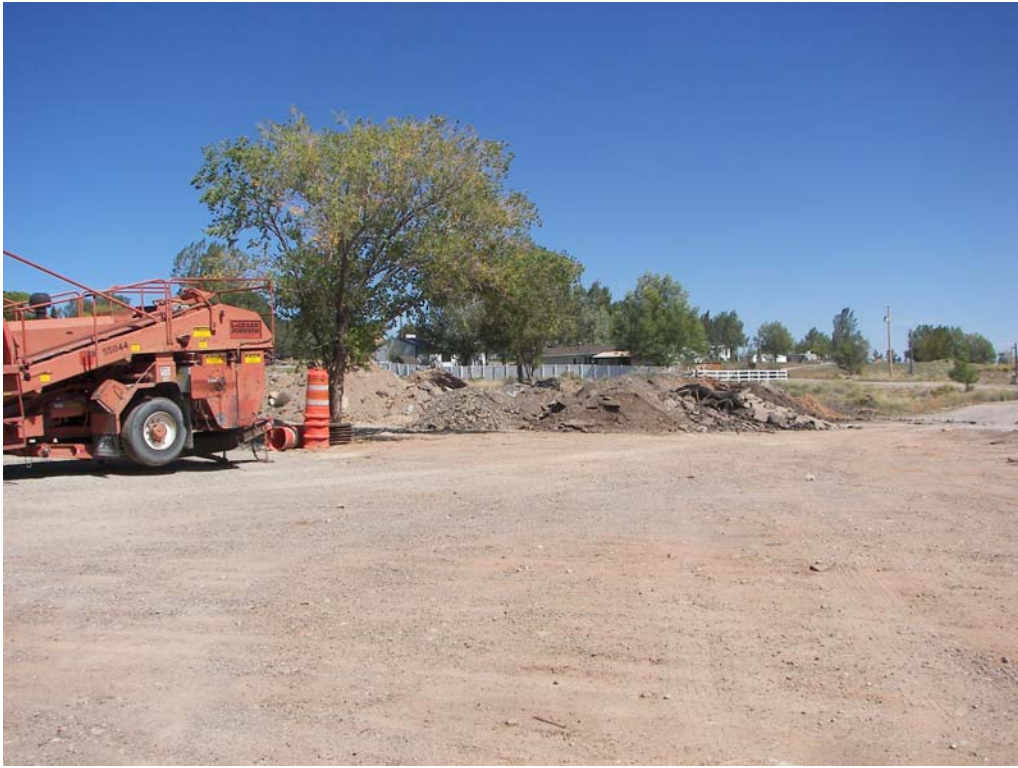
19. Fill materials at City-Owned Property MP-00211.
