**COLORADO DEPARTMENT OF PUBLIC HEALTH
AND ENVIRONMENT
HAZARDOUS MATERIALS AND WASTE MANAGEMENT DIVISION**

FIVE-YEAR REVIEW

DENVER RADIUM SITE

DENVER, COLORADO

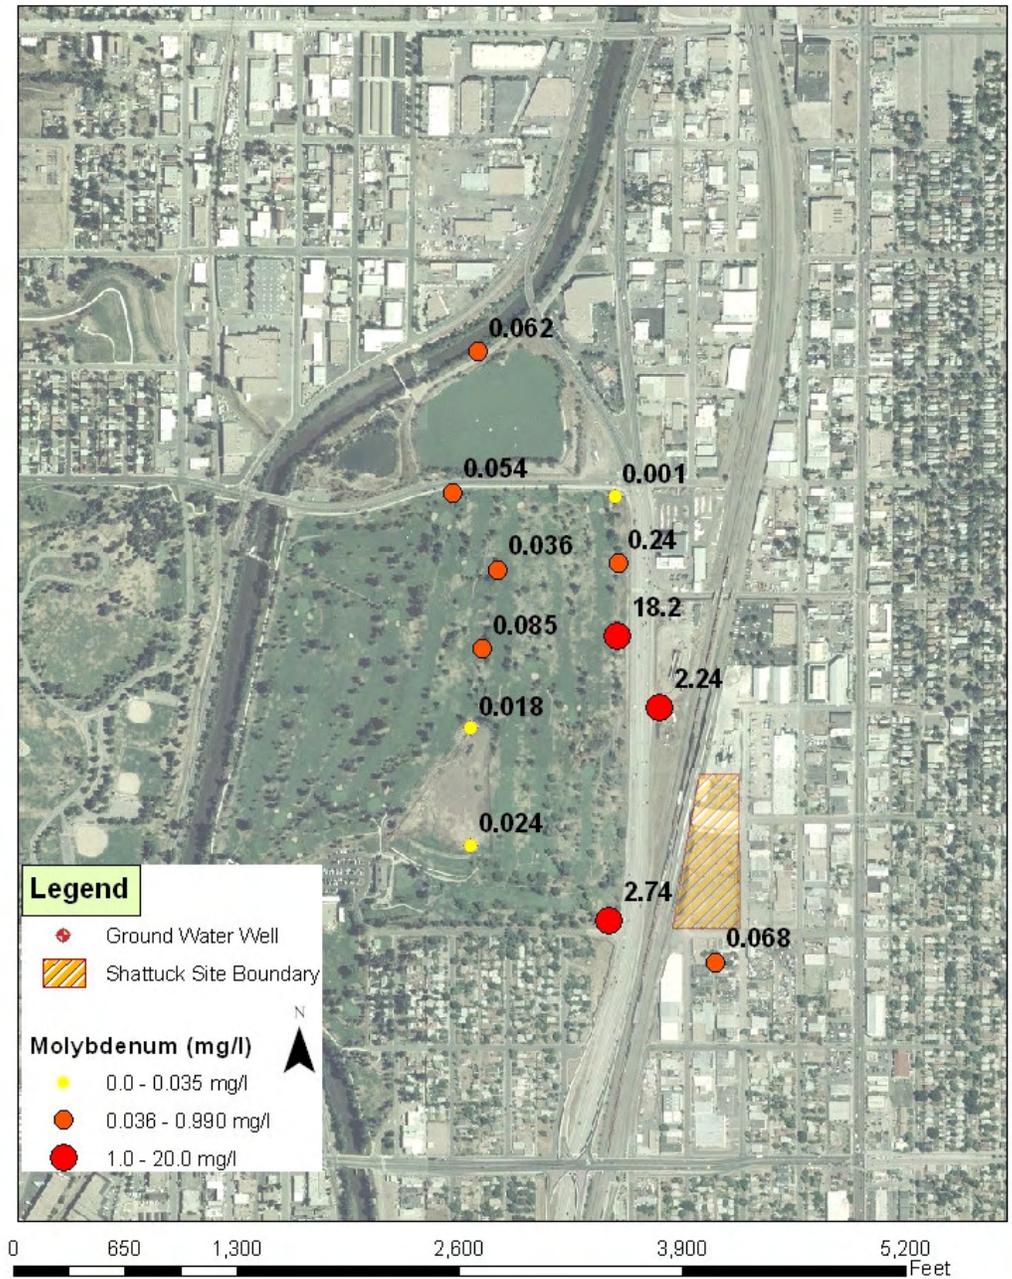
Figure 5
Molybdenum Concentration in Ground Water
March 2008 Sampling
Shattuck Denver Radium OU8

The aerial extent of the molybdenum plume has remained stable. The high levels of molybdenum in the terrace groundwater are generally absent in floodplain monitoring wells. Some of this may be due to interception of the molybdenum plume by the storm sewer line. Data for the recent quarterly monitoring program illustrates that infiltration into the storm sewer is still occurring and the storm sewer is still impacted by elevated concentrations of molybdenum. The molybdenum concentrations from the March 2008 sampling are shown in Figure 3.
