SUBJECT: Five-Year Review for Northwest Transformer

FIVE-YEAR REVIEW

NORTHWEST TRANSFORMER
SOUTH HARKNESS SITE
EVERSON, WASHINGTON

**FINAL FIVE-YEAR REVIEW
NORTHWEST TRANSFORMER
SOUTH HARKNESS SITE
EVERSON, WASHINGTON**

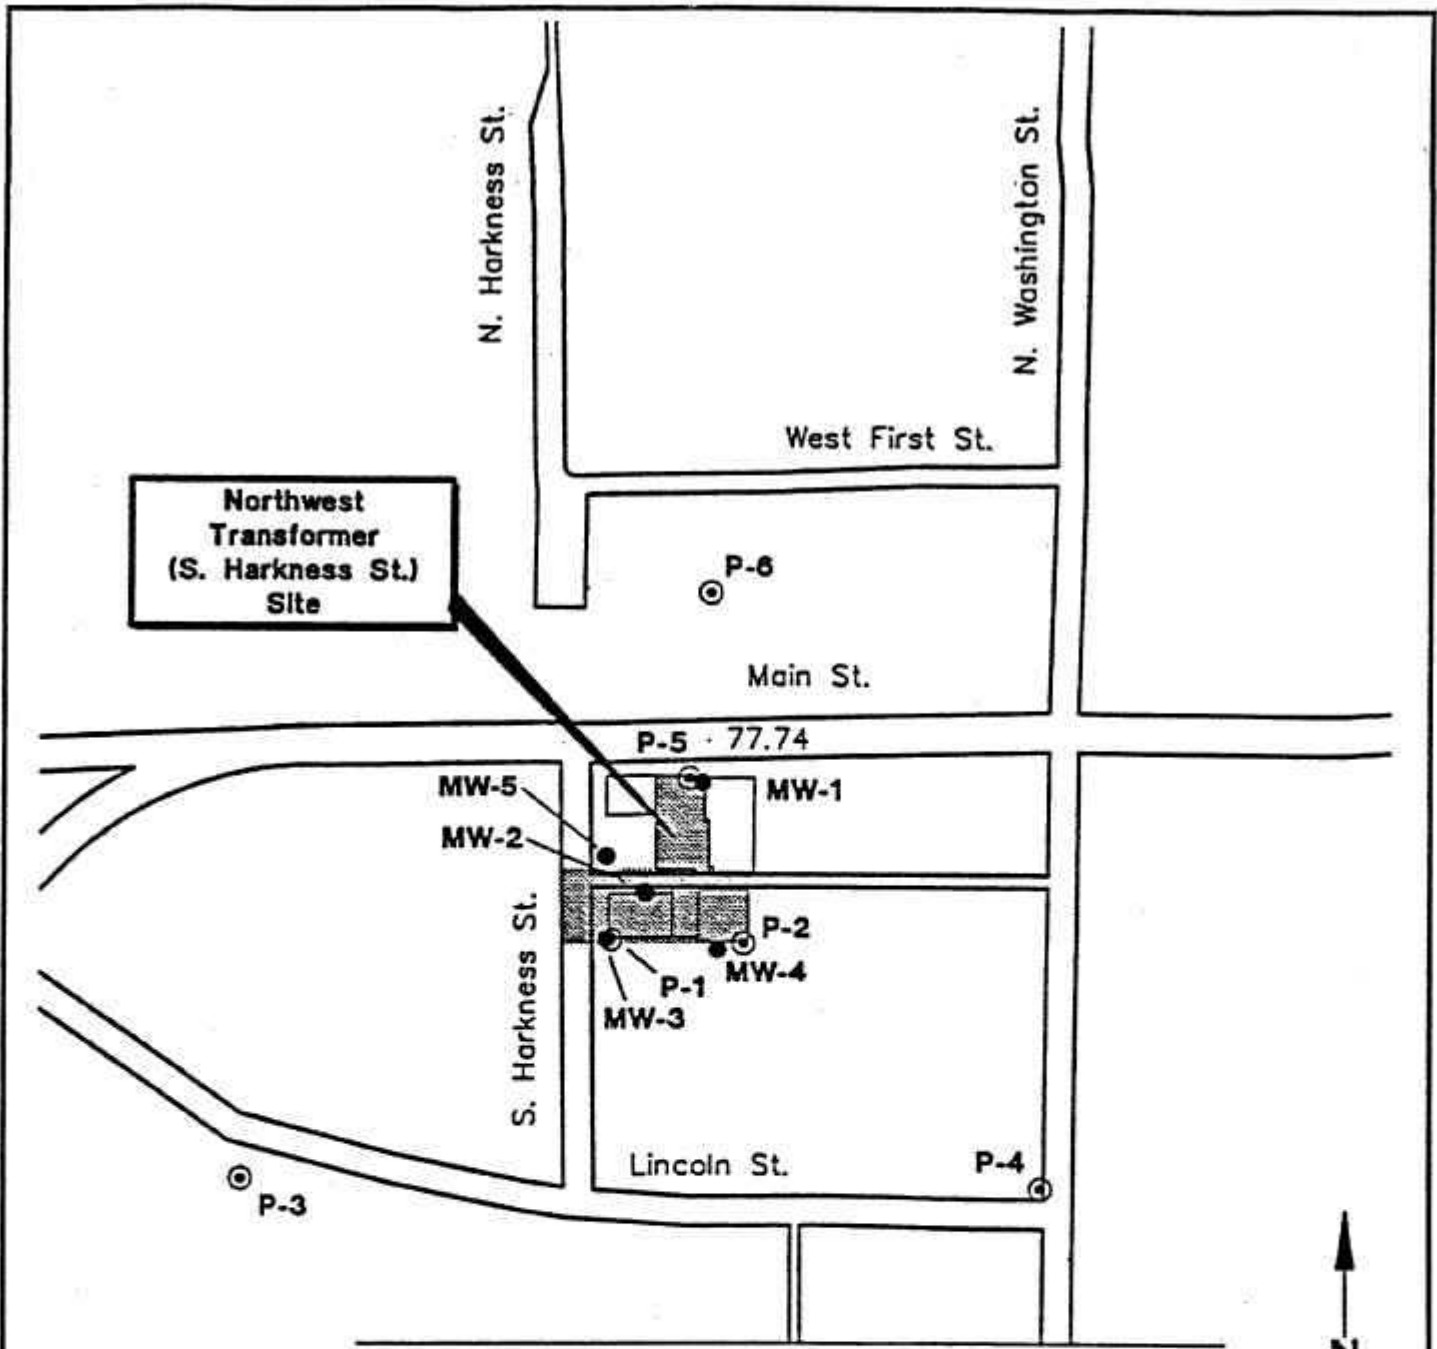
Figure 4
MONITORING WELL & PIEZOMETER LOCATIONS

Monitoring Well MW-2, which was abandoned during removal activities, was replaced by MW-5 approximately 50 feet northwest of the original MW-2 location (Figure 4). The immiscible layer found in MW-2 before it was abandoned was not found in any wells during the post-RA sampling events.

Monitoring Well MW-2, which was abandoned during removal activities, was replaced by MW-5 approximately 50 feet northwest of the original MW-2 location (see Figure 4). The immiscible layer found in MW-2 was not found in any wells during the five post-RA sampling events.

Wells appear to remain in good condition based on a July 25, 1997 on-site visit, are not expected to require active maintenance, and are located outside areas that would likely impact the usability of the overall location. Therefore, it appears reasonable and prudent to retain all wells especially in the event that PCP, associated with some other source, is identified as a groundwater contaminant of potential concern. Wells could serve as sampling points (with associated historical data) for use in any future investigation (e.g., extent of contamination evaluation).

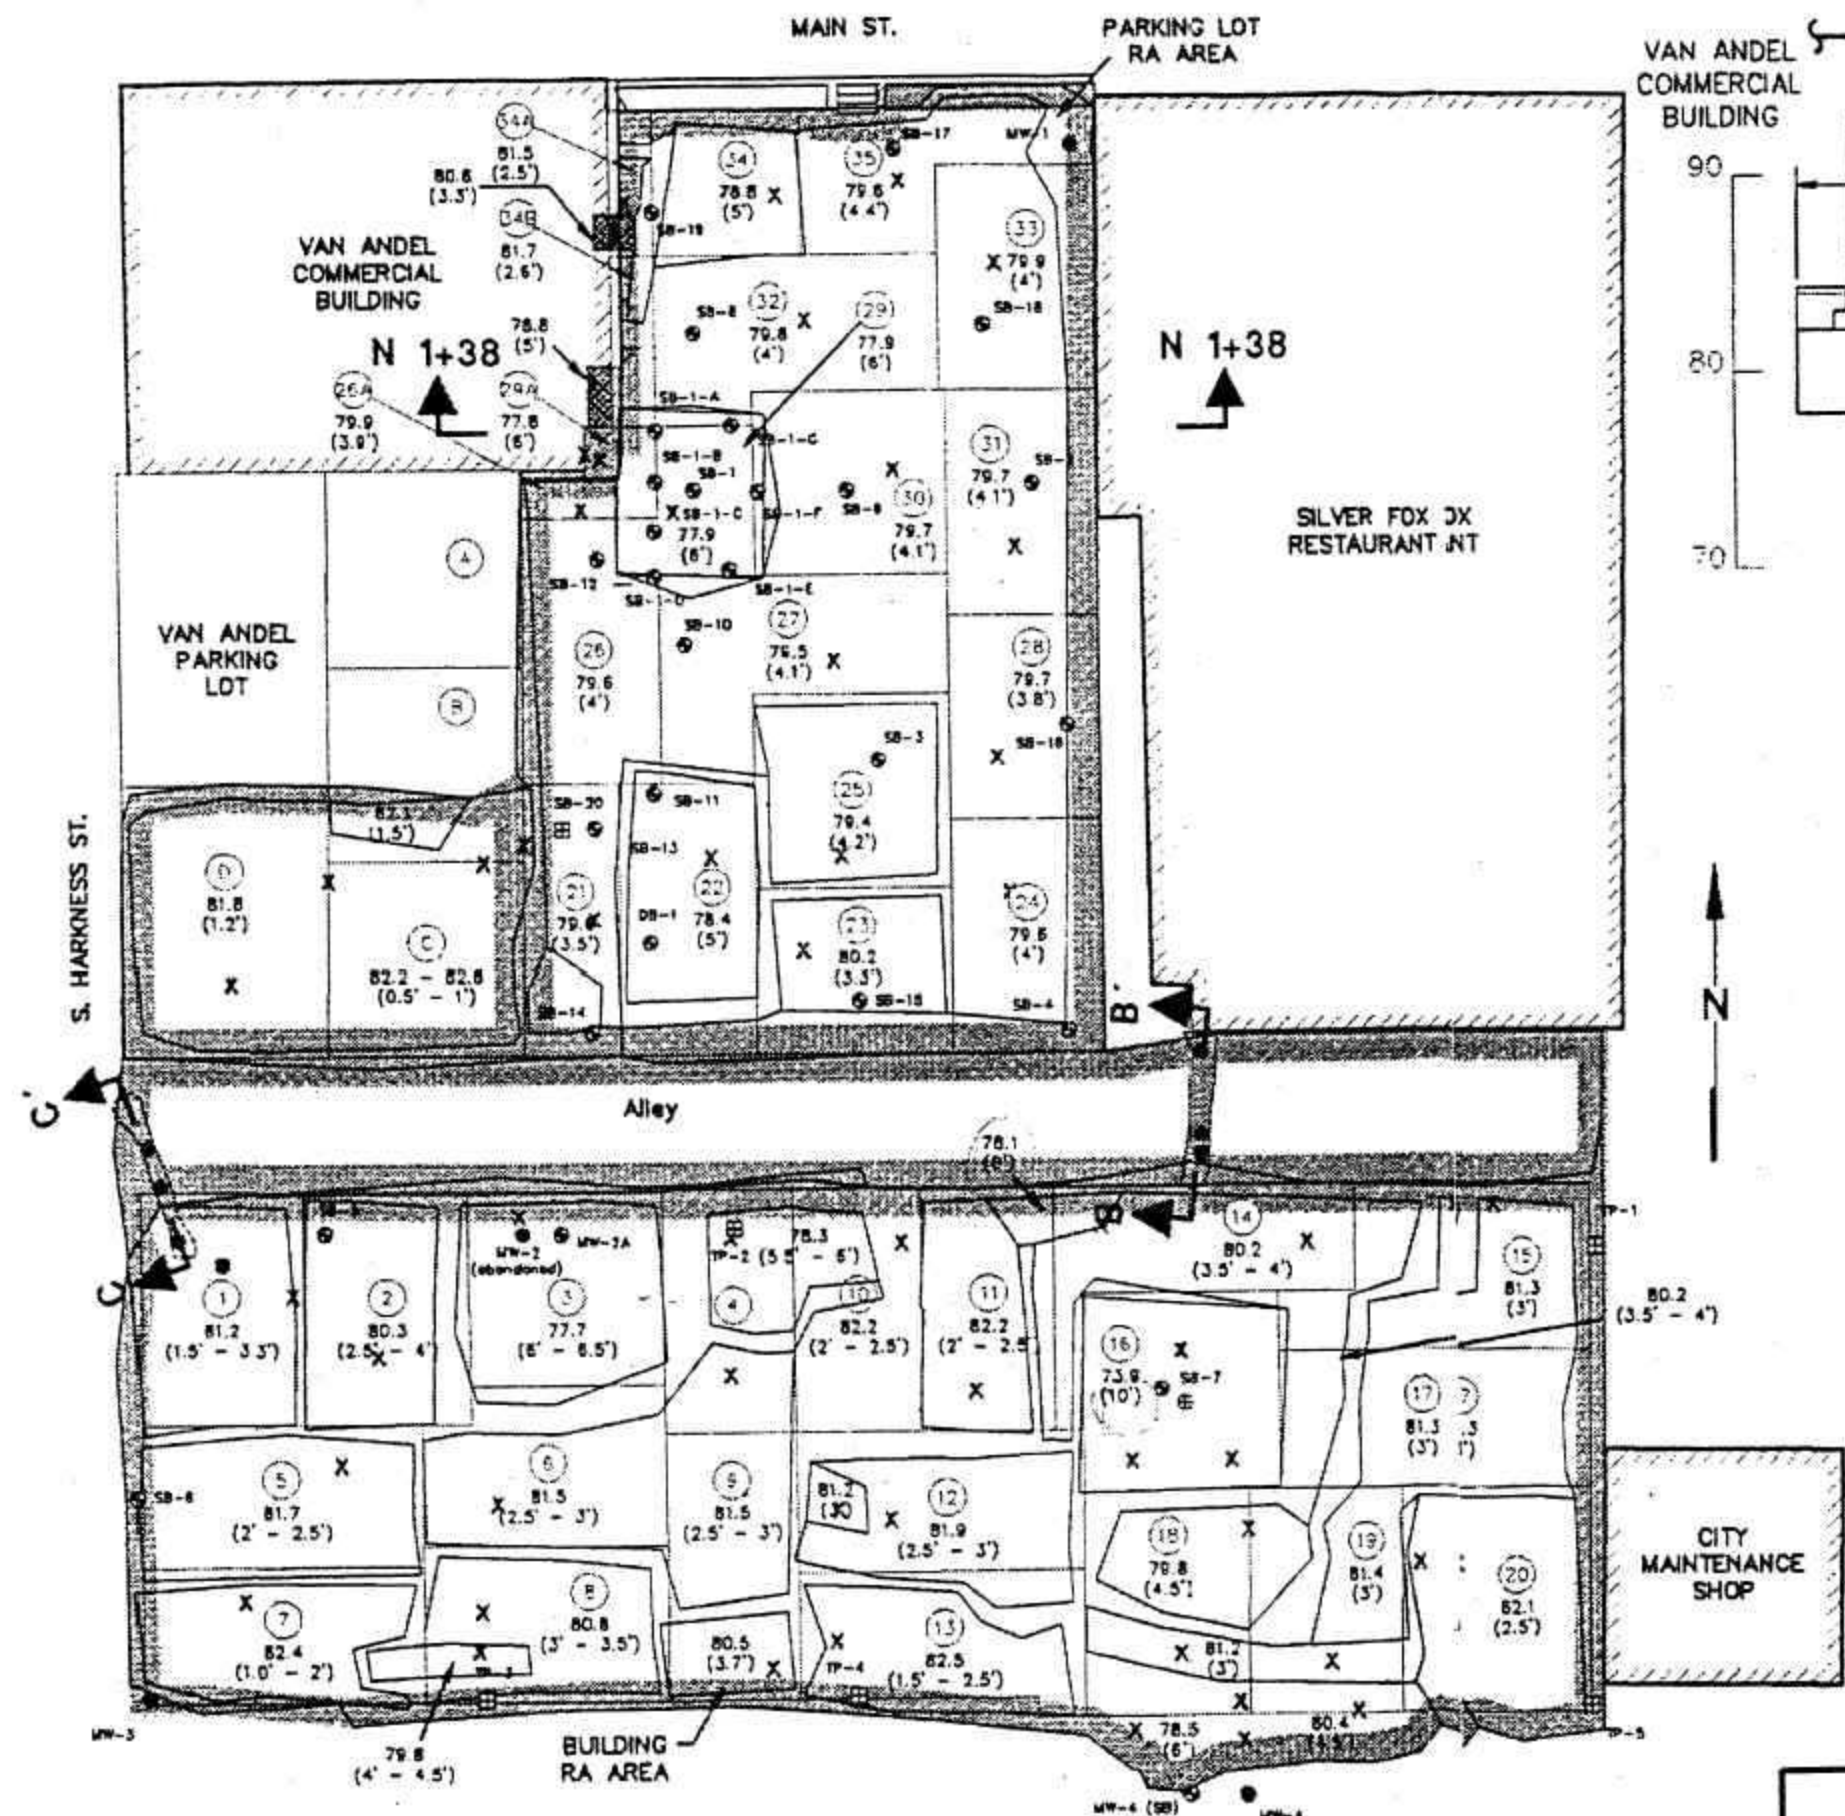
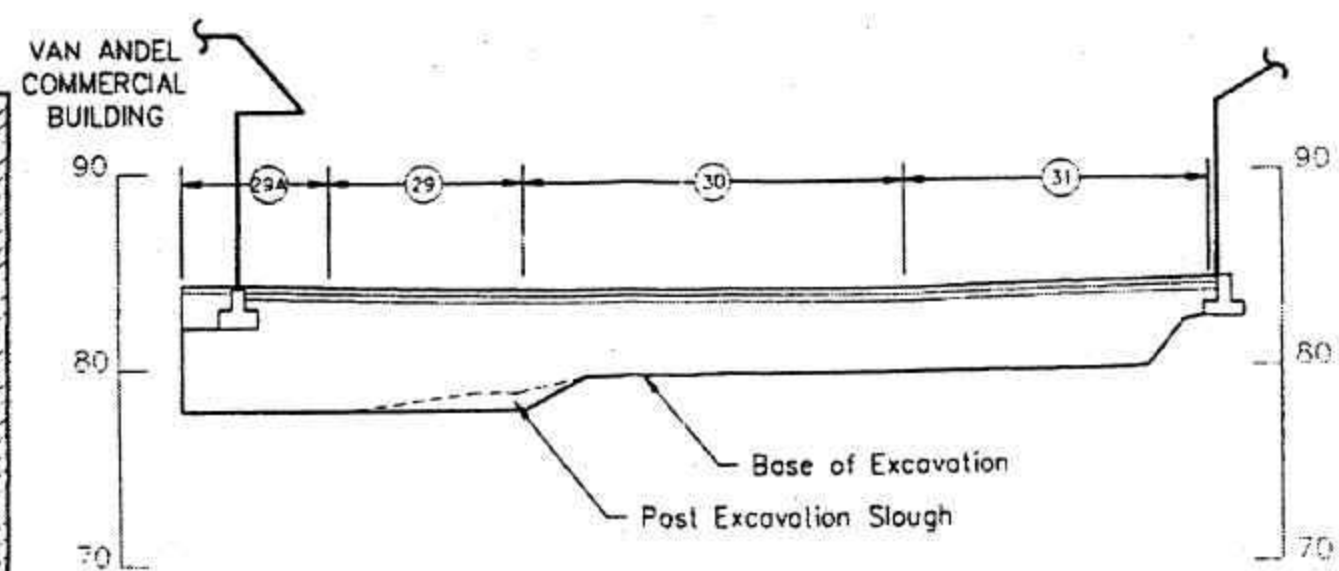
Soils were excavated from approximately 40 “grids” laid out across the site. Figure 5 identifies the grids and depths of soil excavation (typically 4 feet BGS, except adjacent to the Silver Fox Restaurant and Van Andel building, where excavation was limited to about 2 feet to prevent damage to the buildings, and the alley where buried utility lines limited excavation to 6 to 8 inches).

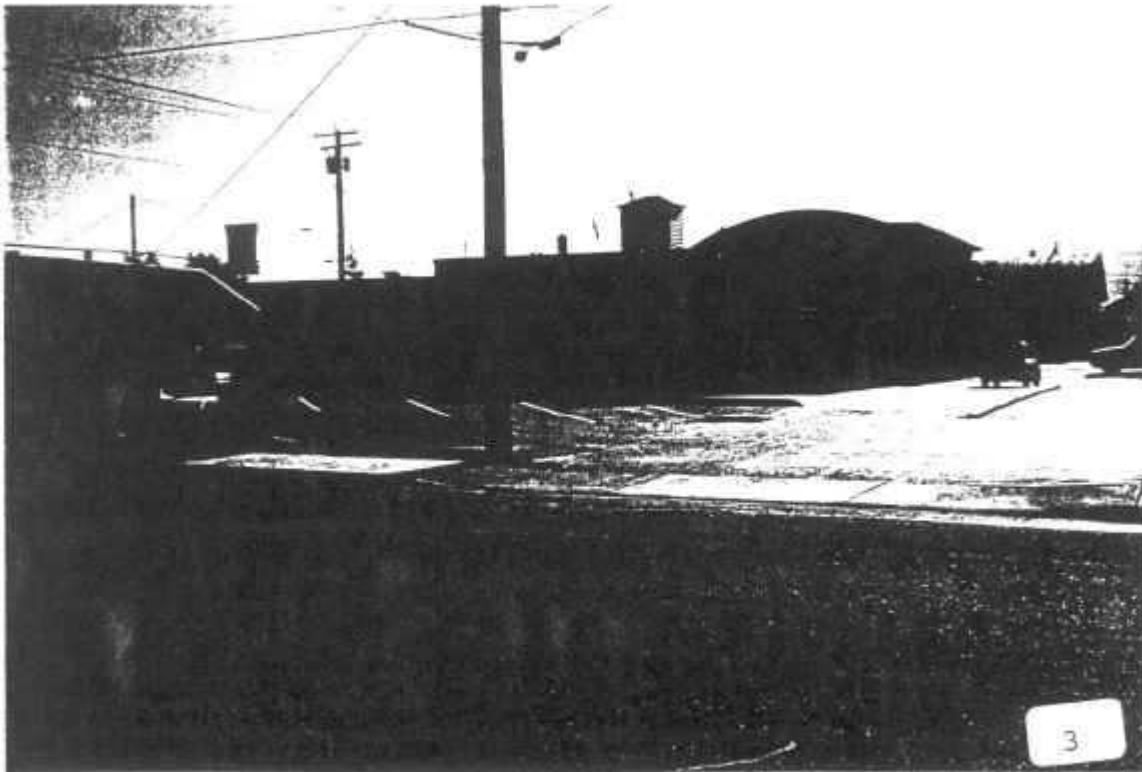
- 3) Looking northeast from across S. Harkness Street, from in front of post office.

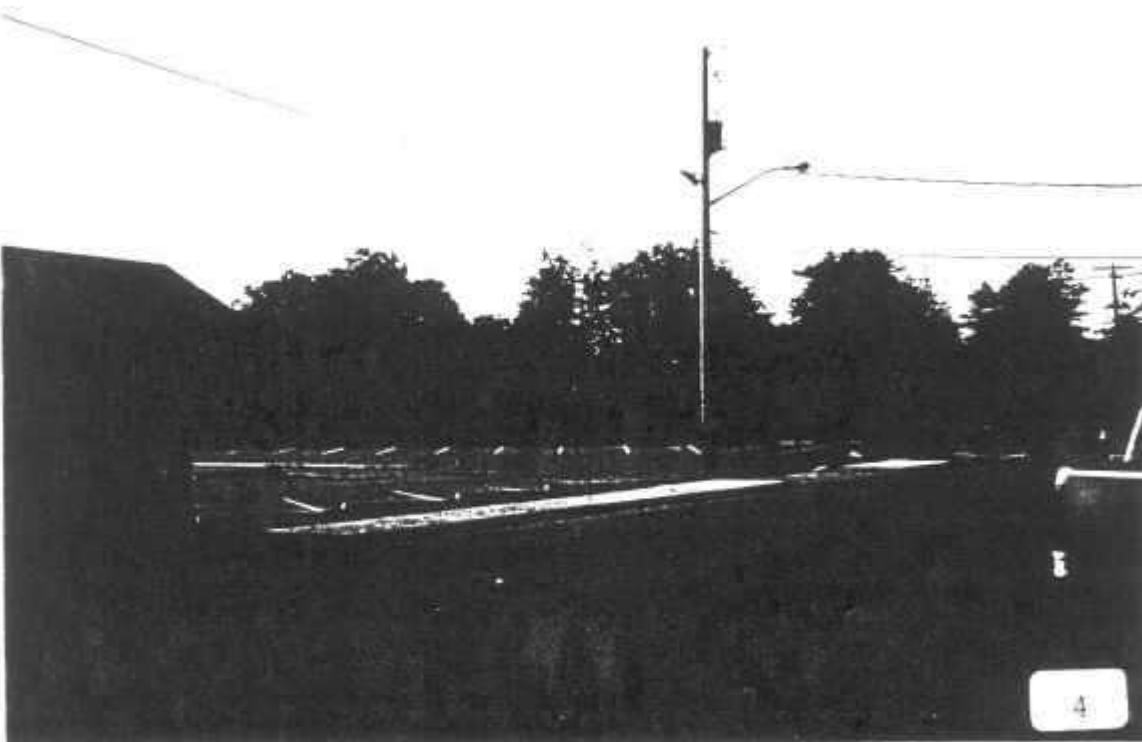
- 4) Looking southeast from southwest corner of Main Street and S. Harkness Street.

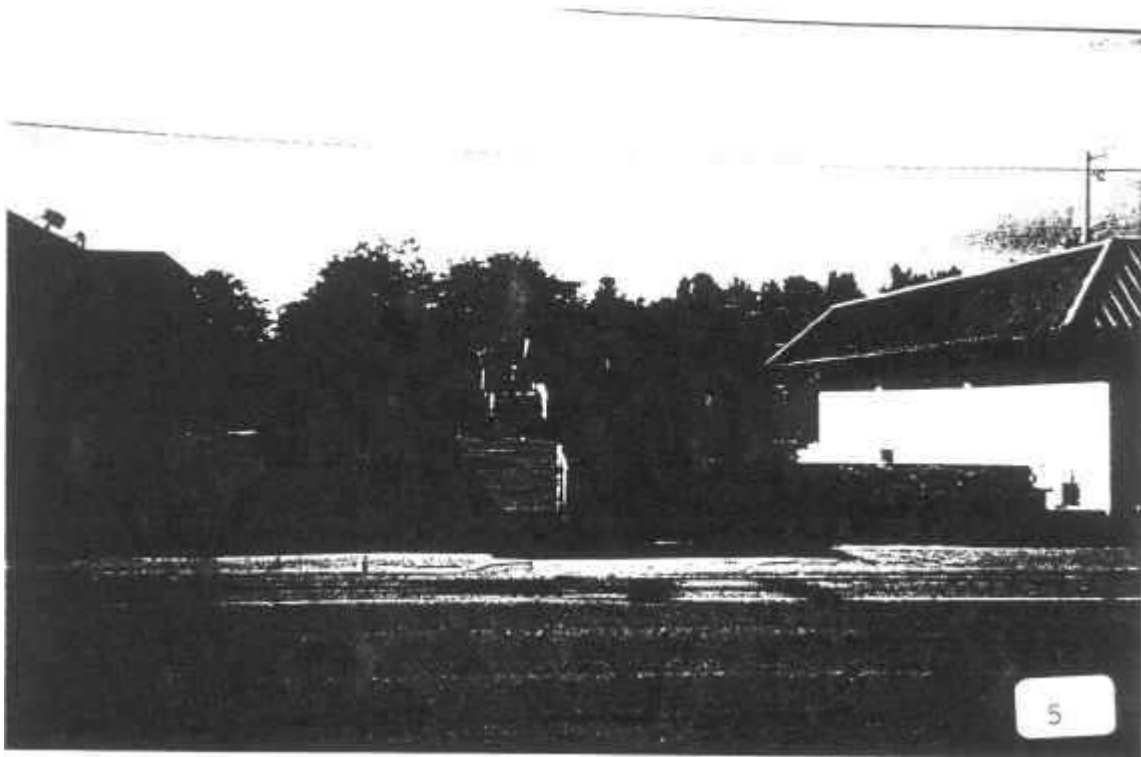
5) Looking south from across Main Street.

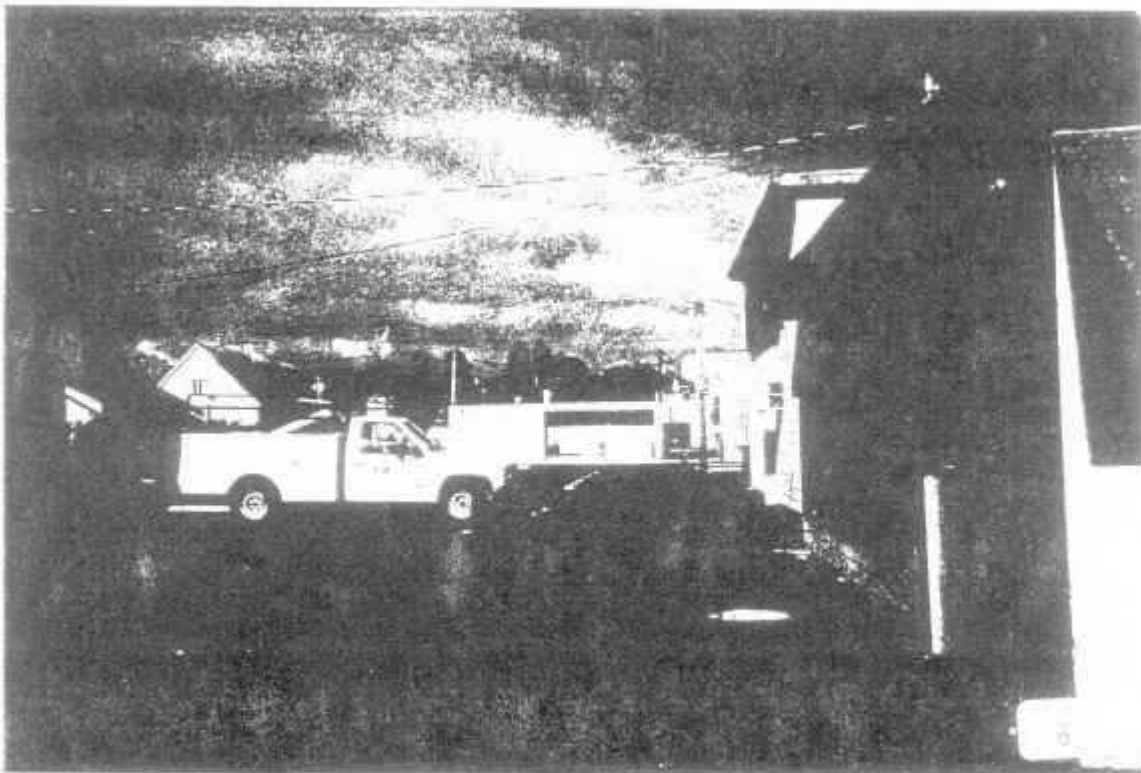
6) Looking west from alley at southeast corner of senior citizens' center.

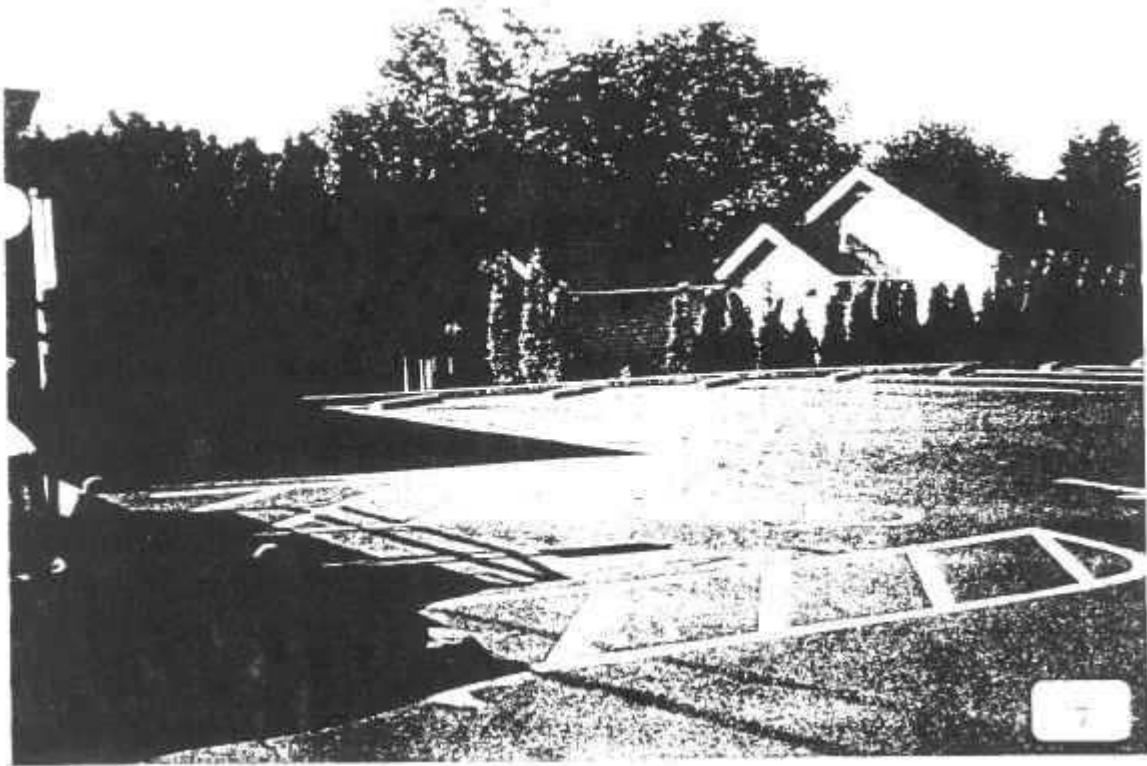
7) Looking southwest from southwest corner of City Hall.

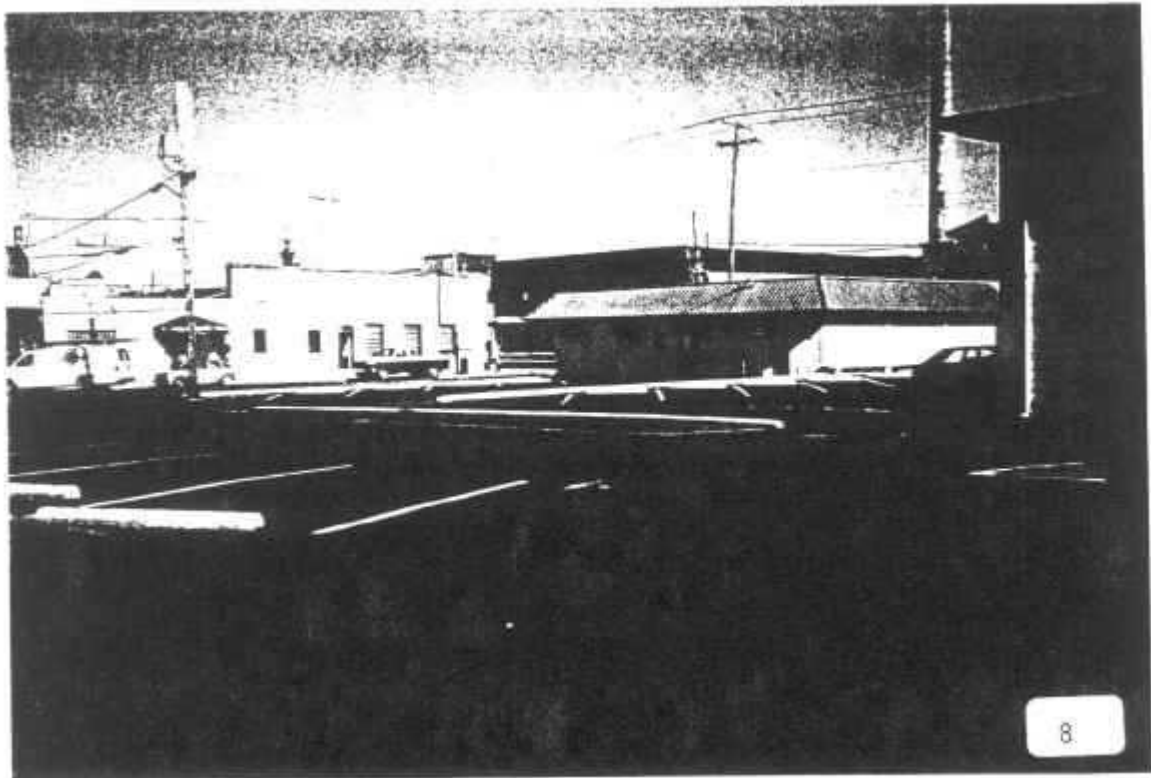
8) Looking northwest from southwest corner of city maintenance shoe.

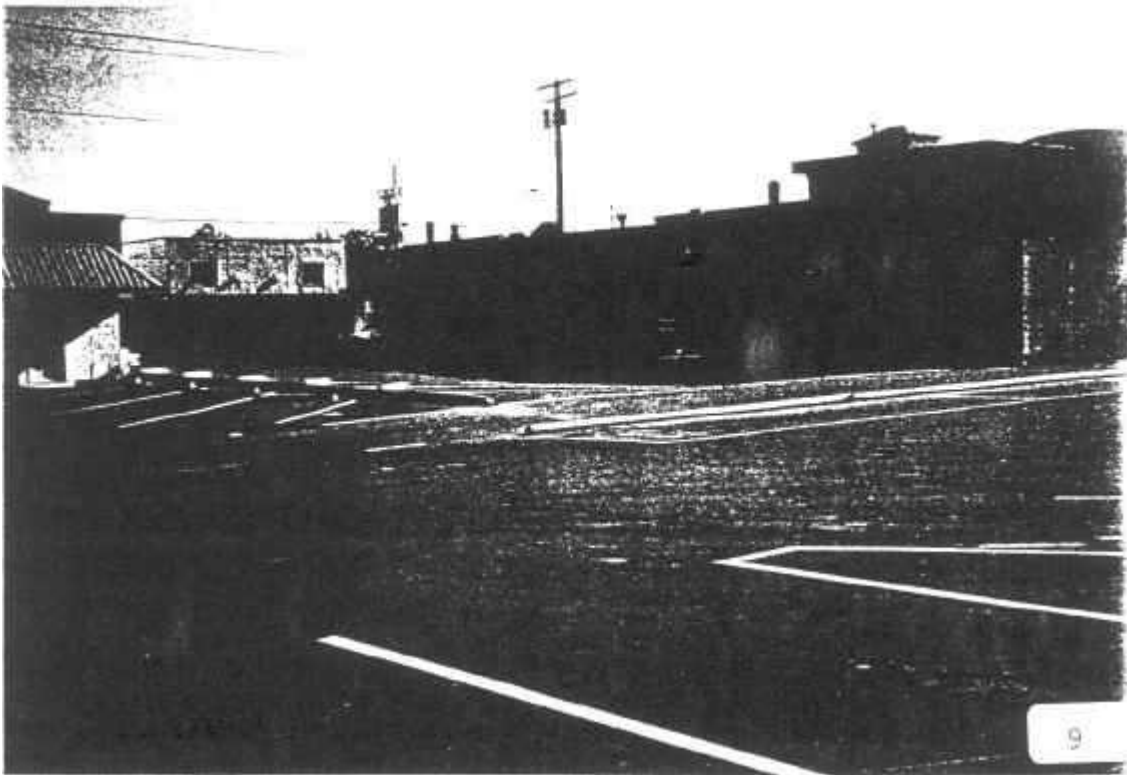
9) Looking northeast from MWB.
