**Section 2.0 - Specification for Abatement and Selective Demolition
Amendment
Submission Date: June 5, 2008**

Amendment #5 REV 02

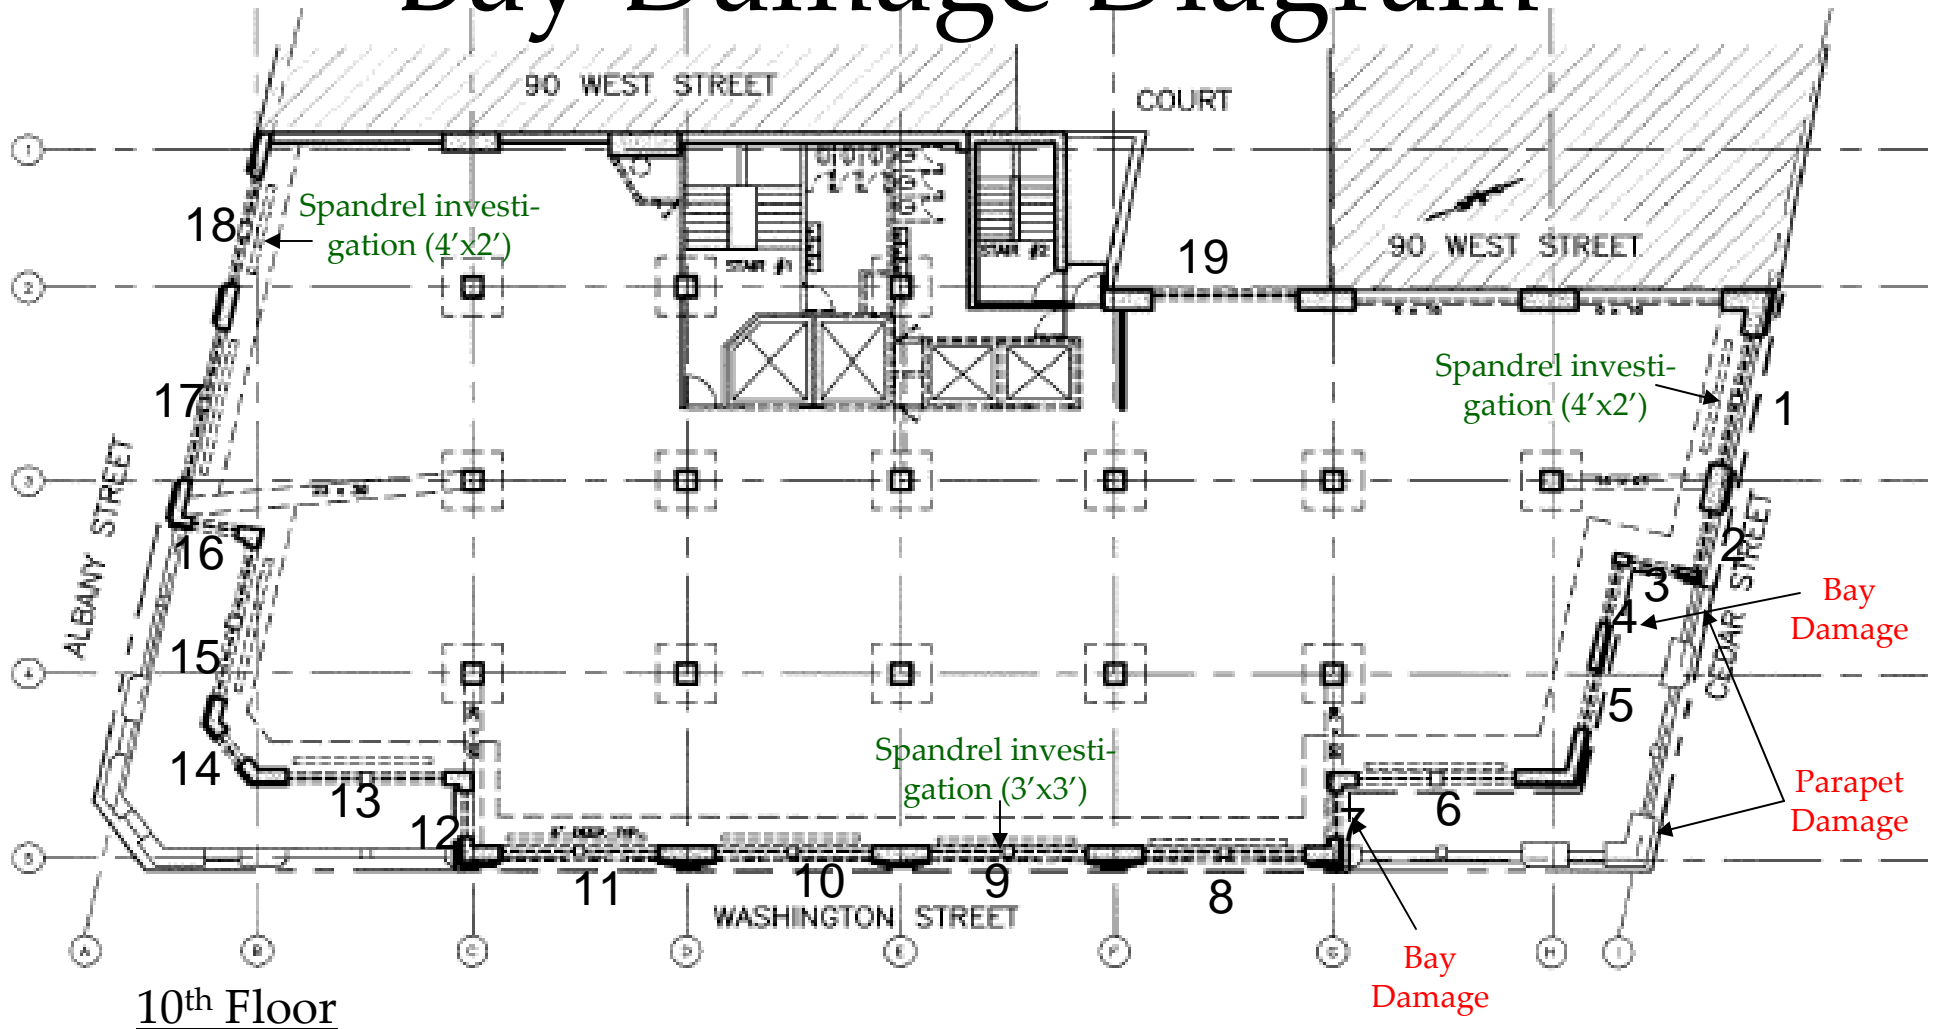
10th Floor

During the containment set-up on the 10th floor, RJLG was asked by Nova to verify the bay damage for bay #8 delineated on the 10th floor Bay Damage Diagram. Field inspections revealed that bay #8 was not damaged however bay #7 was. Bay #7 was not delineated on the Bay Damage Diagram as damaged. This clerical error has been corrected. Bay # 7 shows as damage on the revised bay Damage Diagram and Bay #8 does not.
