NONPOINT SOURCE SUCCESS STORY

Replacing Culverts on Osborn Creek Improves Stream Channel Stability

EPA 841-F-15-001BBB
November 2015

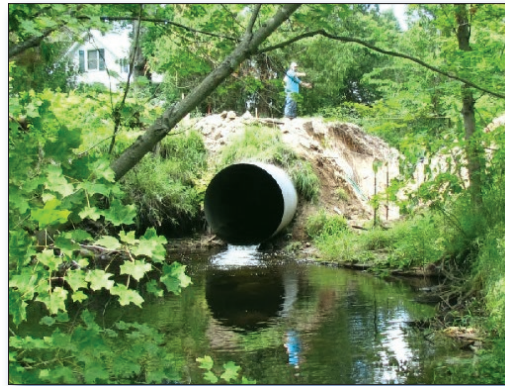
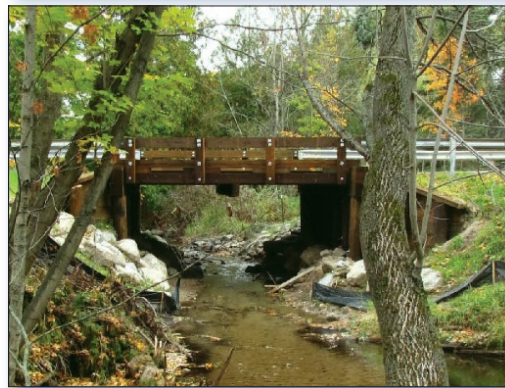
An undersized and perched culvert at Pierce Road on Osborn Creek caused upstream sediment deposition and downstream channel erosion, and prevented upstream migration of native fishes, including brook trout and sculpin, as well as stocked salmonids. The plunge pool immediately downstream of the culvert eroded and destabilized the adjacent stream bank, causing sediment deposition in a riffle immediately downstream (Figure 1). Significant quantities of soil also eroded from the Pierce Road roadbed onto the Osborn Creek floodplain near the stream crossing.

Figure 1. Osborn Creek, looking upstream toward Pierce Road, before (top) and after (bottom) an undersized culvert was replaced with a bridge. Before being replaced, the perched culvert had prevented upstream fish migration. Erosion on either side of the culvert had contributed excess sediment to the creek.

Since 2011, nine culverts on Osborn Creek were replaced using a variety of funding sources. On Pierce Road, a 6-foot culvert was replaced with a 20-foot by 7-foot timber bridge (see Figure 1). Prior to replacement, the plunge pool immediately downstream of the culvert was 40 feet wide and 5.6 feet deep, compared to a normal channel width of 26 feet and depth of 2.7 feet at a nearby riffle. After replacement, sandy floodplain benches had formed in this reach, reducing channel dimensions to 32 feet wide and 1.8 feet deep (Figure 2, next page). The road approaches to the stream crossing were paved as well, reducing soil erosion from the Pierce Road roadbed.

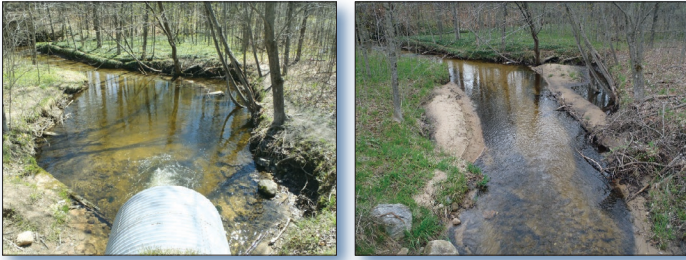
Figure 2. Osborn Creek, looking downstream away from Pierce Road, before (left) and after (right) the culvert was replaced. Downstream sedimentation has declined, allowing the stream to become deeper and narrower.

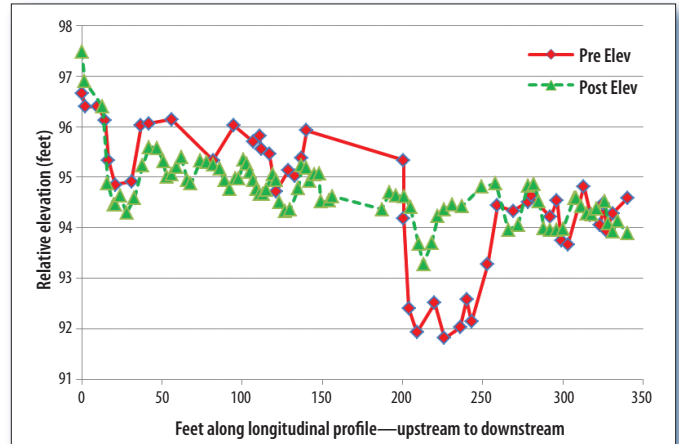
Before culvert replacement, the streambed immediately upstream of the road crossing consisted entirely of fine sand. Although some sand still remains 3 years after replacement, much has been transported downstream, lowering the streambed about 0.5 feet (Figure 3) and exposing coarse gravel. The median particle size (D50) and the particle diameter in the 84th percentile (D84) in this reach, which were visually characterized as 100 percent fine sand (less than 2 millimeters [mm] in diameter) before culvert replacement, were substantially coarser after culvert replacement (D50 = 0.46 mm [medium sand] and D84 = 28 mm [coarse gravel]). Further riffle development is expected in this reach in the coming years.

Figure 3. Overlay graph of longitudinal profile data of Osborn Creek, before and after culvert replacement. The red line, which reflects the elevation of the streambed before restoration, shows a deep plunge pool at the culvert and an accumulation of sediments on either side. The green line, which reflects the stream elevation after the culvert was replaced by the bridge, shows the plunge pool has almost disappeared, and the accumulated sediment has been transported downstream.
