Navajo Abandoned Uranium Mine Site Screen Report

Glover AUM Site

Navajo AUM Eastern Region

May 2009

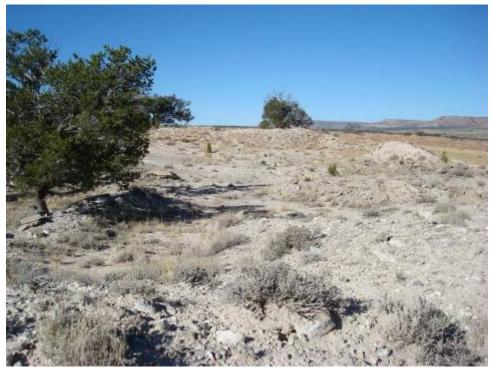
Photo 1. Glover Mine site, towards the south

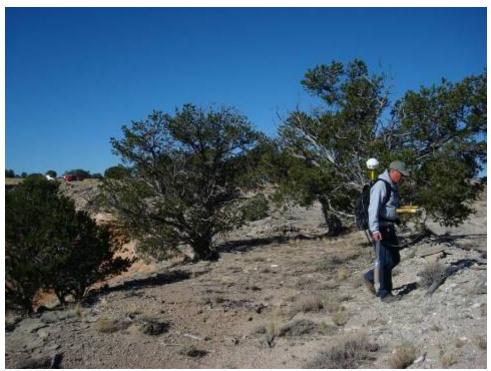
Photo 2. Glover Mine site, towards the west

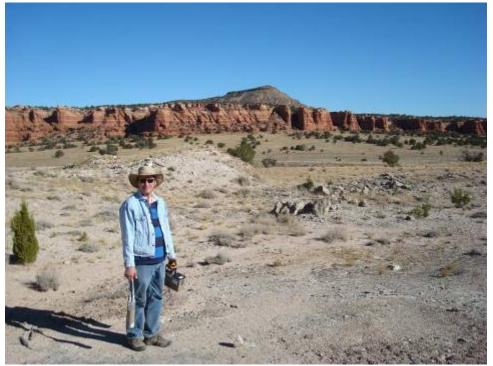
Photo 3. Glover Mine site, towards the north

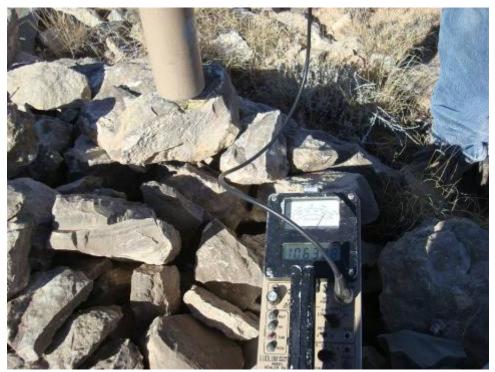
Reclamation status of the mine sites are currently unknown. No visible signs of reclamation were observed. The mine is located on top of a mesa. Piles of waste rock are located through out the mine area. No adits, or other mine features were observed during the site visit.

Photo 4. Glover Mine site, waste rock piles

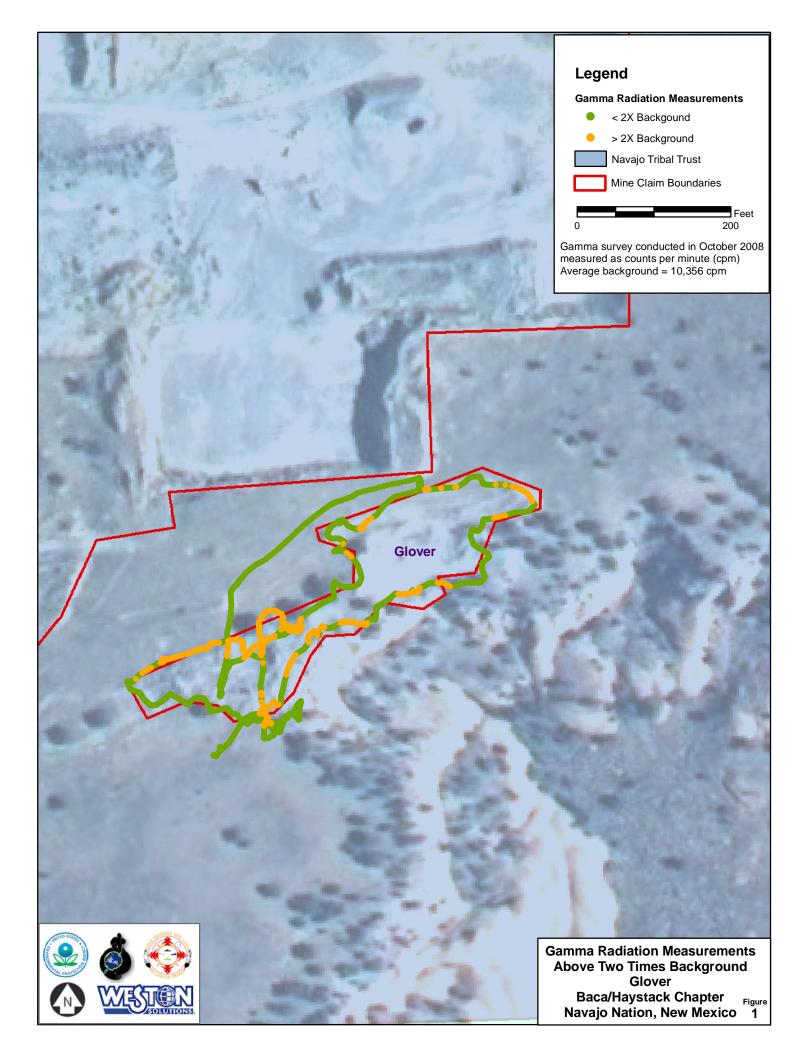
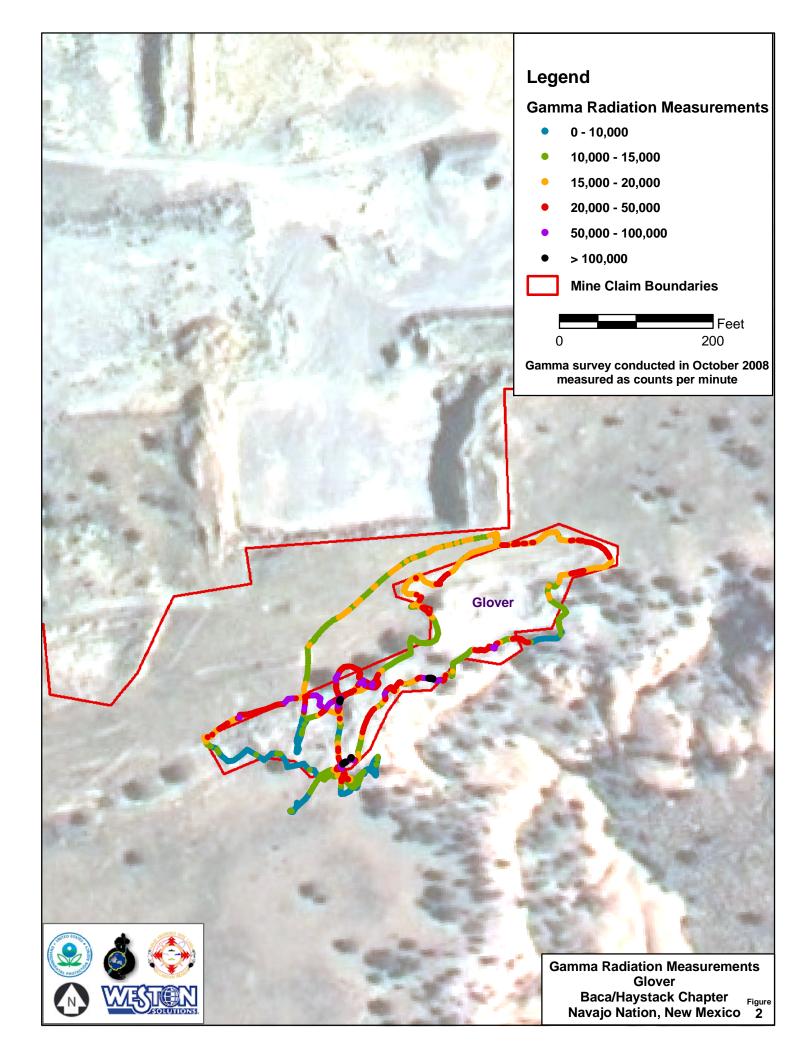
A total of 3,228 gamma radiation measurements were collected from mine sites, ranging from 6,197 cpm to 144,738 cpm. The measurements are represented in Figures 1 and 2. Radiological measurements collected for the New Mexico Mining and Minerals Division during a 2008 field screening survey found gamma radiation levels near the ground surface with a maximum of 140 micro Roentgen per hour (μ R/hr) and a minimum of 10 μ R/hr, levels at the 4-foot elevation with a maximum of 680 μ R/hr and a minimum of 8 μ R/hr, and background levels of 10 μ R/hr.
