# Navajo Abandoned Uranium Mine Site Screen Report

## **Crownpoint ISL Site**

### **Navajo AUM Eastern Region**

**May 2009**

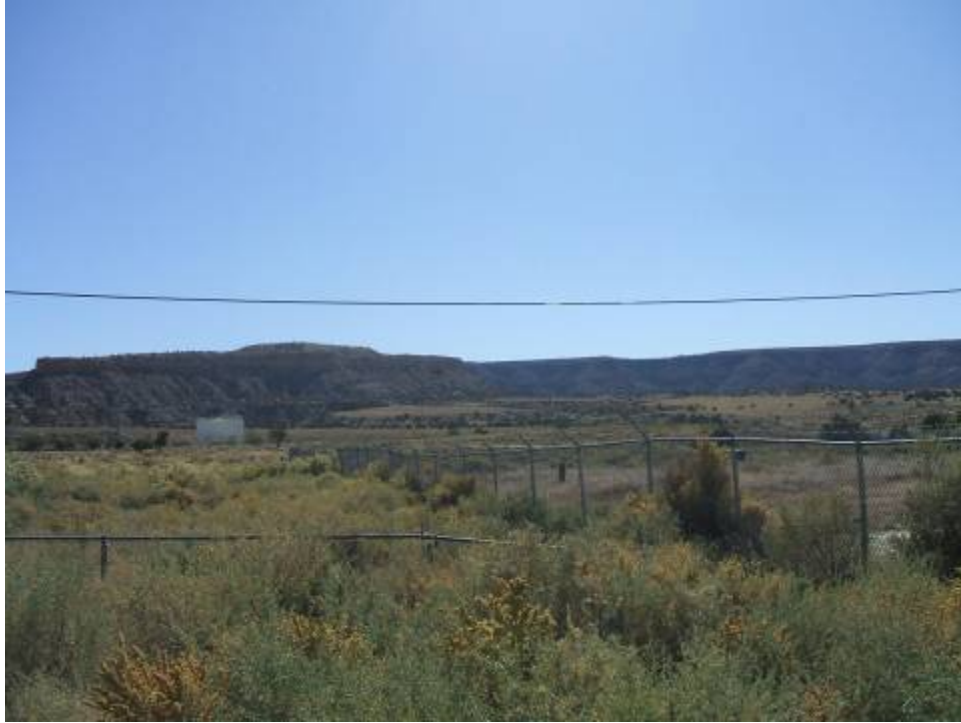
Photo 3. Crownpoint ISL mine site, towards the south

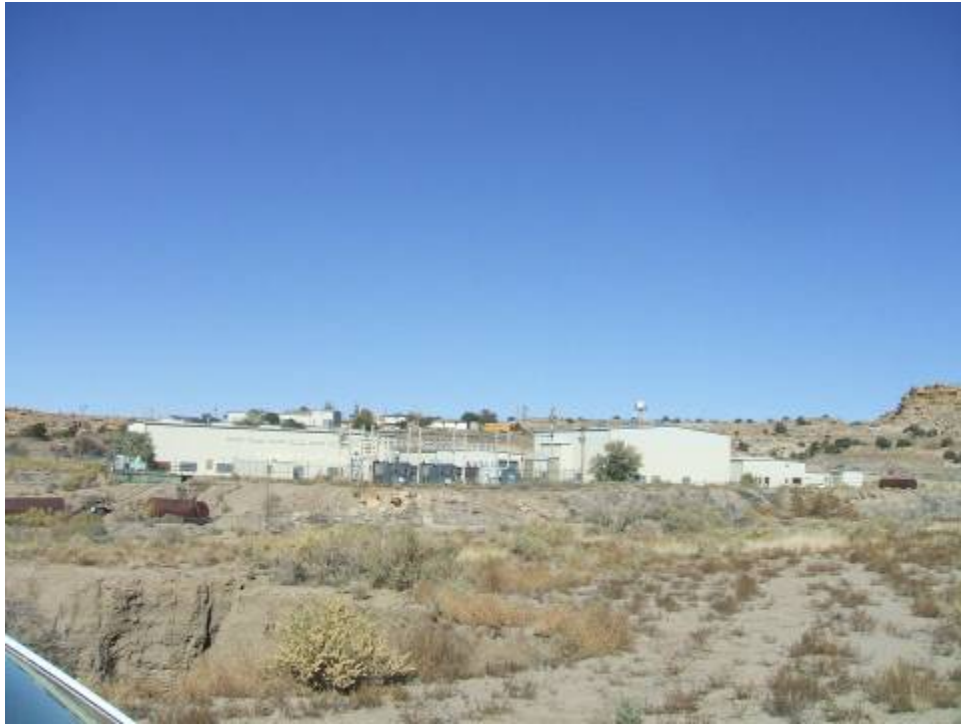
Photo 7. Crownpoint ISL mine site and Hydro Resources building, towards the north

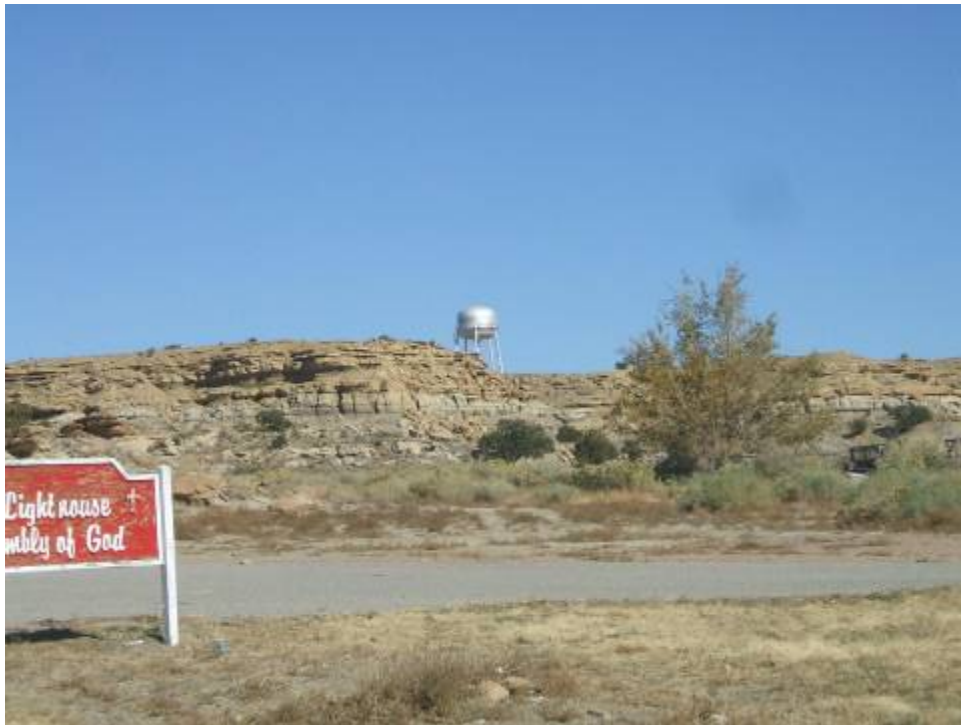
**0.25 miles to 4 miles:** A water tower was observed approximately 0.5 miles north of the site, field personnel were unable to access the tower, and were not able to identify the source of the water.

Photo 8. Water tower approximately 0.5 miles north/northeast of site, towards the northeast

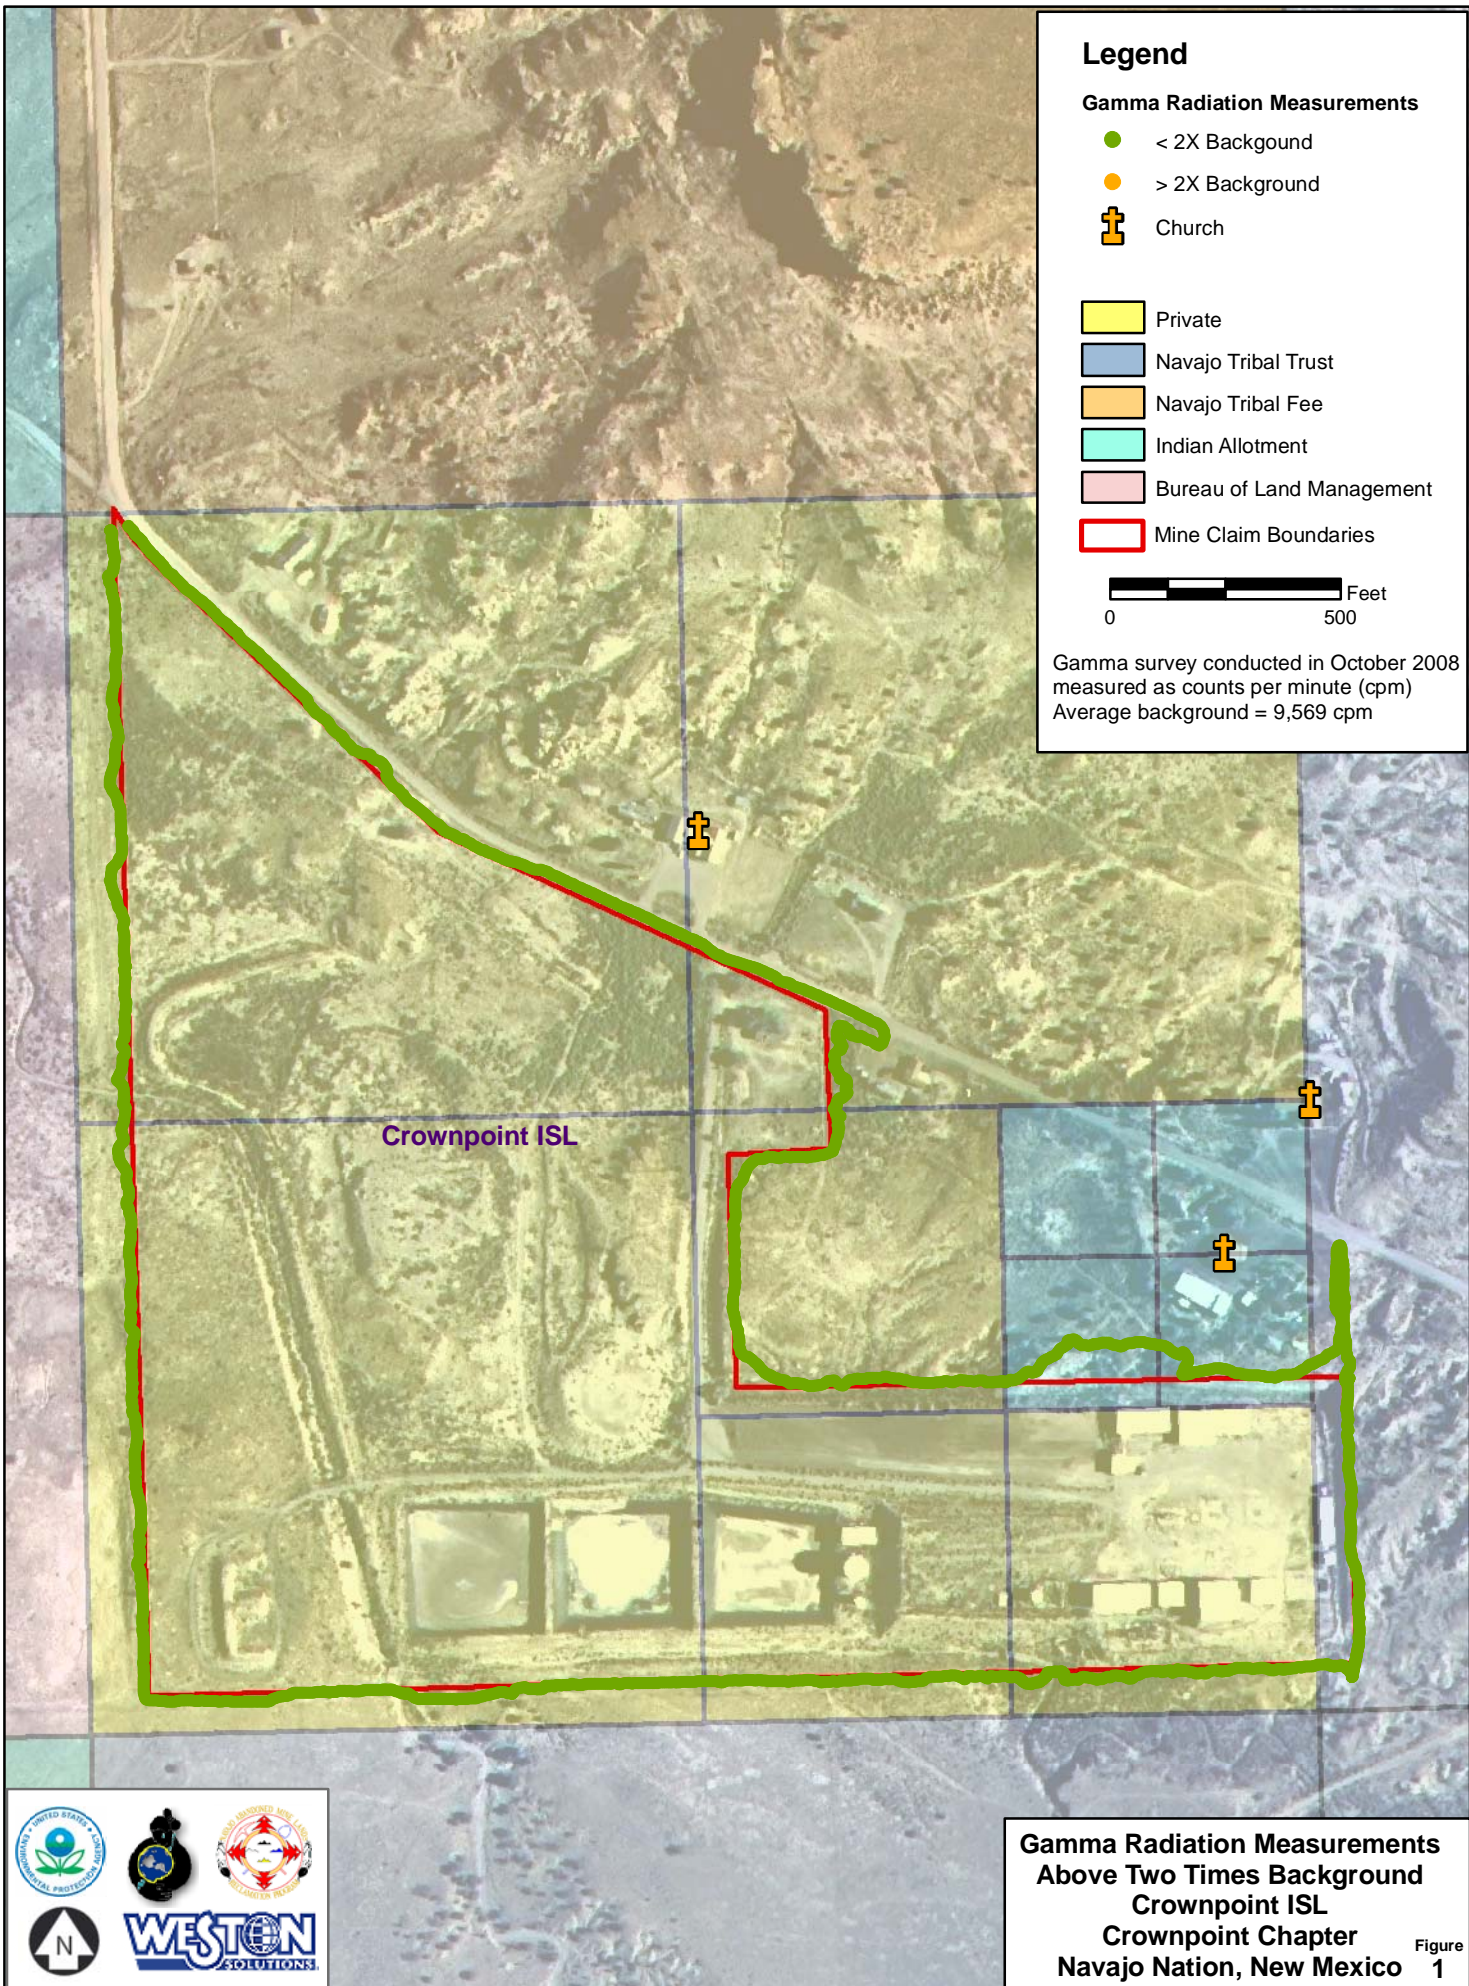
**Gamma Radiation Measurements  
Above Two Times Background  
Crownpoint ISL  
Crownpoint Chapter  
Navajo Nation, New Mexico** Figure 1

A total of 3,344 gamma radiation measurements were collected from mine sites, ranging from 6,248 cpm to 15,680 cpm. The measurements are represented in Figures 1 and 2.

Gamma survey conducted in October 2008  
measured as counts per minute (cpm)  
Average background = 9,569 cpm
