# Navajo Abandoned Uranium Mine Site Screen Report

Nanabah Vandever AUM Site

Navajo AUM Eastern Region

**May 2009**

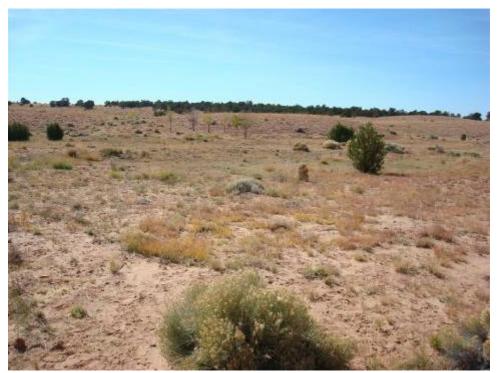
Photo 1. Nanabah Vandever Mine site, towards the south

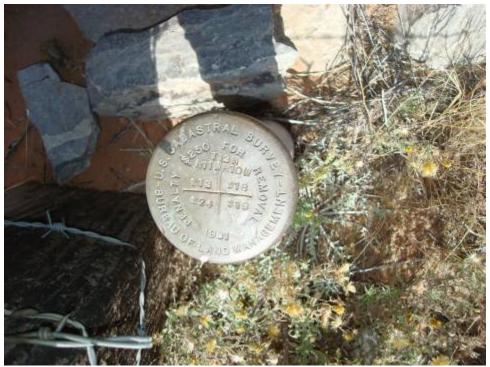
Photo 2. Nanabah Vandever Mine site, section corner survey marker

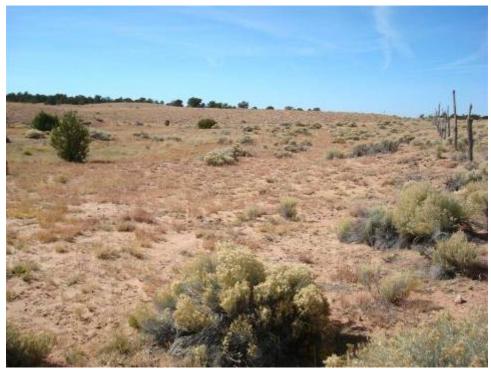
Reclamation status of the mine site is currently unknown. The mine appears to have been reclaimed by dirt covering waste piles. The mine is fenced and posted with signs warning of underground radiological hazards. The signs were faded and nearly illegible. No adits or other mine features were observed during the site visit.

Photo 3. Nanabah Vandever Mine site, suspect covered waste piles

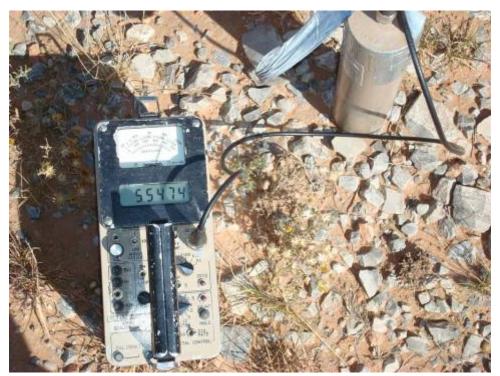
A total of 3,024 gamma radiation measurements were collected from mine sites, ranging from 4,569 cpm to 594,083 cpm. The measurements are represented in Figures 1 and 2.

Photo 4. Nanabah Vandever Mine site, waste rock emitting gamma radiation

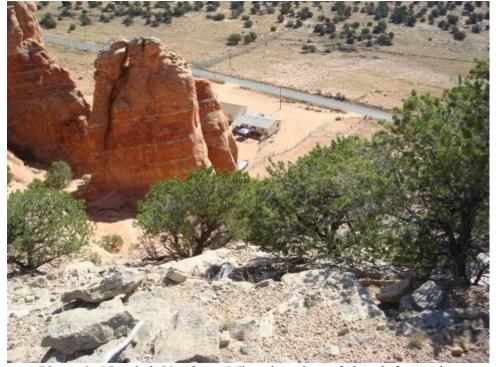
**0 to 200 feet:** None **200 feet to 0.25 mile:** A Church and an attached residence

are located downhill from the mesa approximately 700 feet

south of the site

- Church south of site – measured at less than two-times background levels

Photo 6. Nanabah Vandever Mine site, view of church from mine
