Navajo Abandoned Uranium Mine

Site Screen Report

Juan Horse No. 4 AUM Site

January 2011

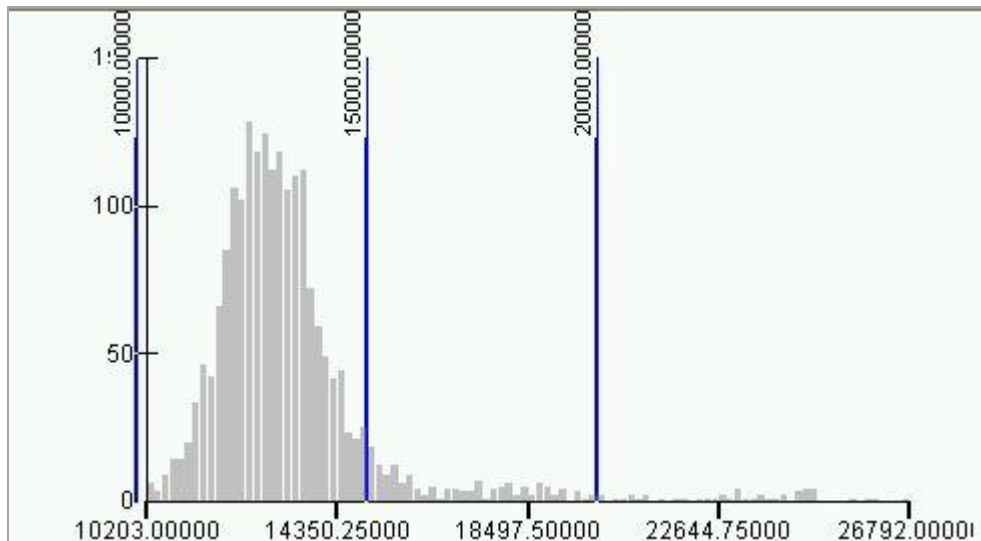
Count:	1999
Minimum:	10203.00000
Maximum:	26792.00000
Sum:	26742210.00000
Mean:	13377.79390
Median:	12983.00000
Standard Deviation:	2060.73314

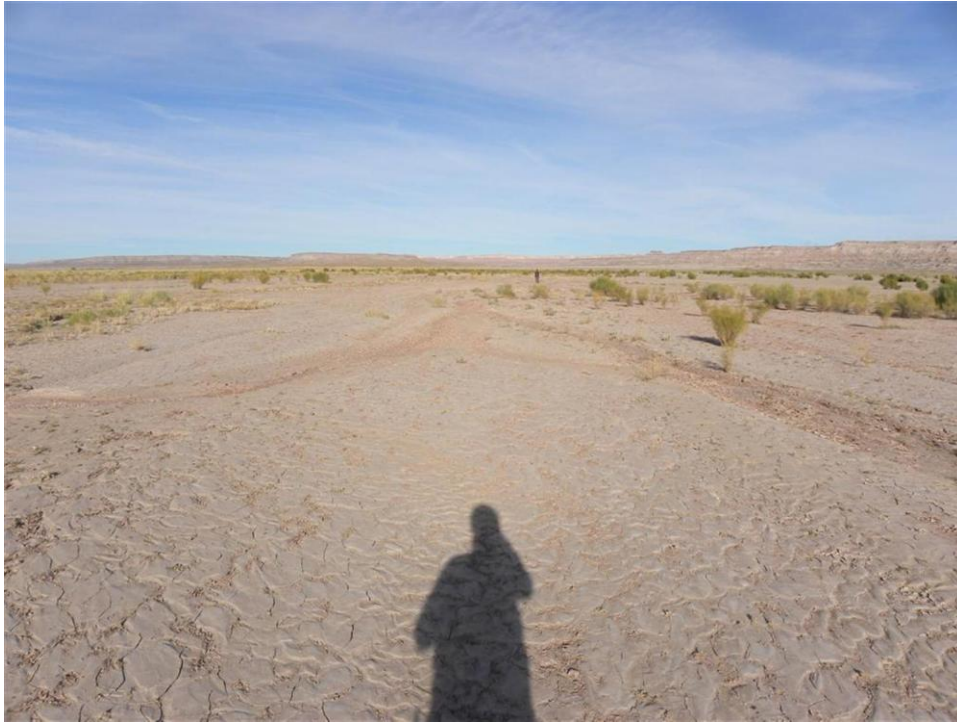
Photo 1. Juan Horse No. 4 mine site

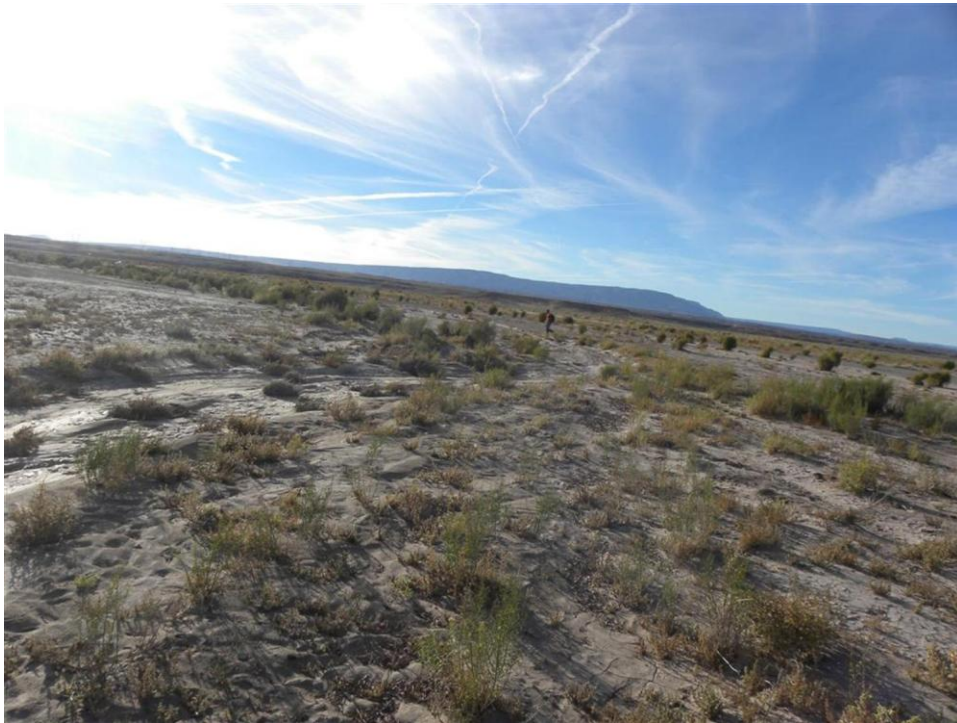
Photo 2. Juan Horse No. 4 mine site

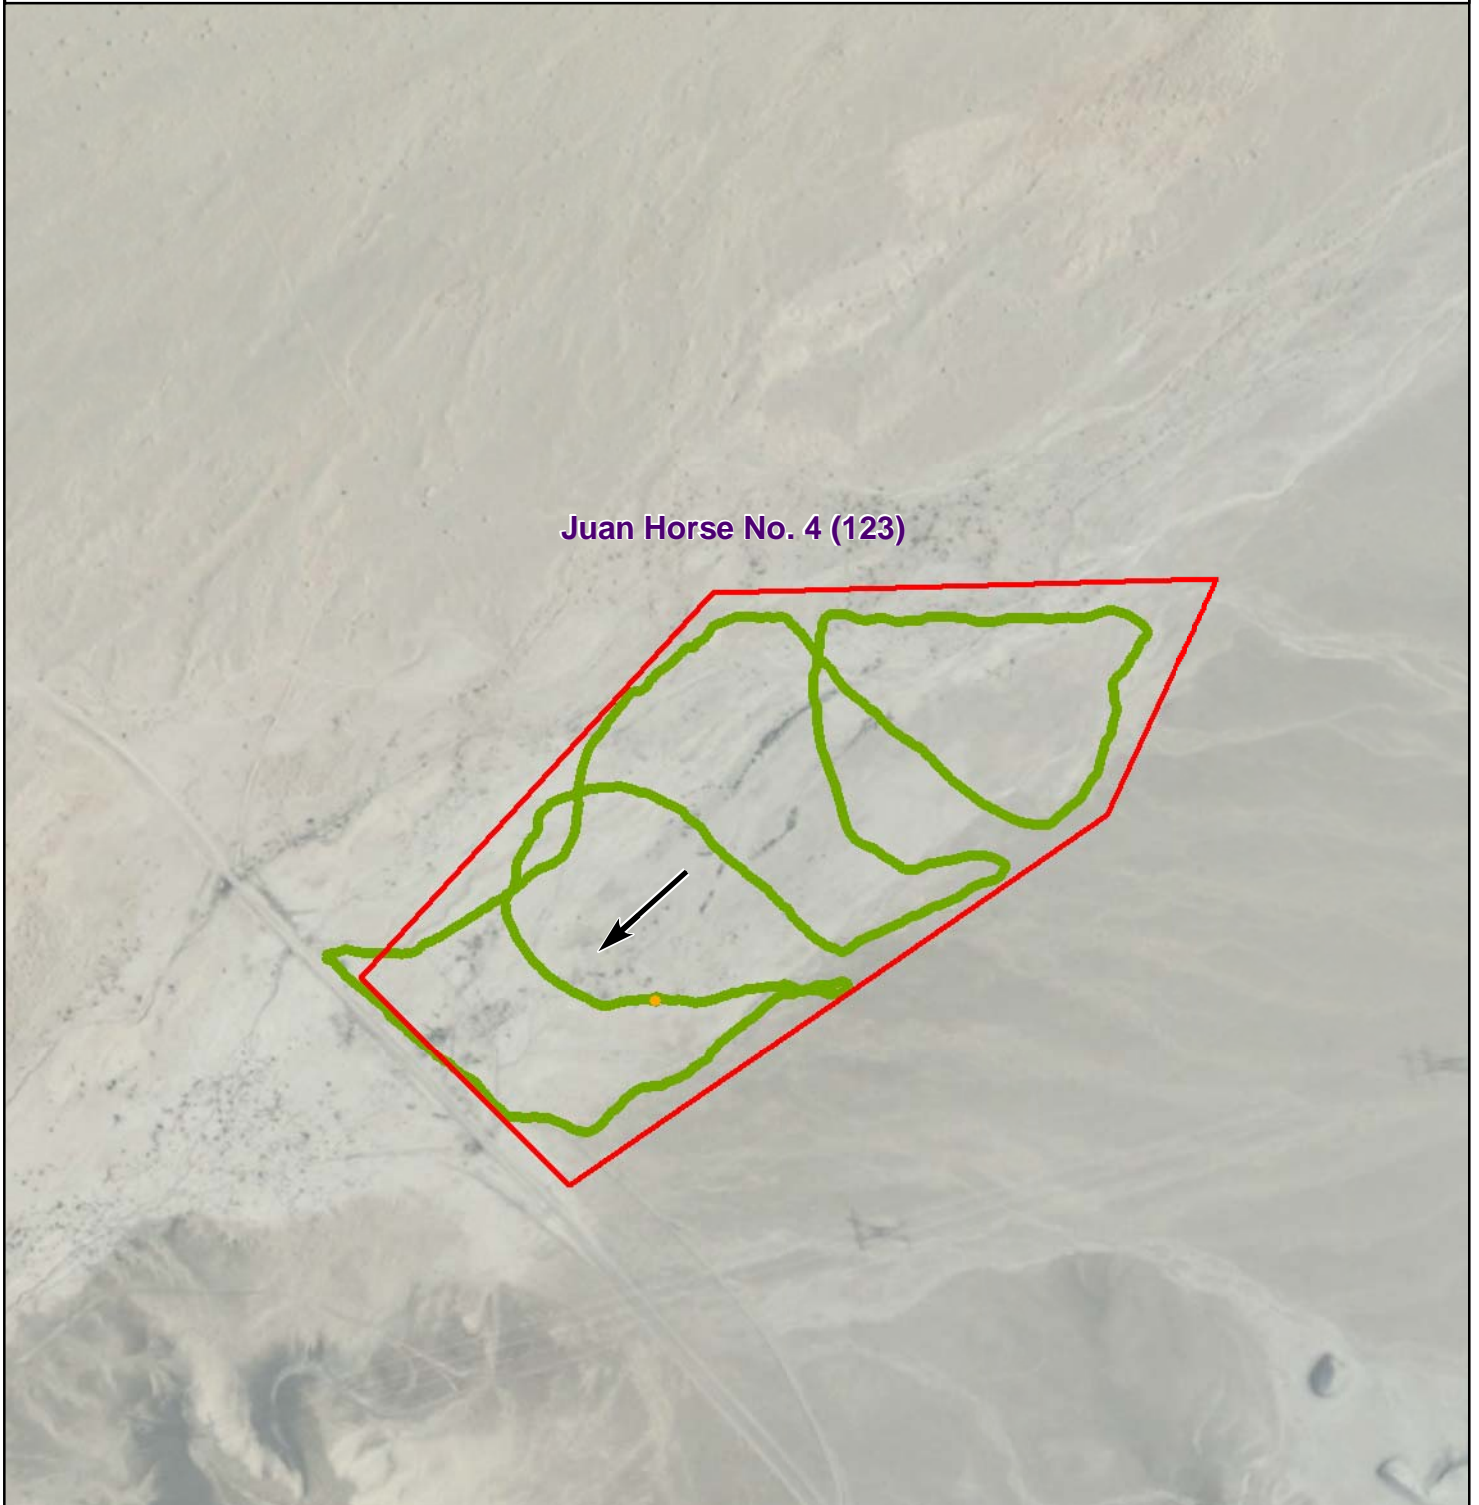
**Figure 1 - Gamma Radiation Measurements, Above Two Times Background
Juan Horse No. 4 (123)
Coalmine Mesa Chapter, Navajo Nation**

A total of 1,999 gamma radiation measurements were collected from the mine site, ranging from 10,203 cpm to 26,792 cpm. The measurements are represented in Figures 1 and 2.

Were any gamma radiation measurements collected at the mine greater than two times the site-specific background levels?

Yes
