Navajo Abandoned Uranium Mine Site Screen Report

Section 13 AUM Site

Navajo AUM Eastern Region

May 2009

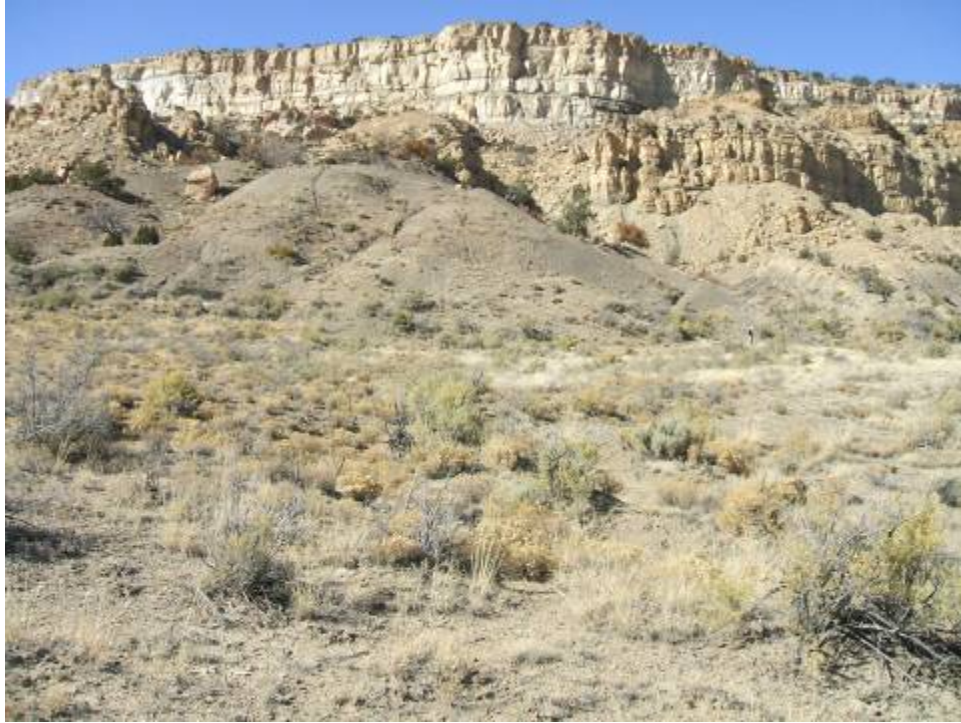
Photo 3. Section 13 mine site, towards the north

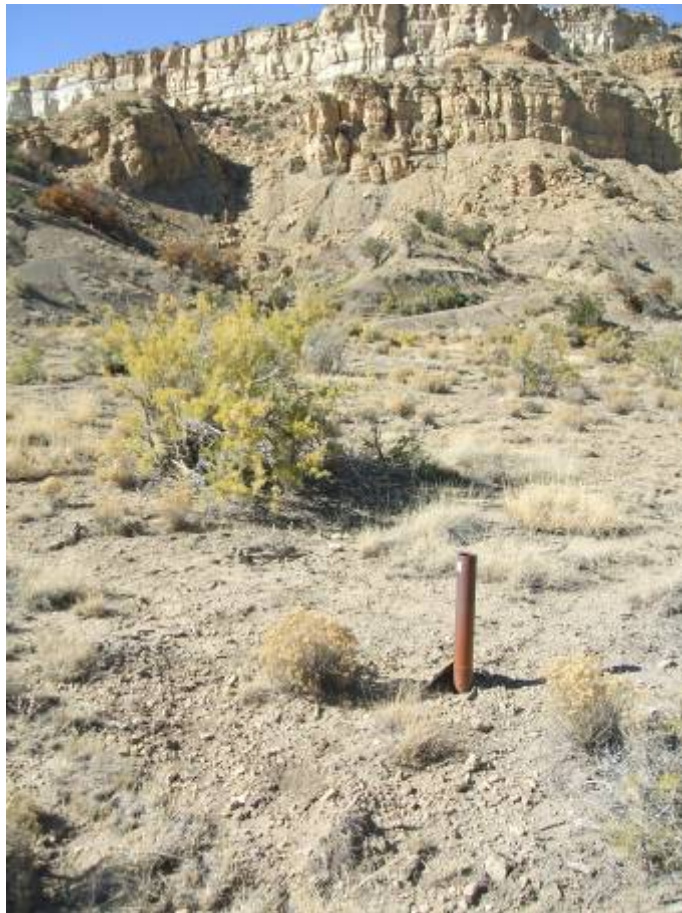
Reclamation status of the mine site is currently unknown. No visible signs of reclamation were observed. A monitoring well was observed within the northern portion of the site. No adits, waste piles, or other mine features were observed during the site visit.

Photo 4. Section 13 mine site well, towards the north

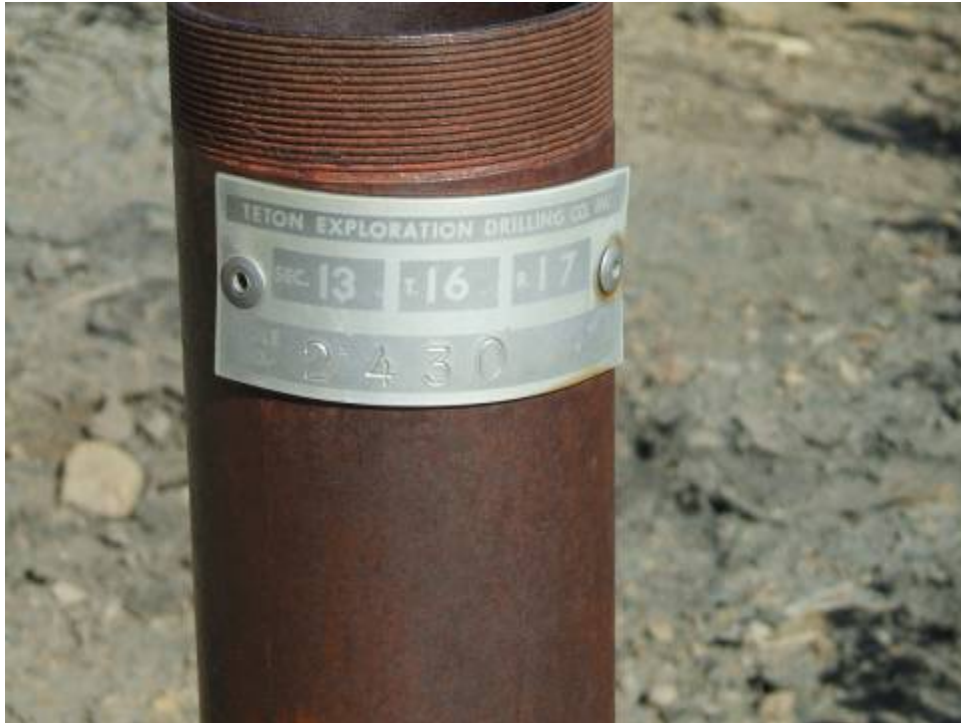
Photo 5. Section 13 mine site well, towards the east

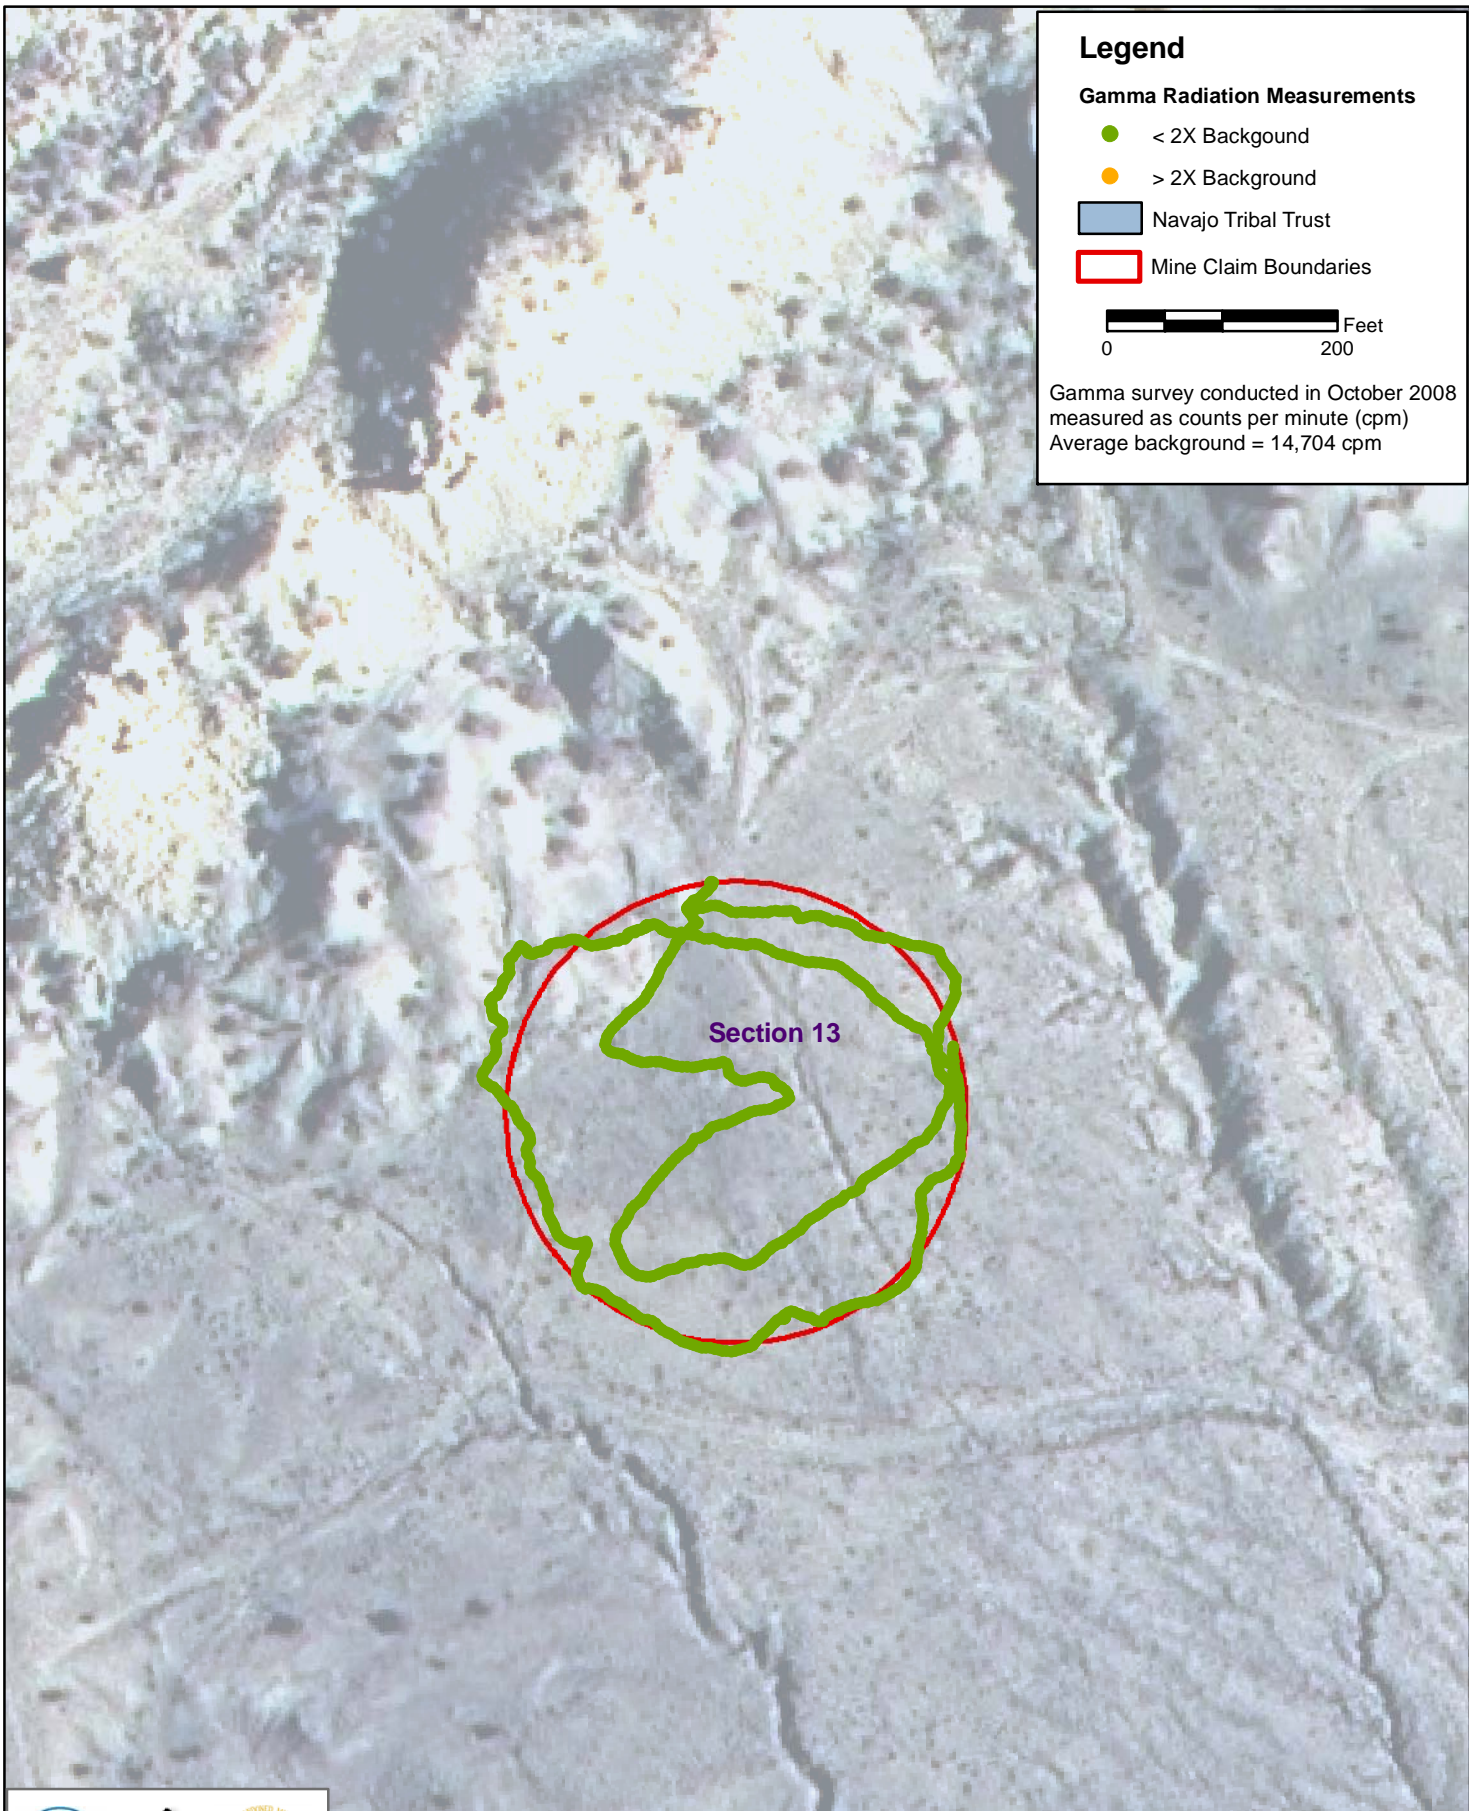
**Gamma Radiation Measurements
 Above Two Times Background
 Section 13
 Church Rock Chapter
 Navajo Nation, New Mexico** Figure 1

A total of 953 gamma radiation measurements were collected from mine sites, ranging from 11,796 cpm to 20,667 cpm. The measurements are represented in Figures 1 and 2.

Gamma survey conducted in October 2008
 measured as counts per minute (cpm)
 Average background = 14,704 cpm
