Navajo Abandoned Uranium Mine Site Screen Report

Grace In-situ Leach AUM Site

Navajo AUM Eastern Region

May 2009

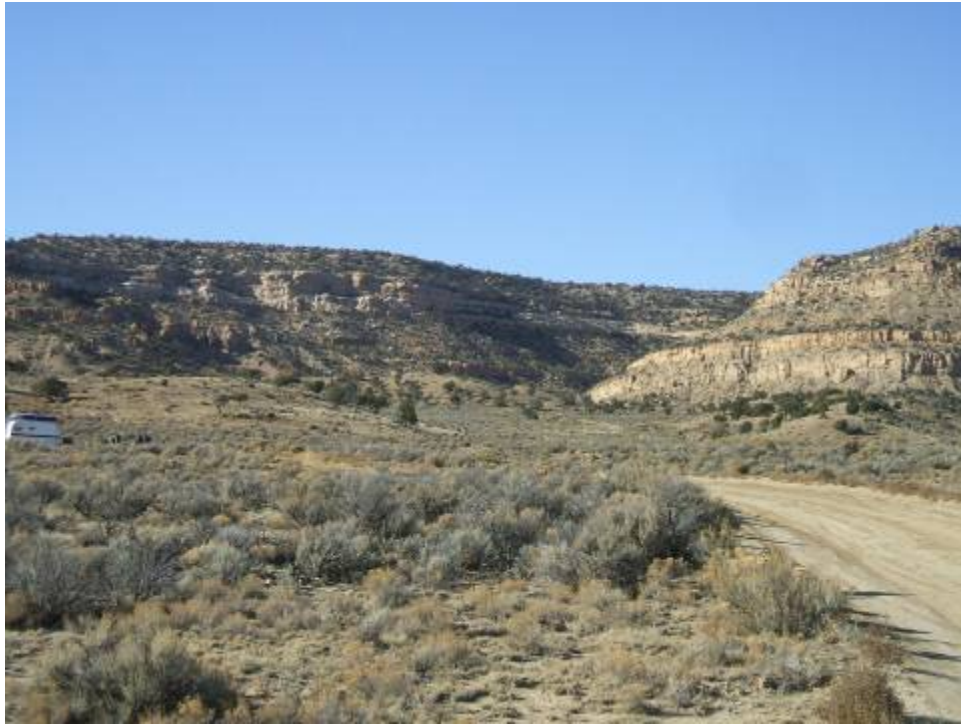
Photo 1. Grace Insitu Leach mine site in the distance, towards the northwest

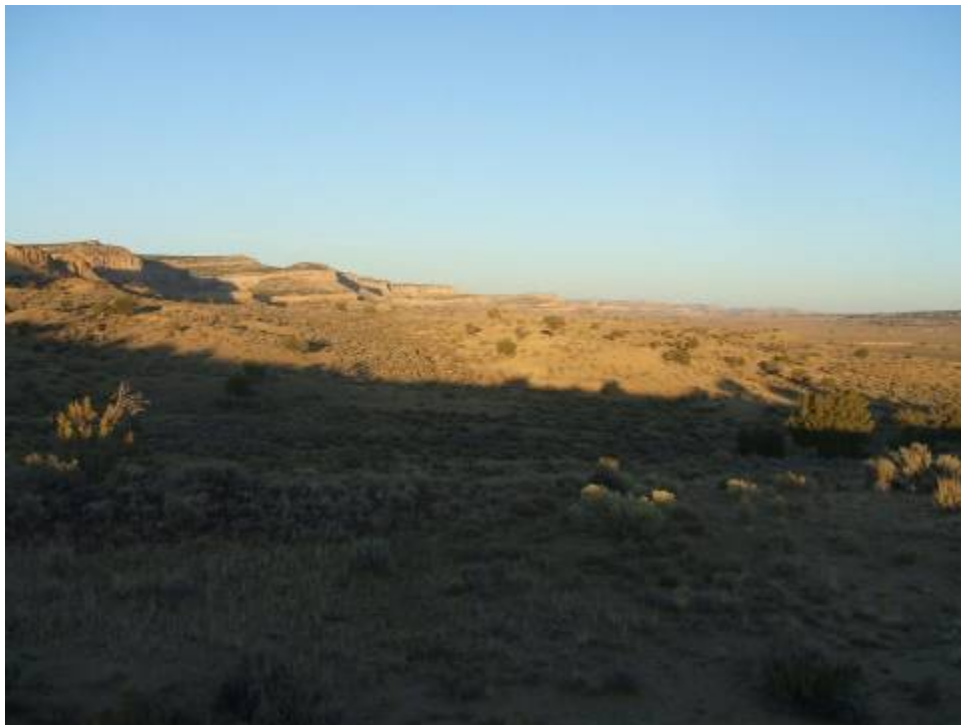
Photo 2. Grace Insitu Leach mine site, towards the north

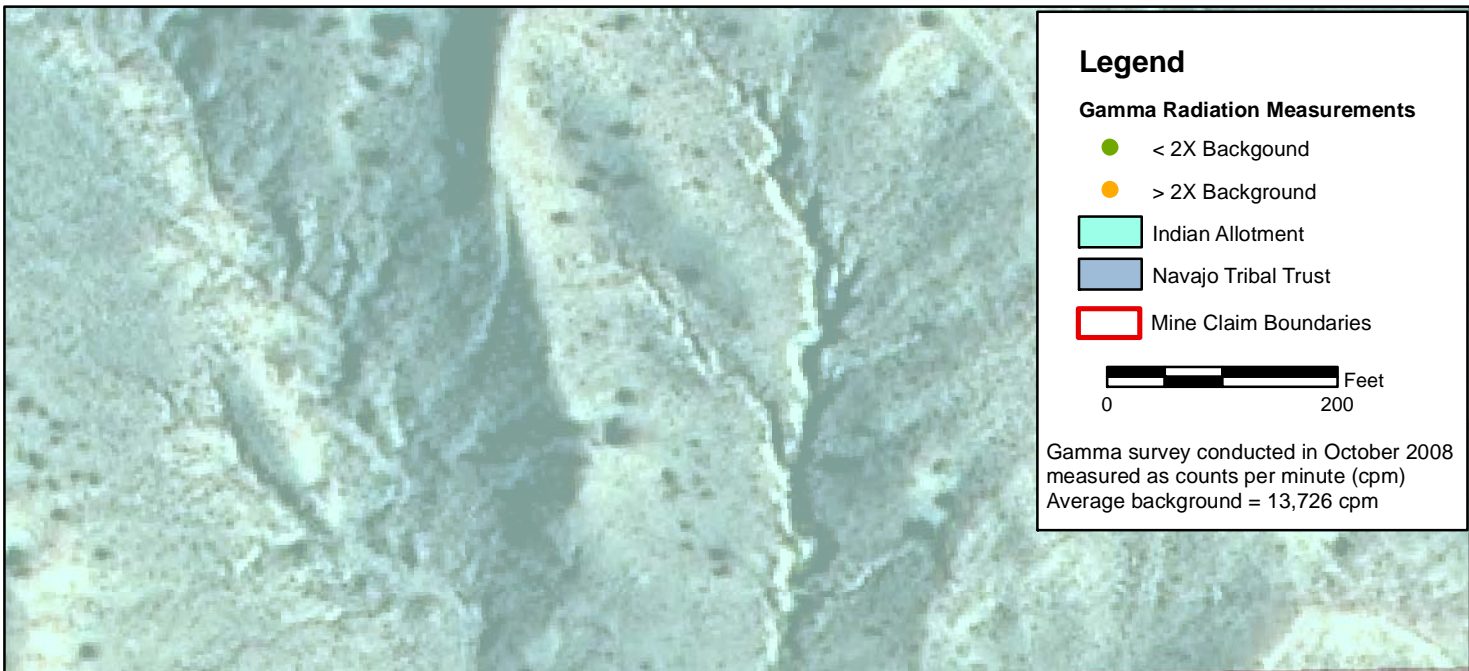
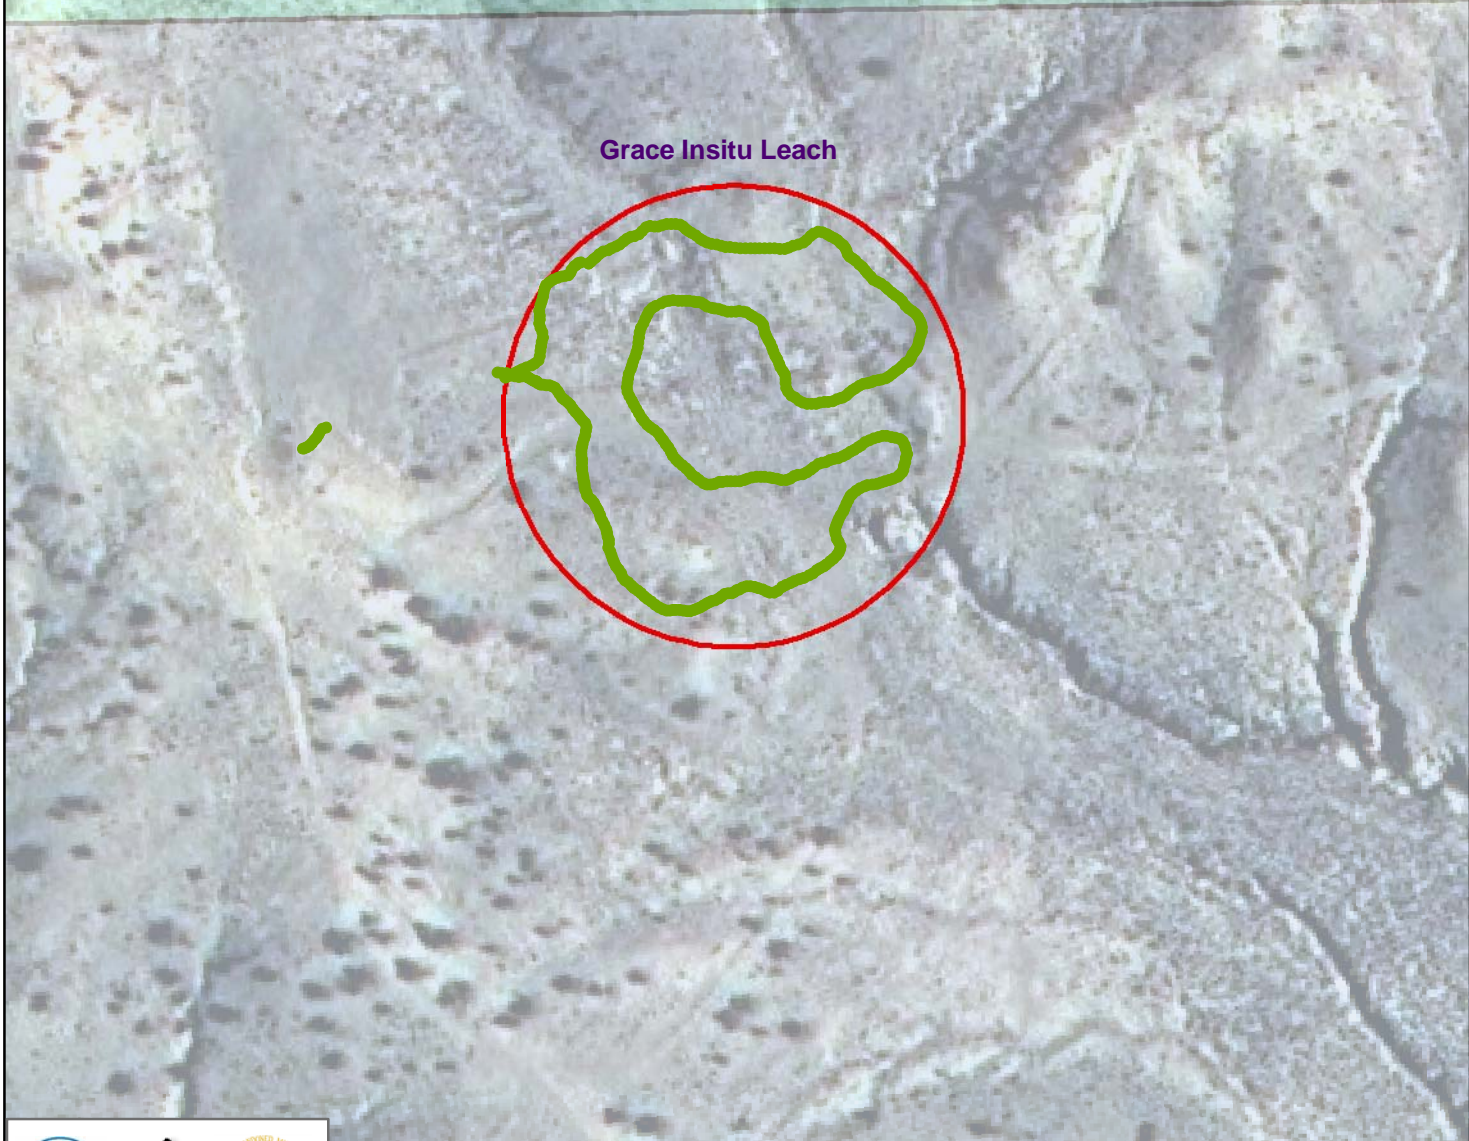
Gamma Radiation Measurements Above Two Times Background Grace Insitu Leach Church Rock Chapter Navajo Nation, New Mexico Figure 1

A total of 509 gamma radiation measurements were collected from mine sites, ranging from 10,717 cpm to 14,672 cpm. The measurements are represented in Figures 1 and 2.

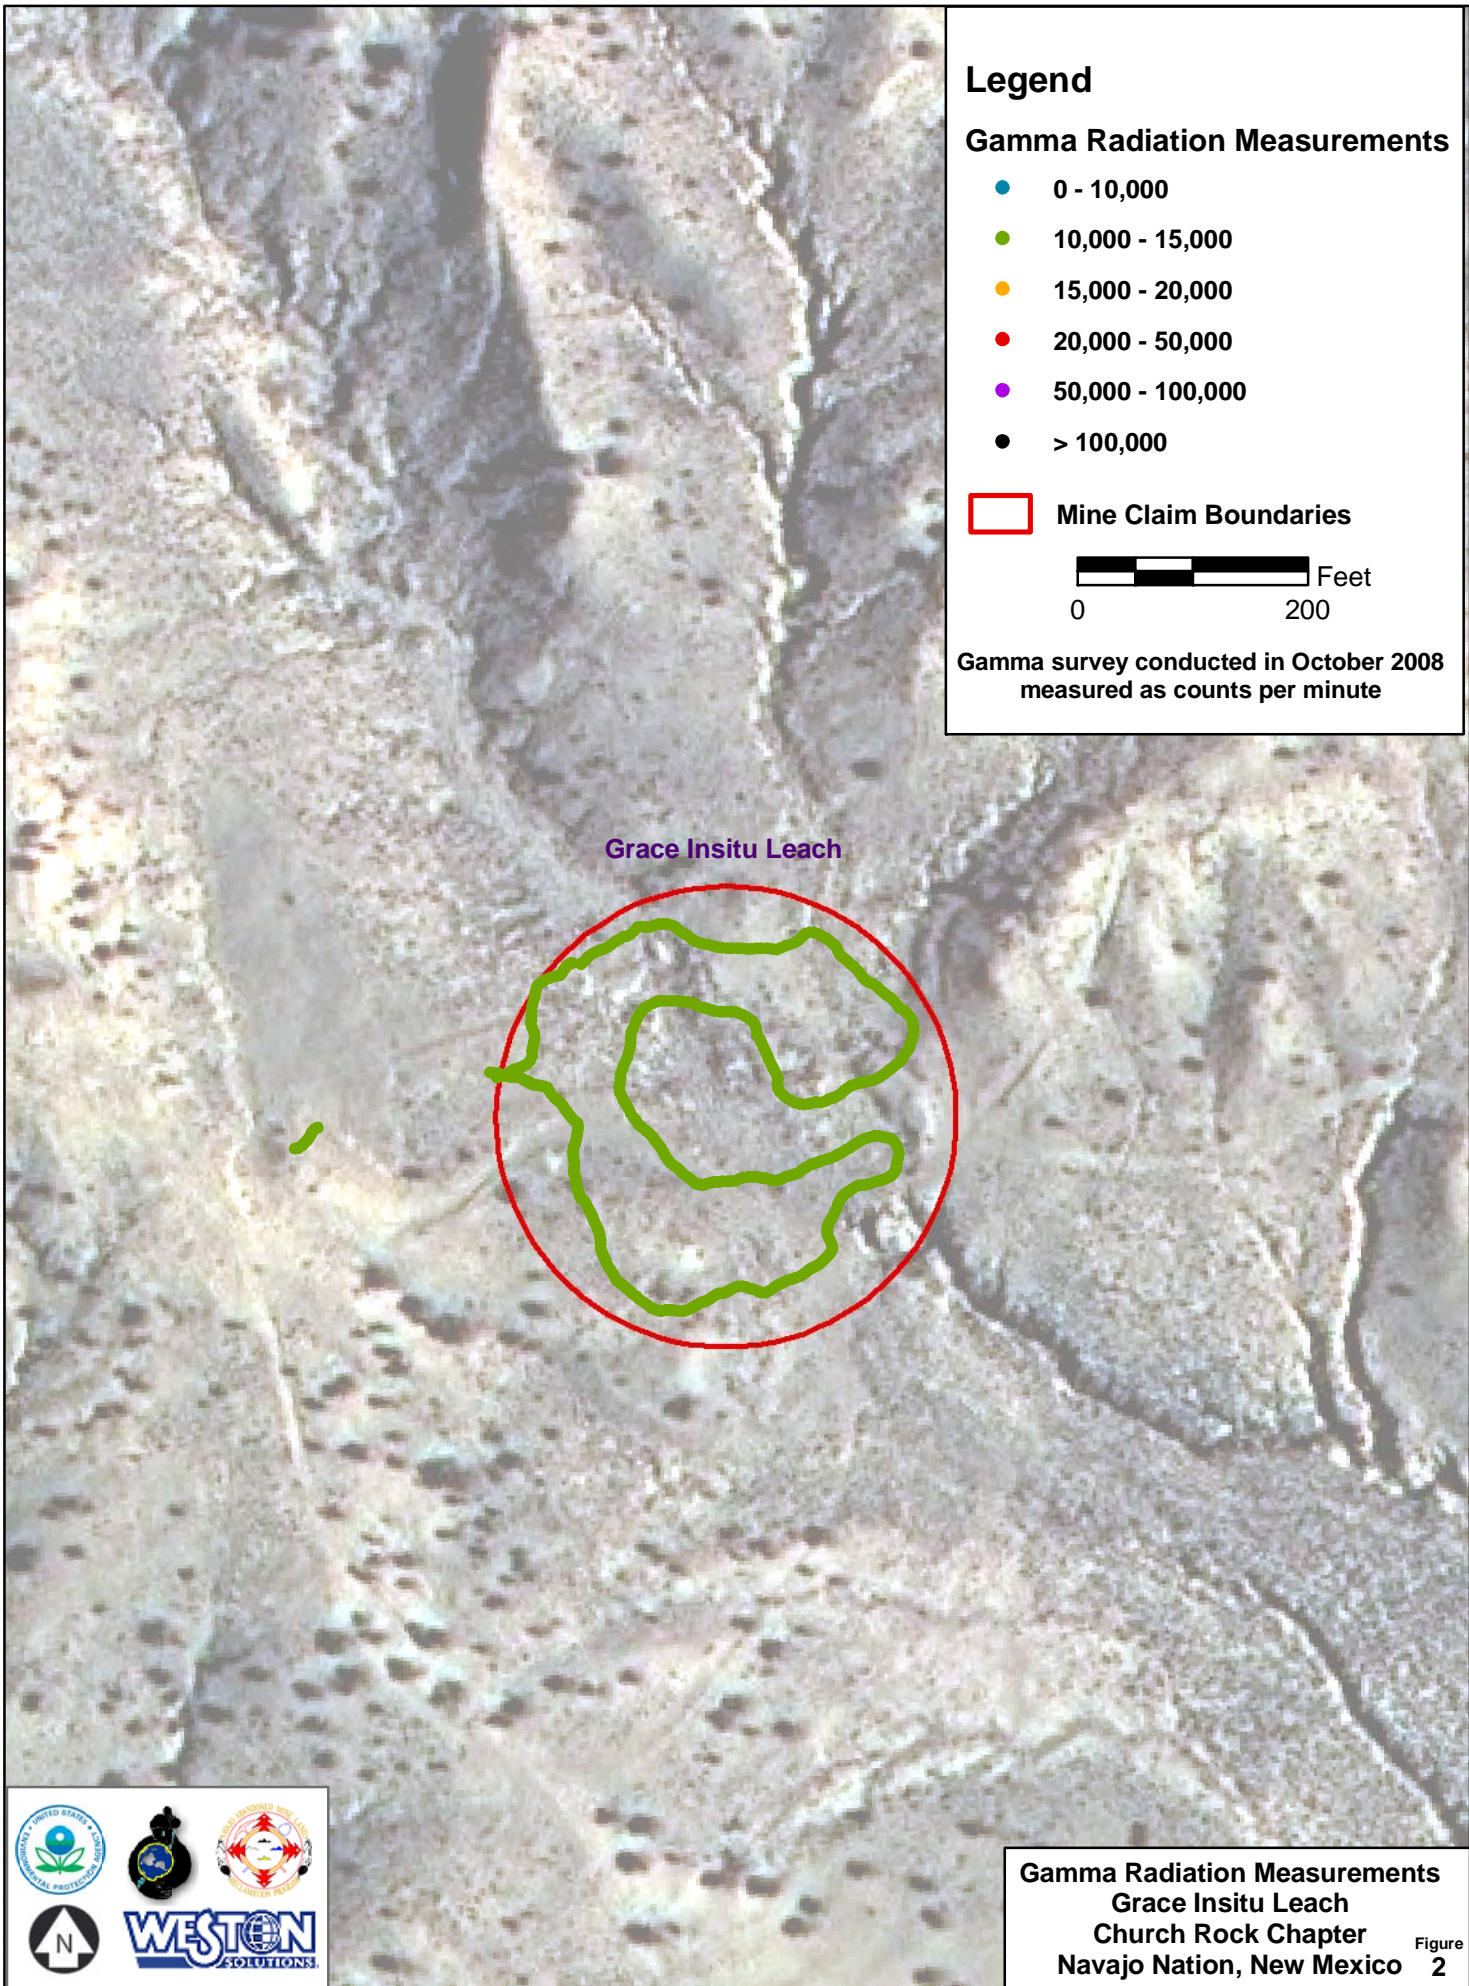
**Gamma Radiation Measurements
Grace Insitu Leach
Church Rock Chapter
Navajo Nation, New Mexico** Figure 2

Gamma survey conducted in October 2008
measured as counts per minute
