Navajo Abandoned Uranium Mine Site Screen Report

Diamond No. 2 AUM Site

Navajo AUM Eastern Region

Weston Solutions, Inc.

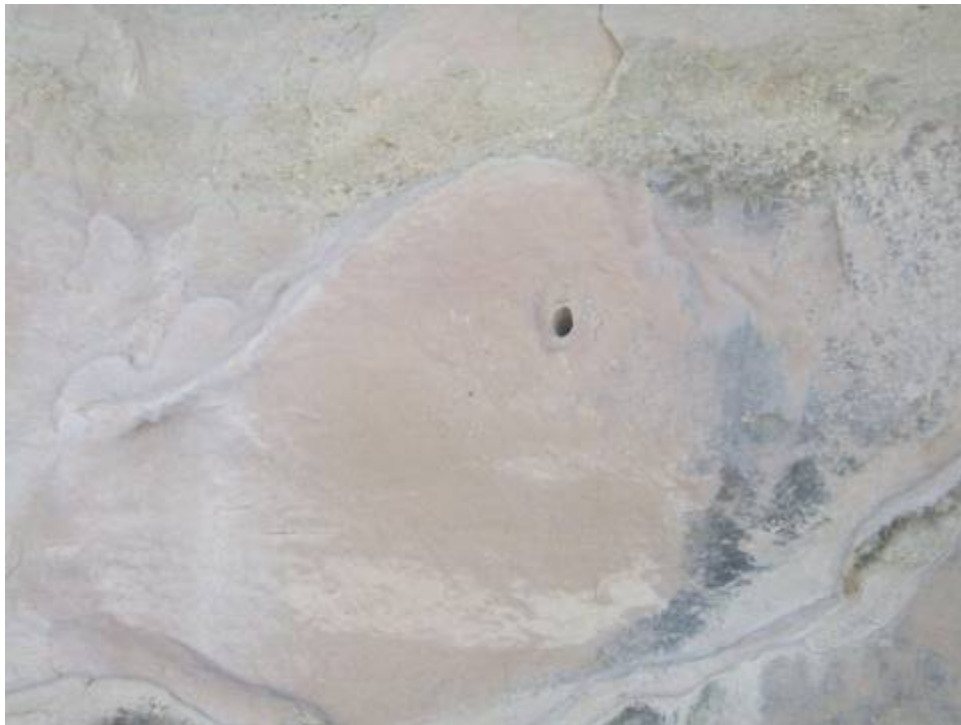
Reclamation status of the mine site is currently unknown. No visible signs of reclamation were observed. Three adits/shafts were observed along the cliff face at the western end of the site (Photo 5). Several drill-holes were also observed along the cliff face (Photo 4). No waste piles, or other mine features were observed during the site visit.

Photo 4. Diamond No 2 mine site, possible blasting hole on the cliff wall, towards the west

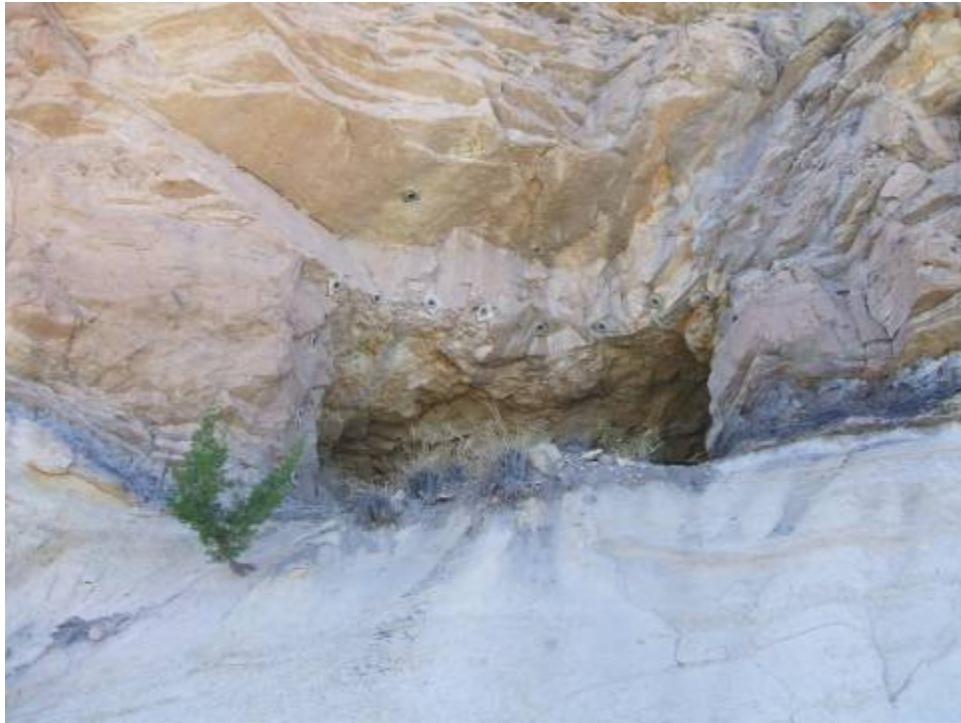
Photo 5. Diamond No 2 mine site, adit / shaft entrance in cliff wall, towards the west

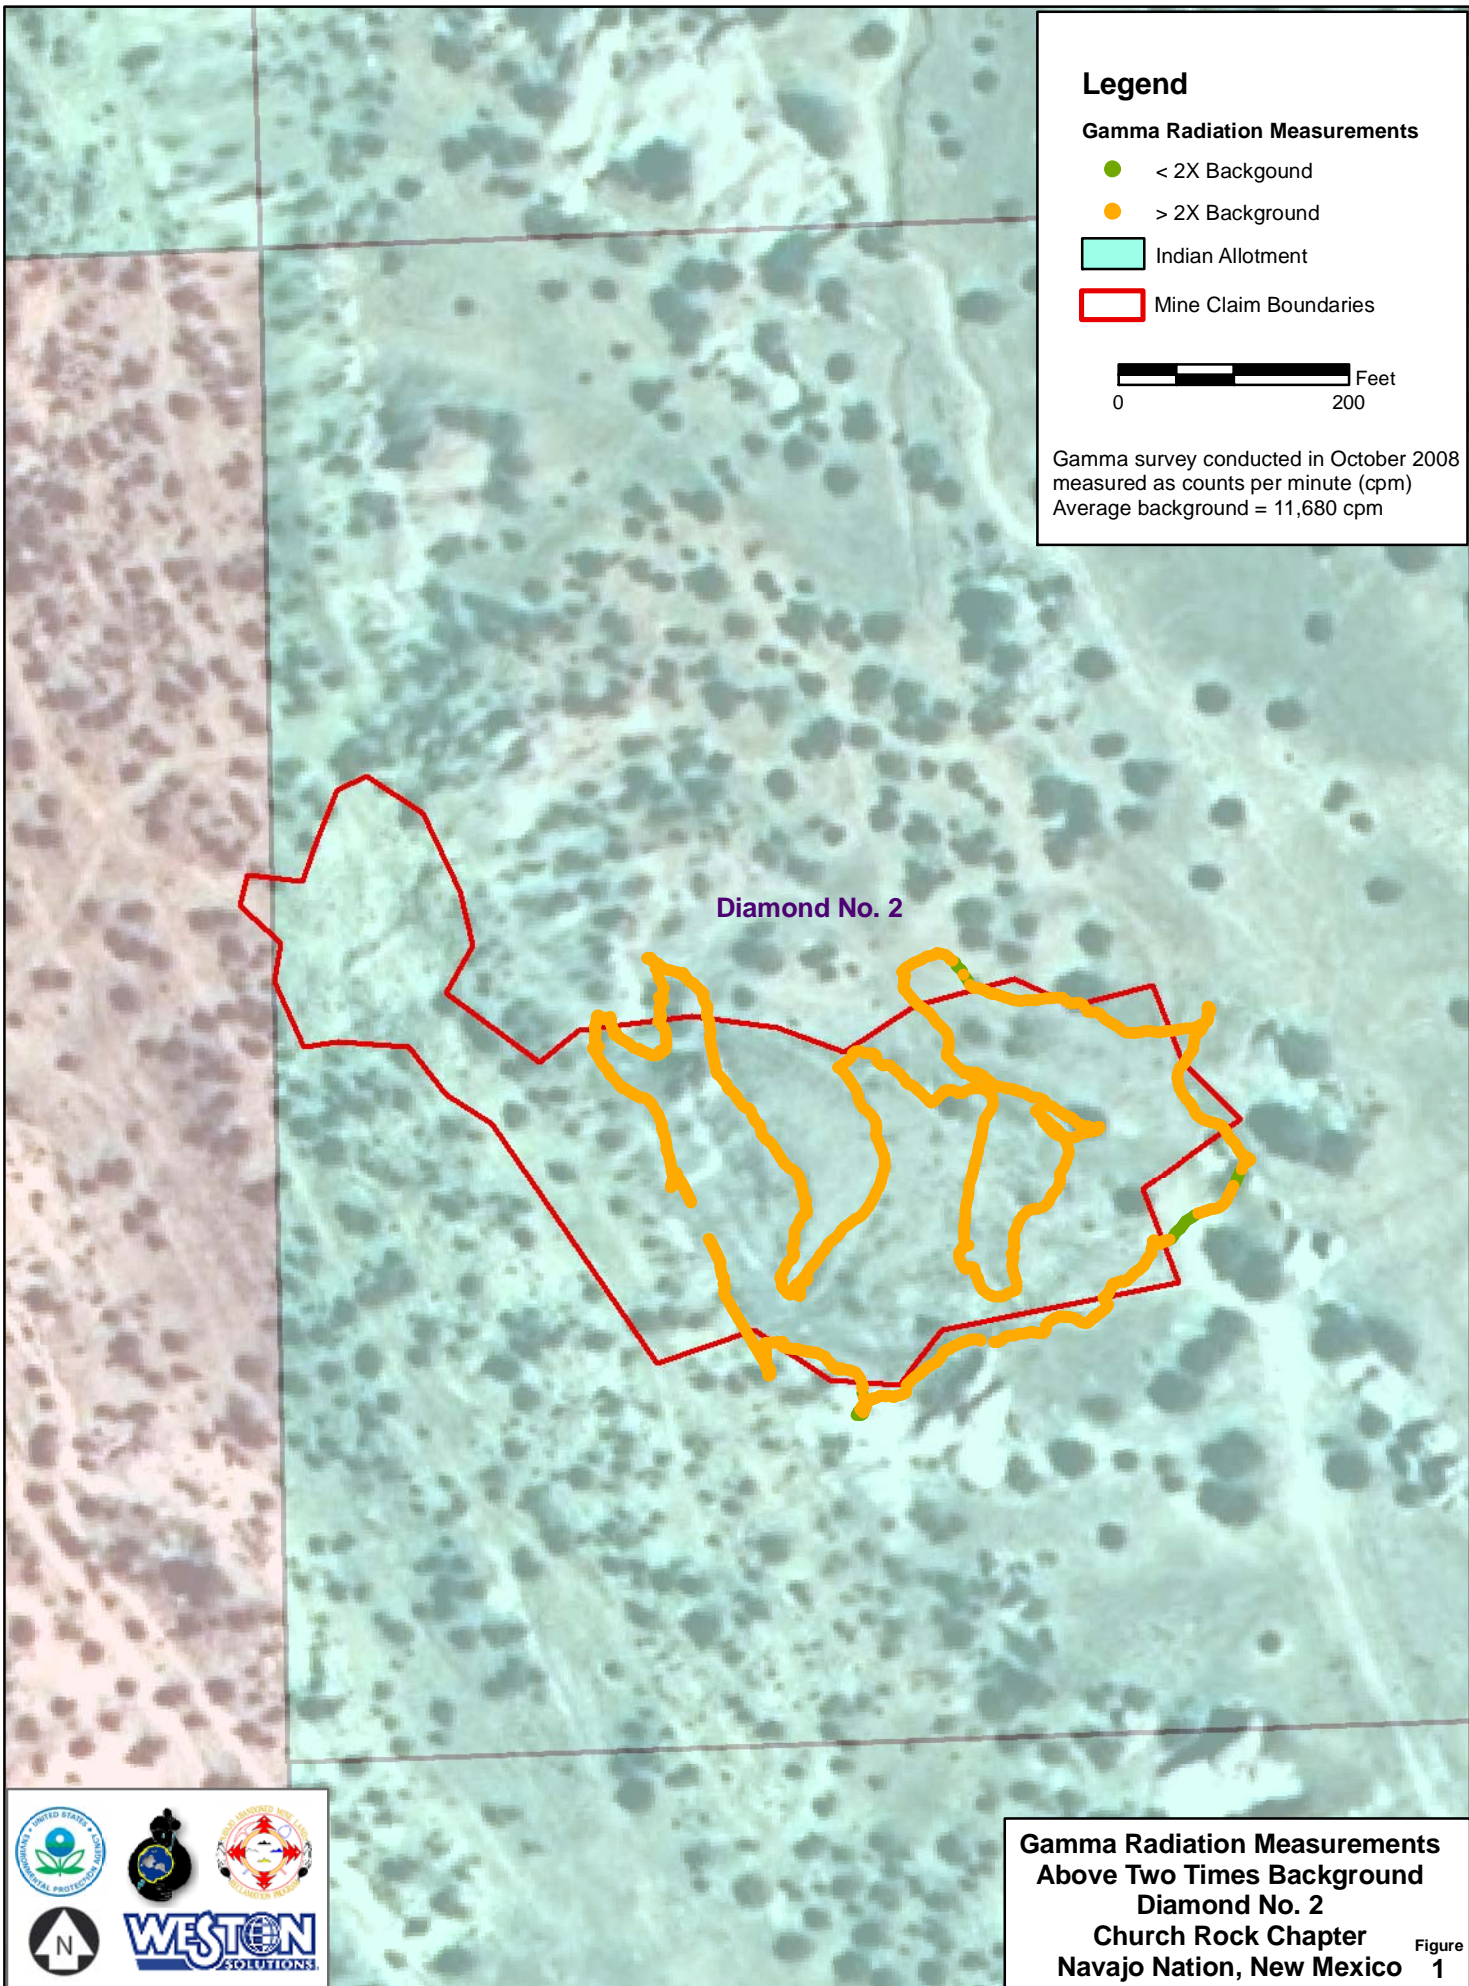
A total of 1,704 gamma radiation measurements were collected from mine sites, ranging from 18,515 cpm to 166,251 cpm. The measurements are represented in Figures 1 and 2.

Gamma survey conducted in October 2008
 measured as counts per minute (cpm)
 Average background = 11,680 cpm

**Gamma Radiation Measurements
 Above Two Times Background
 Diamond No. 2
 Church Rock Chapter
 Navajo Nation, New Mexico**

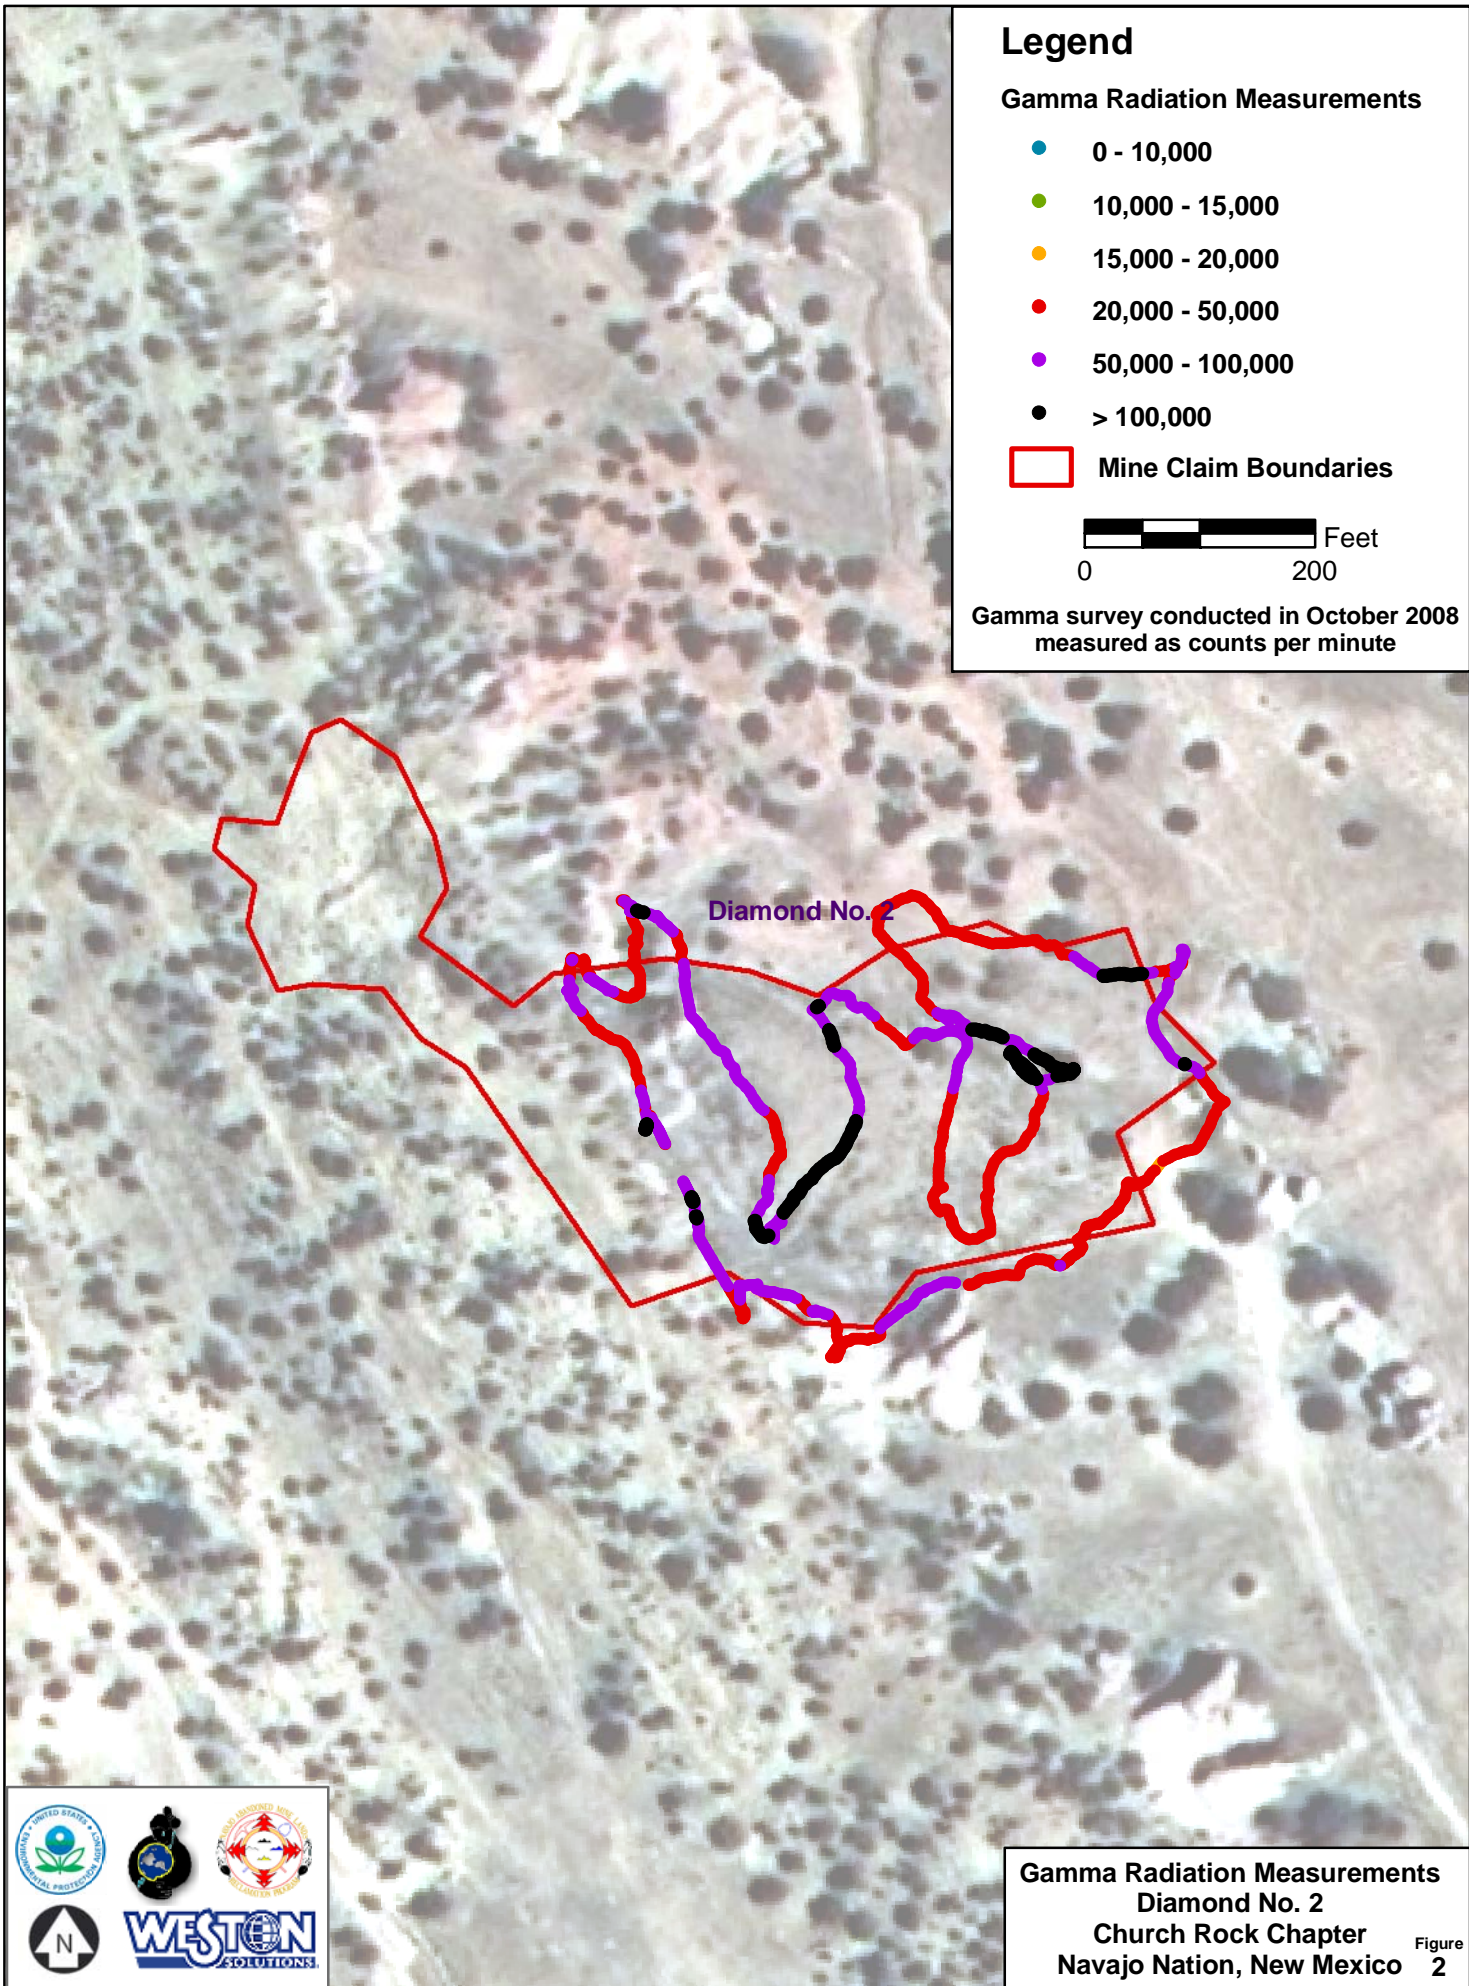
**Gamma Radiation Measurements
Diamond No. 2
Church Rock Chapter
Navajo Nation, New Mexico**
