Navajo Abandoned Uranium Mine Site Screen Report

Mac No. 2 AUM Site

Navajo AUM Eastern Region

May 2009

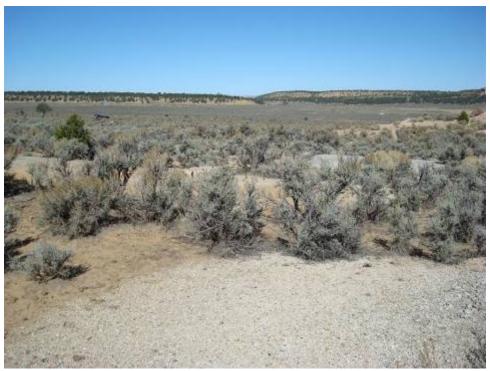
Photo 1. Mac No. 2 Mine site, towards the north

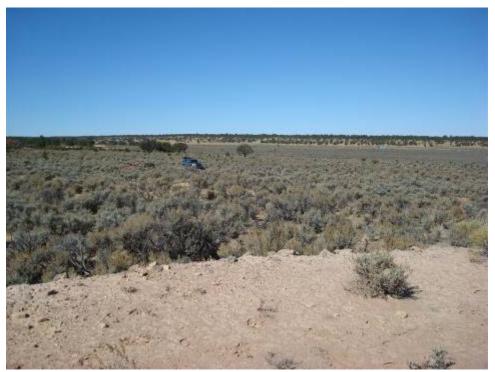
Photo 2. Mac No. 2 Mine site, towards the northwest

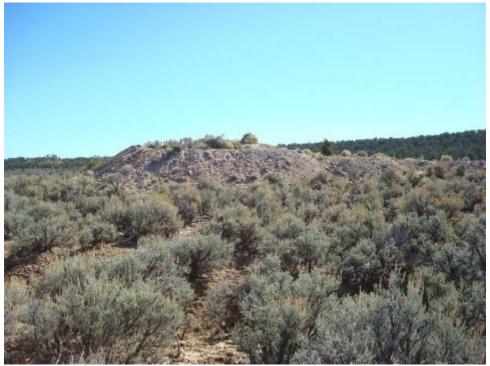
Reclamation status of the mine sites are currently unknown. No visible signs of reclamation were observed. Several piles of pulverized waste rock remain at the site. Two concrete pads are located on the eastern portion of the property. No waste piles, adits, or other mine features were observed during the site visit.

Photo 3. Mac No. 2 Mine site, waste pile located along the eastern edge of the site

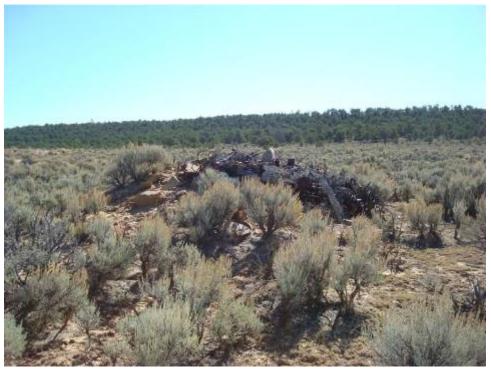
Photo 4. Mac No. 2 Mine site, debris pile on the mine site

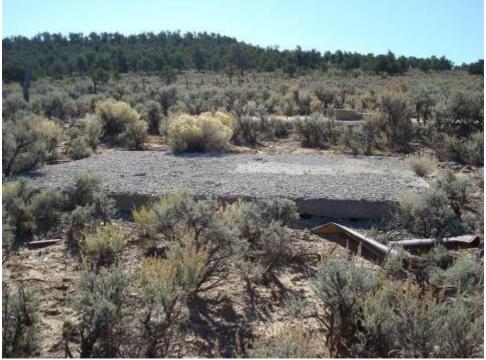
Photo 5. Mac No. 2 Mine site, two concrete pads at the eastern portion of the site

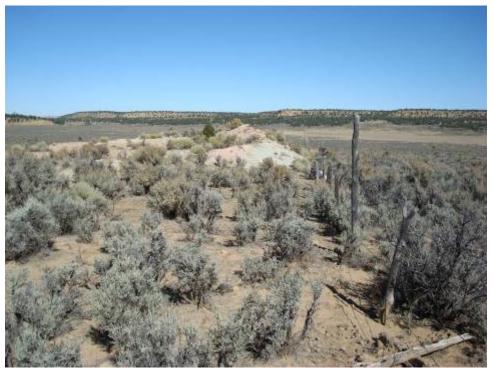
Photo 6. Mac No. 2 Mine site, waste piles along the eastern edge of the site

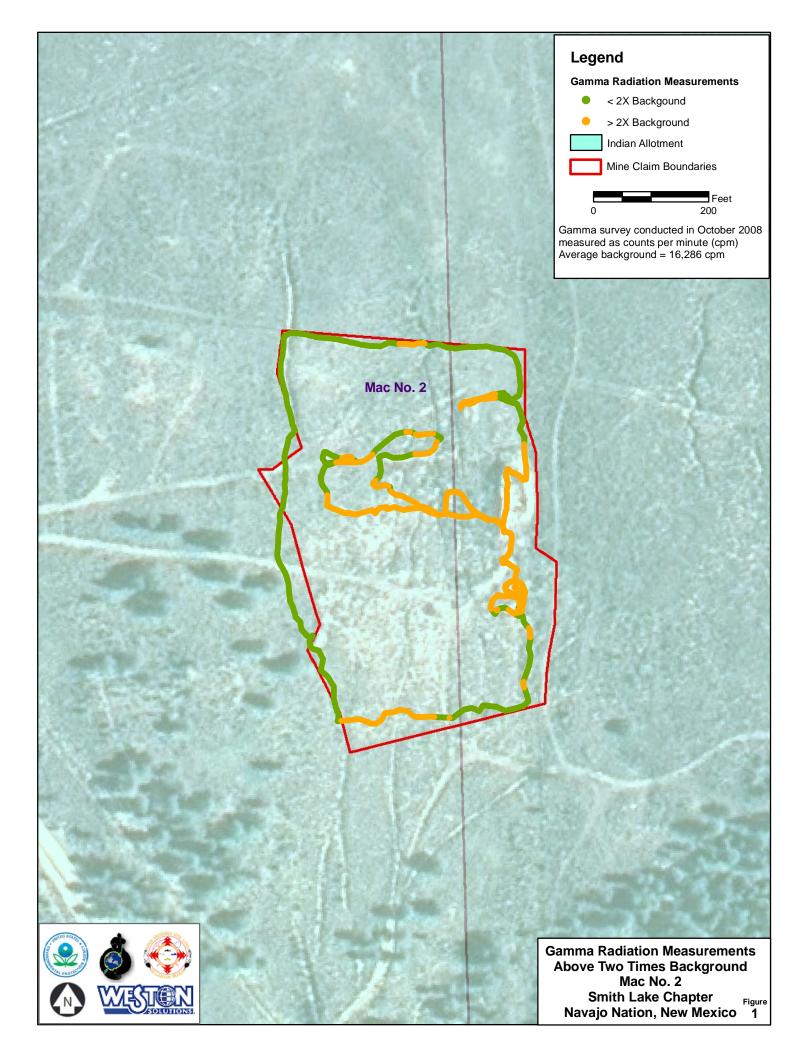
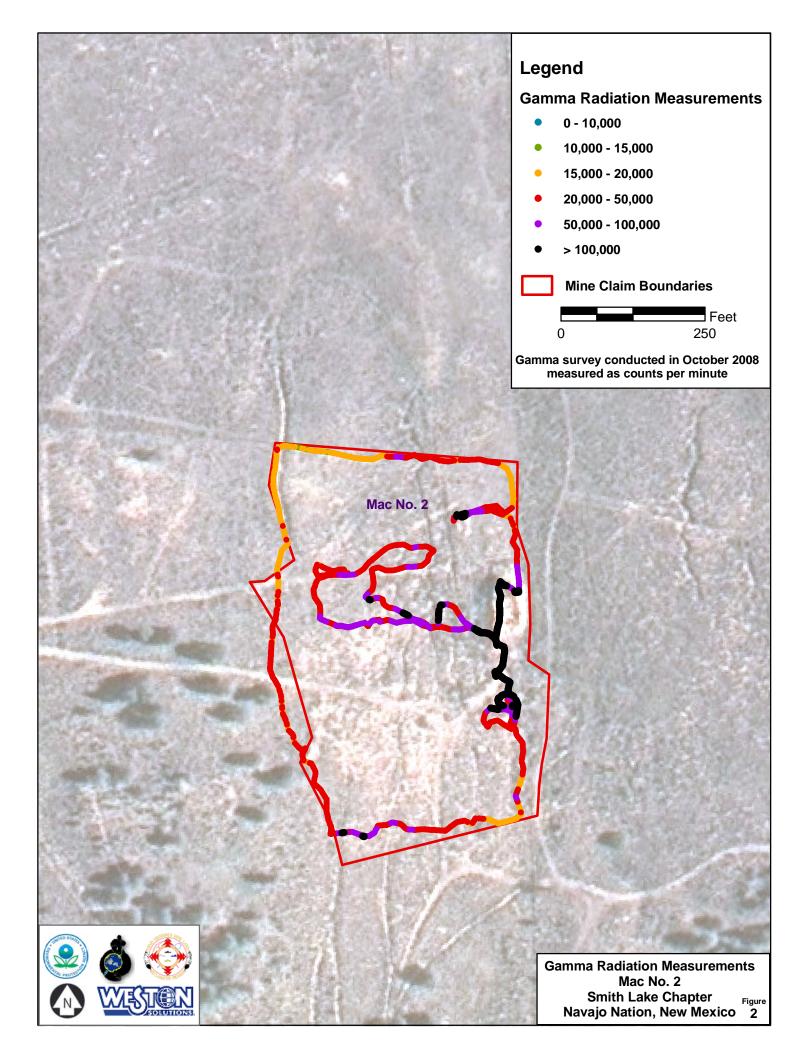
A total of 1,649 gamma radiation measurements were collected from mine sites, ranging from 12,997 cpm to 238,218 cpm. The measurements are represented in Figures 1 and 2.
