Navajo Abandoned Uranium Mine Site Screen Report

Haystack No. 1 AUM Site

Navajo AUM Eastern Region

May 2009

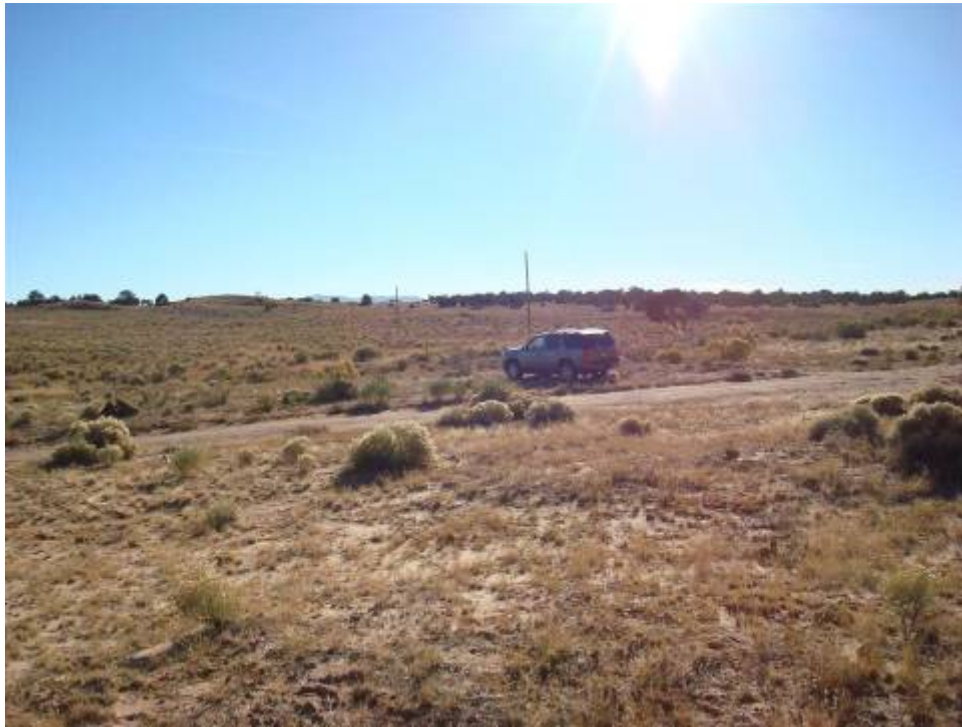
Photo 1. Haystack No 1 Mine site, towards the southwest

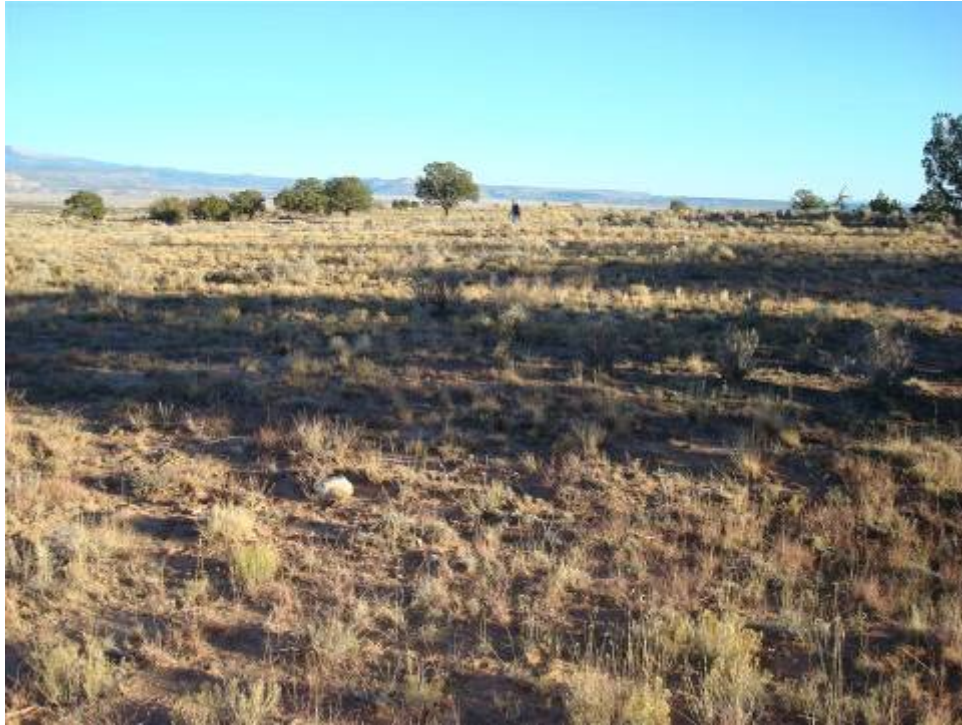
Photo 2. Haystack No 1 Mine site, towards the south

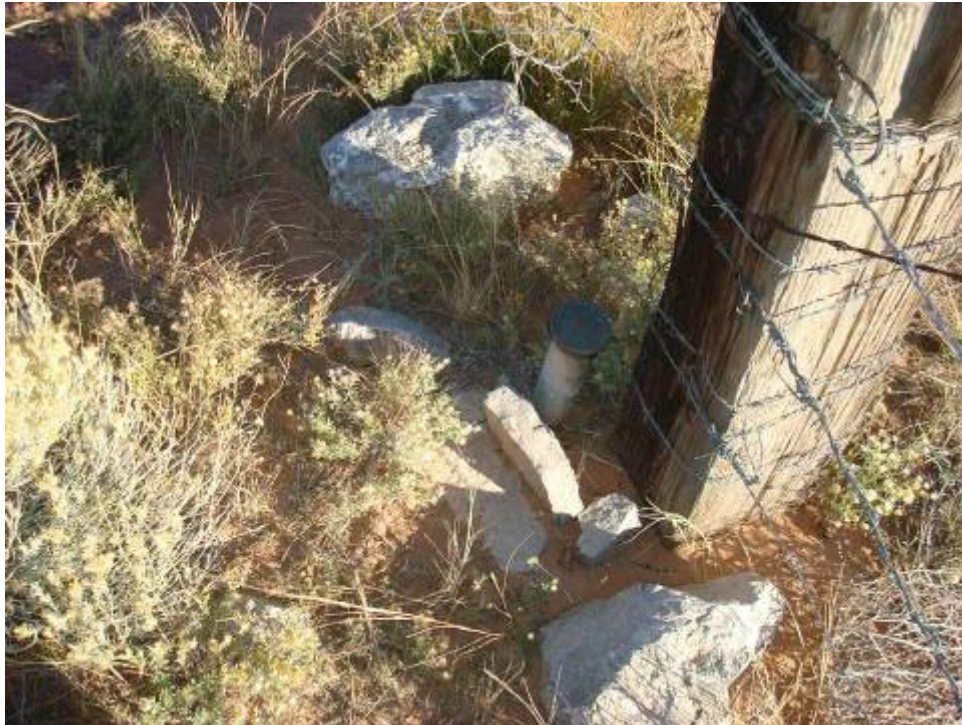
Photo 5. Haystack No 1 Mine site, section corner survey marker

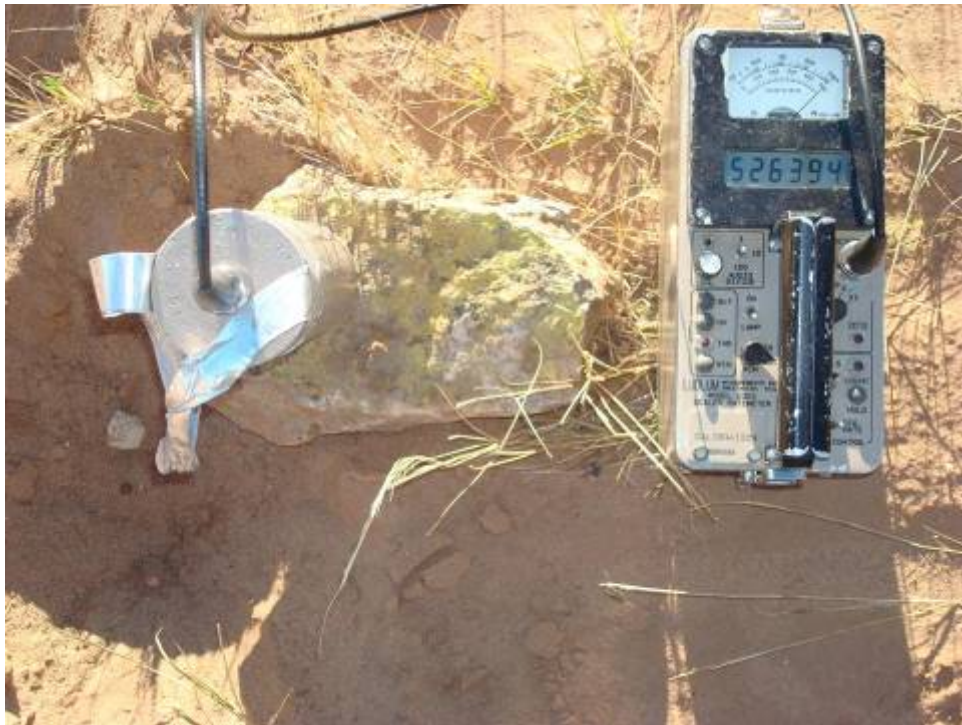
Photo 6. Haystack No 1 Mine site, gamma radiation emitting 500,000 cpm from waste rock located near residence

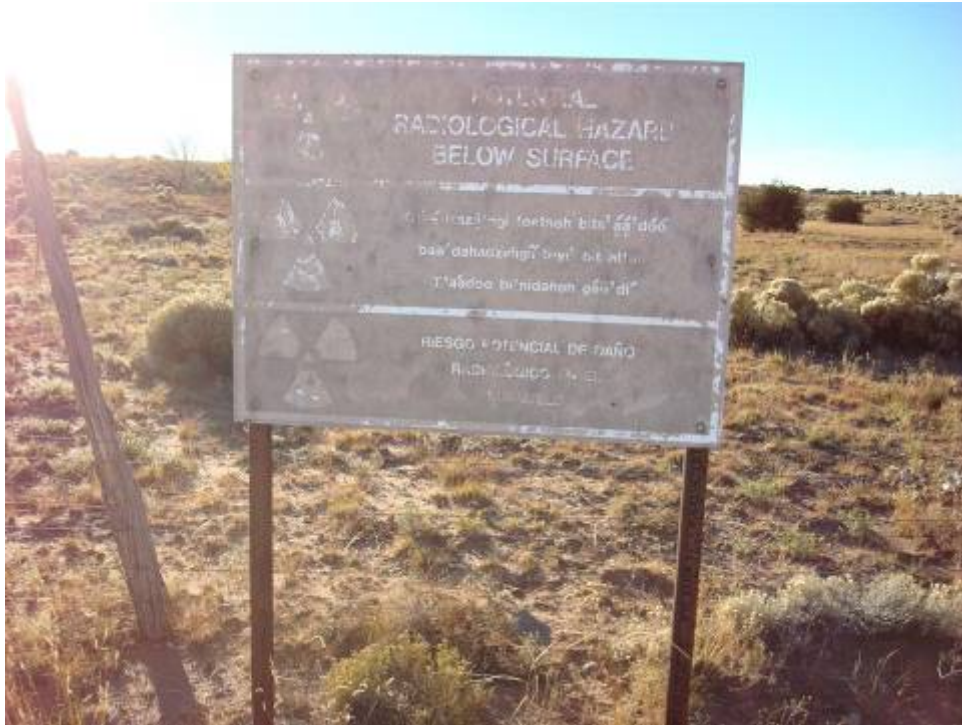
Reclamation status of the mine sites are currently unknown. The mine appears to have been reclaimed. The portion of the mine on private property was fenced and posted with signs warning of underground radiological hazards. The signs were faded and nearly illegible. No adits or other mine features were observed during the site visit.

Photo 6. Haystack No 1 Mine site, faded sign posted on portion of mine located on private property warning of subsurface radiological hazards

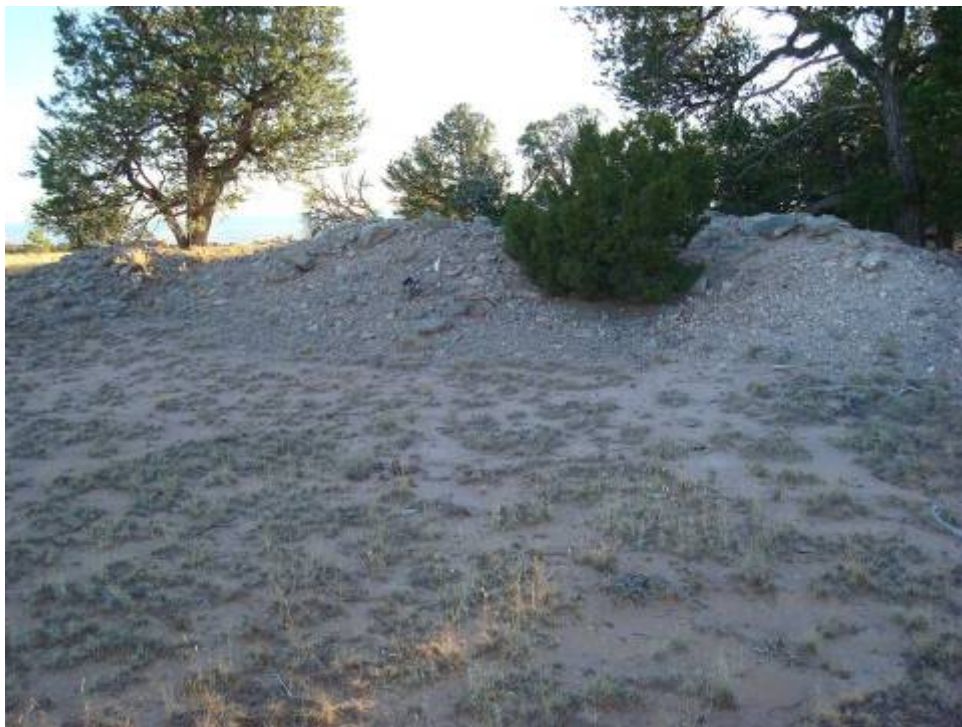
Photo 6. Haystack No 1 Mine site, waste piles on mine

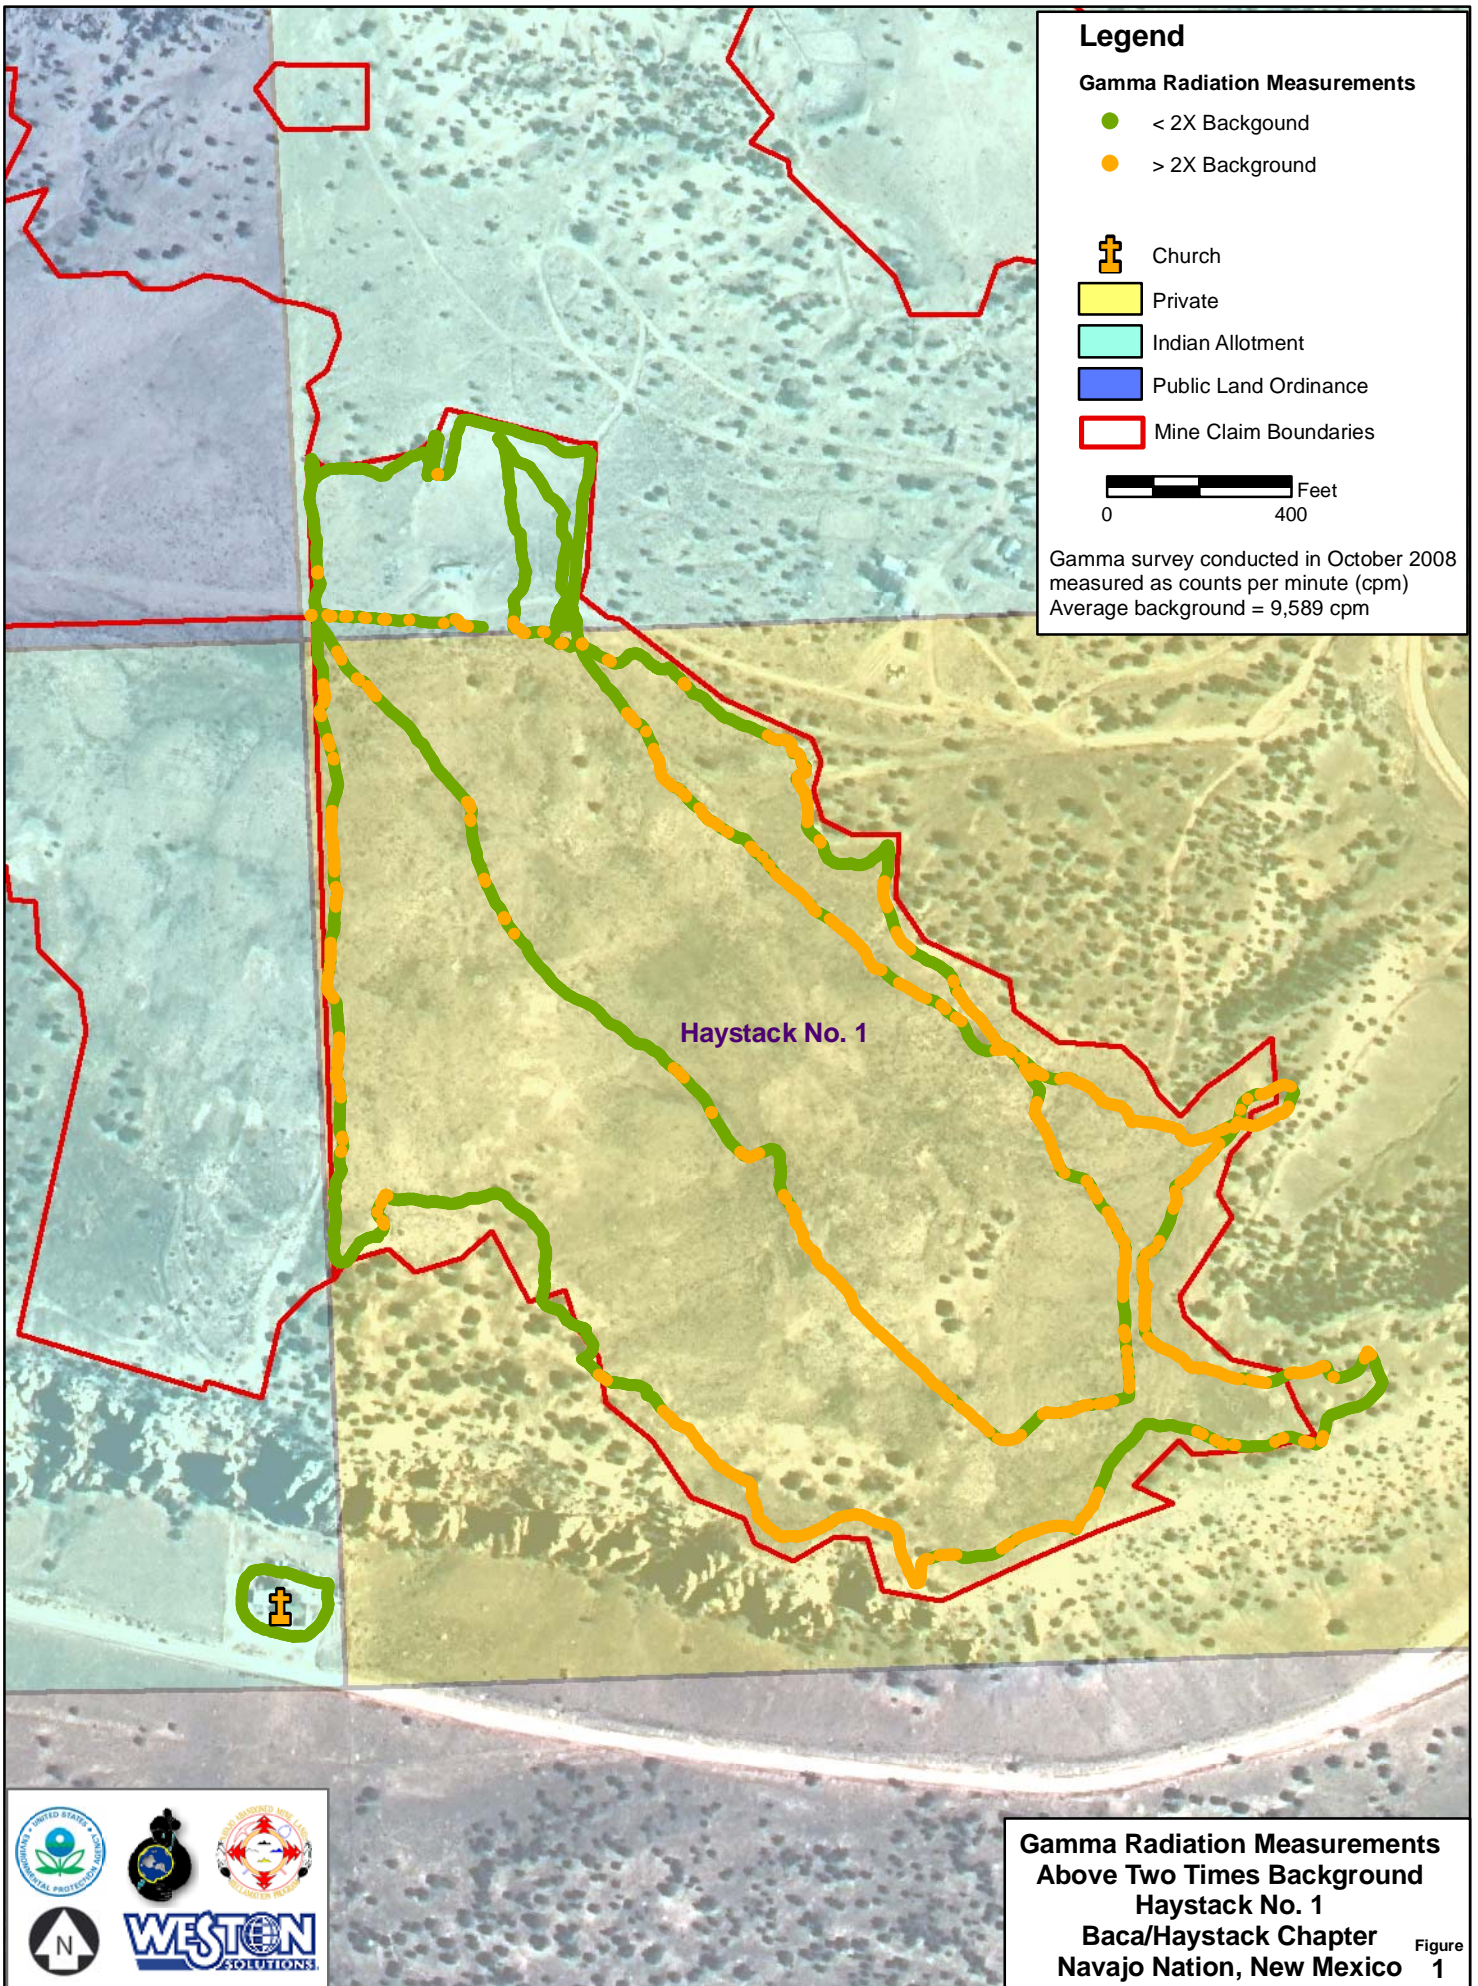
**Gamma Radiation Measurements
 Above Two Times Background
 Haystack No. 1
 Baca/Haystack Chapter
 Navajo Nation, New Mexico** Figure 1

A total of 7,045 gamma radiation measurements were collected from mine sites, ranging from 5,965 cpm to 626,434 cpm. The measurements are represented in Figures 1 and 2.

Gamma survey conducted in October 2008
 measured as counts per minute (cpm)
 Average background = 9,589 cpm
