Navajo Abandoned Uranium Mine Site Screen Report

Section 5 AUM Site

Navajo AUM Eastern Region

May 2009

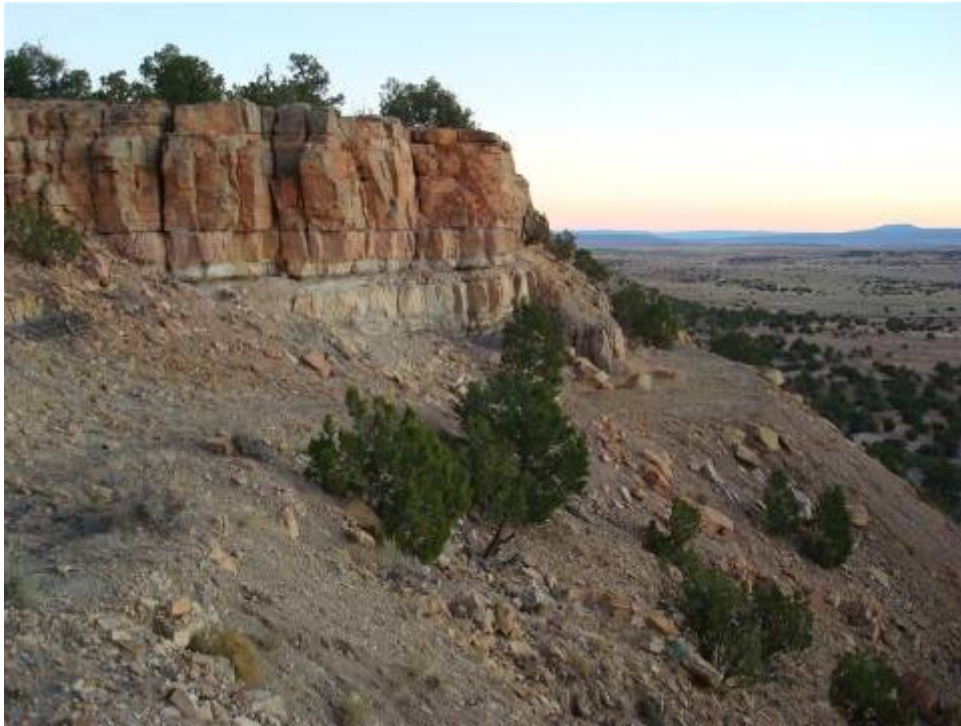
Reclamation status of the mine sites are currently unknown. No visible signs of reclamation were observed. One adit was observed at the site along the bluff with waste rock deposited down slope. Some waste piles were observed above the bluff on top of the mesa. No other mine features were observed during the site visit.

Photo 1. Section 5 Mine site, towards the south.
Mine is in bluff adjacent to bench

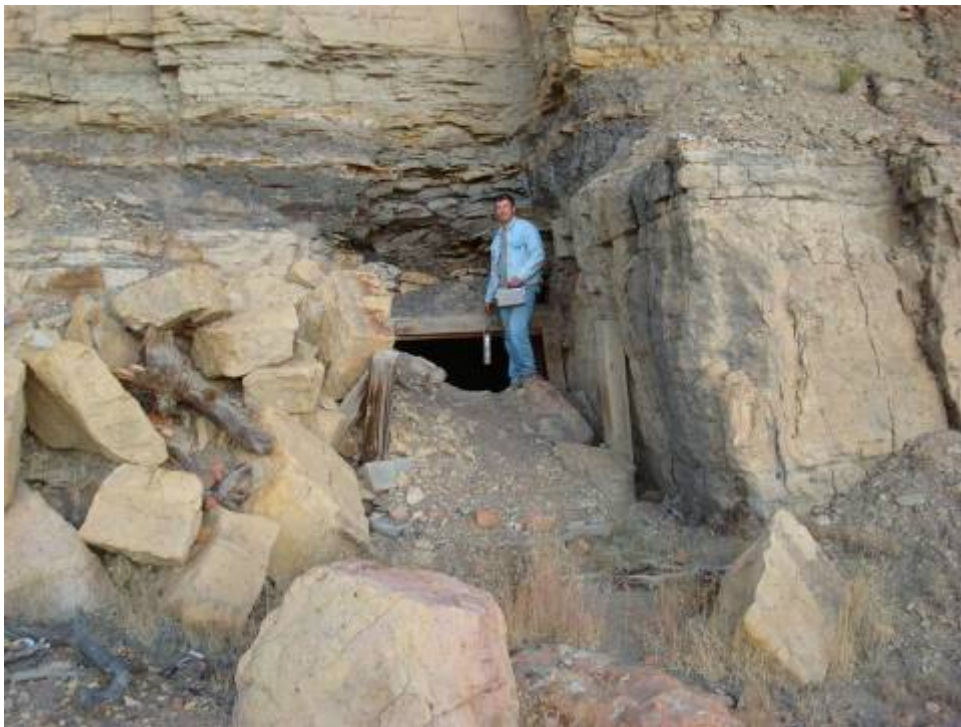
A total of 1,367 gamma radiation measurements were collected from mine sites, ranging from 6,137 cpm to 319,350 cpm. The measurements are represented in Figures 1 and 2. Gamma radiation measurements collected at the adit were greater than 100,000 cpm. The New Mexico Mining and Minerals Division identified radiological measurements with background levels 50 counts per second (cps); adit 800 cps.

Photo 2. Section 5 Mine site, adit in bluff

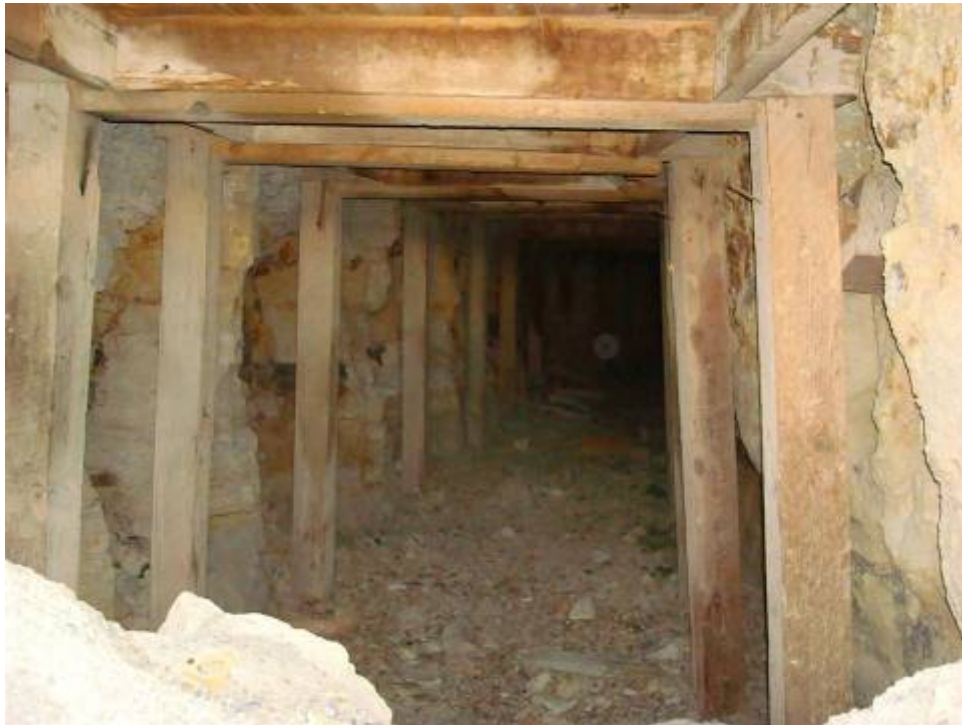
Photo 3. Section 5 Mine site, interior of adit

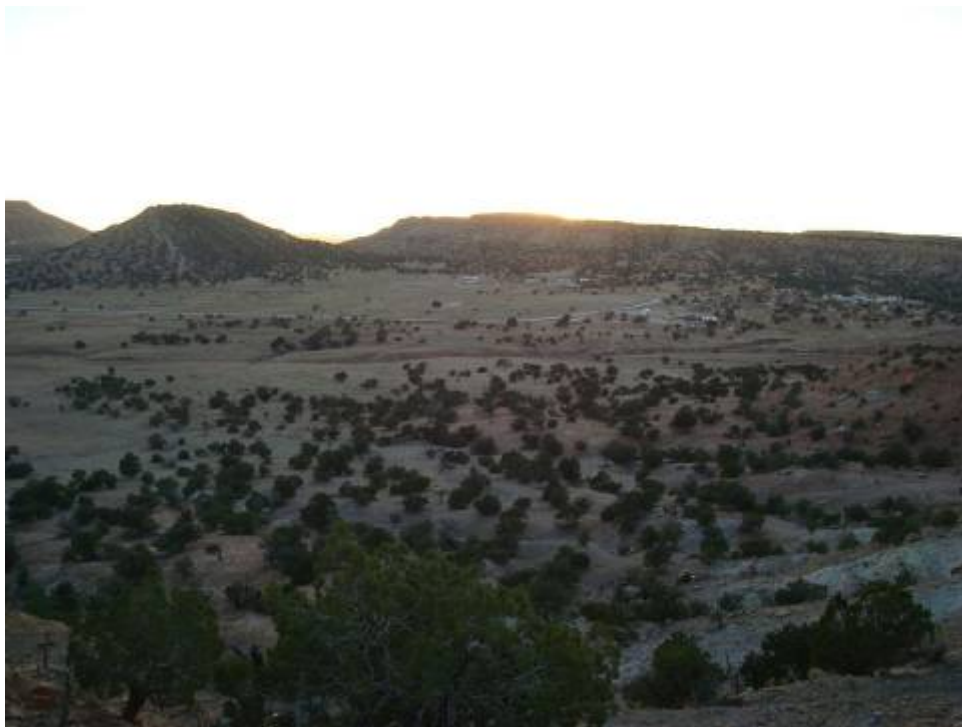
Photo 4. Section 5 Mine site, view to the west

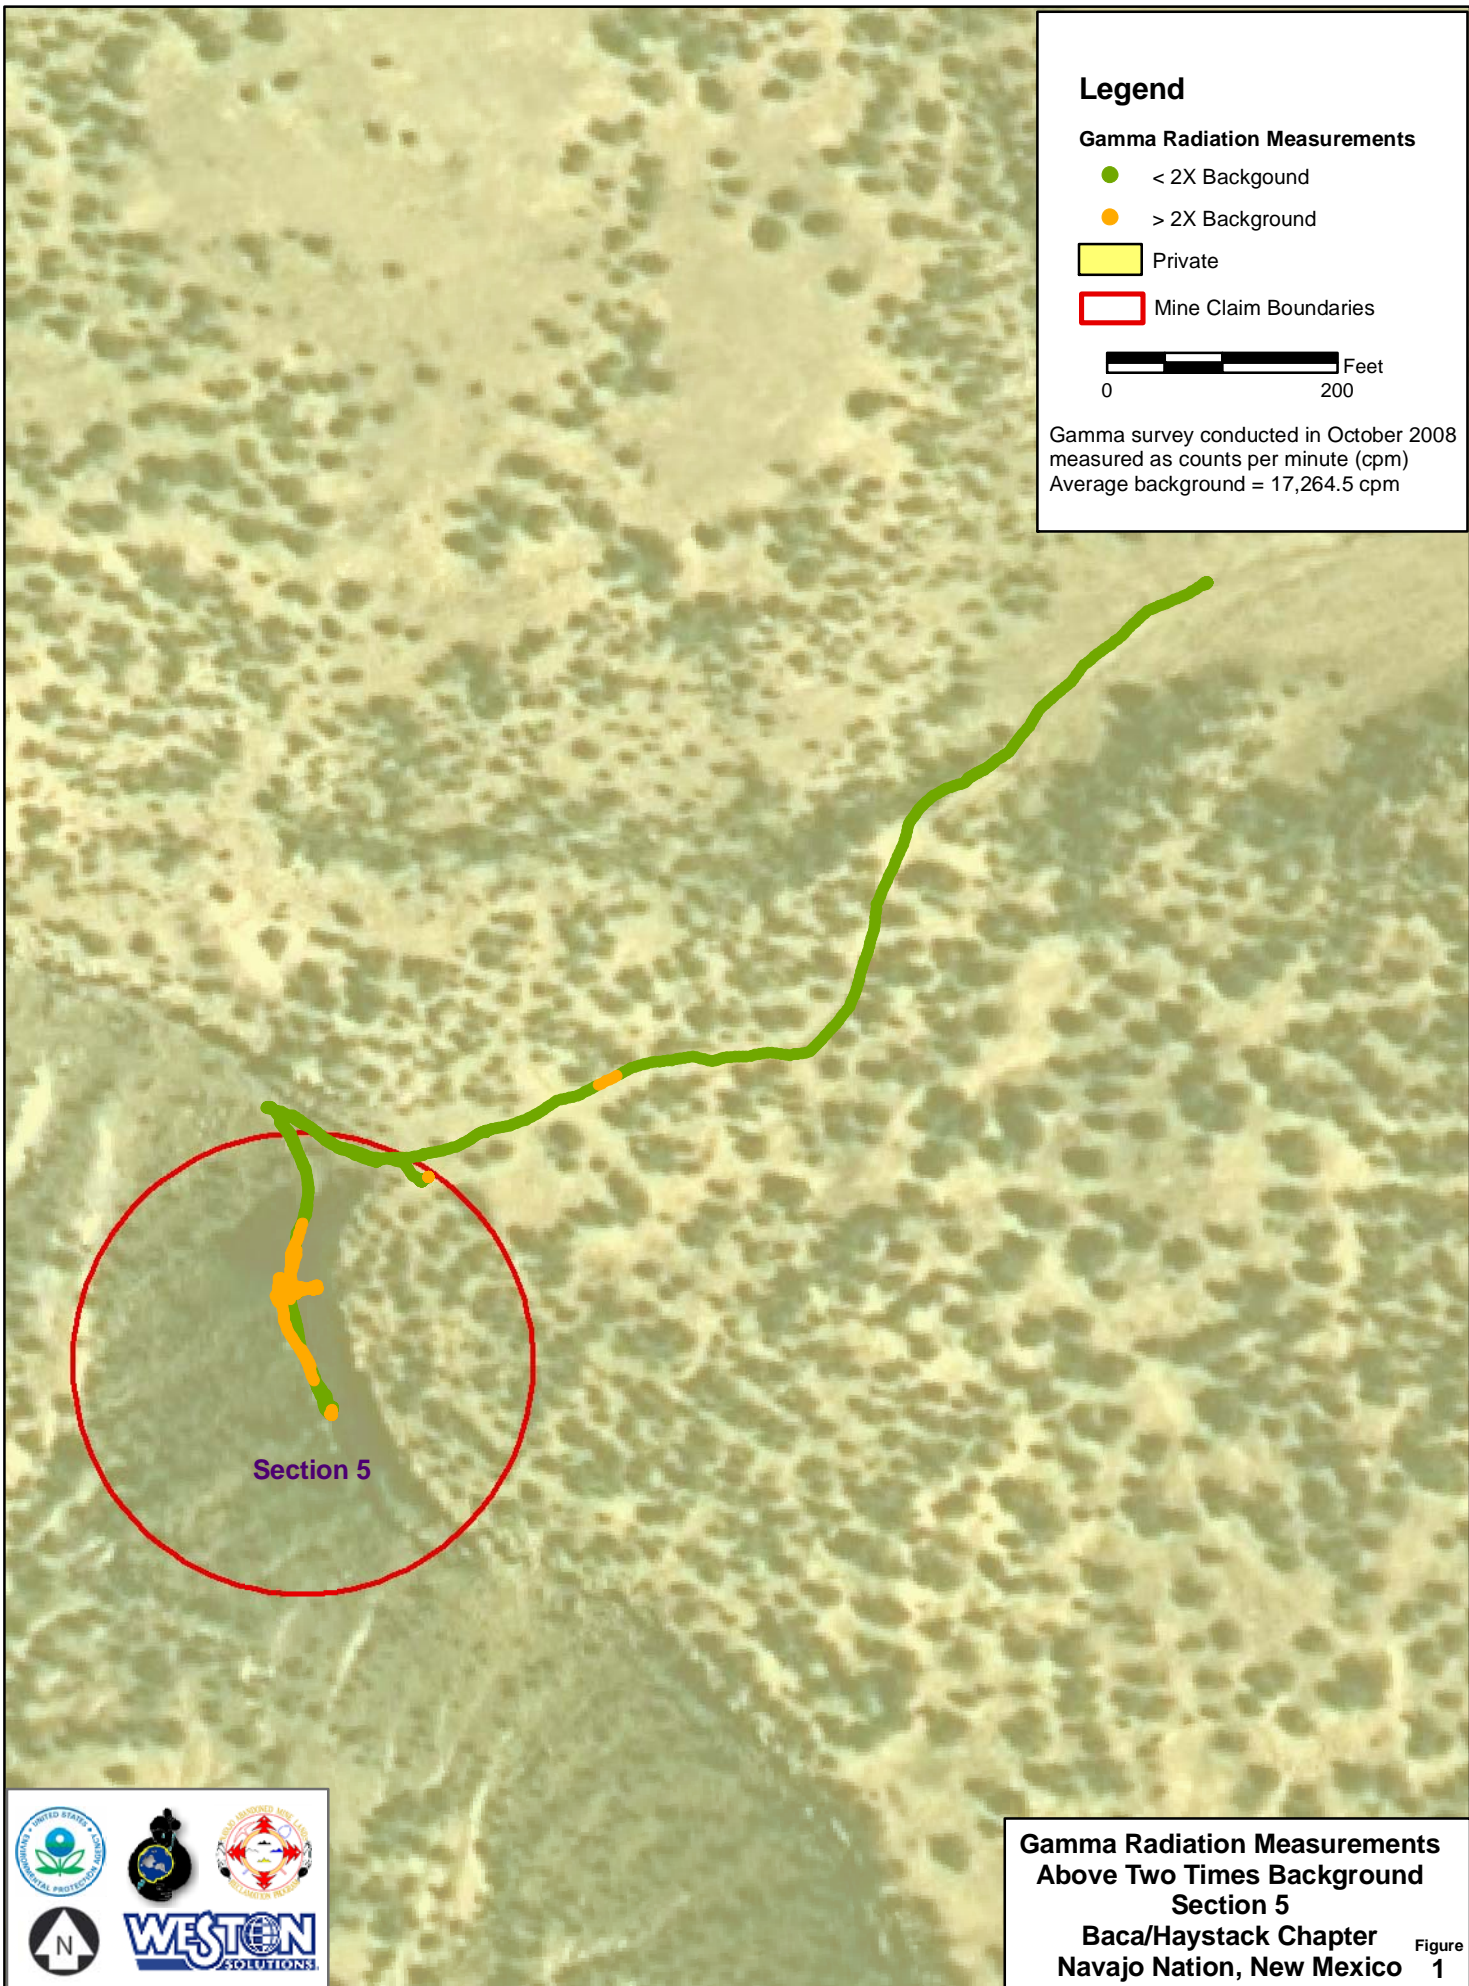
Gamma Radiation Measurements Above Two Times Background Section 5
Baca/Haystack Chapter Navajo Nation, New Mexico Figure 1

Gamma survey conducted in October 2008
measured as counts per minute (cpm)
Average background = 17,264.5 cpm
