Navajo Abandoned Uranium Mine Site Screen Report

Dakota AUM Site

Navajo AUM Eastern Region

May 2009

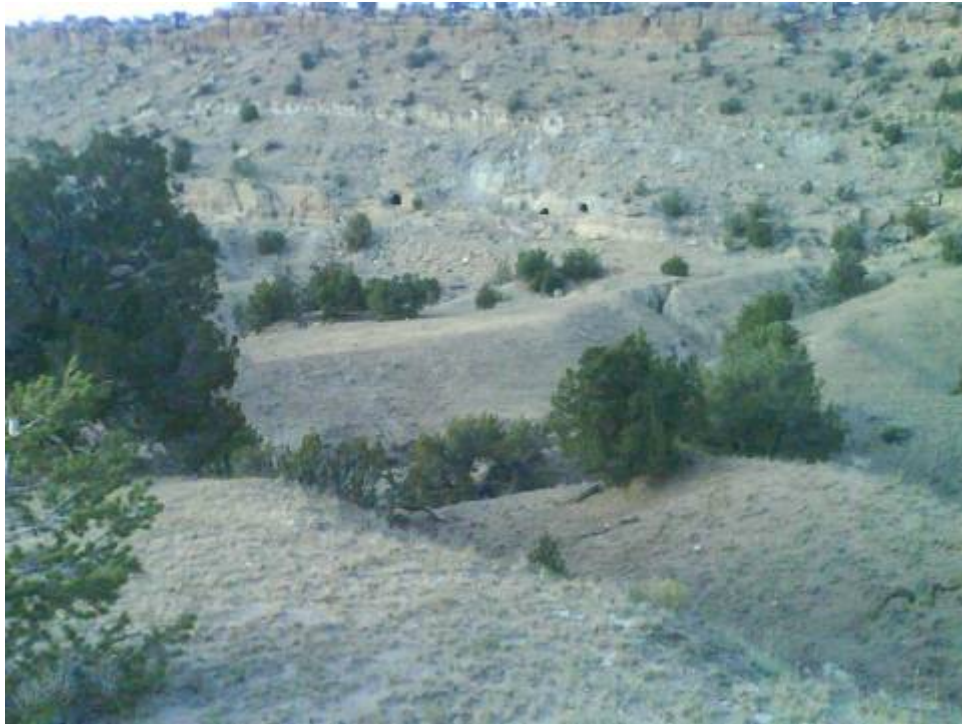
Reclamation status of the mine sites are currently unknown. No visible signs of reclamation were observed. Three adits are located in hillside with waste rock material extending from adits to drainages below the mine. No other mine features were observed during the site visit.

Photo 1. Dakota Mine site, towards the north

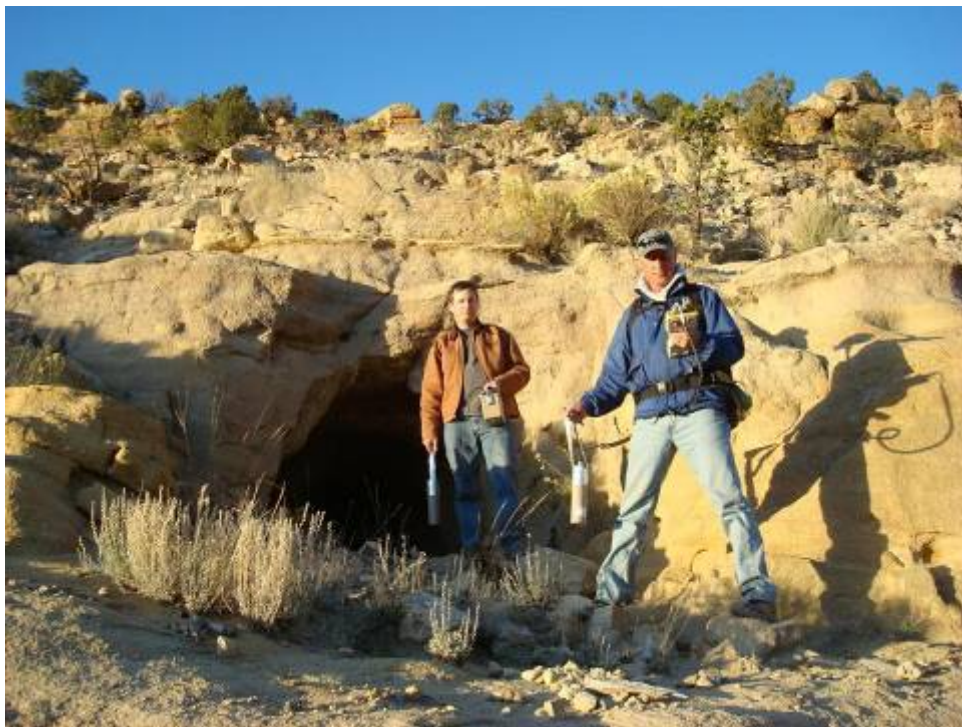
Photo 2. Dakota Mine site, adit in hillside

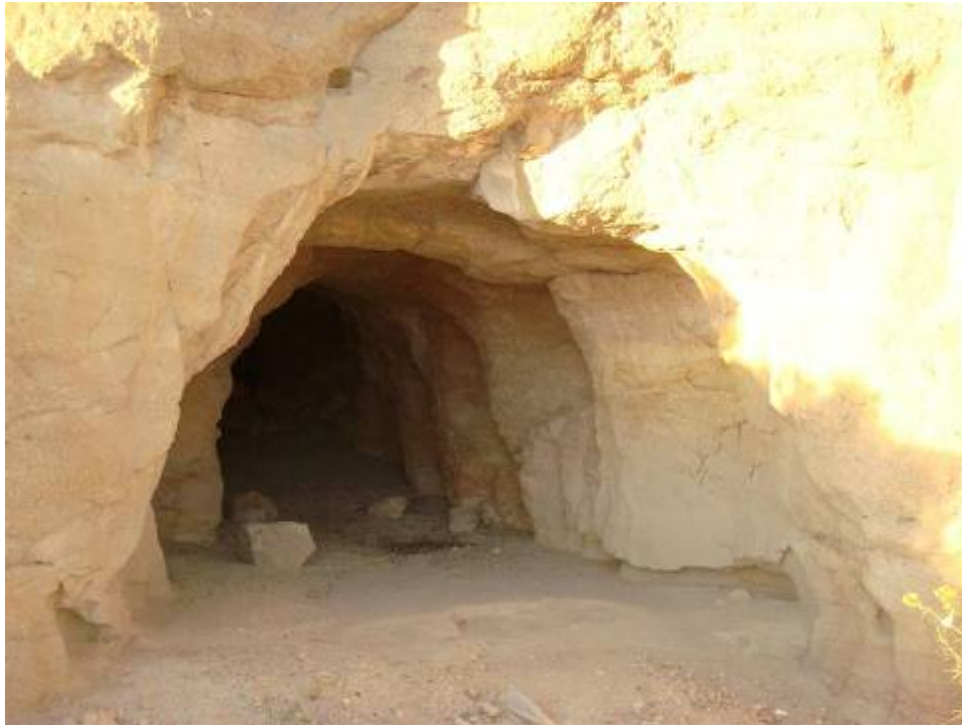
Photo 3. Dakota Mine site, adit in hillside

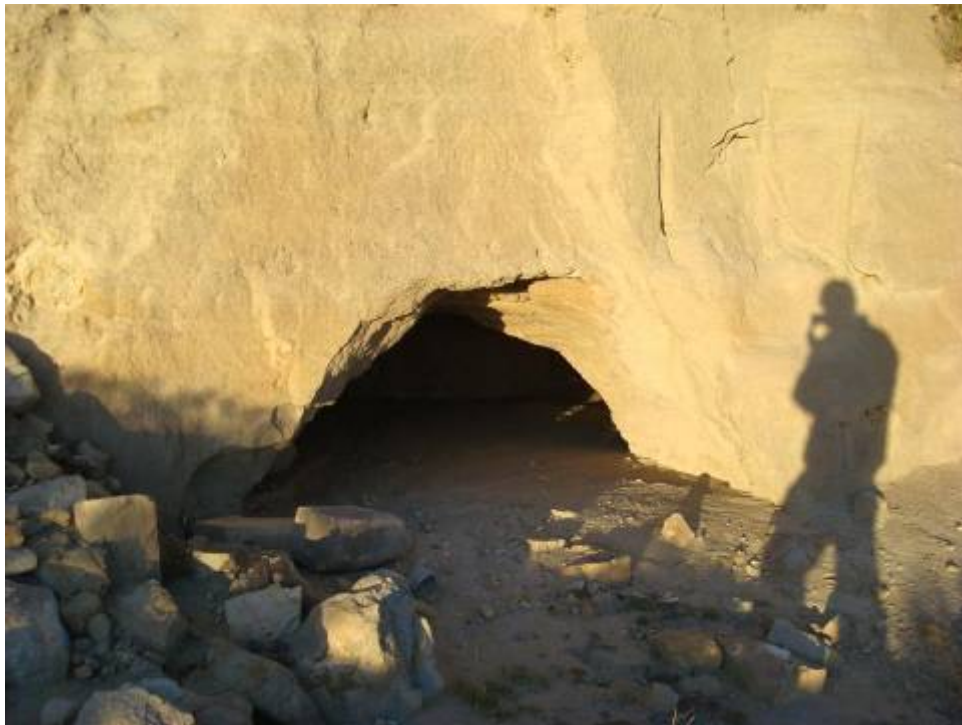
Photo 4. Dakota Mine site, adit in hillside

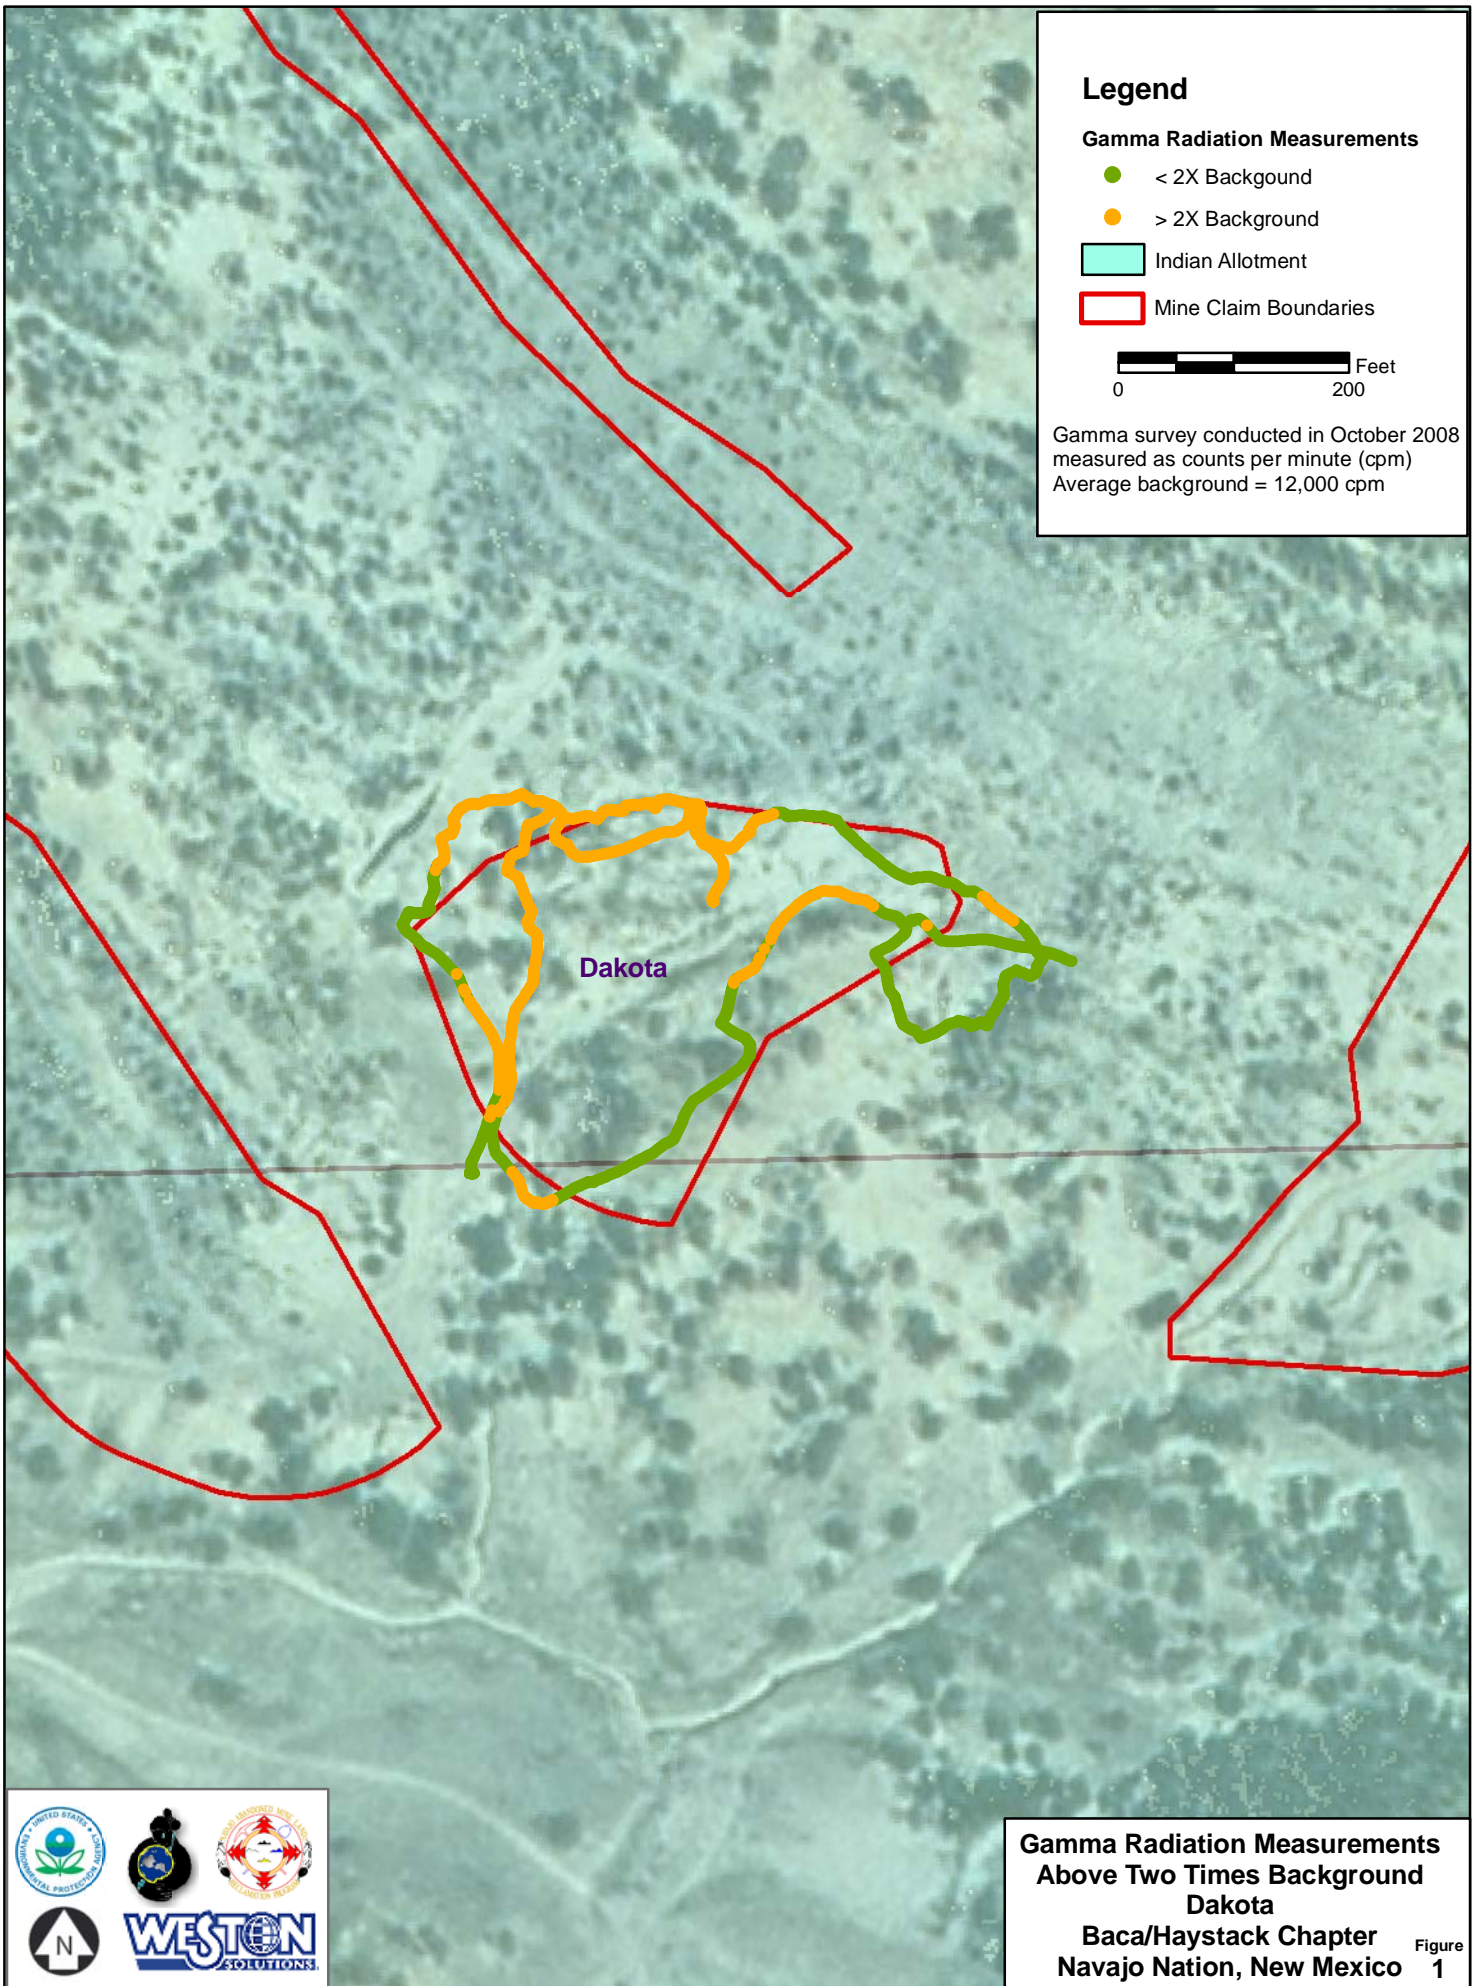
Gamma Radiation Measurements Above Two Times Background Dakota
 Baca/Haystack Chapter Navajo Nation, New Mexico Figure 1

A total of 1,178 gamma radiation measurements were collected from the mine site, ranging from 9,810 cpm to 292,715 cpm. Gamma radiation measurements at the mine adits were as great as 650,000 cpm. The measurements are represented in Figures 1 and 2. The New Mexico Mining and Minerals Division identified radiological measurements with background levels 50 counts per second (cps); and a high of 500 cps.

Gamma survey conducted in October 2008
 measured as counts per minute (cpm)
 Average background = 12,000 cpm
