Navajo Abandoned Uranium Mine Site Screen Report

Kermac No. 24

Navajo AUM Eastern Region

May 2009

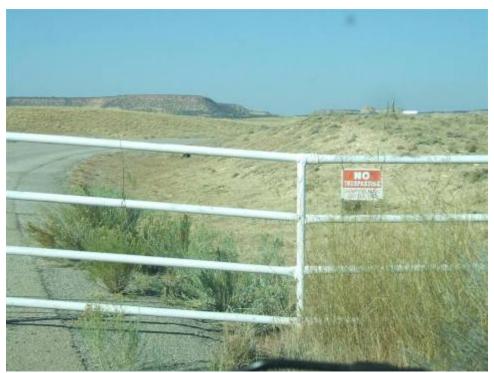
Photo 1. Locked gate on road leading towards Kermac No. 24 mine site

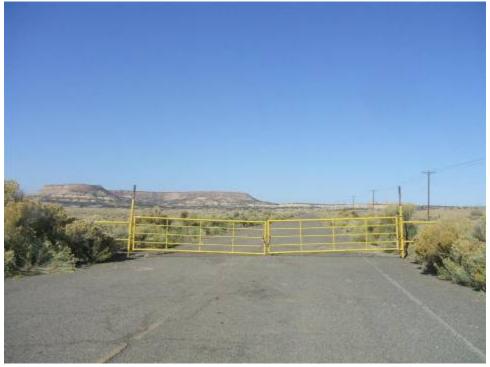
Photo 2. Locked gate on road leading towards Kermac No. 24 mine site
