Navajo Abandoned Uranium Mine Site Screen Report

Homestake Sapin No. 23

Navajo AUM Eastern Region

May 2009

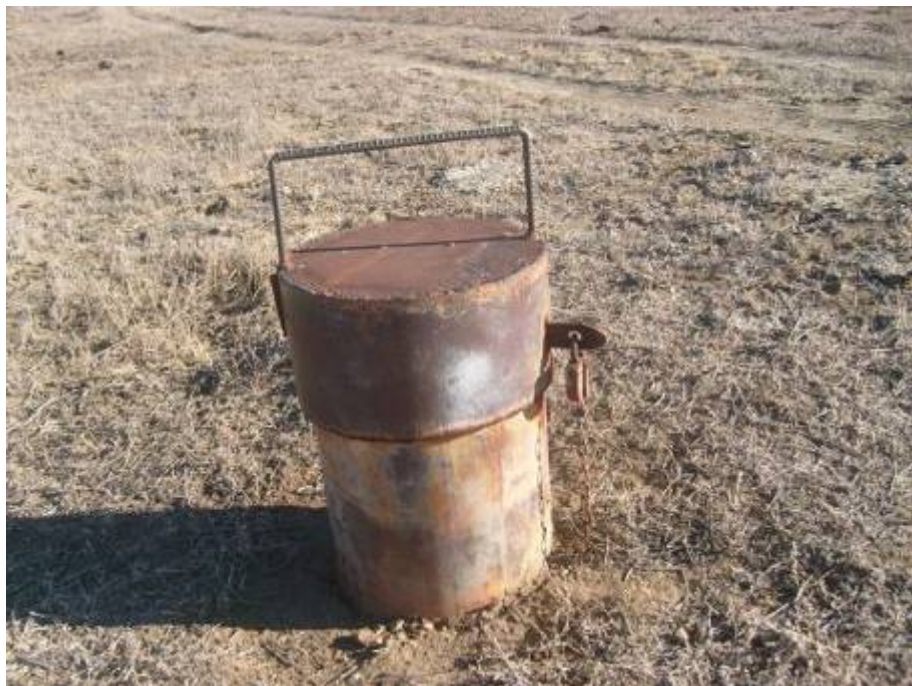
0 to 0.25 miles: Well head with locked cap at north end of site, along fence. Not used for human consumption. **0.25 miles to 4 miles:** Drinking water access for the Rio Algom Mill

Photo 2. Well head at north end of site along fence running north-south

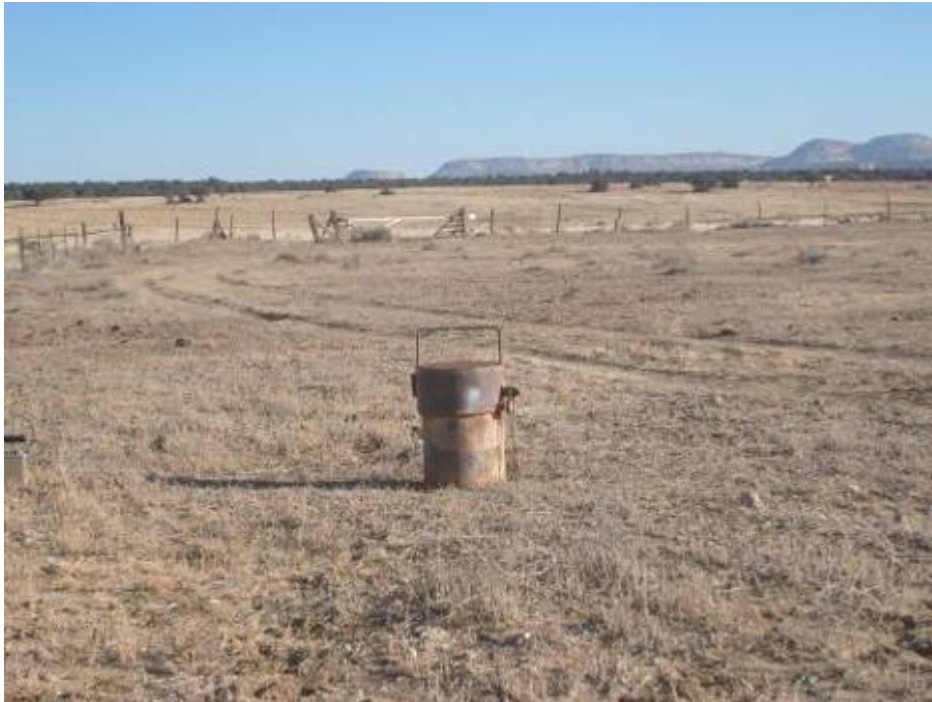
Photo 3. Well head with gate in background (entrance to Homestake Sapin 15), towards the north

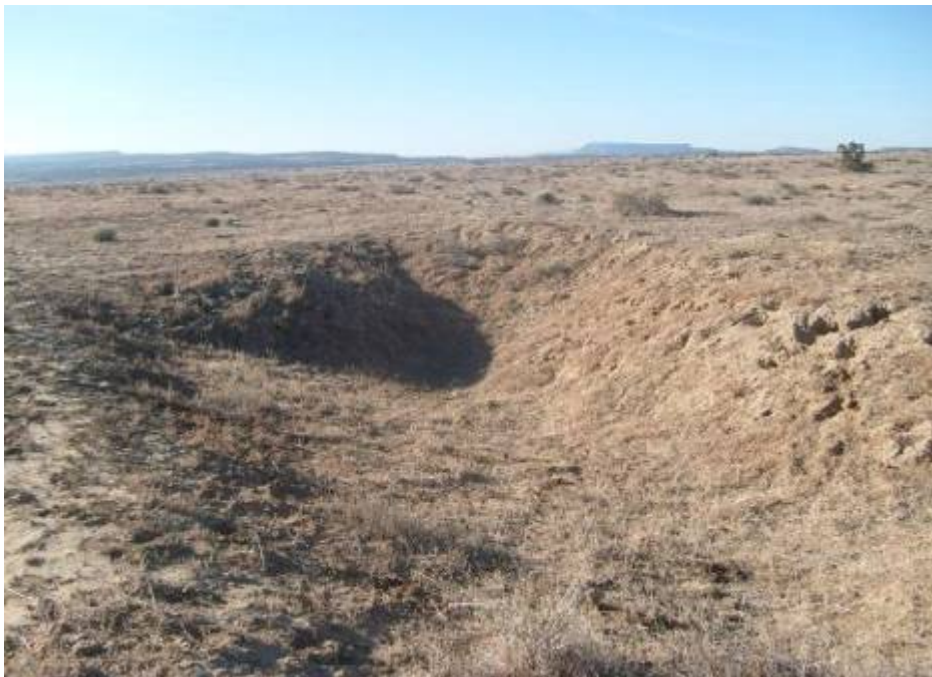
Depressions in the landscape were scattered throughout the site. Two of them were approximately 40' x 16'. The probable cause for these depressions is subsidence.

Photo 4. Depression where first background reading was taken. View looking south/southwest

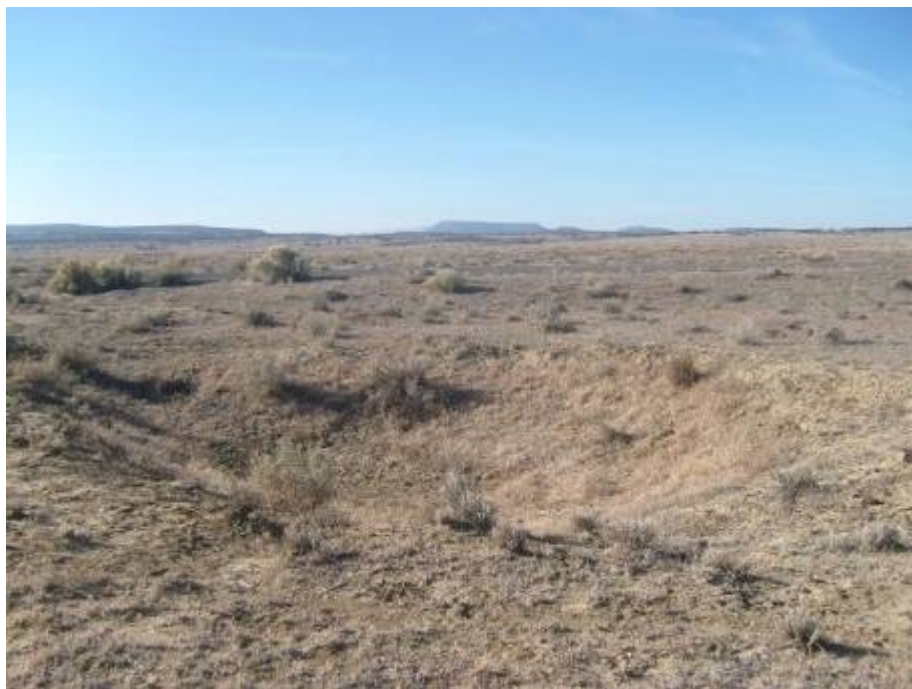
Photo 6. Depression looking south/southwest, with main road in background

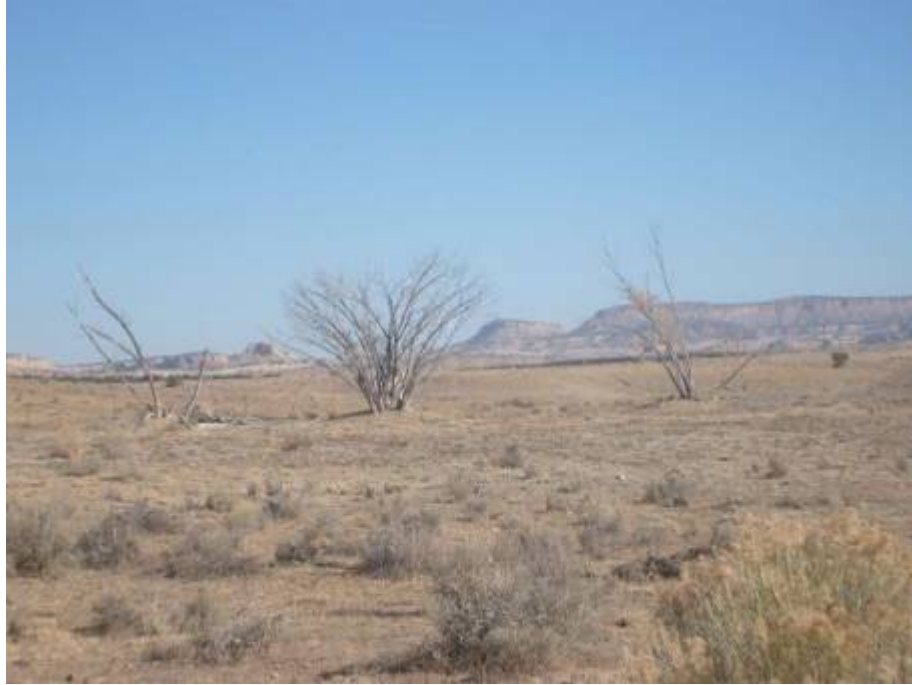
There were three dead trees east of the reclaimed waste pile (fenced in). Readings were approximately 120,000 counts per minute (cpm).

Photo 7. Dead trees east of waste pile, towards the north

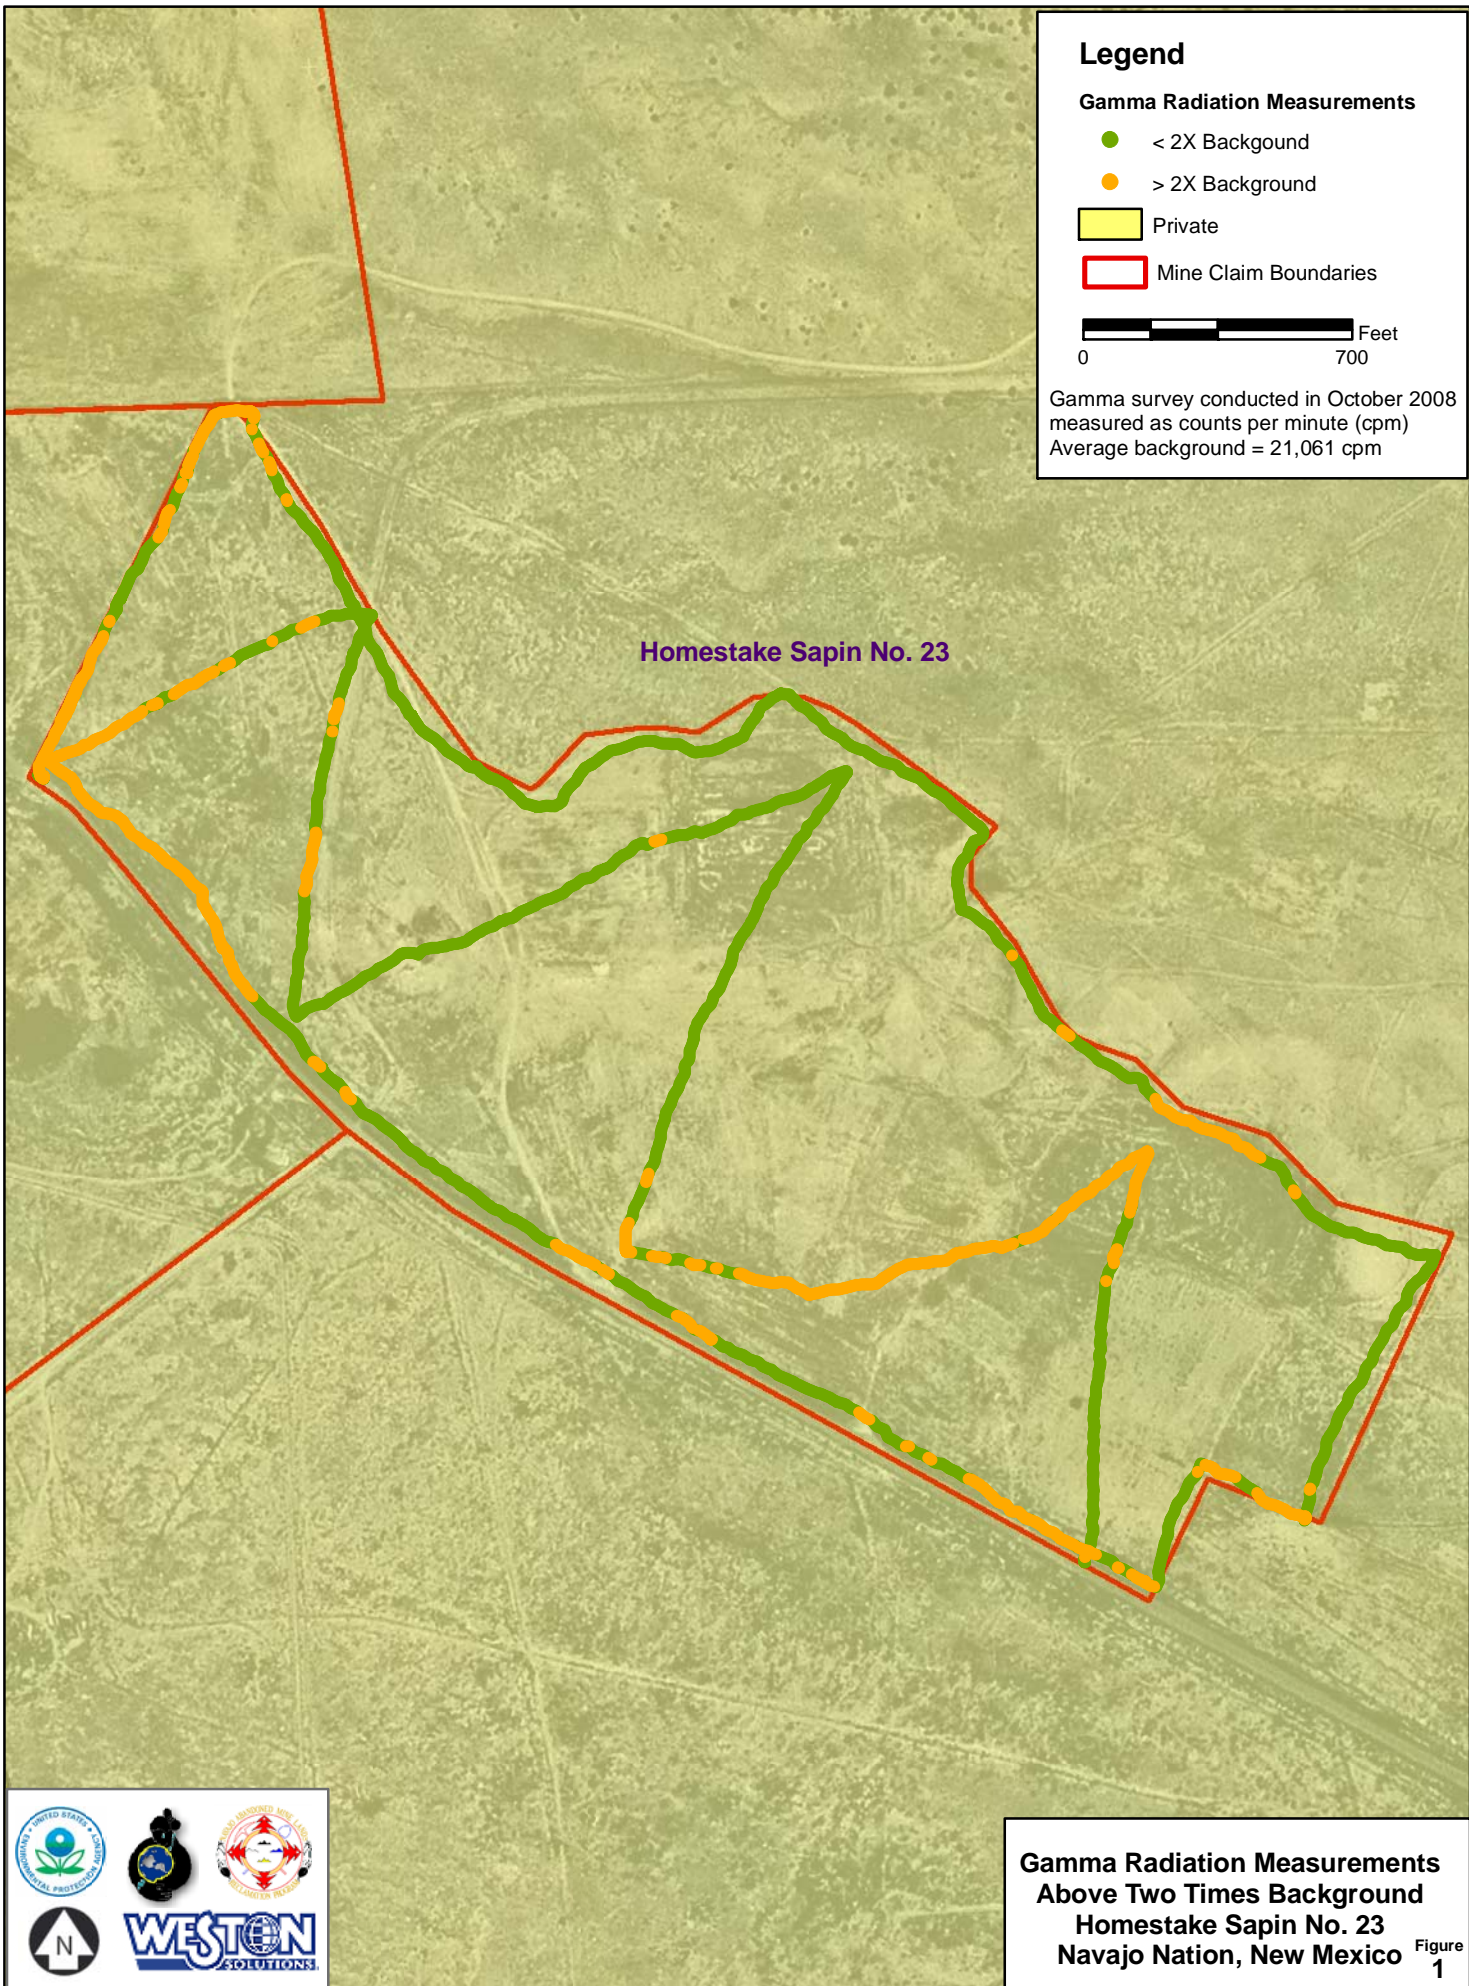
Gamma Radiation Measurements Above Two Times Background Homestake Sapin No. 23 Navajo Nation, New Mexico Figure 1

A total of 5,599 gamma radiation measurements were collected from the mine site, ranging from 12,297 cpm to 301,433 cpm. Reading on the well head was 48,317 cpm. The highest readings detected were primarily in the western part of the site, with the exception of the readings taken at the dead trees (120,000 cpm). The lowest readings recorded as background readings were taken in the depressions, and in a low-lying area (north of main road). The measurements are represented in Figures 1 and 2.
