Navajo Abandoned Uranium Mine Site Screen Report

Kermac No. 10

Navajo AUM Eastern Region

May 2009

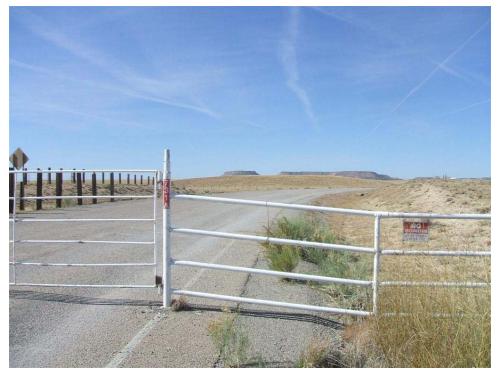
The mine site property is classified as private land. New Mexico MMD identifies the surface and mineral rights owner as Cobb Resources as well as the Bureau of Land Management. Due to locked gates and private property, Weston was unable to access the mine site.

Photo 1. Locked gate on road leading towards Kermac No. 10 mine site

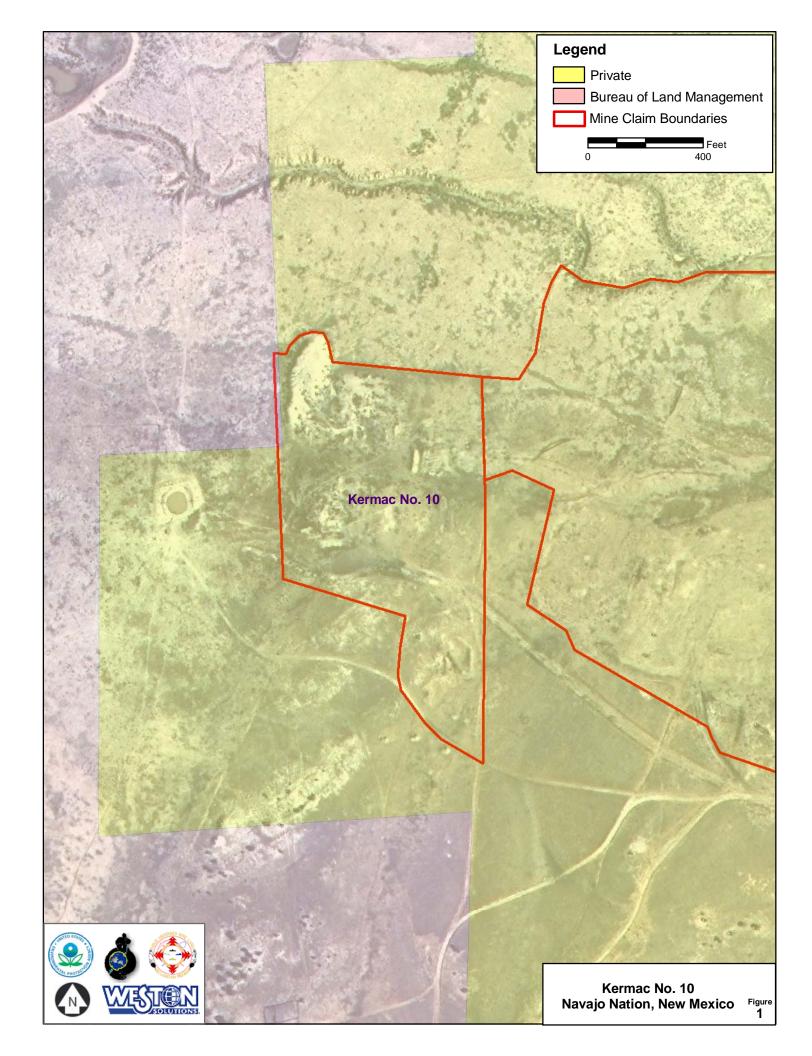
Mine site: Kermac No. 10 - See Figure 1

Radiological measurements collected for the New Mexico Mining and Minerals Division during a 2008 field screening survey found gamma radiation levels in the shaft at 400 counts per second (cps) with a high of 900 cps; in the dump at 400-700 cps; and the ventilation shaft air at greater than 6,000 cps.
