Navajo Abandoned Uranium Mine Site Screen Report

Section 36

Navajo AUM Eastern Region

May 2009

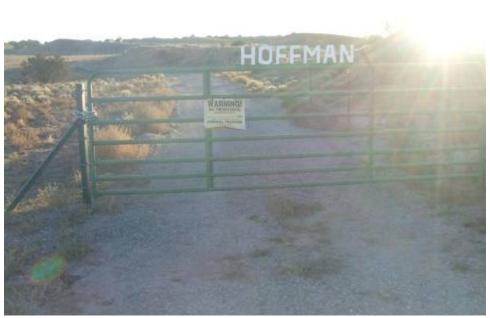
Photo 1. Locked gate on road leading towards Section 36 mine site

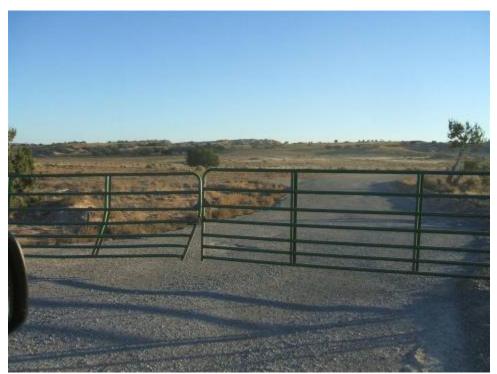
Photo 2. Locked gate leading towards Section 36 mine site

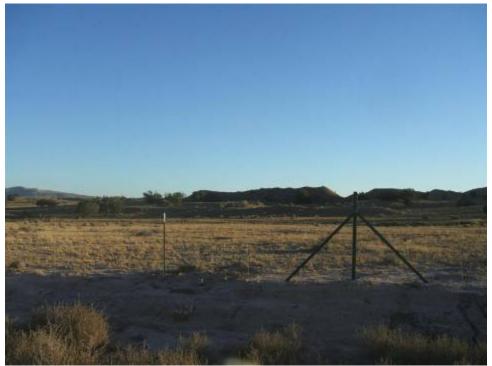
Photo 3. Fenced area leading towards Section 36 mine site

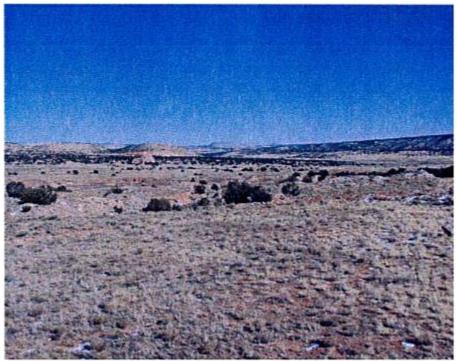
View north, piles and cut

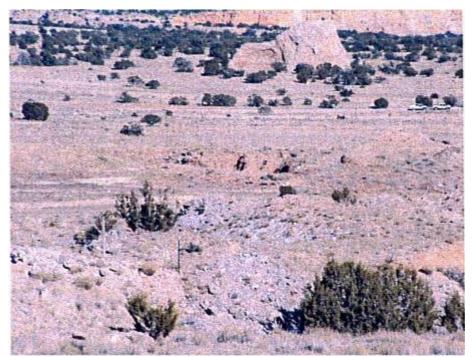
View north, piles, cut, access road

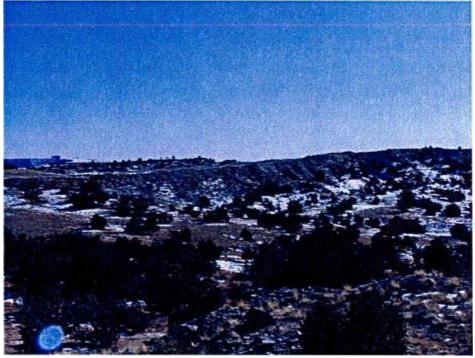
View east at primary disturbance

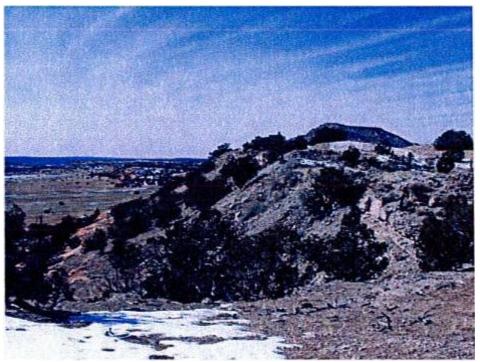
Overall view

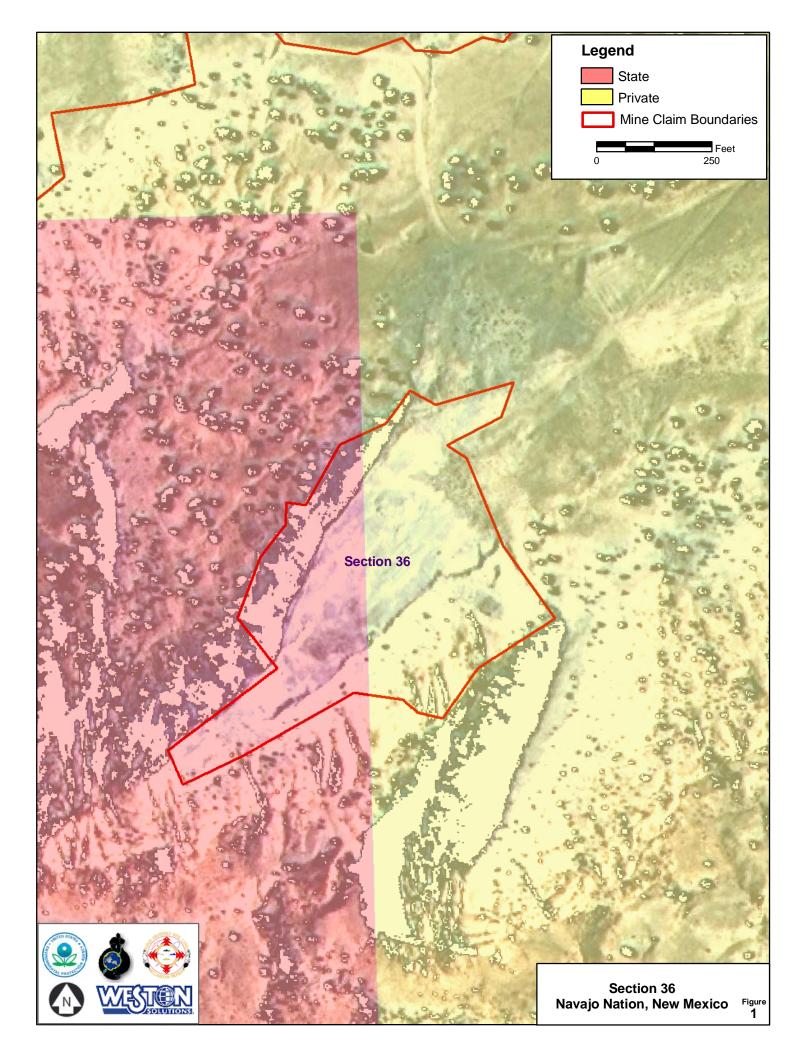
Mine site: Section 36 - See Figure 1

Radiological measurements collected for the New Mexico Mining and Minerals Division during a 2008 field screening survey found gamma radiation levels in the pit as 1,100 counts per second (cps), levels at the ground surface with a maximum of 36 micro Roentgen per hour μ R/hr and a minimum of 10 μ R/hr, and levels at a height of 4-feet with a maximum of 34 μ R/hr and a minimum of 10 μ R/hr.
