Navajo Abandoned Uranium Mine

Site Screen Report

Bec068 AUM Site

March 2010

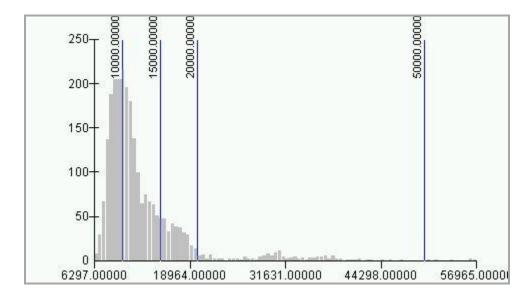
The following chart and statistics were generated by ESRI ArcGIS 9.3.1, and show the general distribution of the site gamma radiation measurements. The horizontal X axis represents the gamma radiation reading levels in cpm (lowest levels to the left). The vertical Y axis represents the frequency of each gamma radiation level.

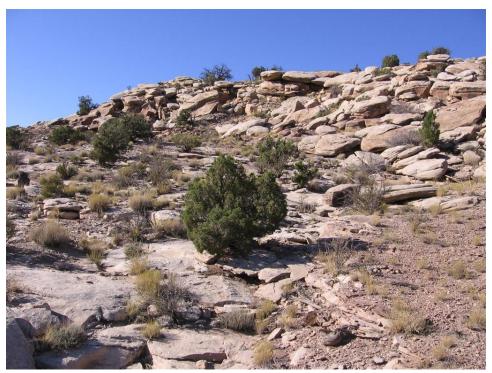
Medium waste pile on northern face, 75' x 75', with a total estimated volume of 1,042 yd³

Photo 1. Mine site

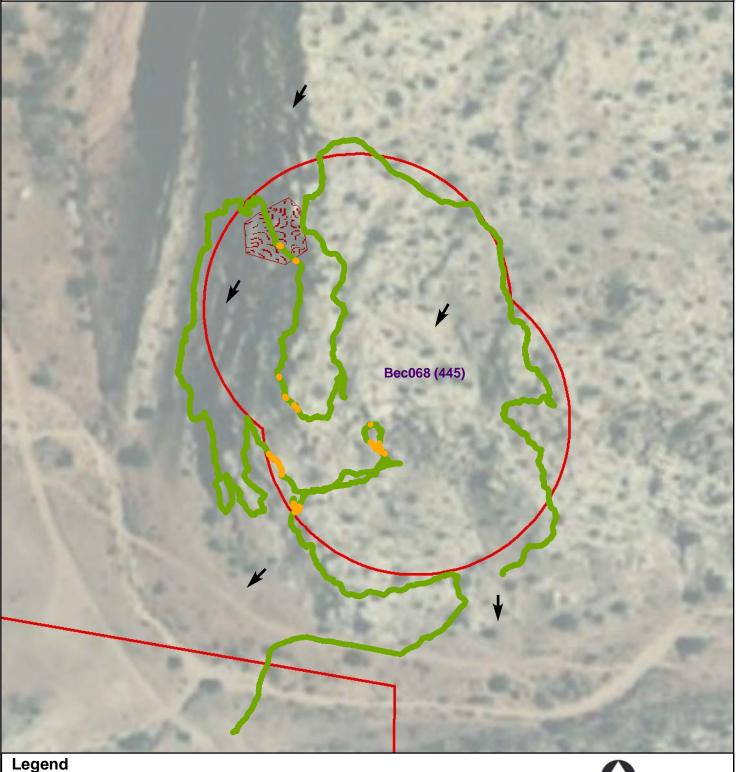
Figure 1 - Gamma Radiation Measurements, Above Two Times Background
Bec068 (445)
Beclabito Chapter, Navajo Nation, Arizona

A total of 2,559 gamma radiation measurements were collected from the mine site, ranging from 6,297 cpm to 56,965 cpm. Measurements in the vicinity of the waste debris were found at levels in up to 30,000 cpm. The measurements are represented in Figures 1 and 2.
