Navajo Abandoned Uranium Mine

Site Screen Report

Harvey Begay 3 AUM Site

August 2010

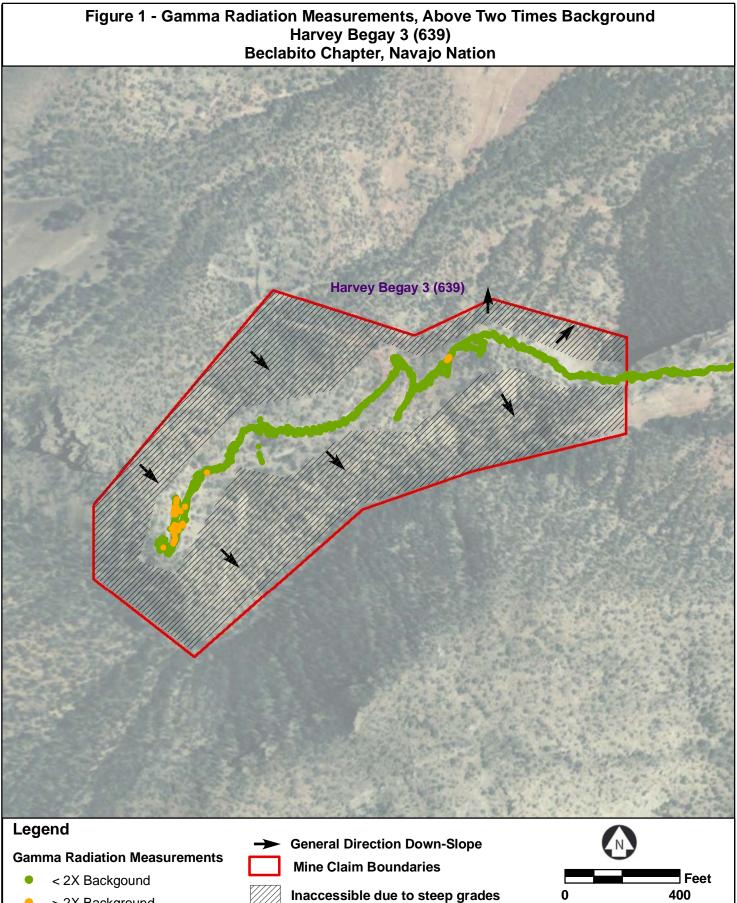
A total of 6,884 gamma radiation measurements were collected from the mine site, ranging from 5,729 cpm to 61,265 cpm. Measurements collected along the haul road were found at levels up to approximately 60,000 cpm. The measurements are represented in Figures 1 and 2.

> 2X Background
