CLEAN AIR ACT INSPECTION REPORT

Skyway Cement Company LLC- Chicago, Illinois

Date of Inspection: December 19, 2015

APPENDIX A: PHOTO LOG

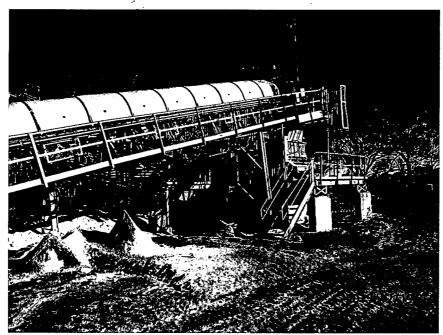
Figure 1 Covered conveyor to shaker screen

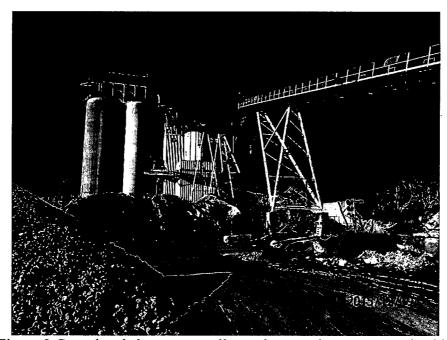
Figure 2 Granulated slag storage piles and covered conveyor to day bin

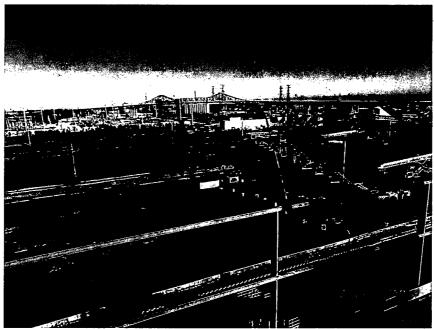
Figure 6 KCBX North terminal from Skyway Cement

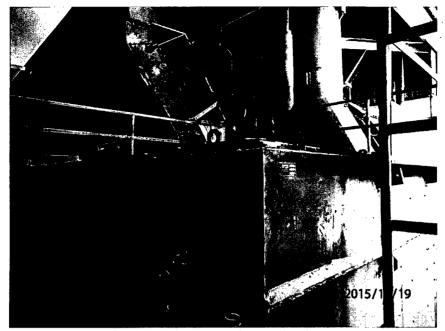
There are four main baghouses, including the mill vent baghouse, mill nuisance collector, polycom nuisance baghouse, and product baghouse. Each baghouse has particulate detectors that operate similarly to continuous opacity monitors (COMS). The particulate detectors are not certified as COMS though. There have been no noticeable opacity issues from these baghouses.

Figure 7 Polycom nuisance baghouse

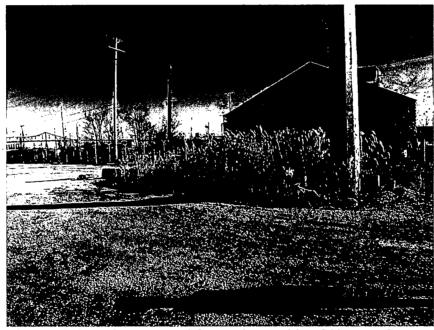
Figure 12 Gravel turnaround for trucks outside of Skyway Cement

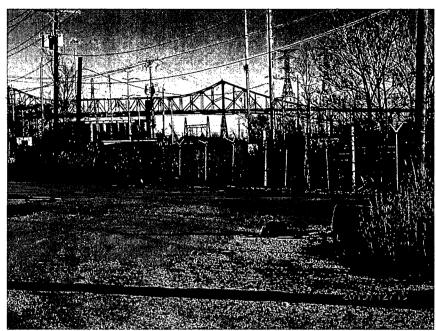
Figure 16 Gravel turnaround area with ambient air monitor in background
