FOCUSED COMPLIANCE INSPECTION REPORT

INSPECTION DATE: July 17, 2017

SITE NAME: Container Life Cycle Management, LLC
d/b/a Mid-America Steel Drum, Inc.

EPA ID NUMBER: WIR 000 131 367

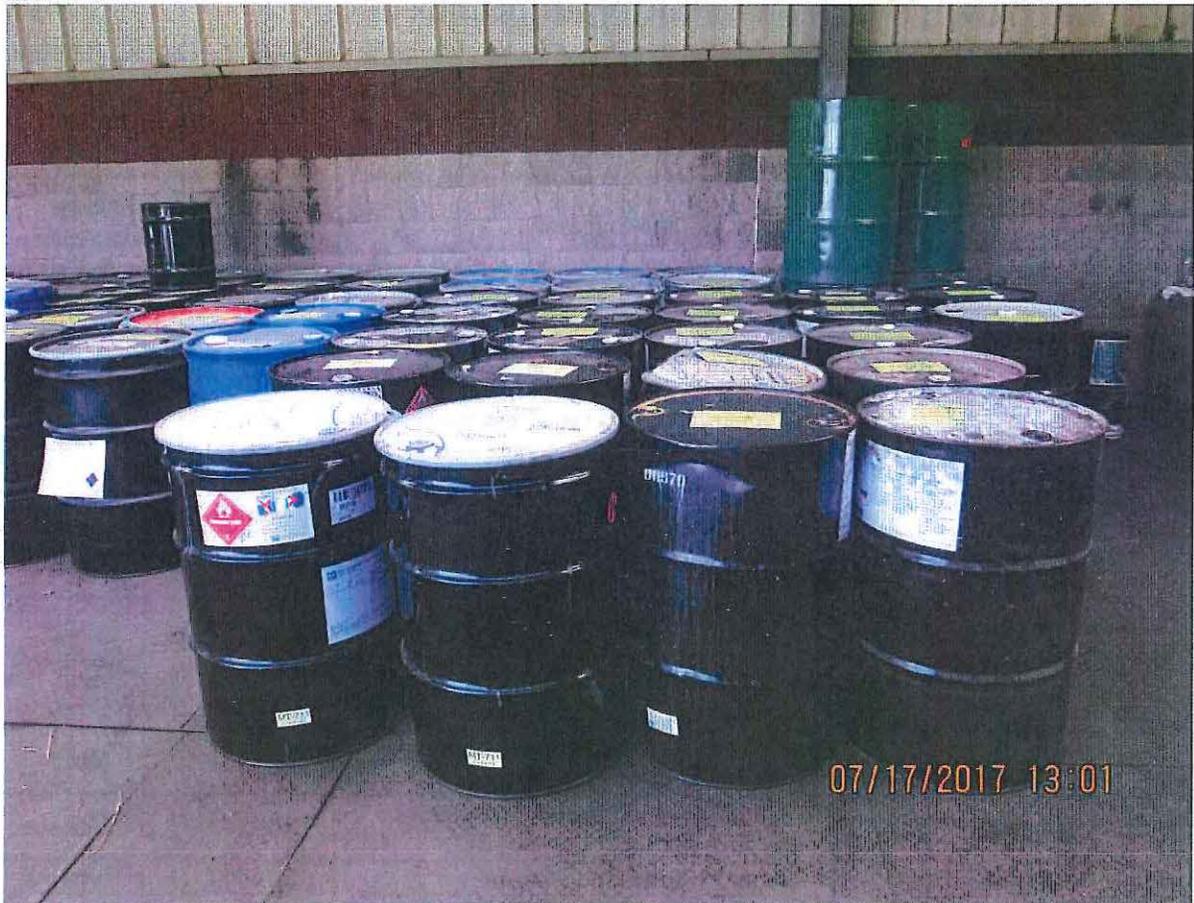
Photo 1:

Inspector Whitney and I proceeded to the "heavies" storage area where MASD segregates incoming drums that "feel" heavy because of liquid inside the drum. There were approximately 60 drums in the heavies area, each with a neon yellow reject label on the lid (See Photo 1 in the Inspection Photographs attachment). The labels stated "Rejected or Heavy Drum" and were marked with a tracking number and the customer that sent the drum. The vast majority of these labels had no date. For those labels with a date, the earliest observed was April 17, 2017 (Photo 2).

Photo	Image File Identifier	Description	Time (CST)	Image Modifications
1	IMG_0647	The "heavies" storage area with approximately 60 drums.	2:01 PM	None
2	IMG_0648	The oldest label observed on a drum in the heavies storage area, dated 4/17/17.	2:08 PM	None
3	FLIR0206	FLIR camera image of liquid line inside a steel drum in the heavies storage area.	Not Recorded	None
4	FLIR0207	FLIR camera image of poly drums inside a trailer that was being unloaded.	Not Recorded	None
5	IMG_0649	An open trailer of drums in the storage yard. It was unclear why this trailer was open.	2:19 PM	None
6	IMG_0650	An open trailer of drums and containers in the storage yard. Drums and containers were stacked and appeared toppled over. It was unclear why this trailer was open.	2:22 PM	None
7	IMG_0651	View of the bake oven with visible smoke near its exit. With camera flash on.	2:29 PM	None
8	IMG_0652	View of the bake oven with visible smoke near its exit. With camera flash off.	2:29 PM	None

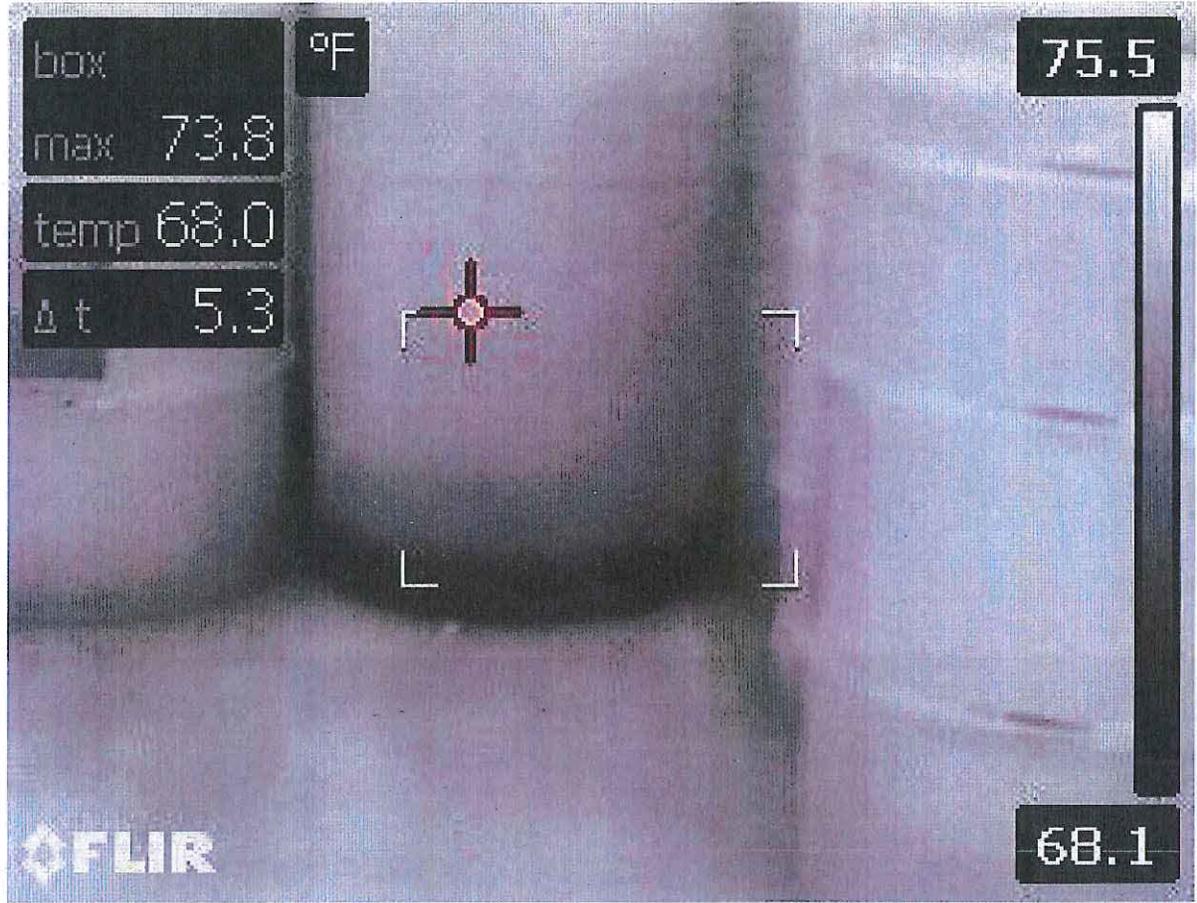
Photo 3:

Inspector Whitney attempted to use the FLIR camera to observe liquids inside the heavy drums. On a high contrast setting ("white hot"), the FLIR camera was able to image the liquid level inside at least one steel drum (Photo 3). It was confirmed that the FLIR camera was imaging the liquid inside the drum by tilting and holding the drum at an angle and observing the resultant contrast change along the lower drum wall. It appeared the FLIR camera was able to image the liquid level inside plastic "poly" drums, but the contrast was less clear (Photo 4). The highest mercury vapor reading in the heavies dock was 300 nanograms per cubic meter, or approximately 0.04 parts per billion.

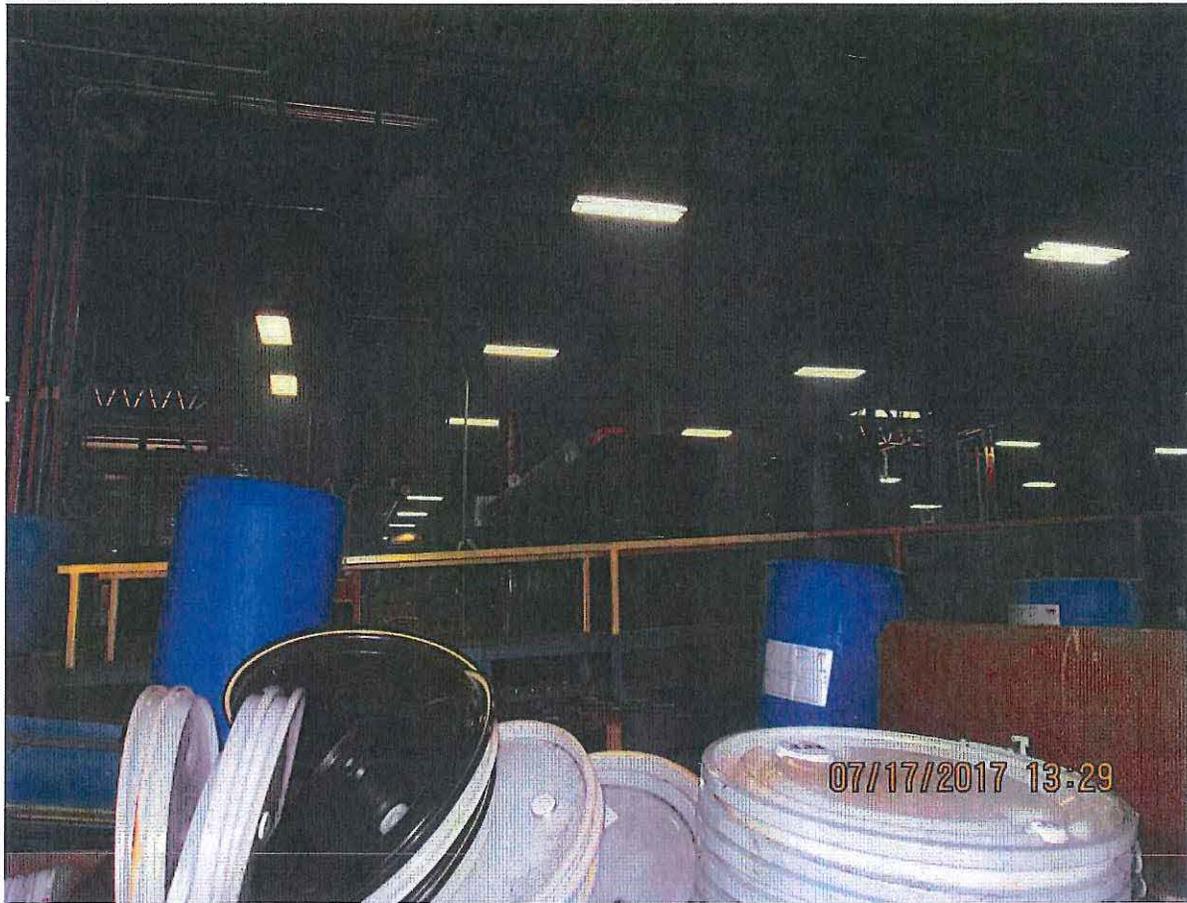
Photo 7:

facility and contributed to a standing haze (Photos 7 and 8). Mr. Laabs explained that the unit was the bake oven for newly-painted steel drums, which cures the coating MASD applies to drums after they pass inspection. Smoke was emanating from the exit of the bake oven where steel drums exit on a conveyor line. I asked Mr. Laabs what the smoke could be and he speculated that it was a combination of combustion byproducts and paint particles. The smoke was white in color and looked similar to the smoke seen outside the facility on South Pennsylvania Avenue. A video of the smoke was taken using the digital camera (See video file MVI_0653.mov). Inspector Whitney imaged the smoke with the FLIR camera. It did not appear to have measurable volatiles content.

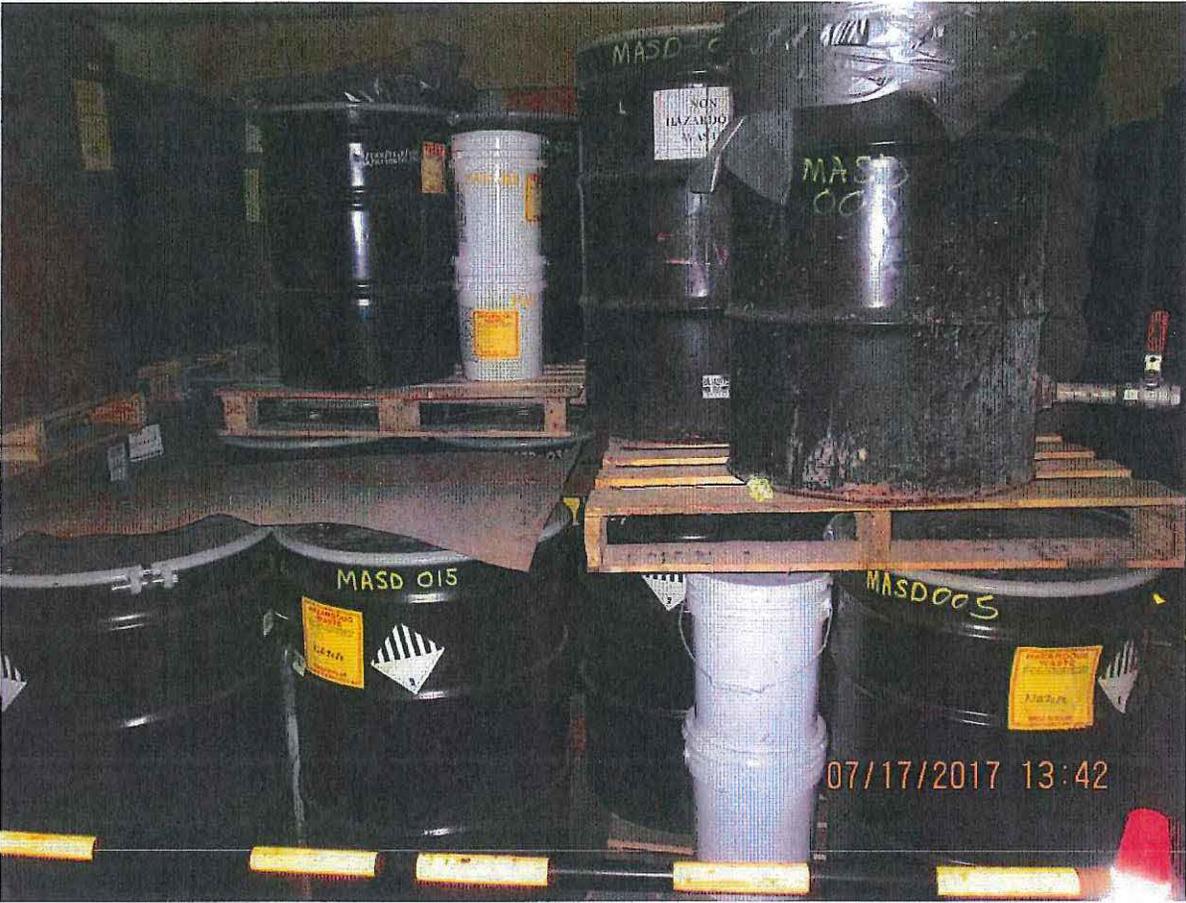
Photo 9:

Inspector Whitney and I continued to the southern side of the facility and observed a hazardous waste storage area. MASD had accumulated approximately two dozen containers of mercury-containing hazardous waste, including cardboard boxes, 5-gallon buckets and 55-gallon drums (Photo 9). The containers were marked as D009 hazardous waste. The earliest date on a 55-gallon drum in the area was April 24, 2017. The mercury vapor analyzer registered a maximum reading of 200 nanograms per cubic meter in this area, or approximately 0.02 parts per billion. It had been previously indicated by MASD representatives that the facility had received a "bad" drum that caused a mercury contamination event. This hazardous waste was generated as a result of a cleanup response.

9	IMG_0654	The mercury waste storage area.	2:42 PM	None
10	IMG_0656	Previously sampled drum (SFS08) now marked as "Save" near the wastewater treatment area.	2:45 PM	None
11	IMG_0655	Previously sampled drum (SFS09) now marked as "Save" near the wastewater treatment area.	2:25 PM	None
12	IMG_0657	A leaking drum marked as "Non Hazardous Waste" near the wastewater treatment area.	2:47 PM	None
13	IMG_0658	Inconclusive pH indicator paper result on the liquid in the leak seen in Photo 12.	2:47 PM	None

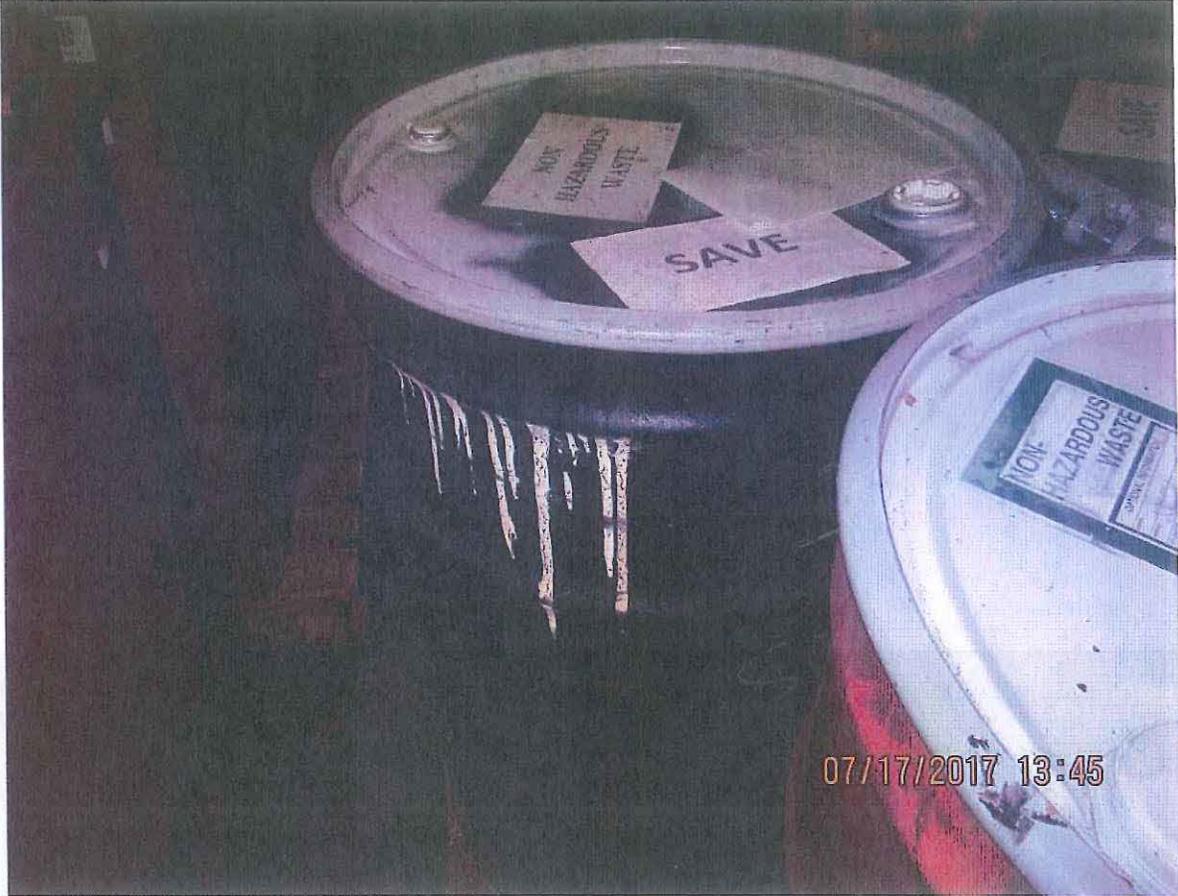
Photo 10:

Continuing west near the wastewater treatment area, I observed two 55-gallon drums that were previously sampled by EPA during a site visit on May 4, 2017. The drum samples were "SFS08" and "SFS09." Both drums were marked as "Non Hazardous Waste" and "SAVE" (Photos 10 and 11). Near these two drums was another 55-gallon steel drum marked as "Non Hazardous Waste" that appeared to be leaking onto the ground (Photo 12). I attempted to screen the leak with pH indicator paper but the result was inconclusive (Photo 13).
