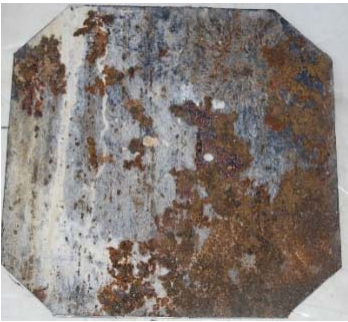
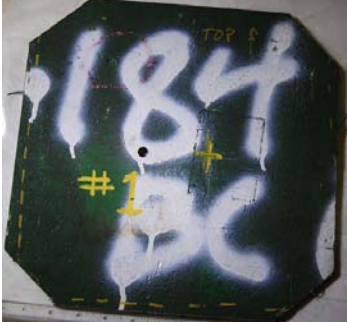
COUPON SPECIFICS		
Coupon ID	1	1
Coupon Location	14-UD-A-42-45-107	
Coupon Dimensions	12" * 12"	
Coupon Thickness	¼" (NDE: minimum 0.147")	
Locations of Welds	None	
ON SITE VISUAL EXAMINATION		
Checks	Observations	
	Exterior	Interior
Deposits, Coatings, Debris	Deposits	Standard coating with paint
Scale	None	None
Observed Biological Material	None	None
Wet or Dry	Wet	Dry
Smell	Damp, burnt	Burnt
Presence of petroleum product between steel and concrete surface, and on or above the leg of the angle backer bar embedded in the concrete	No	No
Provide a sketch of the coupon showing all indications. Provide ID#s for all indications on coupon and compare with NDE expected results sketch

Corrosion found, as expected, but no pits

Presence of corrosion	Yes	No
Isolated pitting	No	No
Isolated pitting within areas of general corrosion	No	No
Linked pitting within areas of general corrosion	No	No
Identify color of corrosion products	Brown	N/A

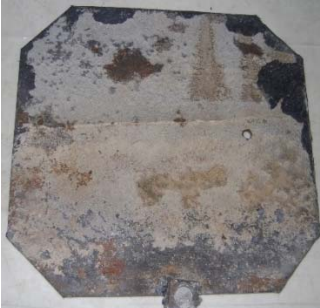
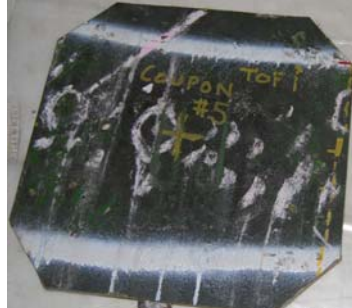
COUPON SPECIFICS		
Coupon ID	5	5
Coupon Location	14-BA-26-15-15-8	
Coupon Dimensions	12" * 12"	
Coupon Thickness	¼" (NDE: minimum 0.047")	
Locations of Welds	None	
ON SITE VISUAL EXAMINATION		
Checks	Observations	
	Exterior	Interior
Deposits, Coatings, Debris	Concrete layer, thin	Standard coating
Scale	None	None
Observed Biological Material	None	None
Wet or Dry	Dry	Dry
Smell	Burnt	Burnt
Presence of petroleum product between steel and concrete surface, and on or above the leg of the angle backer bar embedded in the concrete	No	No
Provide a sketch of the coupon showing all indications. Provide ID#s for all indications on coupon and compare with NDE expected results sketch

<p>Corrosion found, as expected (writing says "horiz bulge")</p>

Presence of corrosion	Yes	No
Isolated pitting	No	No
Isolated pitting within areas of general corrosion	No	No
Linked pitting within areas of general corrosion	No	No
Identify color of corrosion products	Brown	N/A

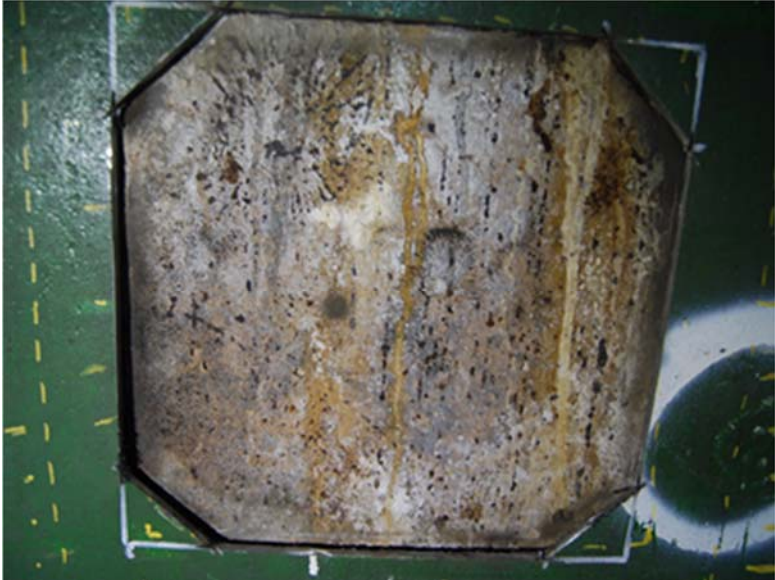
Sample ID	1	1
Sample Location	14-UD-A-42-45-107	
Sample Dimensions	12X12 INCHES

Checks	Observations	
	Exterior	Units
Void space between concrete and liner (if any)	1/8" Void on left side, no voids in all other areas	
Biological Materials	None	
Wet or Dry	Dry	
Smell	None	
Temperature	76.9	F
Surface pH	9 to 9.5	
Structure to Electrolyte	-0.252	Volts/CSE
Concrete Resistivity	26.4 Horizontal 31.1 Vertical	k-ohm-cm k-ohm-cm
General Condition	Excellent, sound concrete with some discoloration and no cracks and no delamination

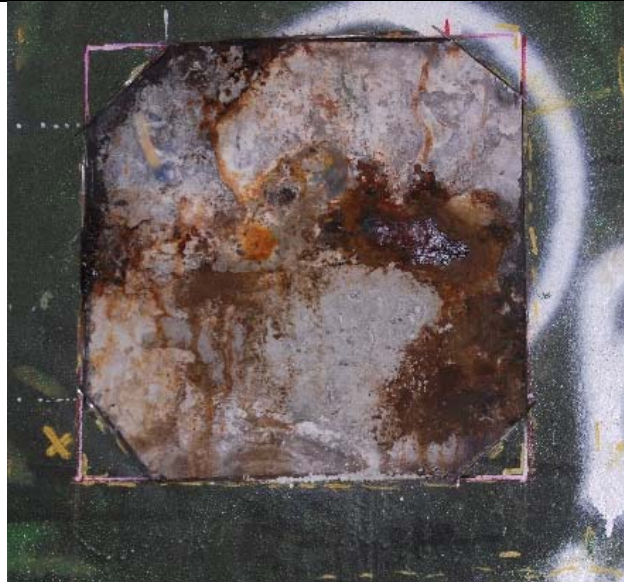
Sample ID	2	2
Sample Location	14-ER-E3-12-33-40	
Sample Dimensions	12X12 INCHES

Checks	Observations	
	Exterior	Units
Void space between concrete and liner (if any)	1/8" void at upper left side. Otherwise no voids.	
Biological Materials	None	
Wet or Dry	Slightly damp	
Smell	Musty, no fuel	
Temperature	80.0	F
Surface pH	10-11 corroded area 11-12 non-corroded area	
Structure to Electrolyte	-0.380	Volts/CSE
Concrete Resistivity	19.0 Horizontal 17.5 Vertical	k-ohm-cm k-ohm-cm
General Condition	Good sound condition with some minor spalling and corrosion product. Coupon took some hammering to remove

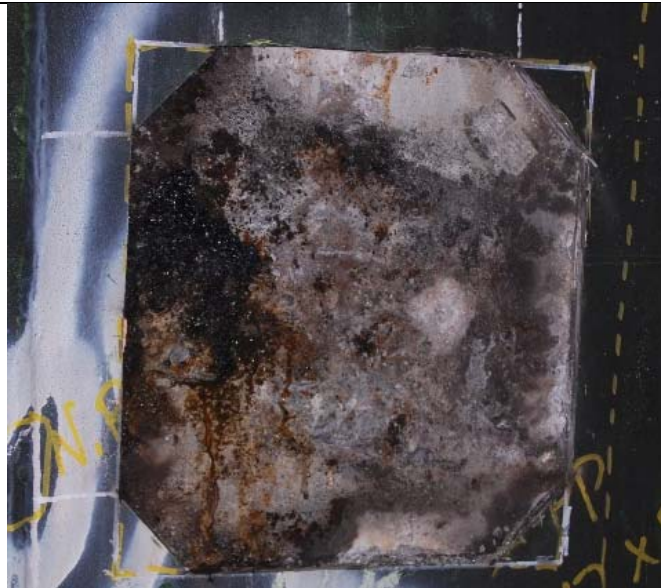
Sample ID	3	3
Sample Location	14-ER-E3-13-7-18	
Sample Dimensions	12X12 INCHES

Checks	Observations	
	Exterior	Units
Void space between concrete and liner (if any)	On left side, uneven corrosion product and a 1/16-inch void. Otherwise, no voids.	
Biological Materials	None	
Wet or Dry	Mostly dry, with some damp spots	
Smell	None	
Temperature	79.3	F
Surface pH	11-12 dry areas, 7-8 in areas with corrosion product	
Structure to Electrolyte	-0.488	Volts/CSE
Concrete Resistivity	27.8 Horizontal 31.2 Vertical	K-Ohm-cm
General Condition	Good, with some corrosion products. Corrosion product was black on the left side, and brown in some other areas. Concrete was hard and difficult to drill for powder samples. Coupons required some hammering and prying to remove after cutting.

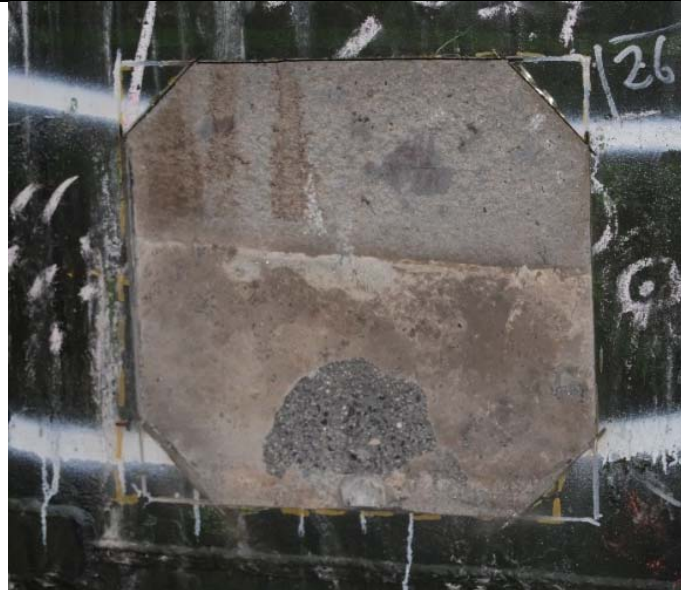
Sample ID	5	5
Sample Location	14-DA-26-15-15-8	
Sample Dimensions	12X12 INCHES

Checks	Observations	
	Exterior	Units
Void space between concrete and liner (if any)	1/16" Void on top right side, no voids in all other areas	
Biological Materials	None	
Wet or Dry	Dry	
Smell	None	
Temperature	78.5	F
Surface pH	11-12	
Structure to Electrolyte	-0.220	Volts/CSE
Concrete Resistivity	19.1 Horizontal 22.0 Vertical	k-ohm-cm k-ohm-cm
General Condition	Excellent, sound concrete

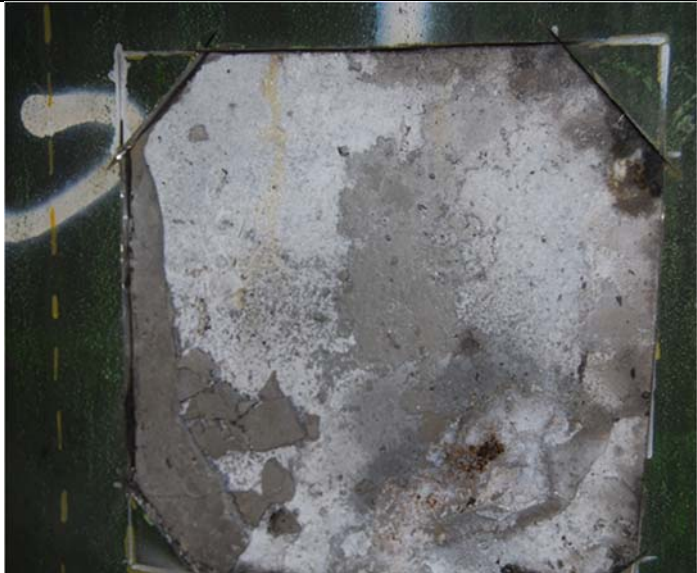
CONCRETE SAMPLE SPECIFICS		
Sample ID	6	6
Sample Location	14-BA-24-8-36-30	
Sample Dimensions	12X12 INCHES	
ON SITE VISUAL EXAMINATION		
Checks	Observations	
	Exterior	Units
Void space between concrete and liner (if any)	None, however some loose adhering grout present	
Biological Materials	None	
Wet or Dry	Dry	
Smell	None	
Temperature	77.4F	F
Surface pH	12.5	
Structure to Electrolyte	-0.387	Volts/CSE
Concrete Resistivity	Horizontal = 387 Vertical = 359	k-ohm-cm k-ohm-cm
General Condition	Concrete is sound, no delamination. There is loose adhering grout on left side and middle

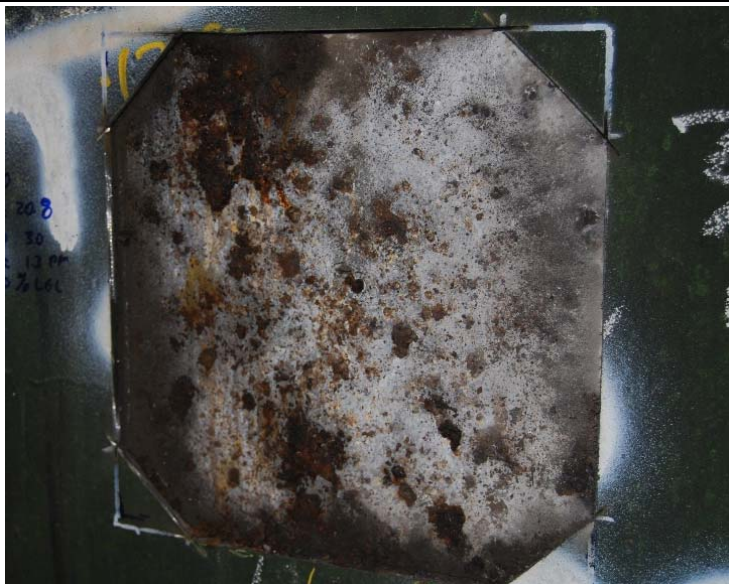
CONCRETE SAMPLE SPECIFICS		
Sample ID	7	7
Sample Location	14-BA-23-7-38-49	
Sample Dimensions	12X12 INCHES	
ON SITE VISUAL EXAMINATION		
Checks	Observations	
	Exterior	Units
Void space between concrete and liner (if any)	3/8" void on left side. 1/16" void on top right otherwise no voids	
Biological Materials	None	
Wet or Dry		
Smell	none	
Temperature	77.5F	F
Surface pH	9- 10	
Structure to Electrolyte		Volts/CSE
Concrete Resistivity	Horizontal = 39.3 Vertical = 42.4	k-ohm-cm k-ohm-cm
General Condition	Concrete is sound with no delamination or cracks. Some brown and black corrosion products on concrete

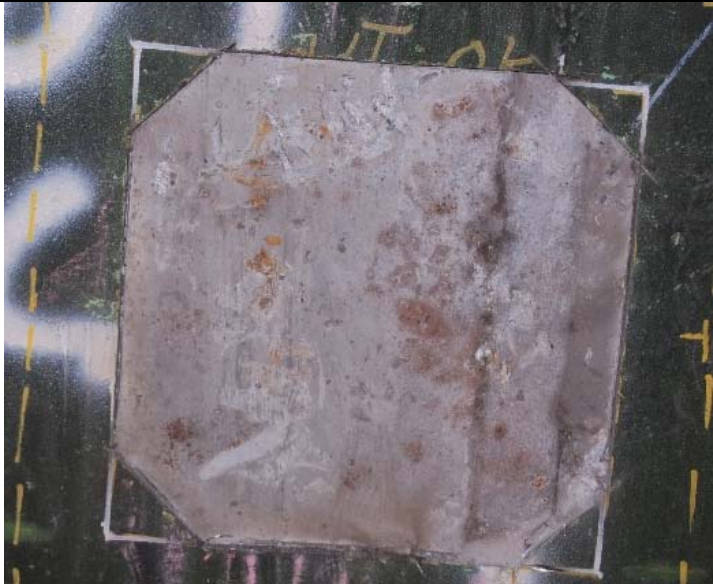
CONCRETE SAMPLE SPECIFICS		
Sample ID	8	8
Sample Location	14-BA-20-13-23-4	
Sample Dimensions	12X12 INCHES	
ON SITE VISUAL EXAMINATION		
Checks	Observations	
	Exterior	Units
Void space between concrete and liner (if any)	1/16" Void on left side, no voids in all other areas	
Biological Materials	None	
Wet or Dry	Dry	
Smell	None	
Temperature	80.0	F
Surface pH	11-12	
Structure to Electrolyte	-0.248	Volts/CSE
Concrete Resistivity	30.9 Horizontal 27.5 Vertical	k-ohm-cm k-ohm-cm
General Condition	Excellent, sound concrete with no cracks or delamination. Coupon had steel backing plate

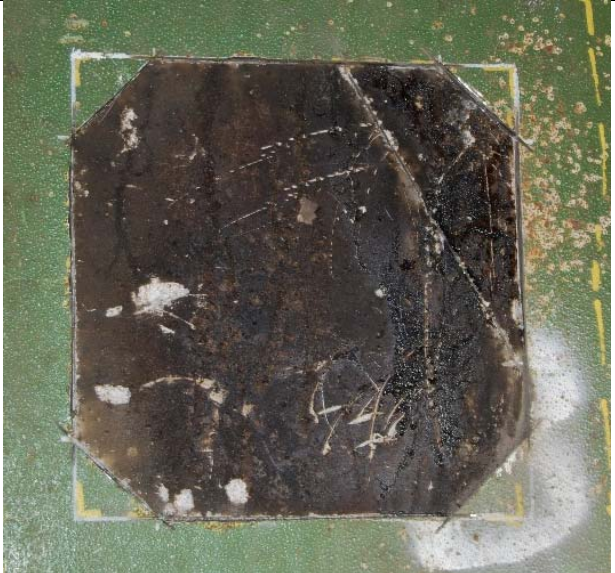
Sample ID	10	10
Sample Location	14-LD-3-9-24-215	
Sample Dimensions	12X12 INCHES

Checks	Observations	
	Exterior	Units
Void space between concrete and liner (if any)	None	
Biological Materials	None	
Wet or Dry	Dry	
Smell	Smells like coal tar	
Temperature	77.6	F
Surface pH	12-12.5	
Structure to Electrolyte	-0.181	Volts/CSE
Concrete Resistivity	27.3 Horizontal 38.1 Vertical	k-ohm-cm k-ohm-cm
General Condition	Excellent, sound concrete with no cracks or delamination. Coupon had to be cut into two pieces to remove. What appears to be coal tar coating present on backside of coupon and concrete.

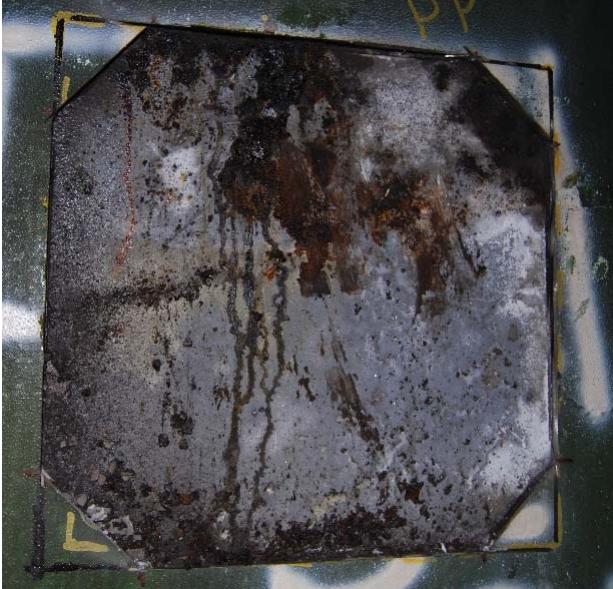
CONCRETE SAMPLE SPECIFICS		
Sample ID	A1	A1
Sample Location	14-BA-23-9-95-50	
Sample Dimensions	12X12 INCHES	
ON SITE VISUAL EXAMINATION		
Checks	Observations	
	Exterior	Units
Void space between concrete and liner (if any)	1/8" Void on left side, no voids in all other areas	
Biological Materials	None	
Wet or Dry	Mostly dry with damp areas around corrosion product	
Smell	None	
Temperature	77.5	F
Surface pH	11-12 in dry areas, 7-8 in corroded area	
Structure to Electrolyte	-0.448 (dry area) -0.432 (damp area w. corrosion products)	Volts/CSE
Concrete Resistivity	32.9 Horizontal 37.0 Vertical	k-ohm-cm
General Condition	Good condition with sound concrete, no cracks or delamination. Corrosion products are present on concrete.
