Subject: October 1, 2019 Reconnaissance Inspection Report for ArcelorMittal Burns Harbor

**CWA COMPLIANCE EVALUATION INSPECTION REPORT
U.S. ENVIRONMENTAL PROTECTION AGENCY, REGION 5**

ArcelorMittal Burns Harbor, LLC
250 US-12
Burns Harbor, Indiana 46304
Porter County
41.625, -87.117

IN0000175

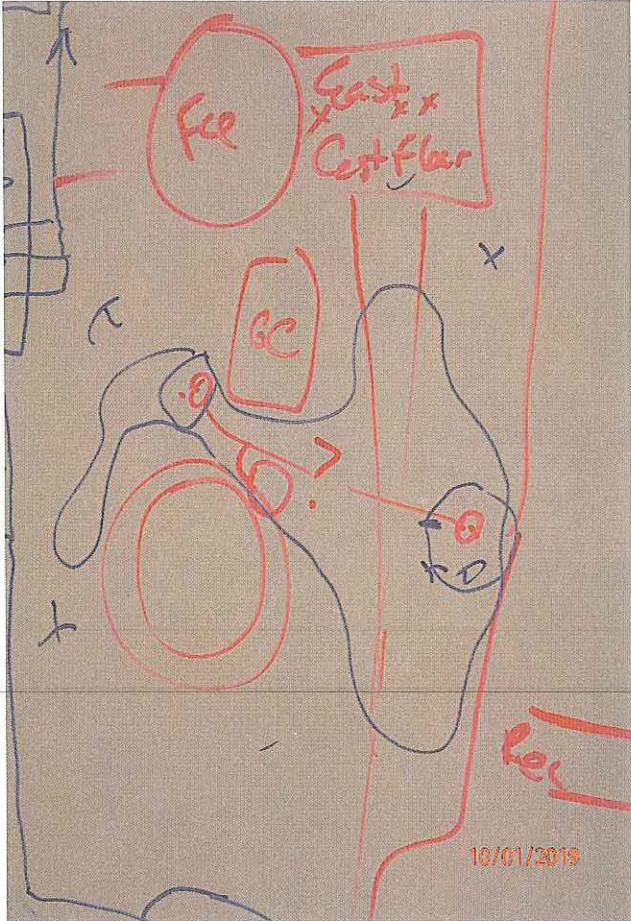
1: PA010138

Description: White board drawing by Blake Crisman of the extent of flow to the ground on the day of the pump failure.

Location: White board in conference room.

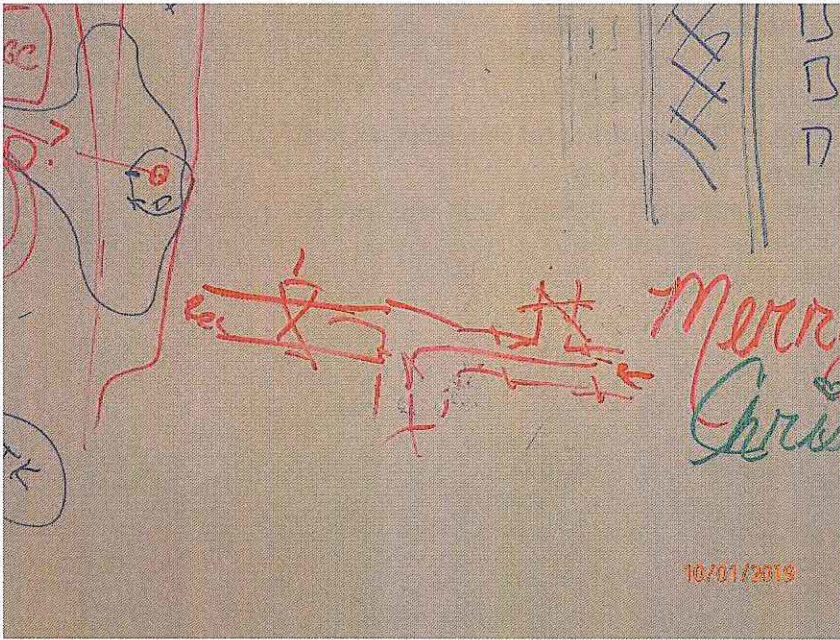
2: PA010139

AMBH: Mr. Crisman stated that the lake water entered the pump house by the gas cleaning building and drew a diagram of it on the white board (Photo 2). He explained that the flow for Furnace D was 1250 to 1400 gpm to get enough water to the air scrubber. He did not know the flow rate for Furnace C. He explained that since the lake water is cooler, less was needed, but the flow rate for lake make-up water for both furnaces was approximately 3000-4000 gpm.

Description: Drawing by Blake Crisman of the piping for lake intake water.

Location: White board in the conference room.

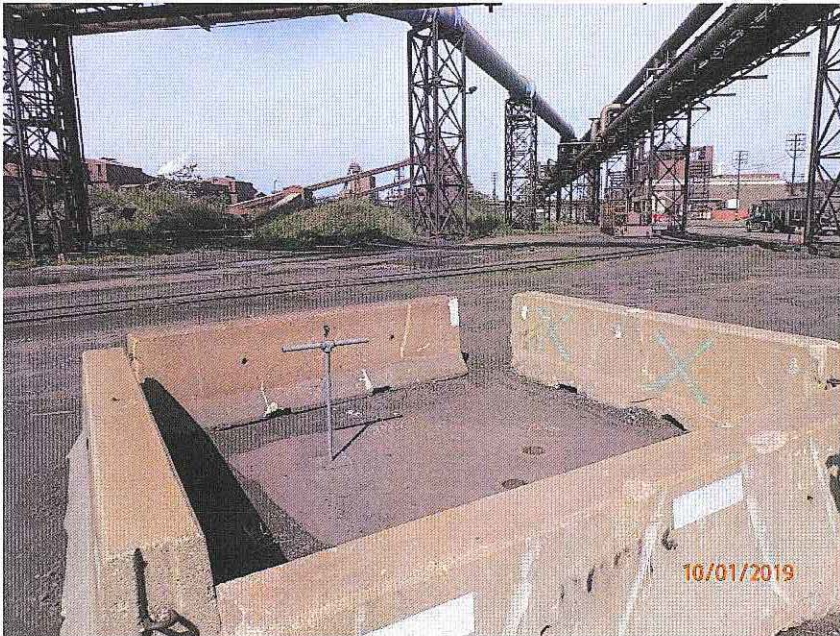
3: PA010140

Description: Location of the pit that housed the valves to shut of lake water to the wells. On August 11, 2019, this pit flooded and had to be dewatered before the valves could be turned to shut off lake water intake.

Location: Near the pump house building.

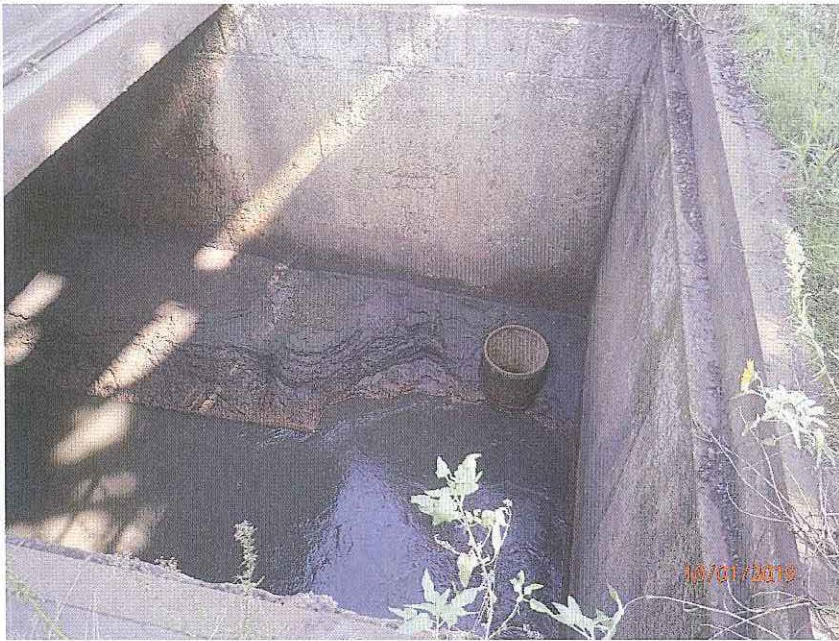
4: PA010141

AMBH: Mr. Balunda stated that the 24" pipe was the choke point for flow out of the system and that there was no quantifiable number for the flow to it. He approximated it at around 4000 gpm. After the lake water was shut off and there was approximately 2000 gpm for each furnace, the level of water in the pump wells started draining. He also stated that the facility had plans to confirm that flow rate.

Description: 24" standpipe that limited the flow from leaving the well.

Location: Near the pump house building.

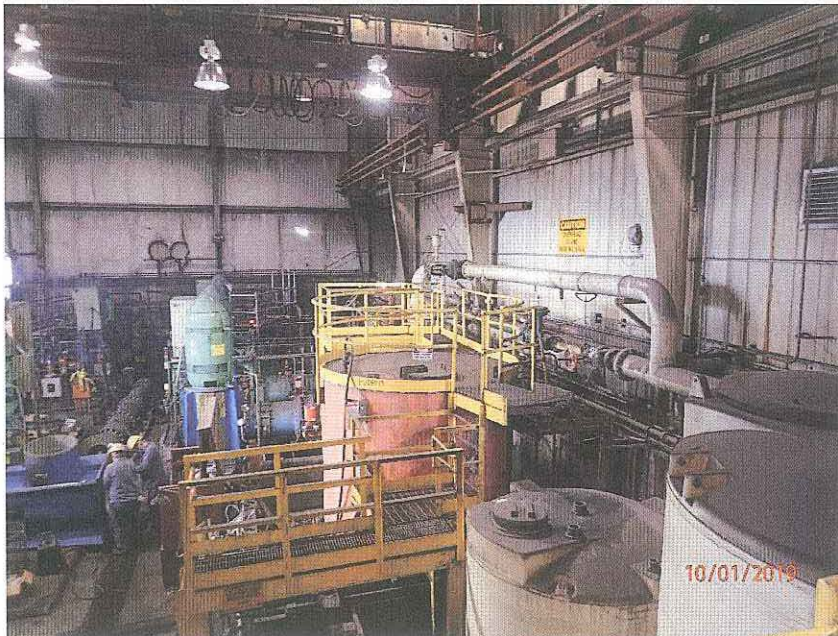
5: PA010142

AMBH: Ms. Kirk and Mr. Maciel stated that the water sprayed up and over the wall and down into the other room that housed the 250 v DC battery system.

Description: An air valve break in this room of the pump house building caused water to spray up to the ceiling and over the wall on the right into the adjacent room.

Location: Pump house building.

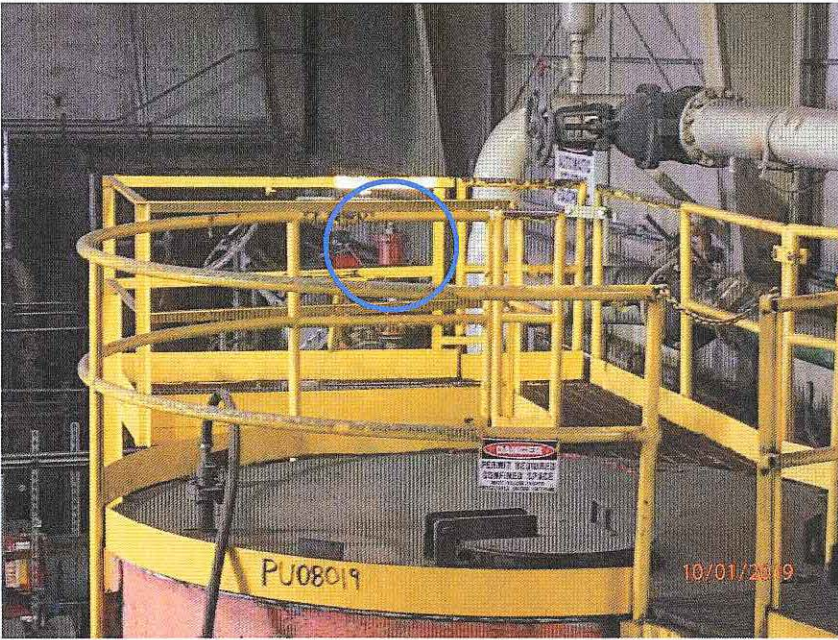
6: PA010143

Description: Air valve break happened on the air valve in the background denoted by a blue circle.

Location: Pump house building.

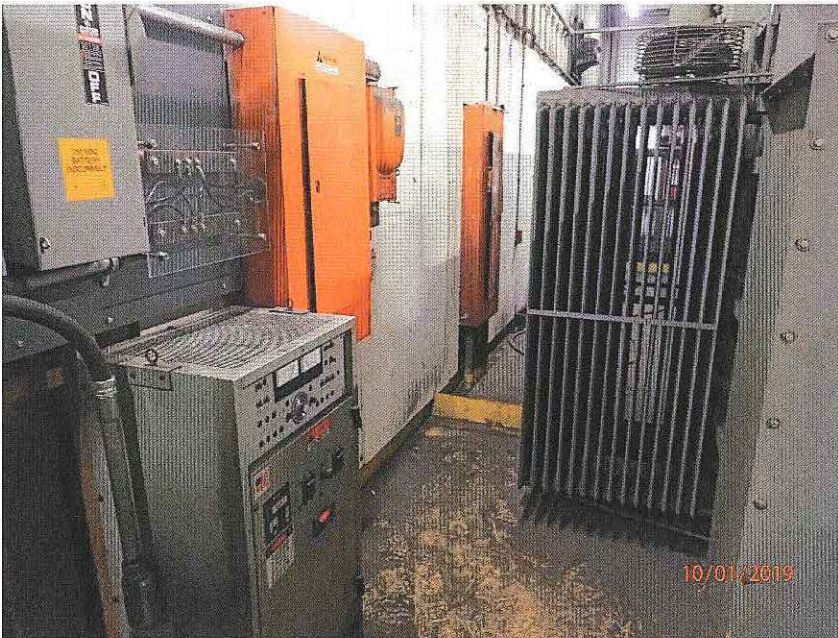
7: PA010144

Description: Battery charger (in foreground) for battery pack for blast furnace gas washer recycle pumps. There are water marks on the white wall from water that came down from the ceiling after the air valve broke.

Location: Pump house building.

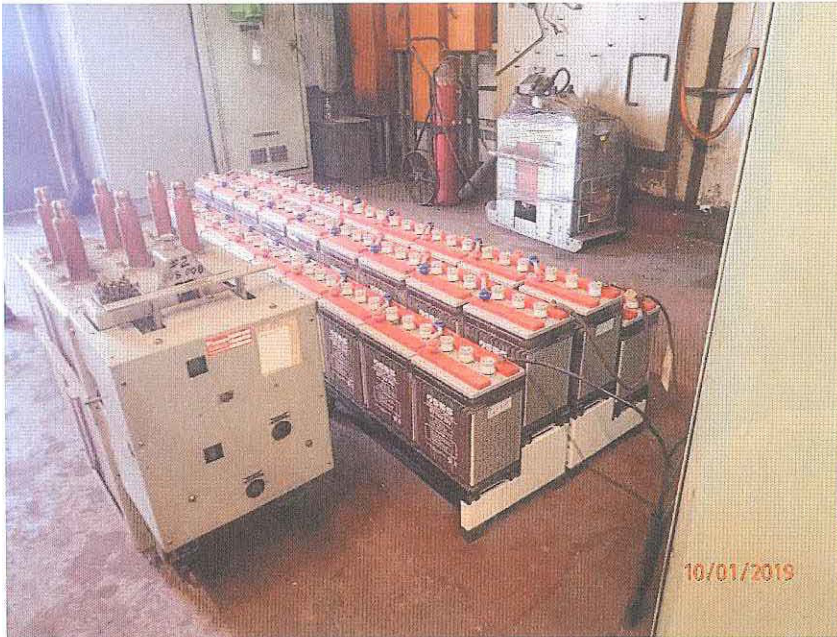
8: PA010145

Description: The battery pack for the blast furnace gas washer recycle pumps.

Location: Pump house building.

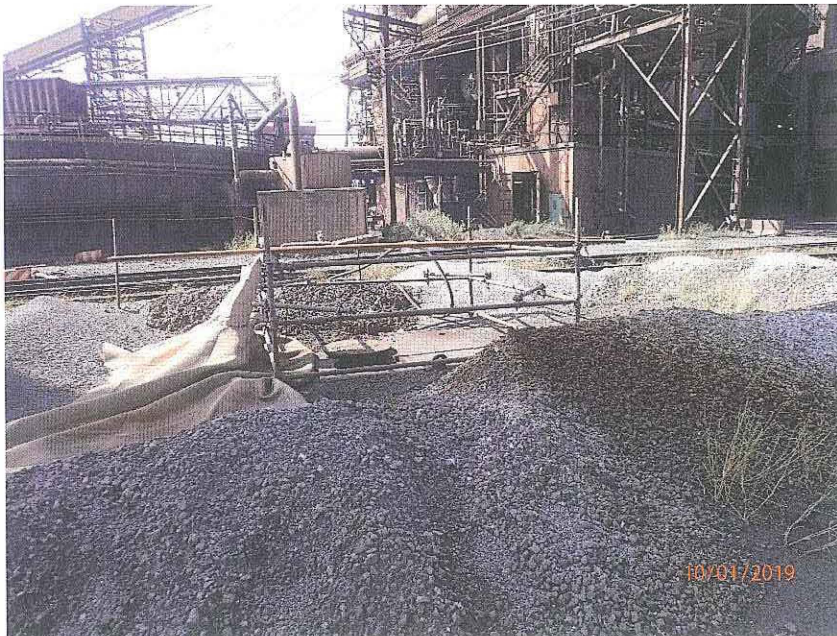
9: PA010146

Description: The manhole that overflowed on August 11, 2019.

Location: South of the east cast floor.

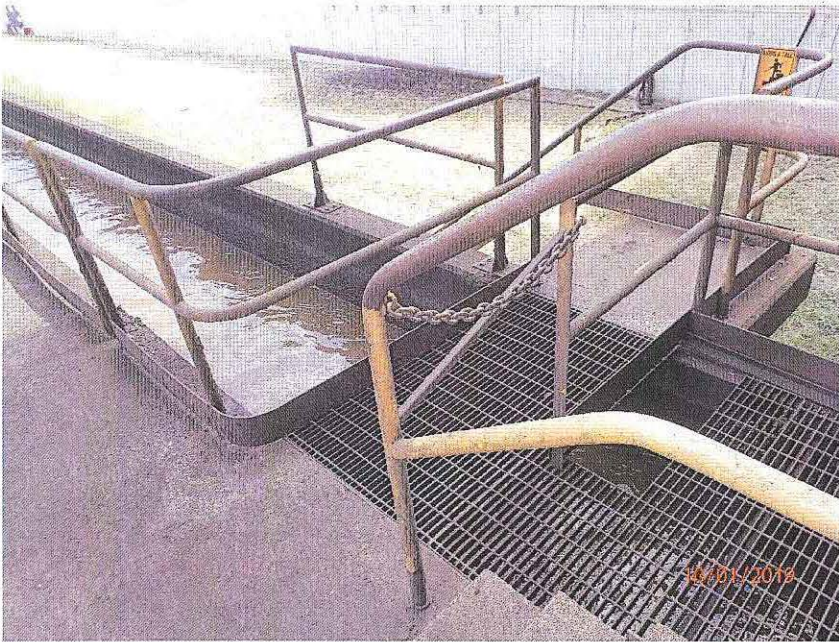
10: PA010147

Description: Influent to the hot side of the Secondary Wastewater Treatment Plant

Location: Hot side of the Secondary Wastewater Treatment Plant.

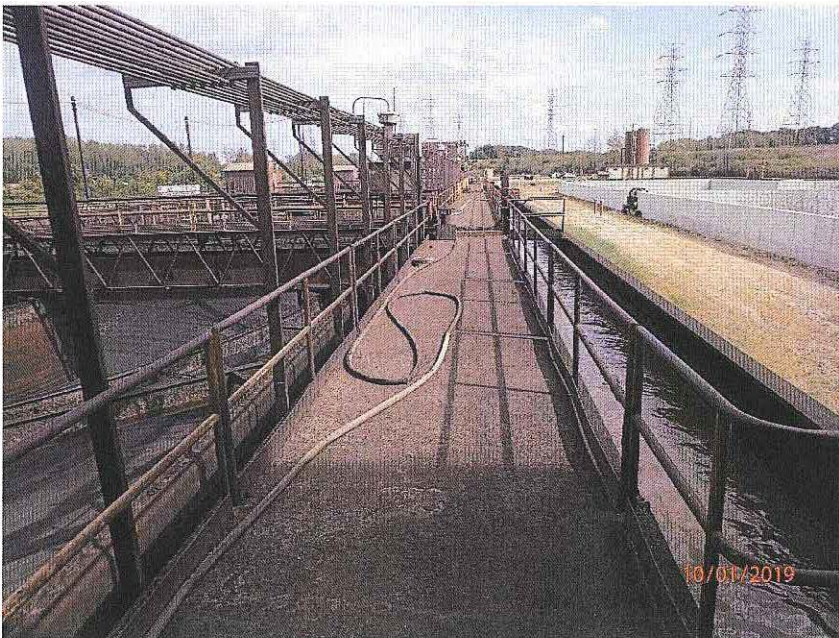
11: PA010148

Description: Influent is directed to one of the clarifiers on the hot side of the plant.

Location: Hot side of the Secondary Wastewater Treatment Plant.

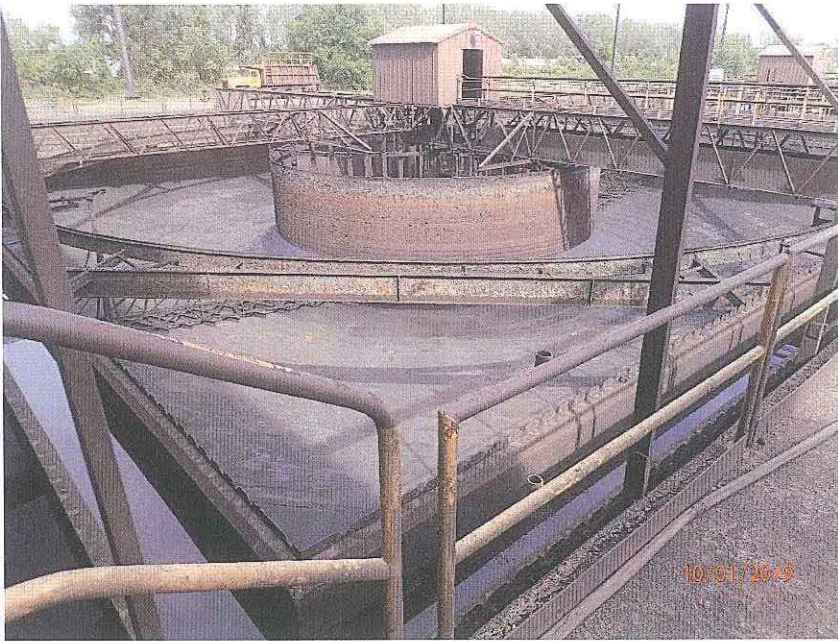
12: PA010149

Description: #1 Hot Mill Clarifier.

Location: Hot side of the Secondary Wastewater Treatment Plant.

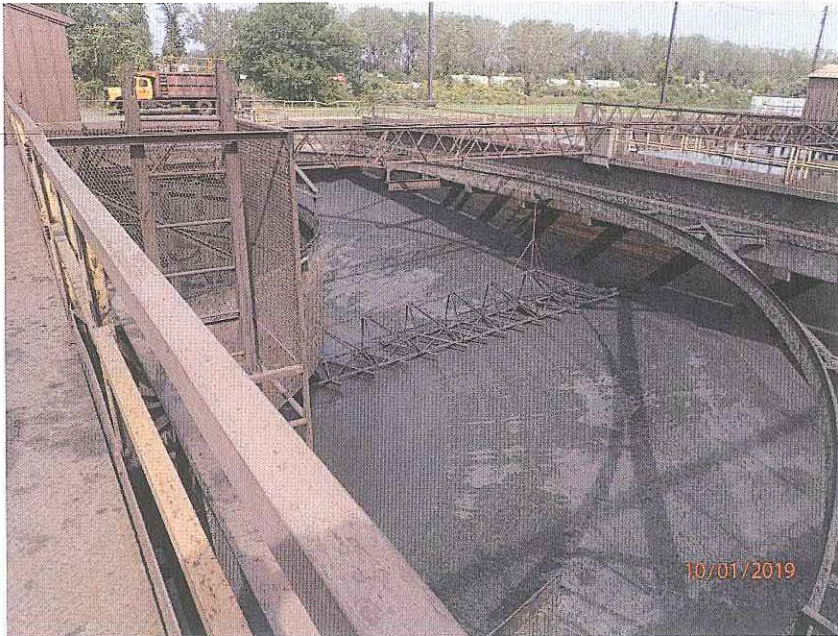
13: PA010150

Description: #1 Hot Mill Clarifier is out of use for cleaning.

Location: Hot side of the Secondary Wastewater Treatment Plant.

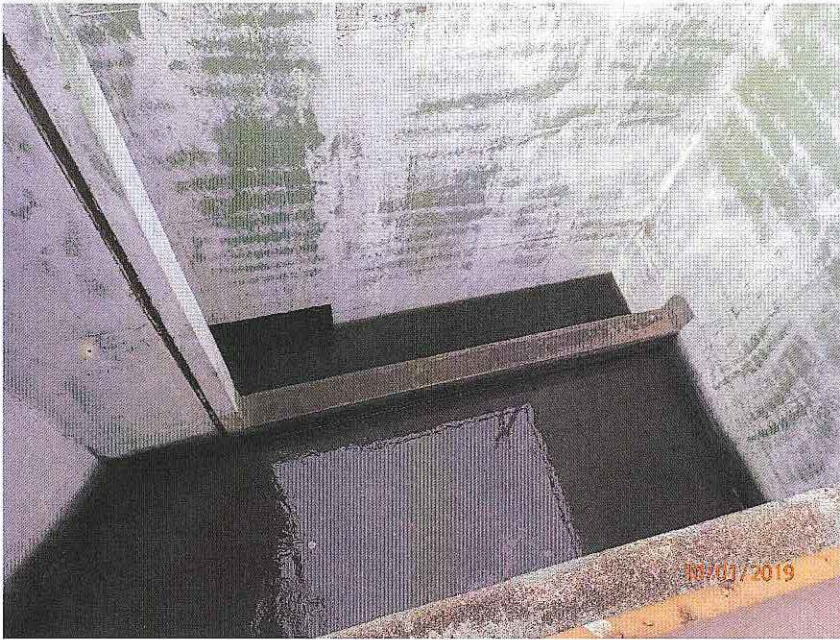
14: PA010151

Description: Influent from hot mill, plate mill, and (cold) finishing mill merge in Manhole 120.

Location: Manhole 120.

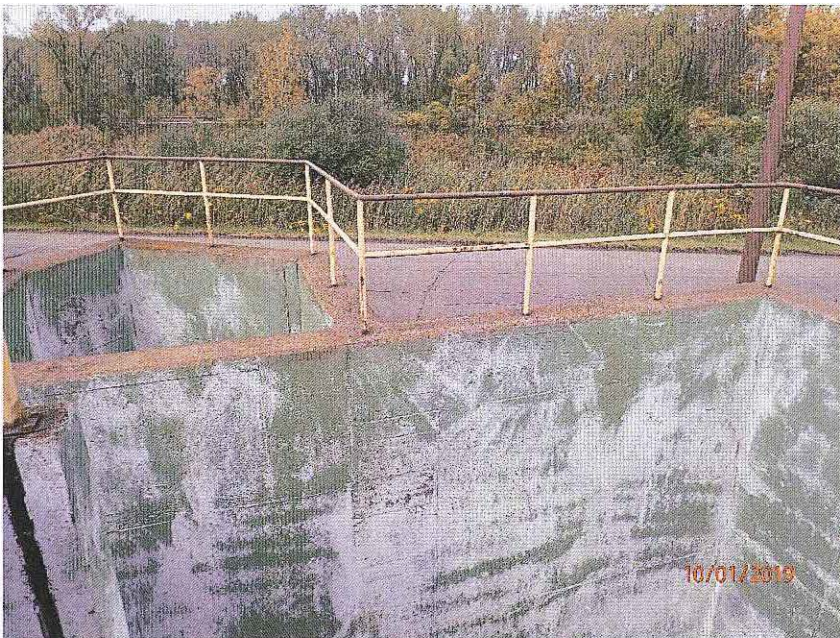
15: PA010152

Description: No evidence that there has been an overflow from Manhole 120 over the walls. The receiving waterway, called "The Storm Ditch", is in the vegetation in the background. A pipe (not shown in photo) would discharge any overflow from this manhole to the waterway.

Location: Manhole 120.

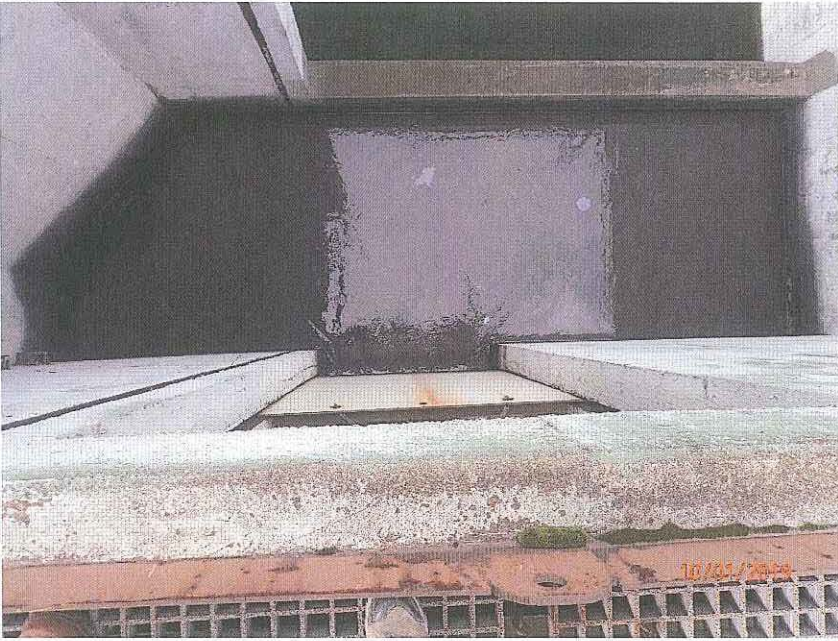
16: PA010153

Description: Looking down into Manhole 120.

Location: Manhole 120.

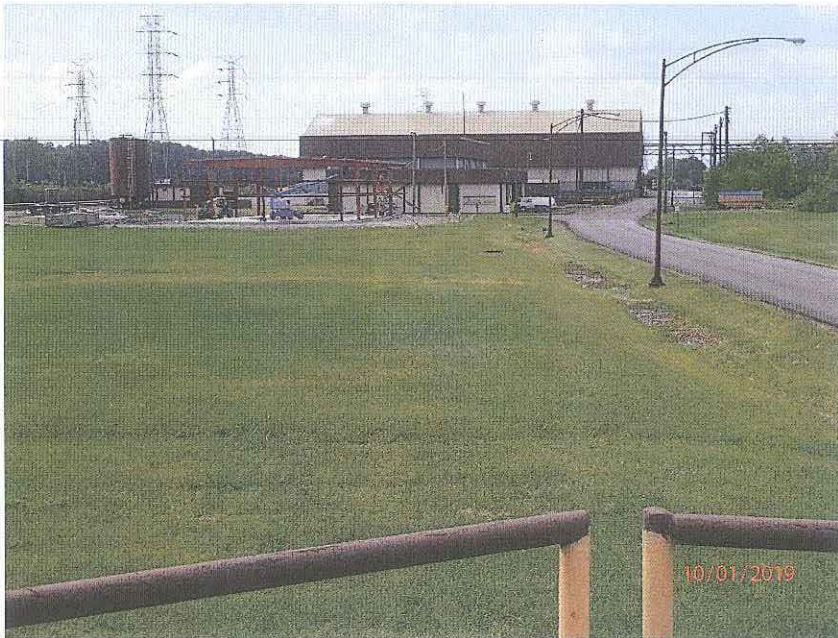
17: PA010154

Description: Flow from Manhole 120 goes to Wastewater I building, the small building in the foreground of the photo.

Location: Manhole 120.

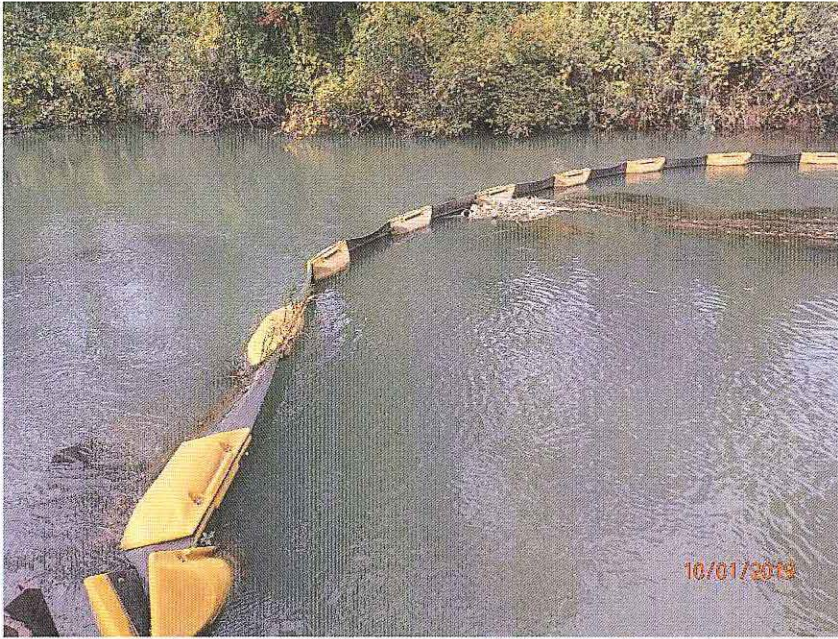
18: PA010155

Description: Permanent boom in the Storm Ditch. There was no evidence of a discharge from Manhole 120 to the Storm Ditch.

Location: Storm Ditch near Manhole 120.

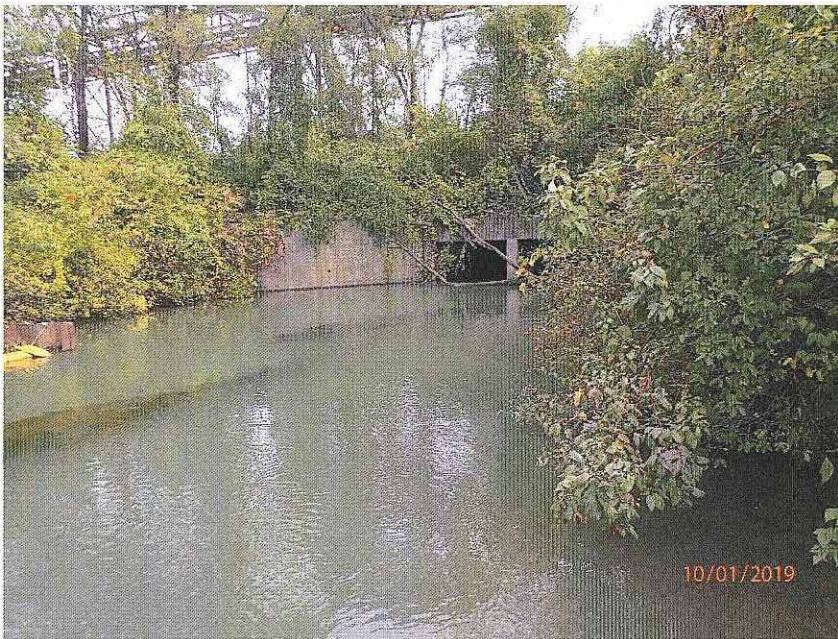
19: PA010156

Description: Looking upstream at the water in the Storm Ditch.

Location: At the boom in the Storm Ditch.

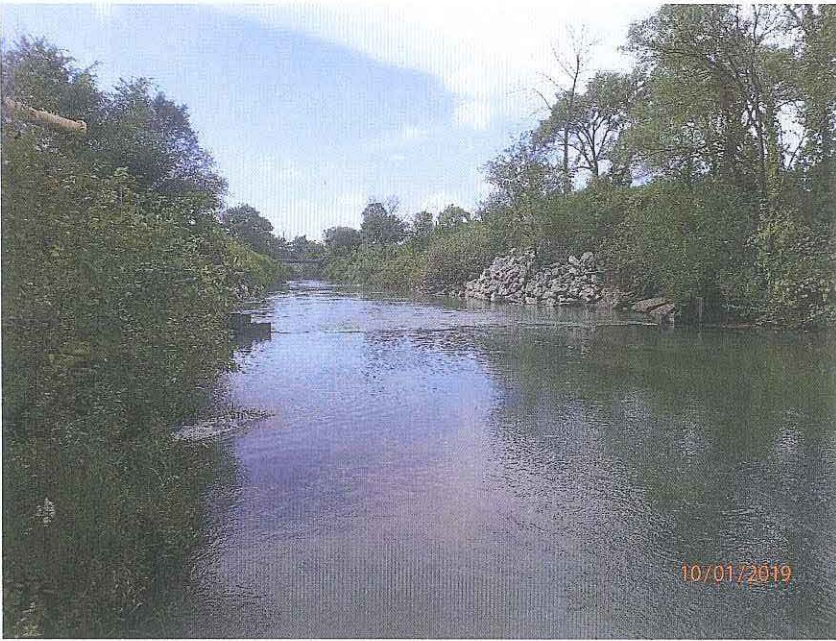
20: PA010157

Description: Looking downstream at the water in the Storm Ditch. The water in the Storm Ditch flows to Outfall 001 and enters the waterway after Outfall 011,

Location: At the boom in the Storm Ditch.

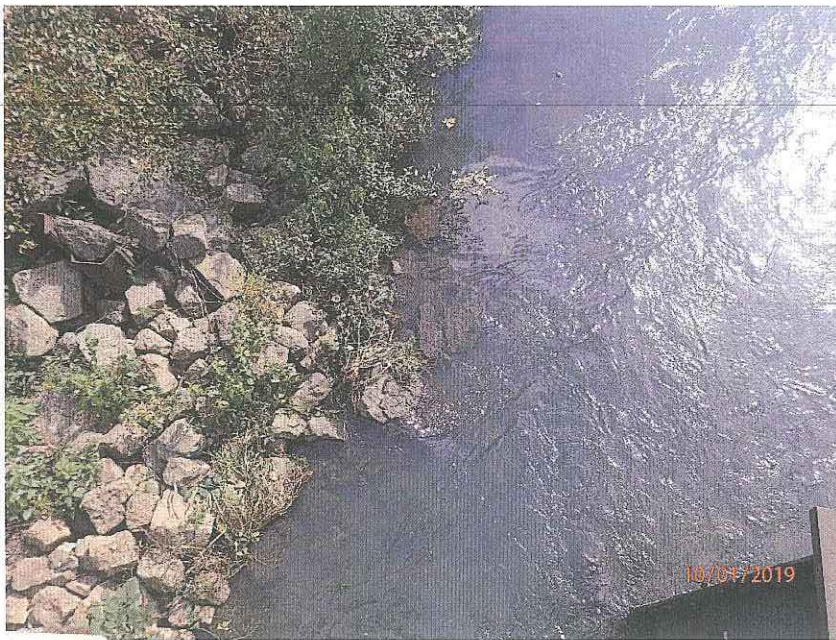
21: PA010158

Description: Water downstream of the sampling location for Outfall 001.

Location: Outfall 001.

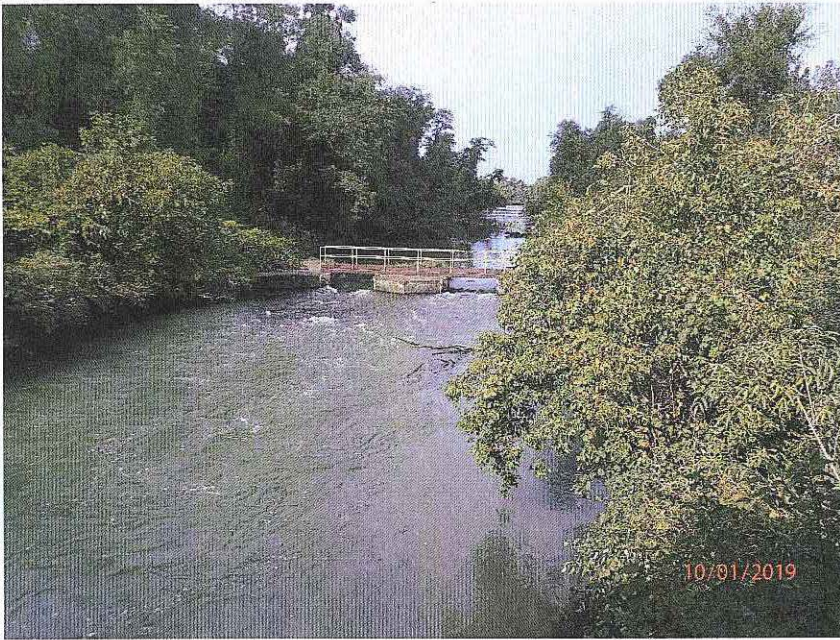
22: PA010159

Description: Looking upstream at the flow to Outfall 001.

Location: Outfall 001.
