Subject: November 7-8, 2019 Compliance Evaluation Inspection Report for ArcelorMittal Burns Harbor, NPDES Permit Number IN0000175

**CWA COMPLIANCE EVALUATION INSPECTION REPORT
U.S. ENVIRONMENTAL PROTECTION AGENCY, REGION 5**

ArcelorMittal Burns Harbor, LLC
250 US-12
Burns Harbor, Indiana 46304
Porter County
41.625, -87.117

IN0000175

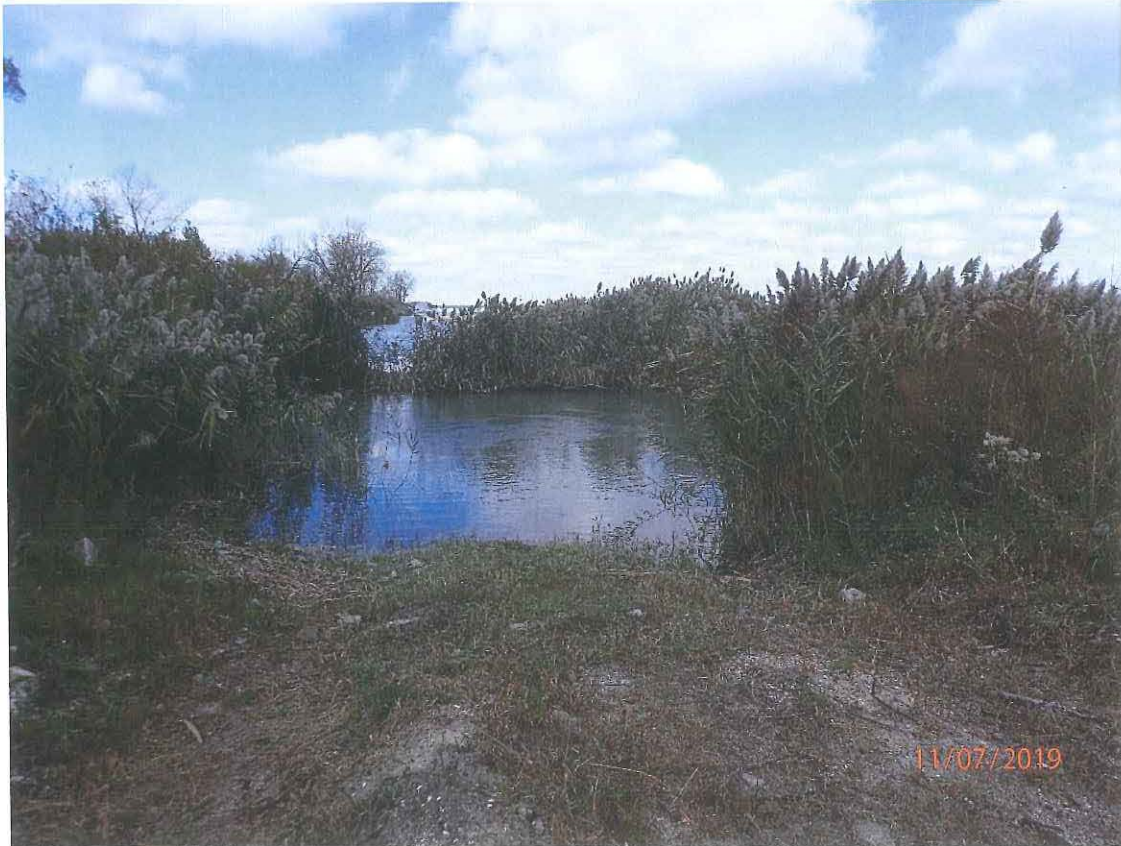
1: PB070001

Outfall 003 flows into Lake Michigan and receives the backwash from the #1 and #2 Lake Water Pump Station traveling screens. There is a limit for Total Residual Chlorine from this outfall. Outfall 003 has a levy installed around it to contain the flow and prevent it from flowing freely into Lake Michigan. Years ago, the facility had issues with grease balls at the outfall and the levy kept the grease balls from going into the lake. Since then, the facility identified operational practices that led to the formation of the grease balls and subsequently changed those practices. There has not been a problem with grease balls since the change in practices.

Description: Outfall 003 has a levy installed around it to separate it from Lake Michigan.

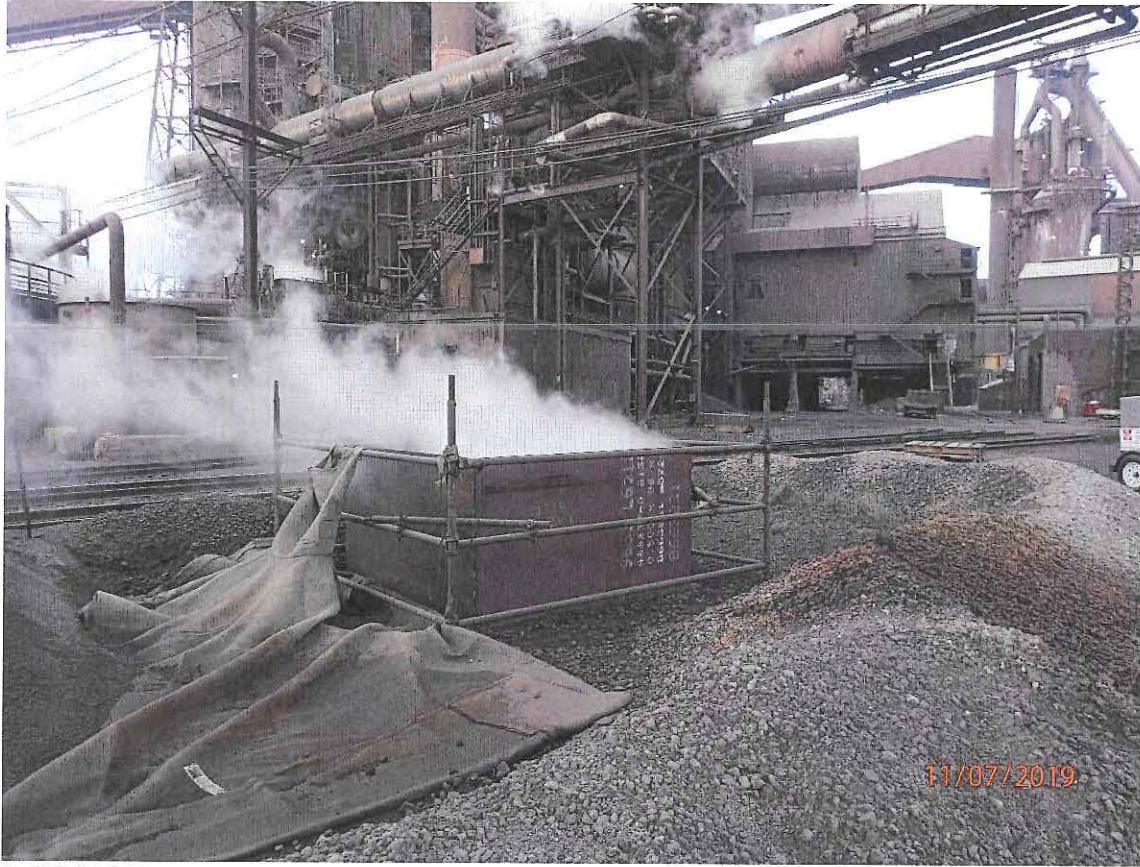
2: PB070002

EPA and IDEM inspectors then drove to a manhole that had a “top hat” installed on it. This manhole was located by the C Furnace. There was an additional dirt berm around the manhole. The top hat is intended to prevent flow from surging out of the manhole and to the ground around it.

Description: A manhole with a “top hat” installed on it to prevent releases from the manhole.

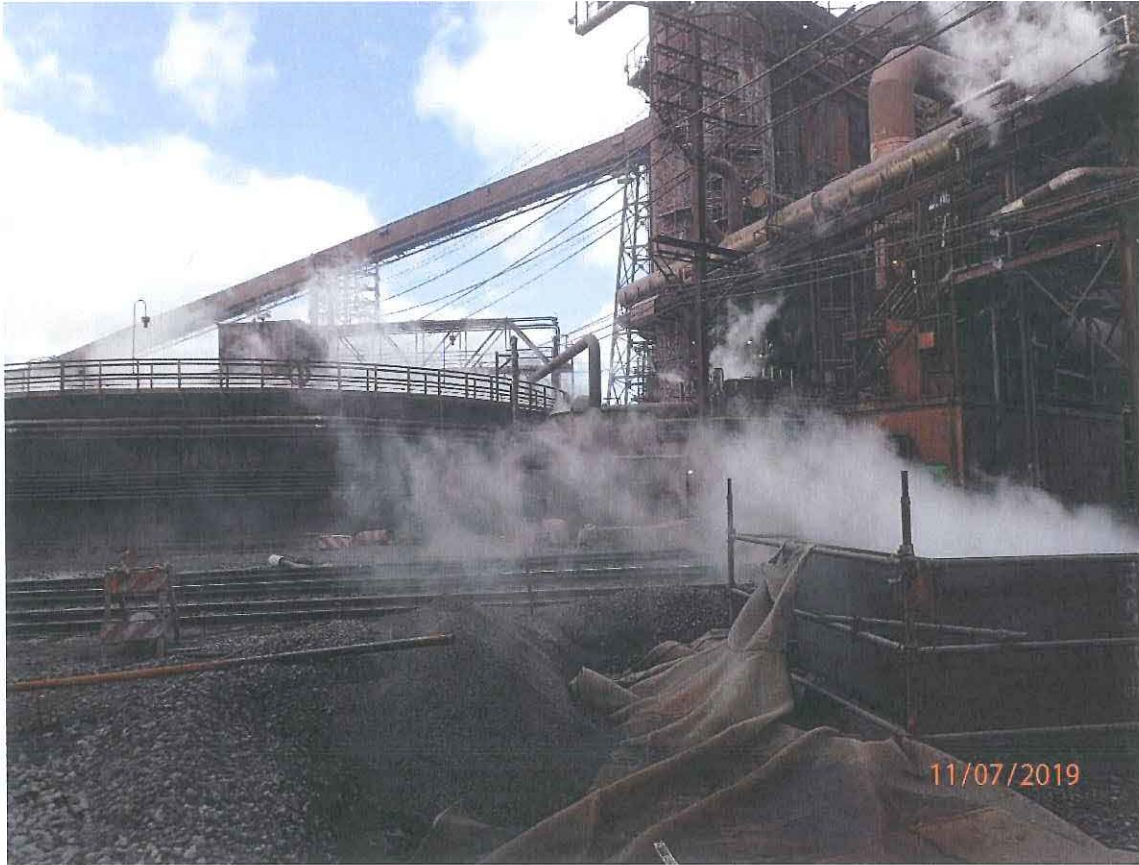
3: PB070003

Description: The “top hat” installed on the manhole was installed to prevent releases from the manhole.

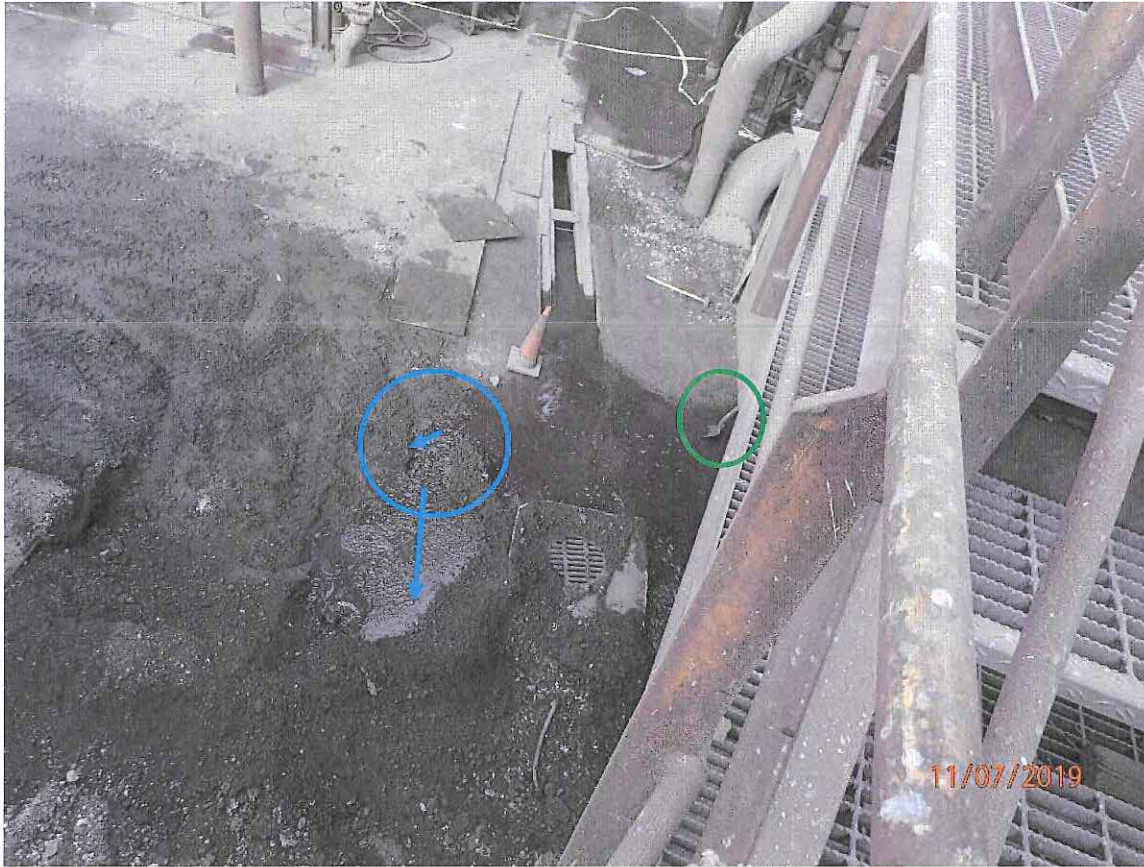
4: PB070004

While on the catwalk, the inspectors noticed that some pooled wastewater on the ground had broken through a dirt berm that appeared to have been built recently to contain it. EPA noticed a shovel leaning against the wall and tire tracks from a nearby skid steer around the area of the pooled water. There was also a manhole adjacent to the pooled water. Concerned about the water potentially going into the manhole, EPA and IDEM inspectors notified Ms. Kirk and she called other facility personnel. Later, this was explained to be a release of water from the Quick Dump Sump, which was beneath the manhole. The facility personnel stated that they were aware of this pooled water and that the whole area is concrete underneath so water could not percolate into the groundwater.

Description: Pooled water began breaking through a dirt berm and began flowing out of the pooled up area. Break in dirt berm is denoted by a blue circle and water flow is denoted by blue arrows. Facility personnel called other personnel about the flow. Later, this was explained to be a release of water from the Quick Dump Sump. The facility personnel stated that they were aware of this and that the whole area is concrete underneath.

There was flow from the flume channel to this area and the manhole in the photo is elevated from the pooled water area by several inches. EPA observed a shovel, a skid steer, and skid steer tire tracks nearby that indicated recent work had been done in this area. The shovel is leaning up against a wall. A green circle denotes its location in the photo.

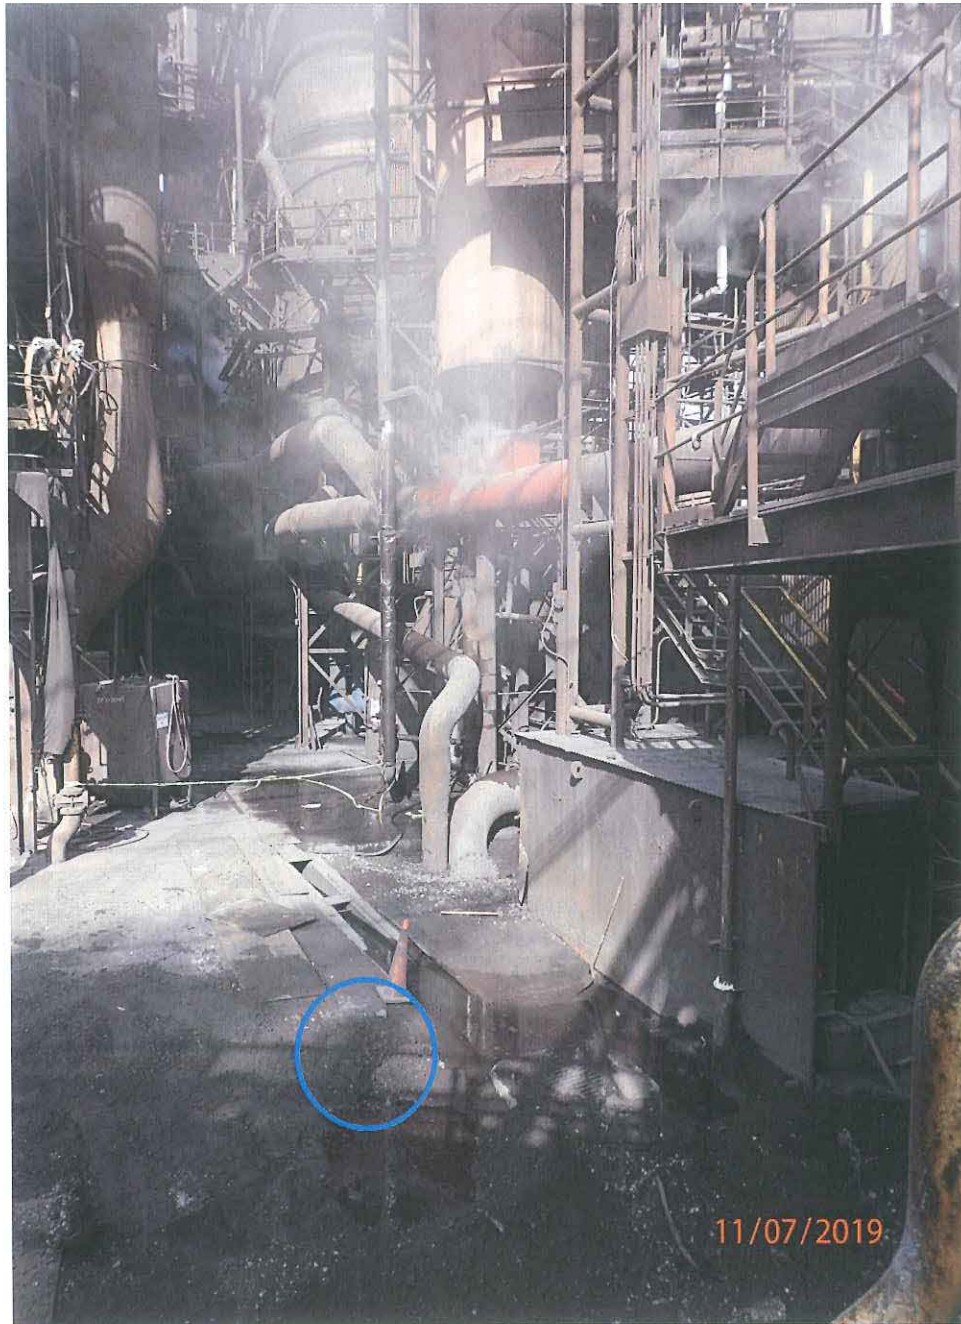
5: PB070005

Description: The leak from the Quick Dump Sump as observed from the ground. The blue circle denotes the location of the breach in dirt berm.

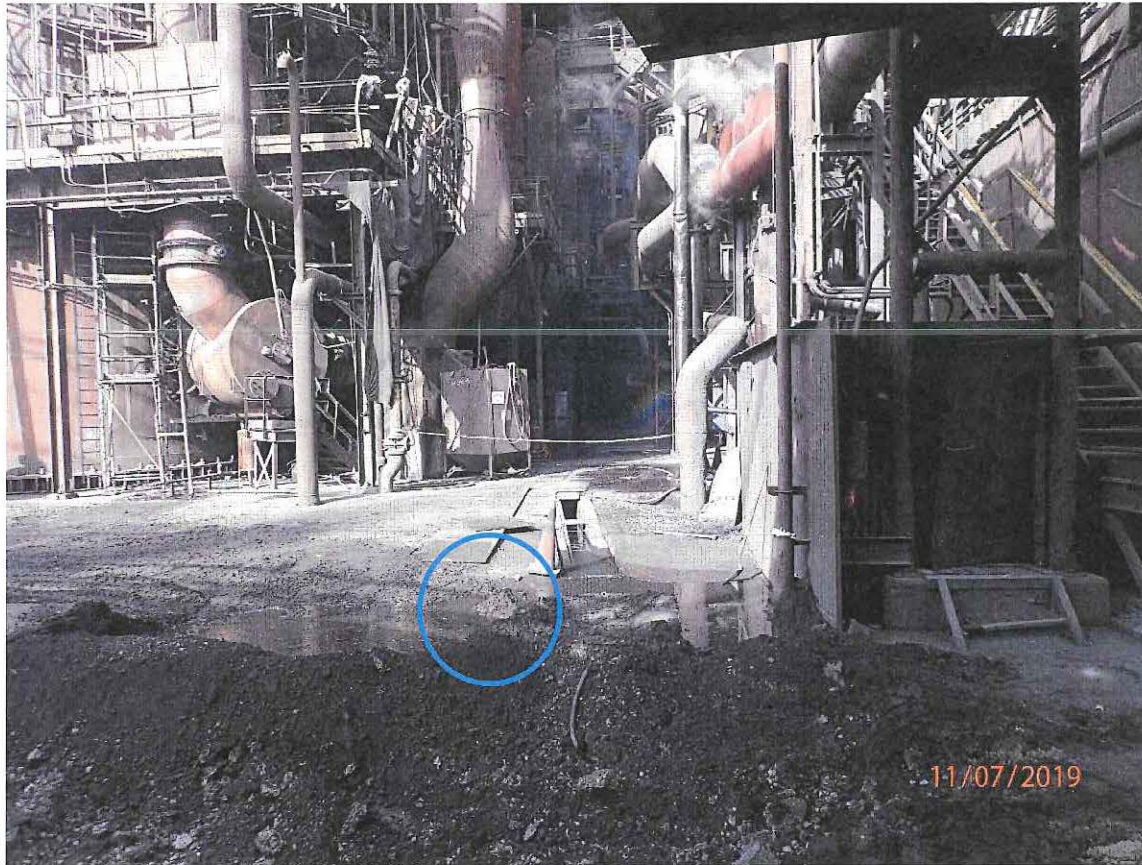
6: PB070006

Description: The leak from the Quick Dump Sump as observed from the ground. The blue circle denotes the location of the breach in dirt berm.

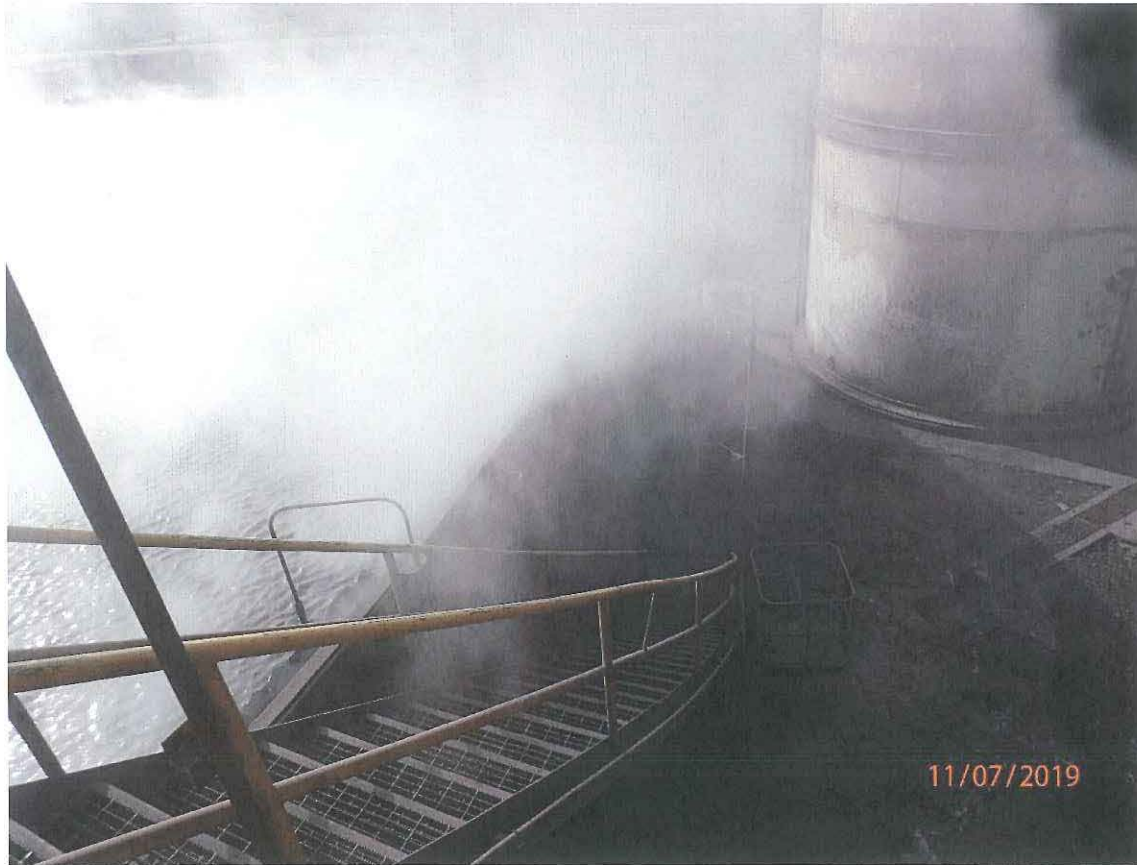
7: PB070007

Description: Effluent from the Final Thickener goes to the Secondary Wastewater Treatment Plant.

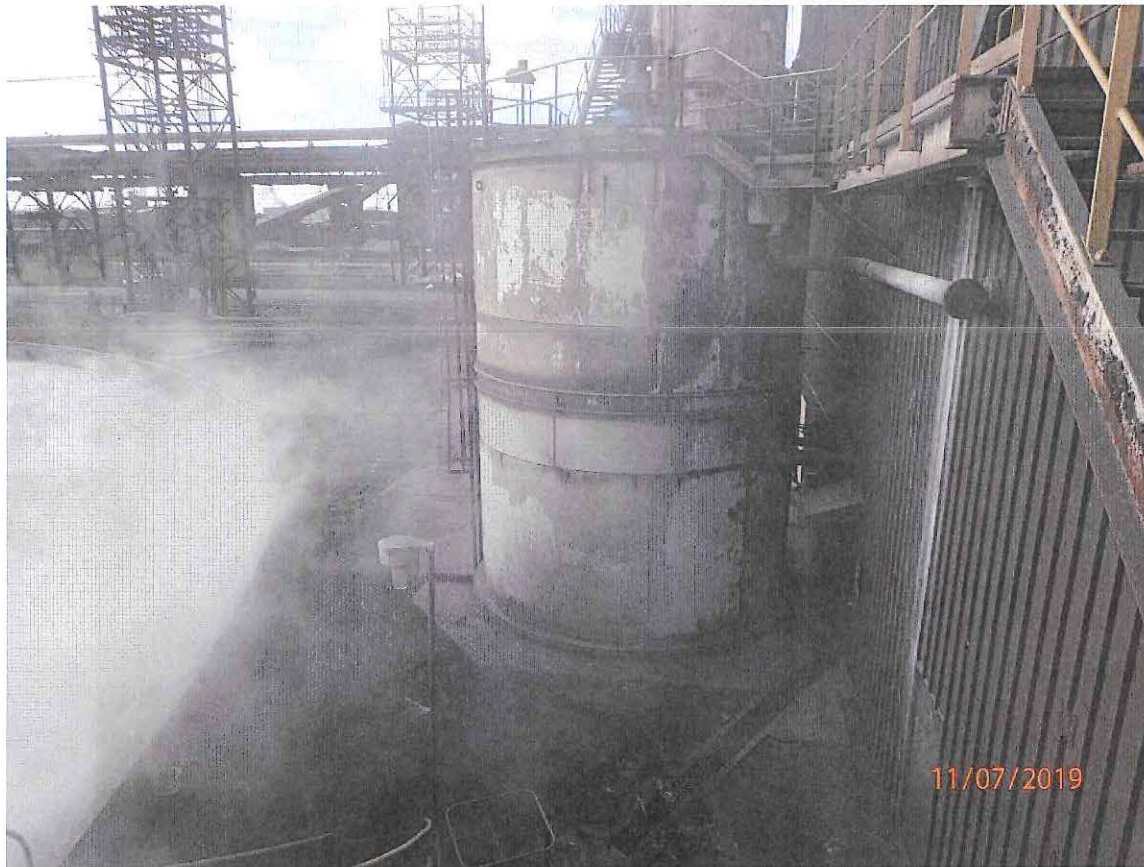
8: PB070008

Description: The Hi Cap Thickener receives Basic Oxygen Furnace scrubber water.

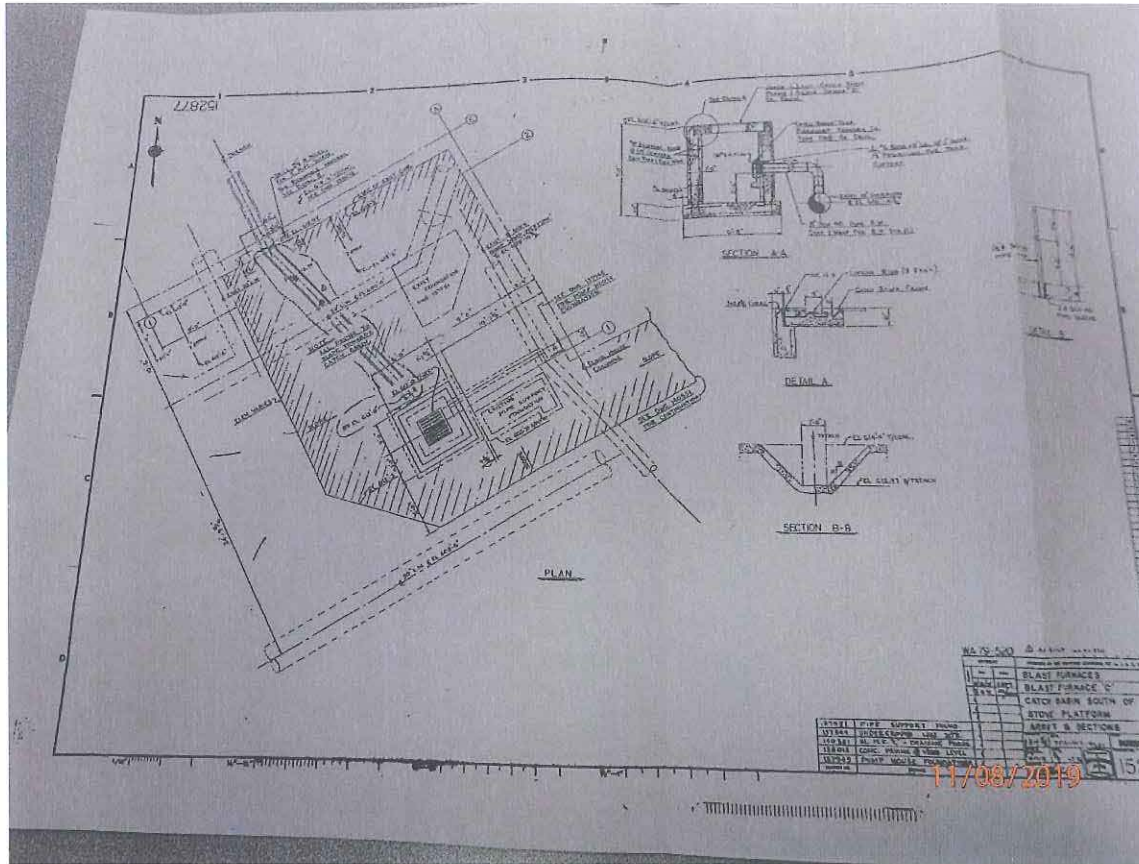
9: PB080009

Ms. Kirk began the meeting by producing an engineering drawing of the area around the slag pits. The engineering drawing has hatch marks around the catch basin that EPA and IDEM inspectors saw pooled water near the manhole on the previous day. Ms. Kirk stated that the hatched area on the drawing represented concrete, although there is no legend item stating that.

She stated that the area was lined with concrete in 2008.

Description: Facility personnel provided an engineering drawing of the area around the Quick Dump Sump showing that the area was concreted. Facility personnel stated that hatched areas on drawing indicated that there was concrete underneath.

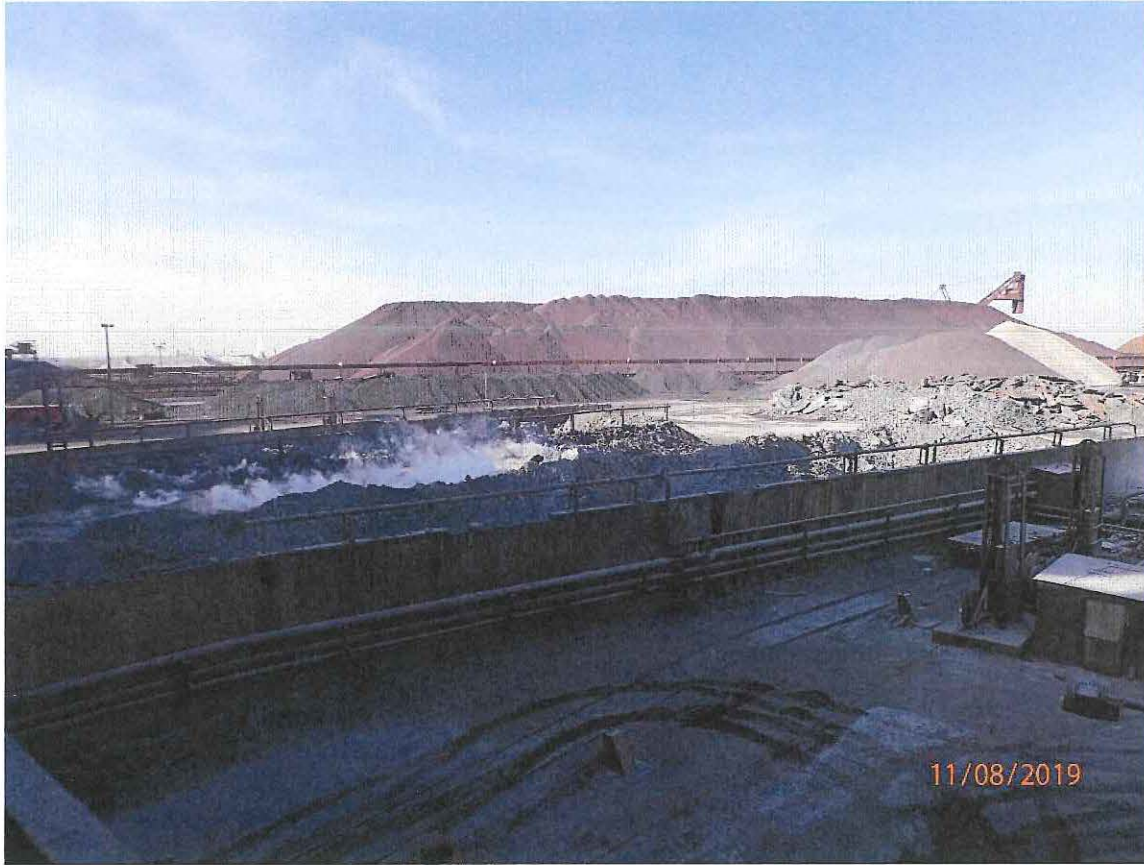
10: PB080010

At 11:30 A.M., EPA and IDEM inspectors followed the AMBH personnel to the Blast Furnace area and observed the East Cast Furnace. At the time of the inspection, the facility was not casting steel. EPA and IDEM inspectors also observed the Slag Quench Pit adjacent to the East Cast Furnace and the flow from the Slag Quench Pit. The effluent from the Slag Quench Pit flows via gravity to the far end of the pit and to a sump. A pump in the sump pumps the flow to the Quick Dump Sump.

Description: Slag is quenched in the Slag Quench Pit and effluent from the Slag Quench Pit flows via gravity to the far end of the pit and to a sump. A pump in the sump pumps the flow to the Quick Dump Sump.
