# Design Investigation Report

Cline Avenue Oil Spill Site  
Gary, Indiana

Glenn Springs Holdings (GSH)

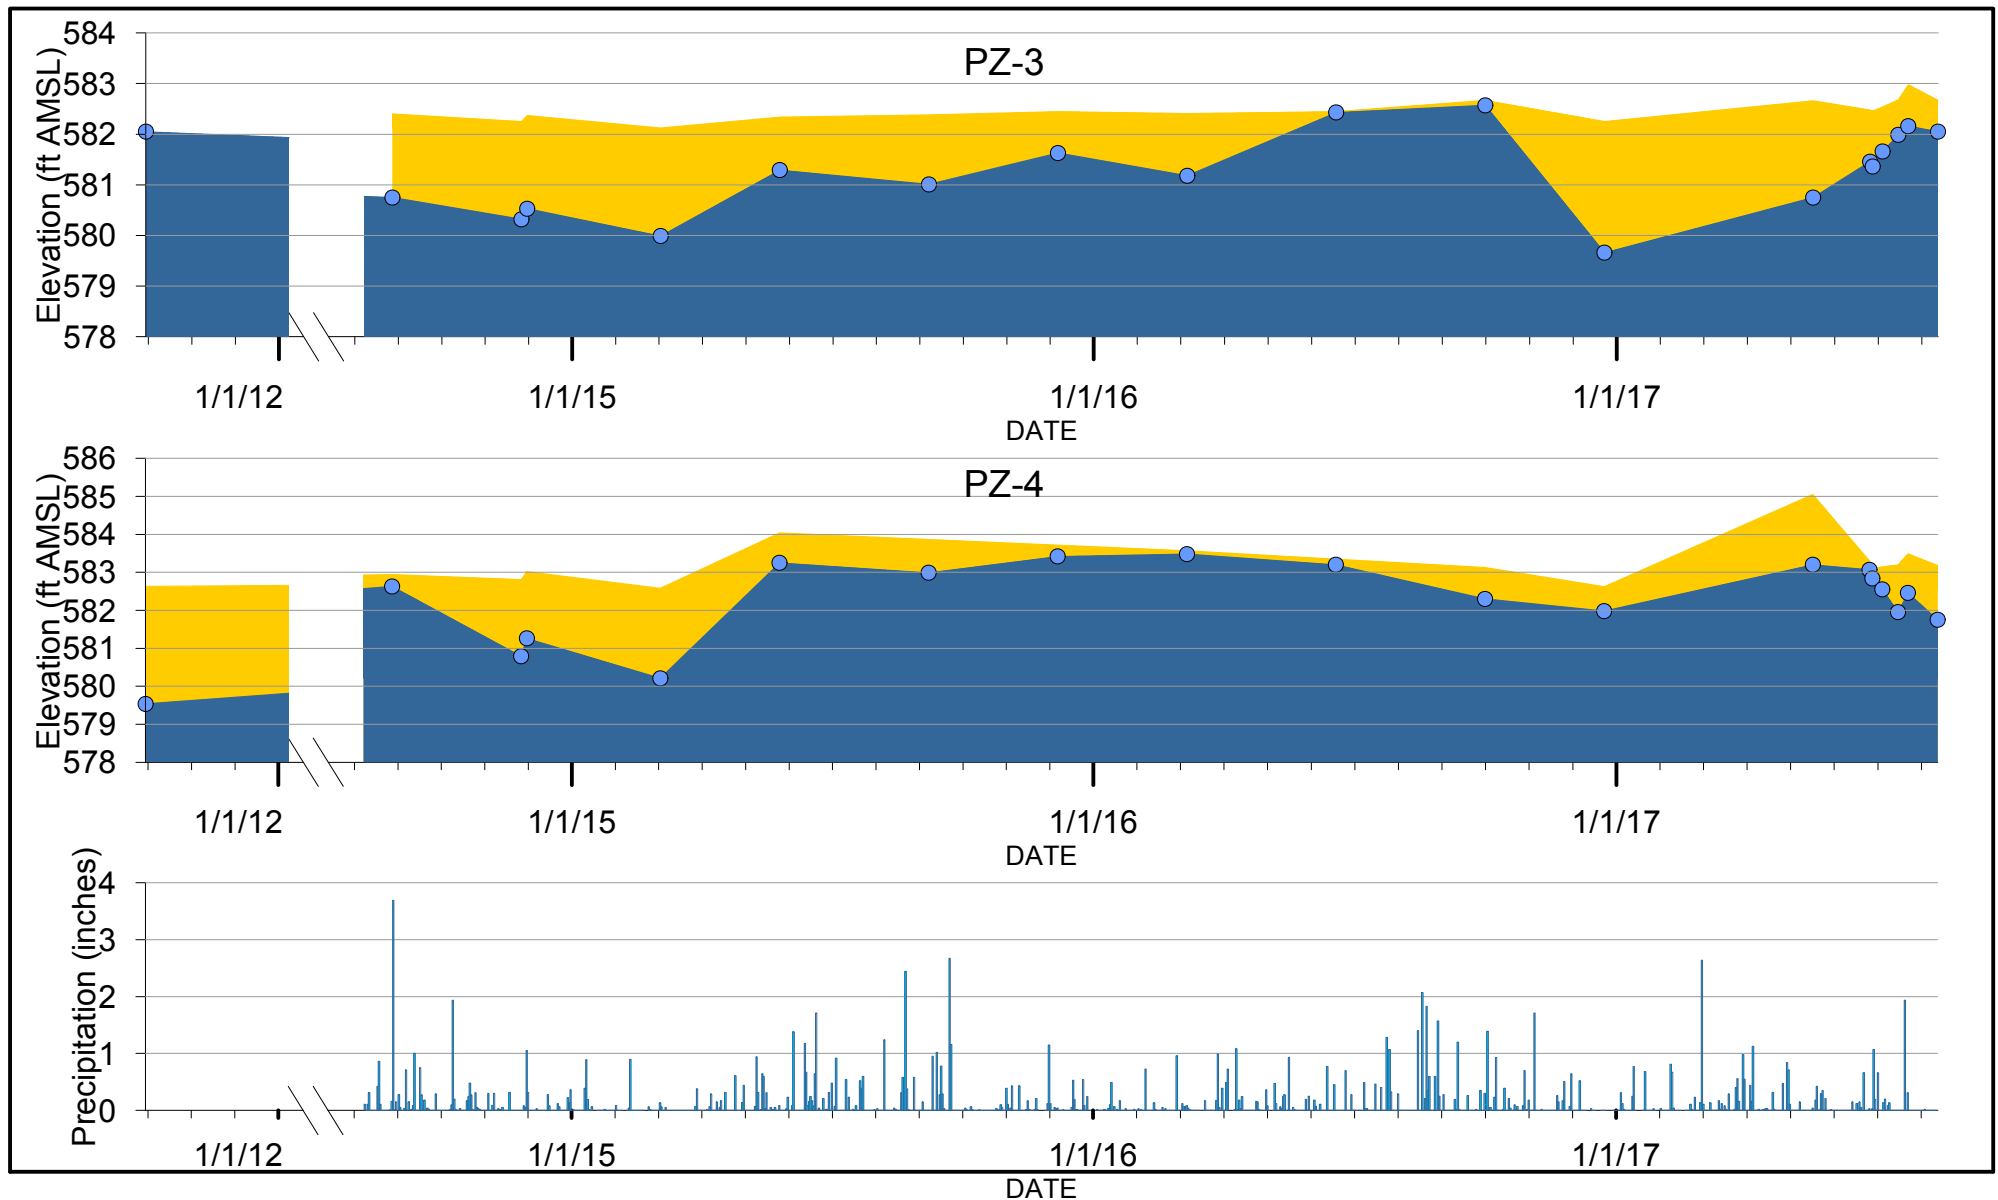
FIGURE 2.2

IN-WELL LNAPL THICKNESS AT PZ-3 AND PZ-4

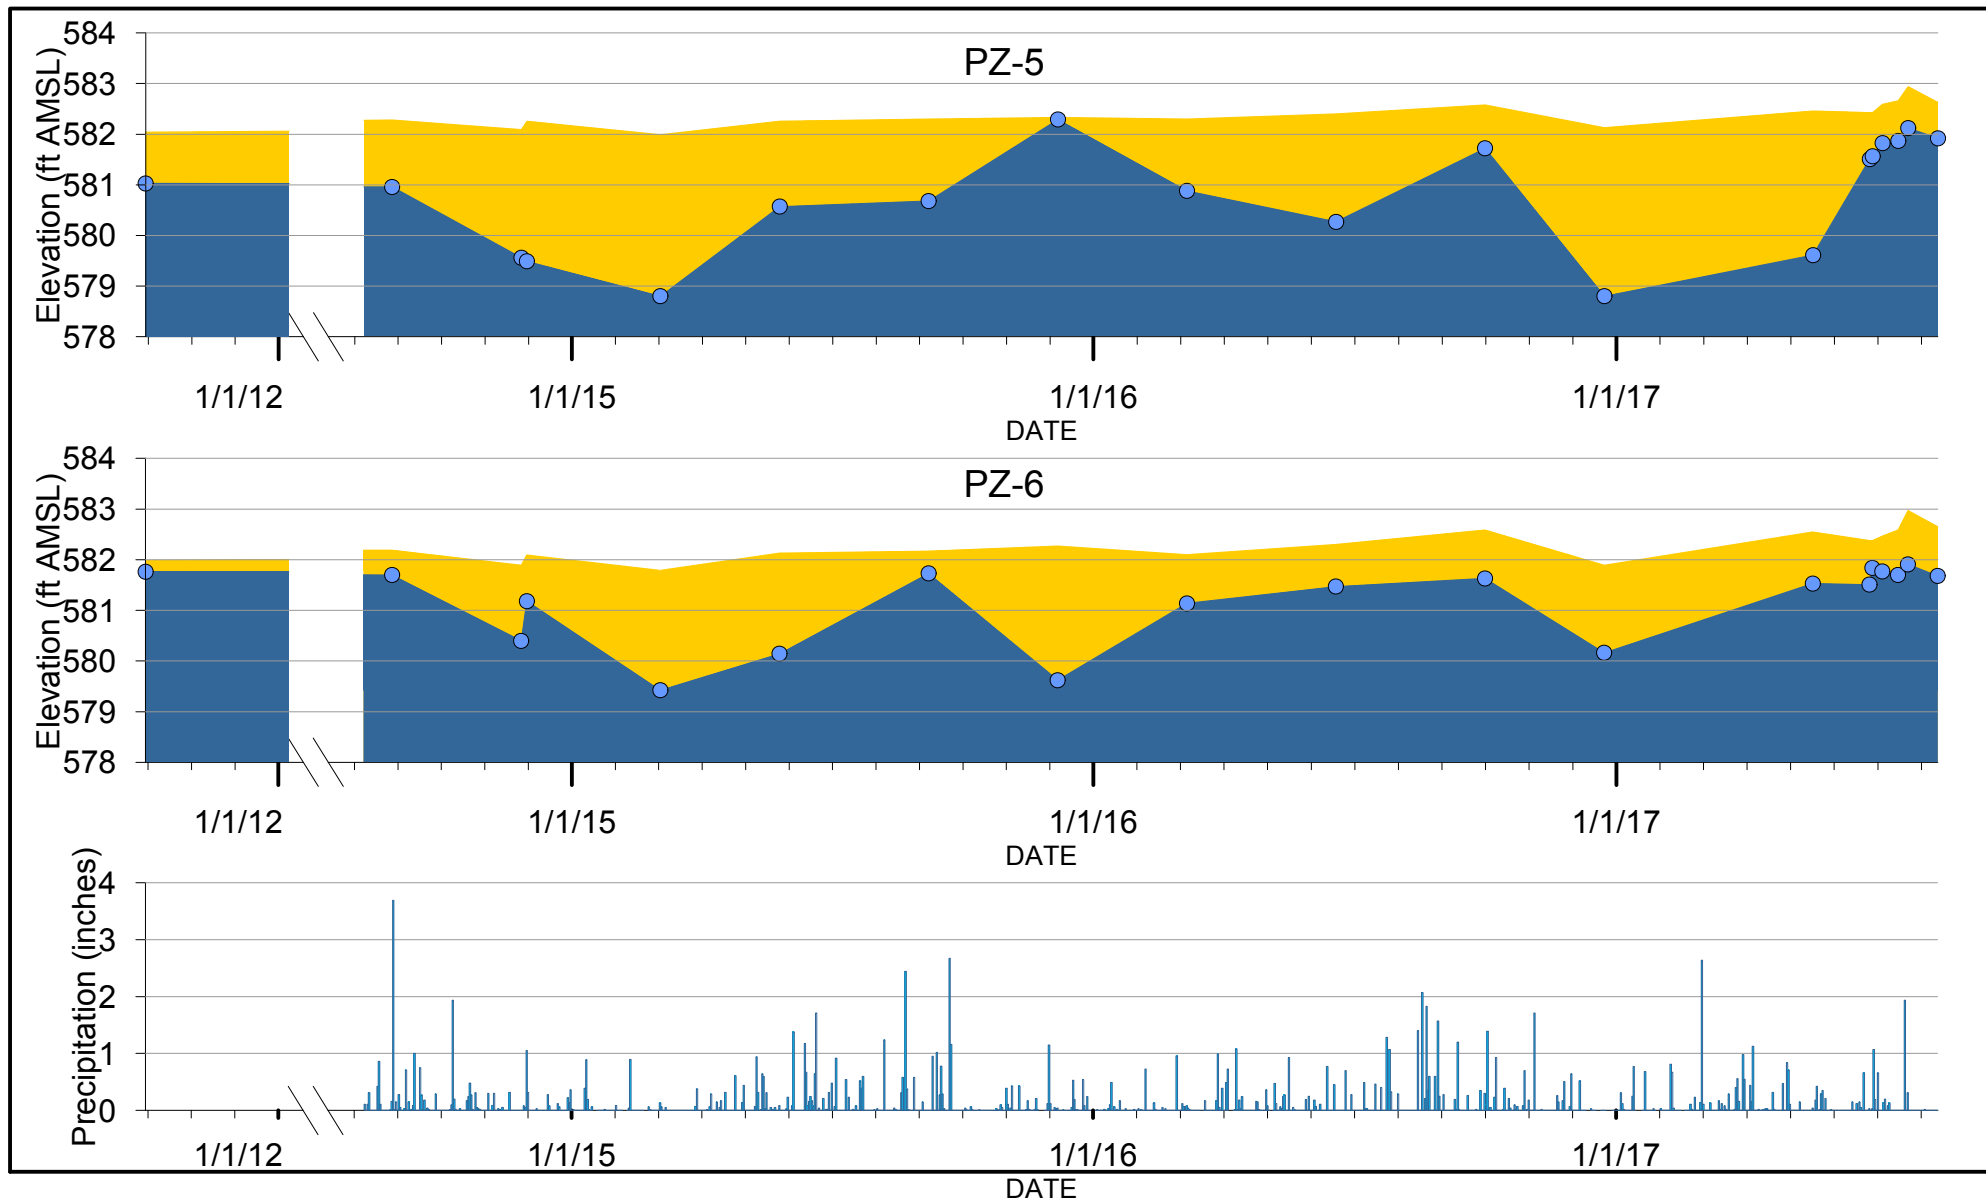
FIGURE 2.3

IN-WELL LNAPL THICKNESS AT PZ-5 AND PZ-6

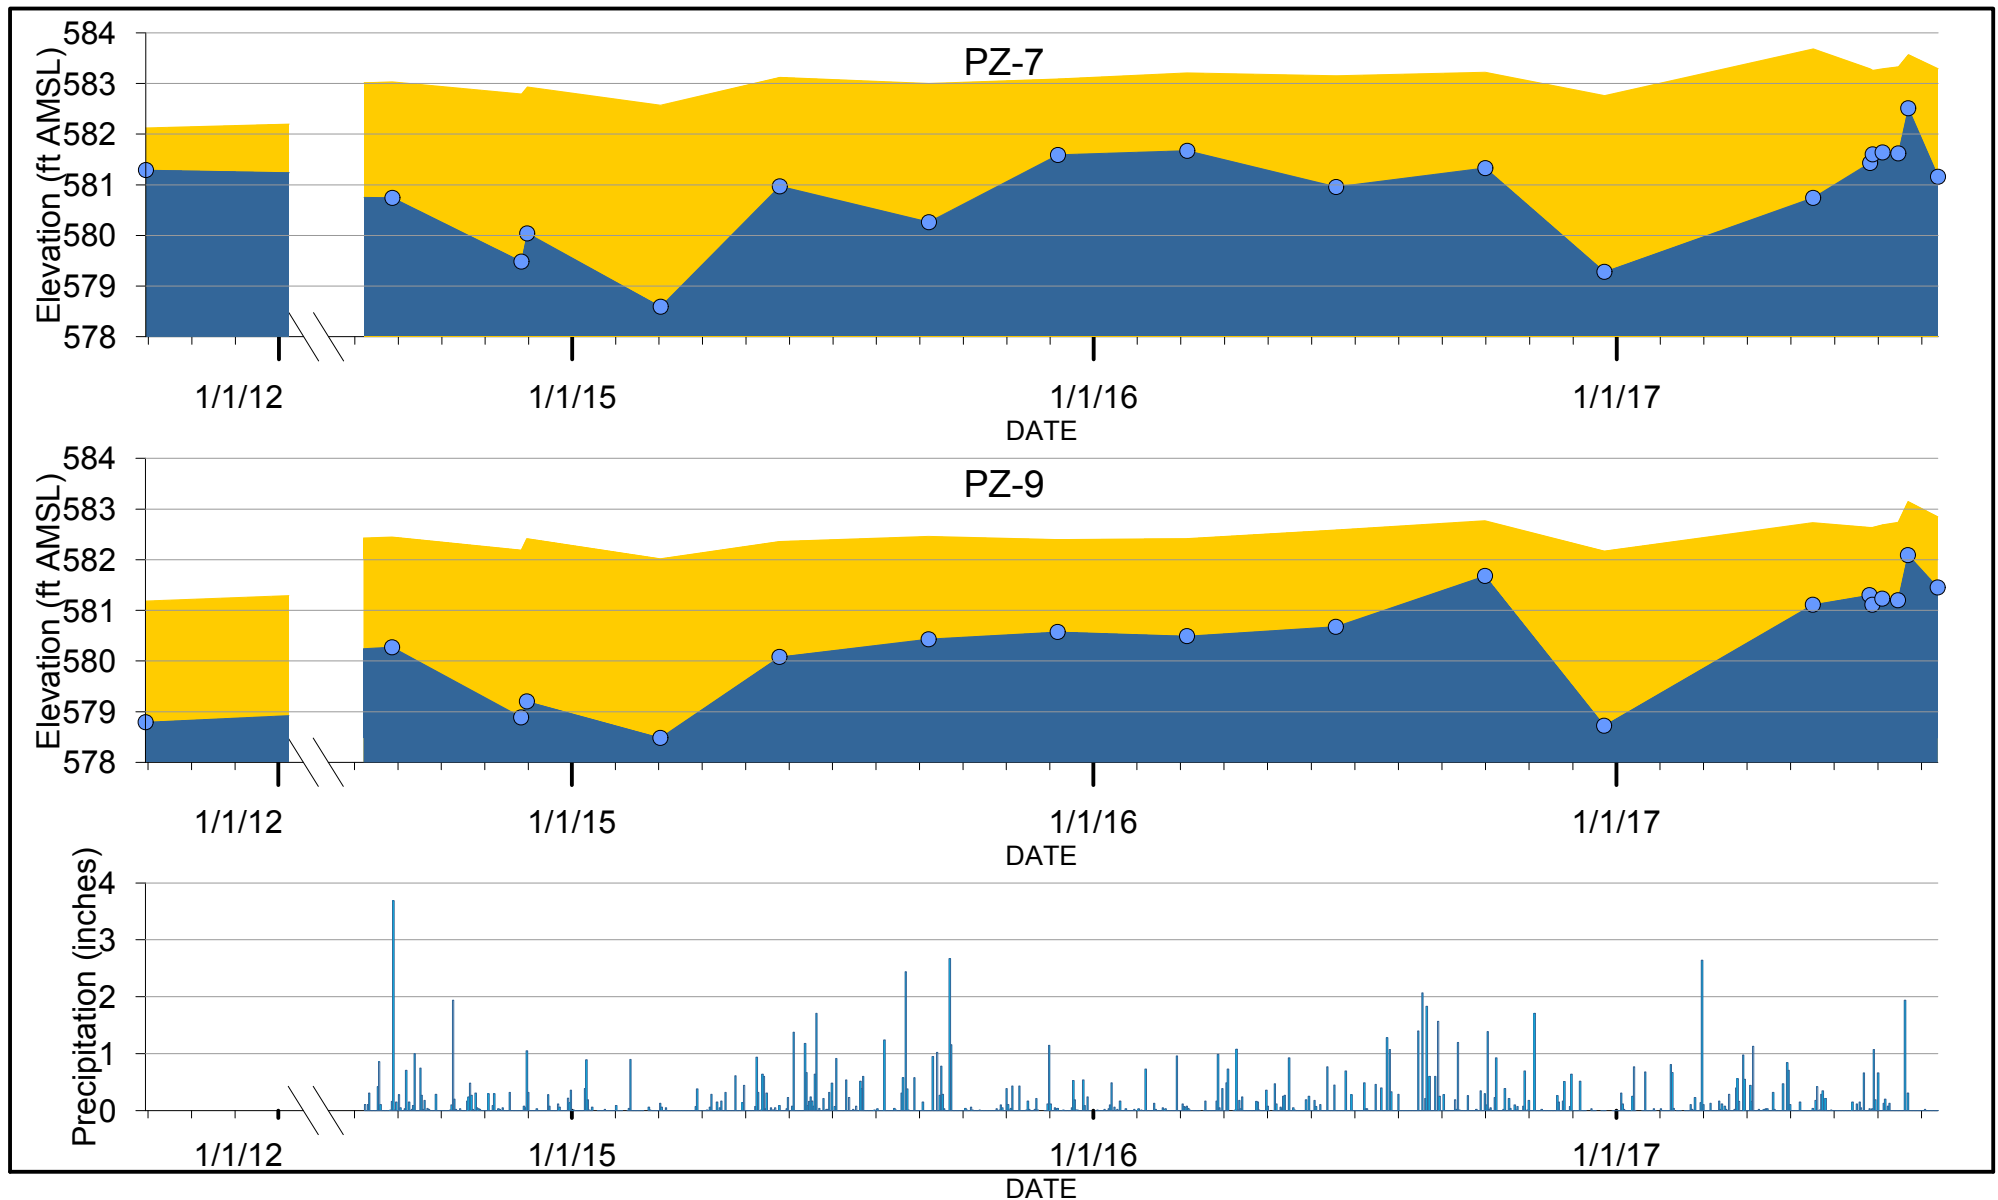
FIGURE 2.4

IN-WELL LNAPL THICKNESS AT PZ-7 AND PZ-9

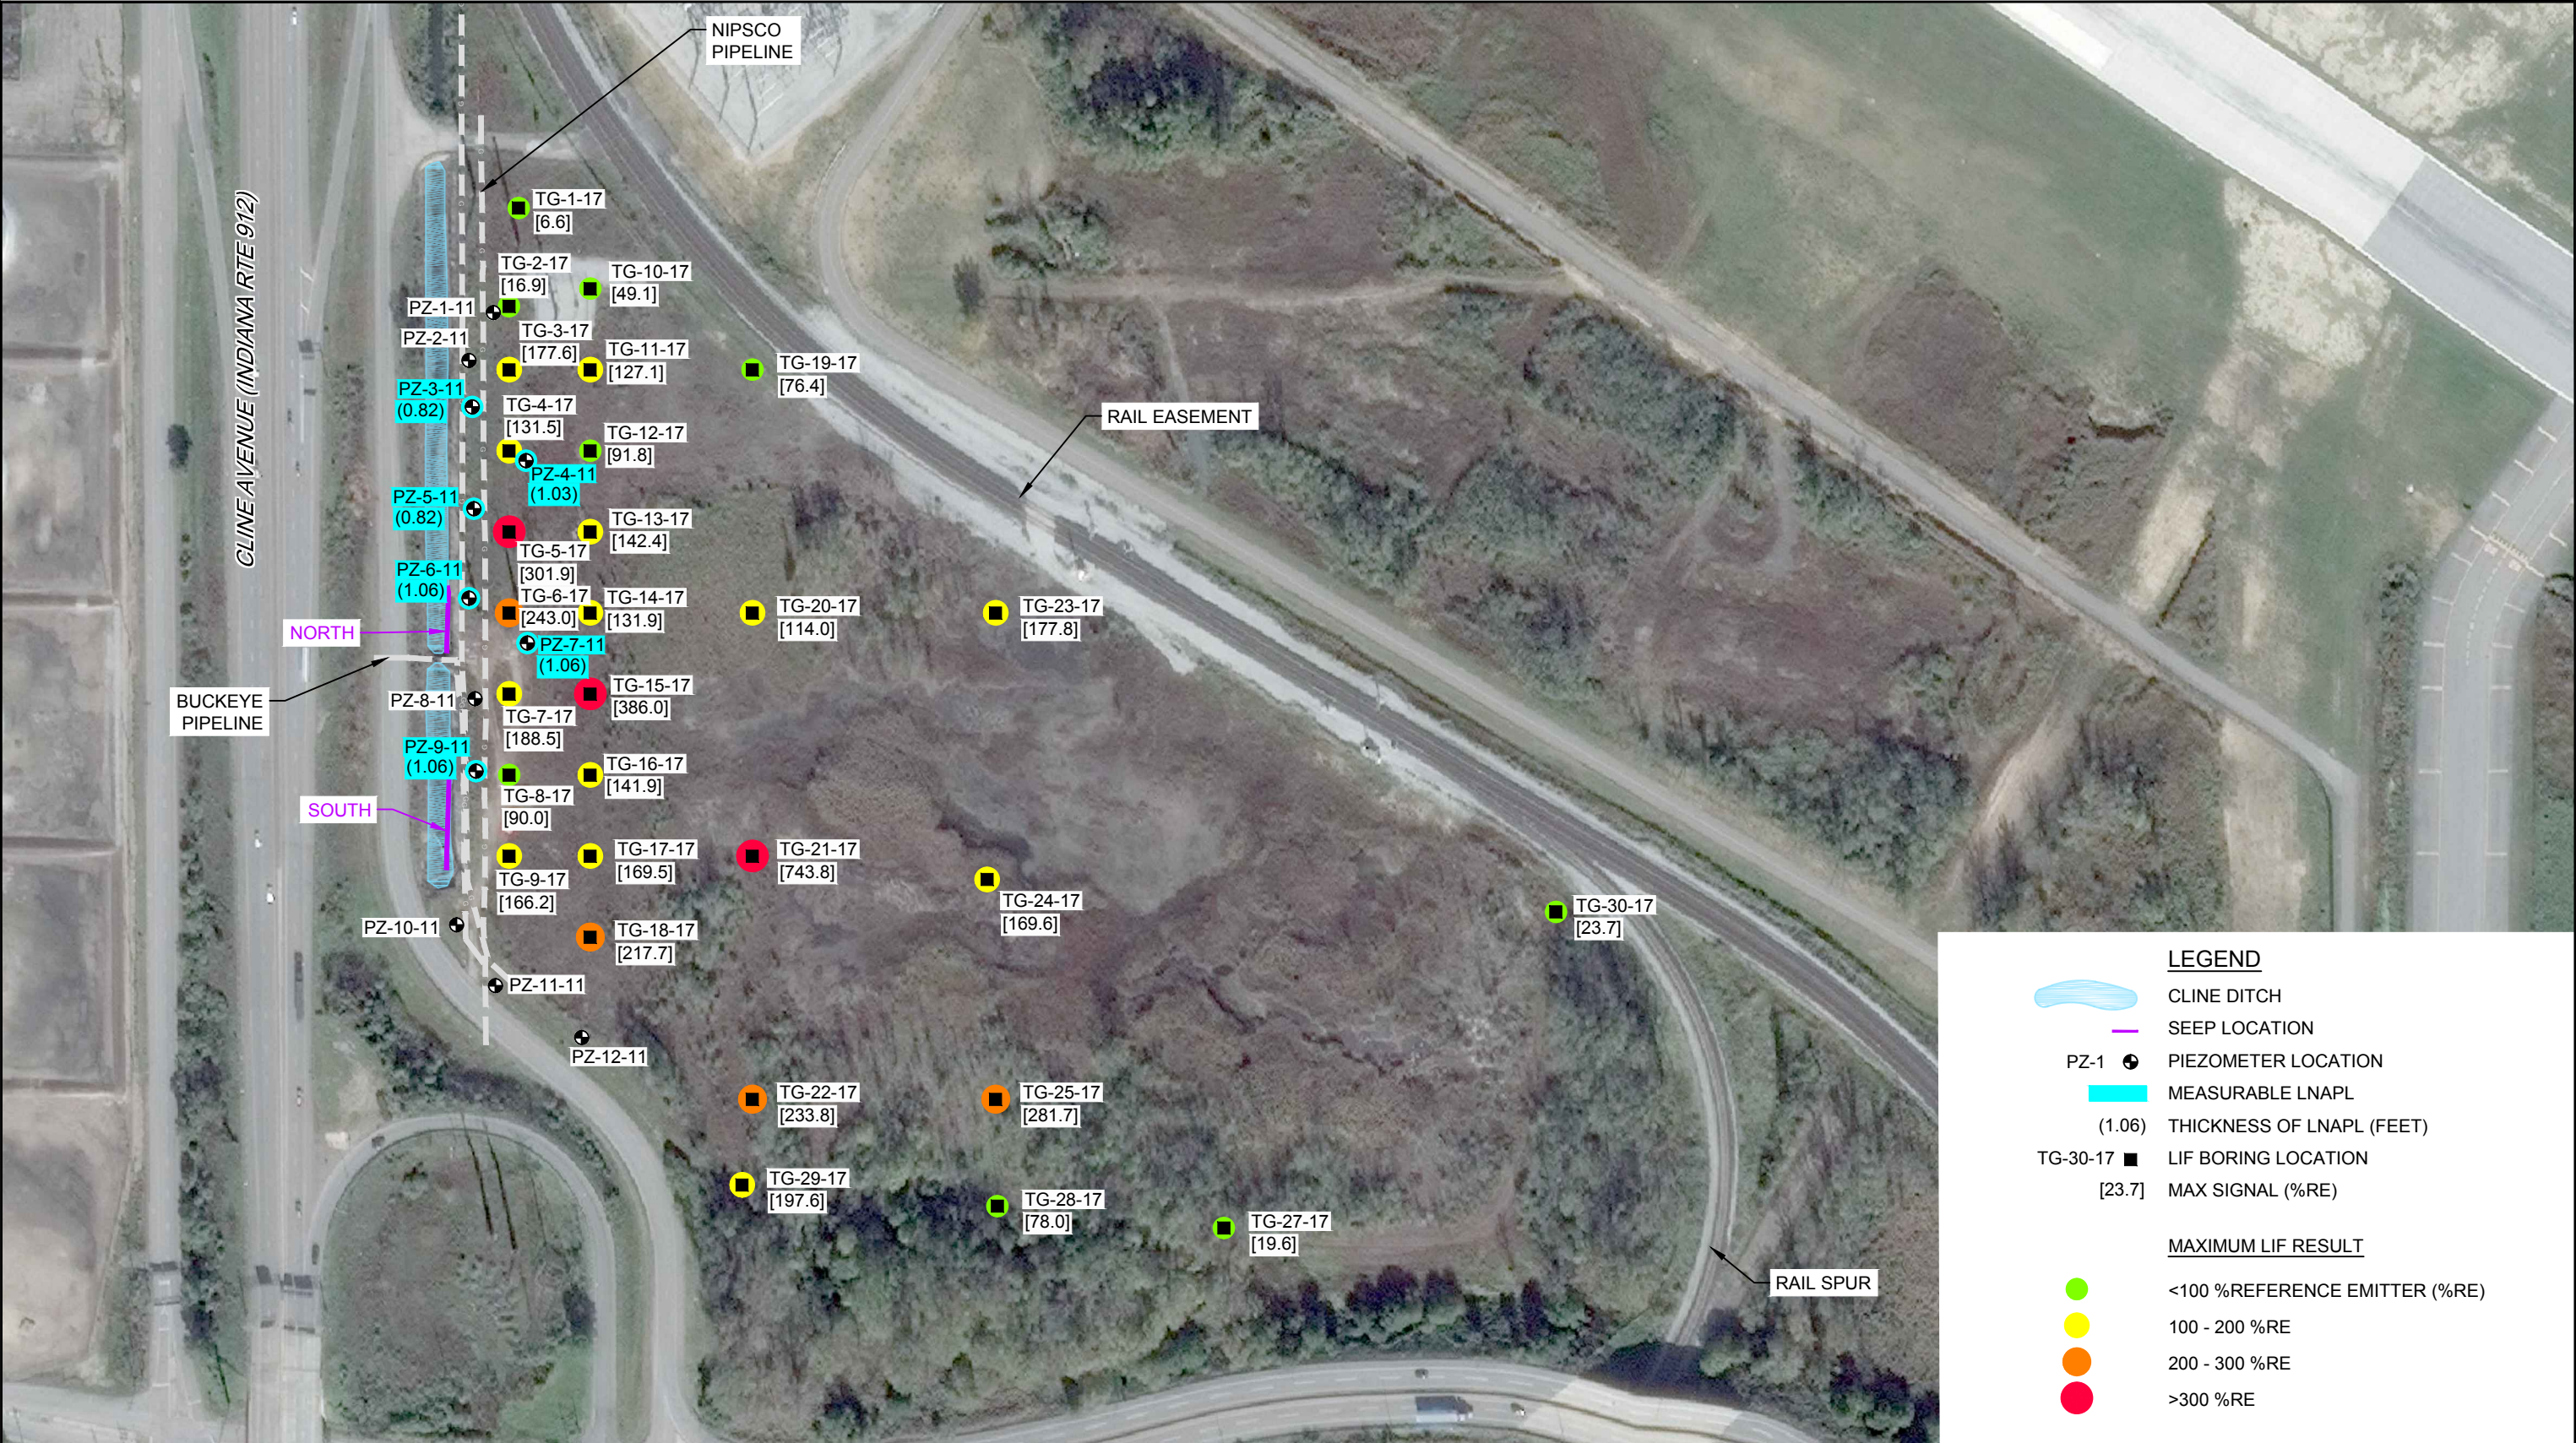
FIGURE 2.5

The LIF boring locations and maximum response at each boring is presented on Figure 2.5. The %RE ranged from 6.6 to 744, confirming the typical scenario of highly variable LNAPL saturation levels across an old LNAPL site. The highest %RE was observed at TG-21-17 (approximately 300' east of the ditch). Other elevated %RE readings were not consistent with a single source area which may indicated multiple source events or preferential migration pathways for the LNAPL. It is noted that the spacing of the LIF points in the Site interior was large enough that additional

investigation may produce results that adjust this interpretation. The northern, eastern, and southern boundaries of the investigation had lower %RE.

The intensity of the responses broadly indicates residual hydrocarbon saturation levels. Most of the hydrocarbon responses, including some of the highest responses, are below the water table, which typically signifies that the LNAPL is largely immobile residual. This suggests that much of the impact to the ditch is resulting from residual LNAPL impacts in the vicinity of the ditch, and is not due to bulk movement of LNAPL from the interior of the Site towards the ditch currently.
