Subject: November 16, 2020 and November 19, 2020 Inspection Report for ArcelorMittal Burns Harbor, NPDES Permit Number IN0000175

1. BACKGROUND

Attachment A
ArcelorMittal Burns Harbor
EPA Inspection November 16, 2020 and November 19, 2020
All photos taken by Joan Rogers, Environmental Scientist, U.S. EPA
Camera: Olympus TG-4

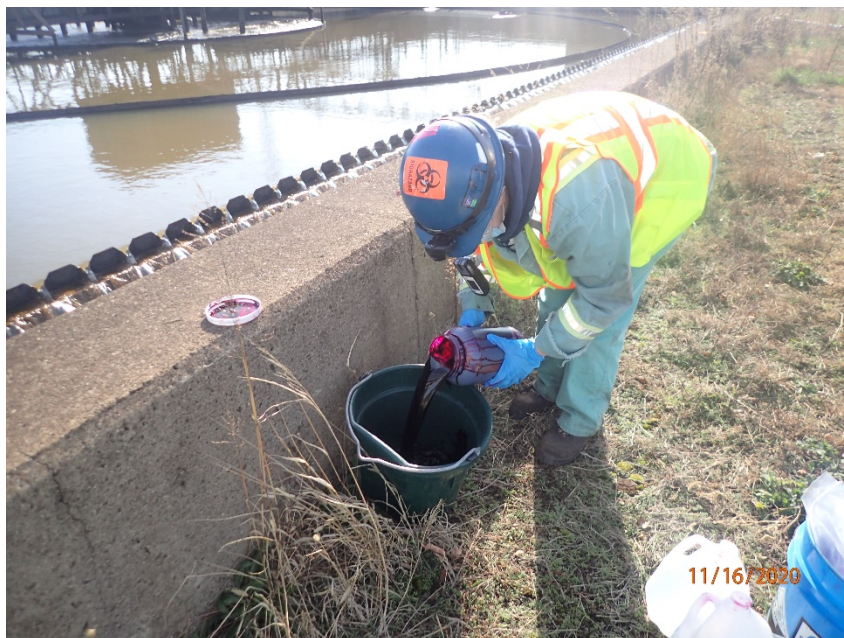
1: PB160001

Description: Pouring the dye into a bucket with water before introducing it to the system.

Location: Secondary Wastewater Treatment Plant (SWTP).

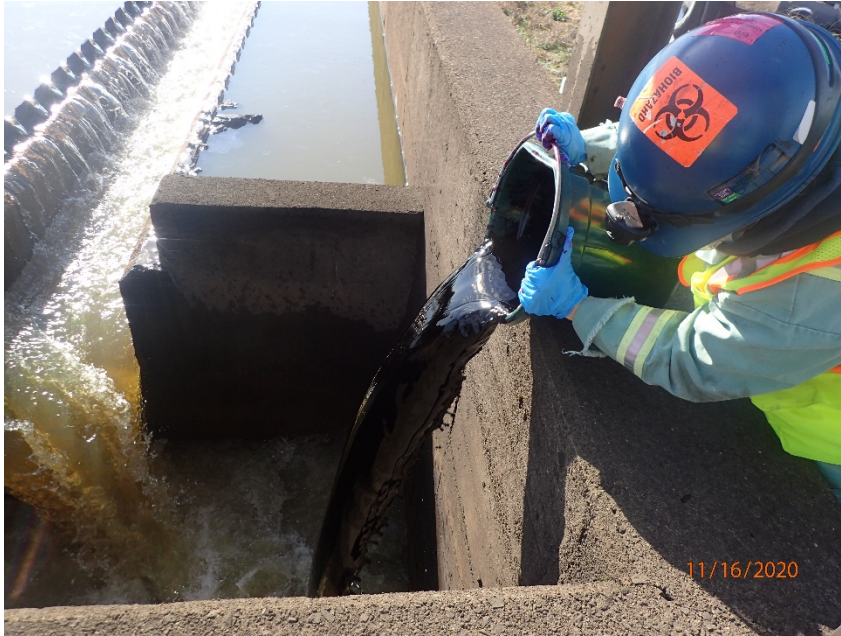
2: PB160002

At 10:13 A.M., the dye was introduced into the effluent channel and the effluent turned pink. By 10:20 A.M., dye could not be observed with the eye in the effluent channel.

Description: Pouring the dye into the effluent channel at the SWTP.

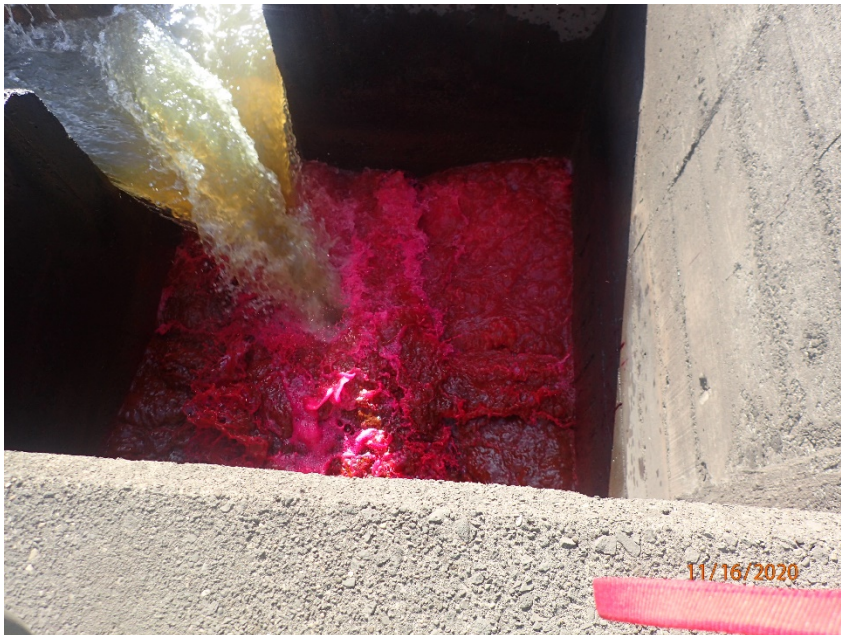
3: PB160003

Description: Effluent color is changed from the dye.

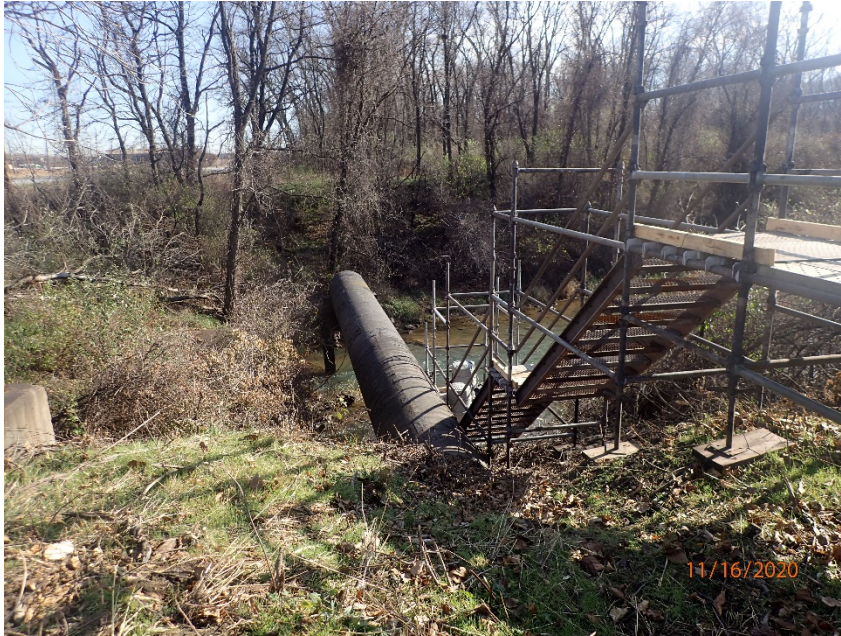
4: PB160004

Description: The location of sampler SD-16c in the Storm Ditch.

Location: Storm Ditch south of Highway 12.

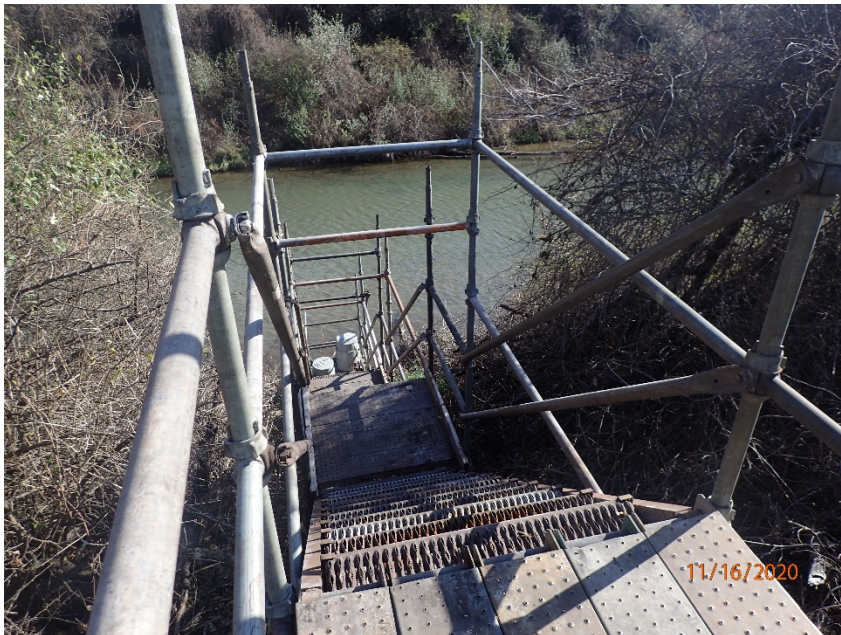
5: PB160005

Description: The location of sampler SD-17 in the Storm Ditch.

Location: Approximately 500' south of Highway 12.

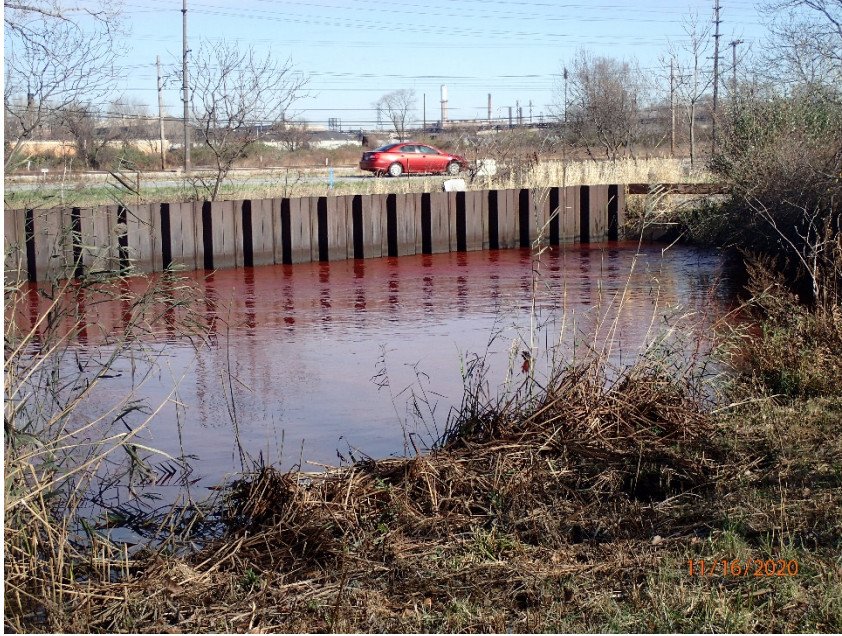
6: PB160006

After observing location 2, EPA observed that the water in the effluent channel leading to the lagoons was tinted pink. EPA did not observe any pink tint in any of the Storm Ditch locations.

Description: The color of the effluent in the channel before the lagoons has changed as dye reaches this location.

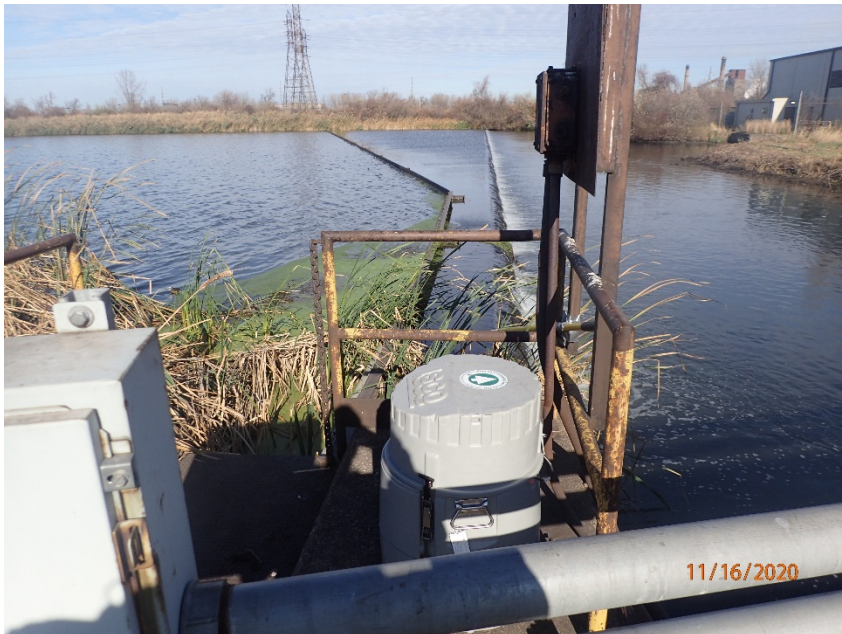
7: PB160007

Description: Location of sampler named North Lagoon Discharge (NLD).

Location: Southeast corner of the North Lagoon.

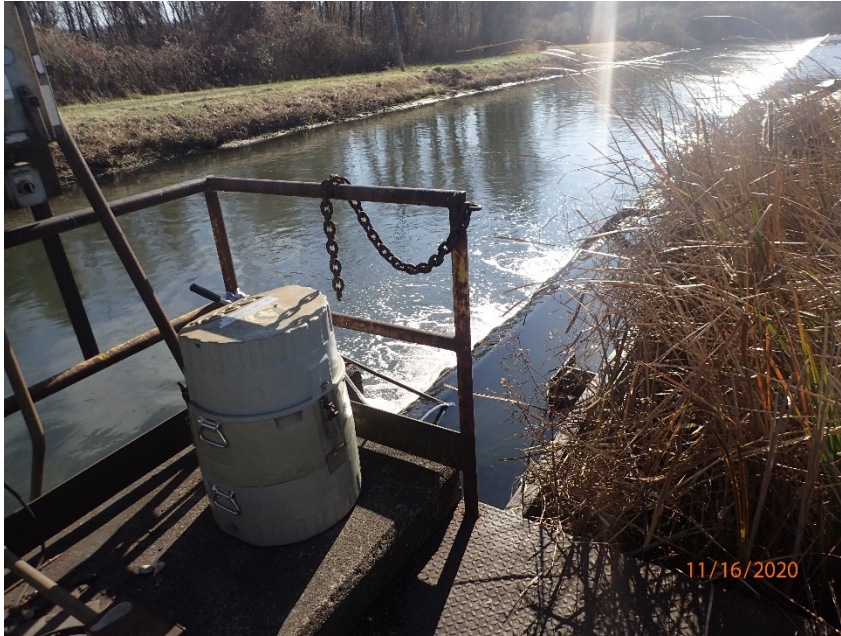
8: PB160008

Description: Location of sampler named South Lagoon Discharge (SLD).

Location: Northeast corner of the South Lagoon.

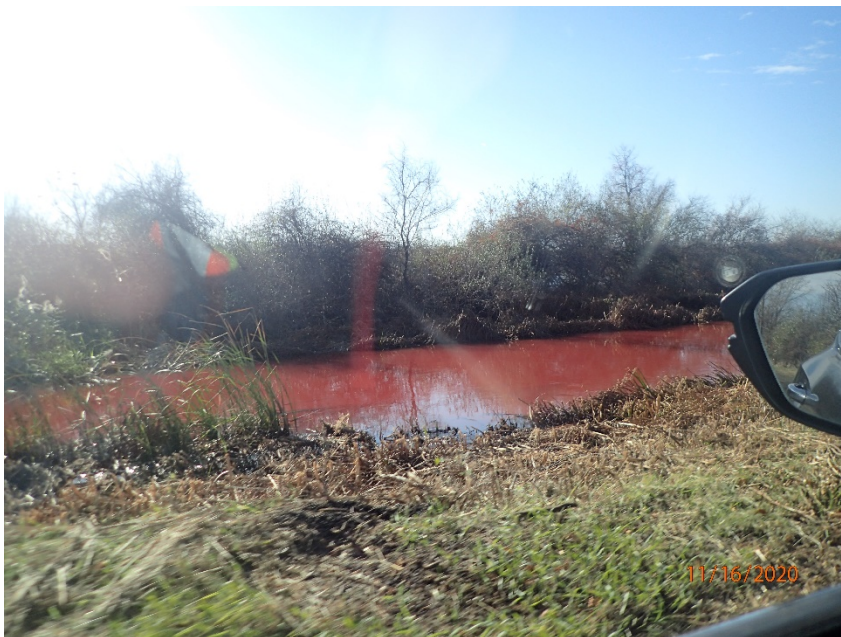
9: PB160009

Description: The color of the effluent in the channel before the lagoons has changed as dye reaches this location.

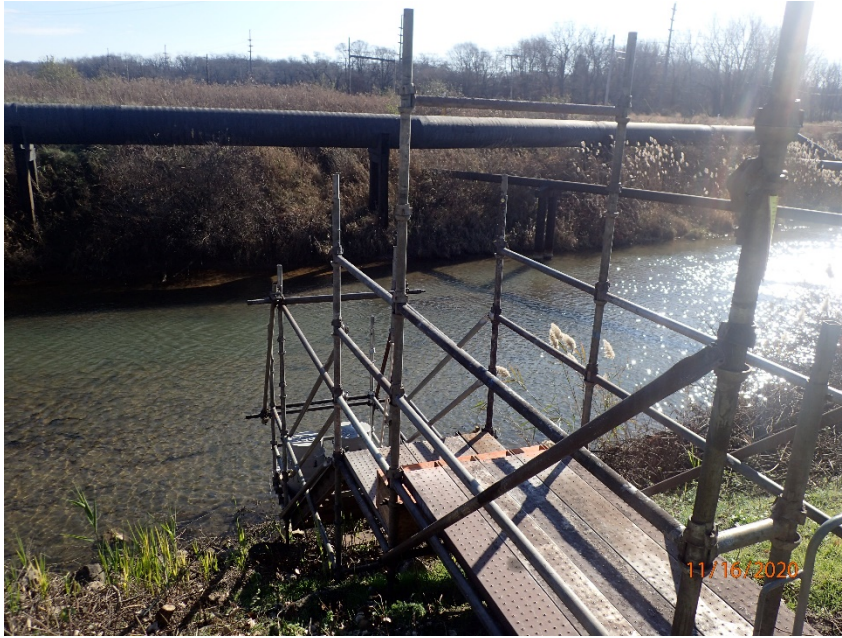
10: PB160010

Description: The location of sampler SD-16a in the Storm Ditch.

Location: Storm Ditch north of Highway 12.

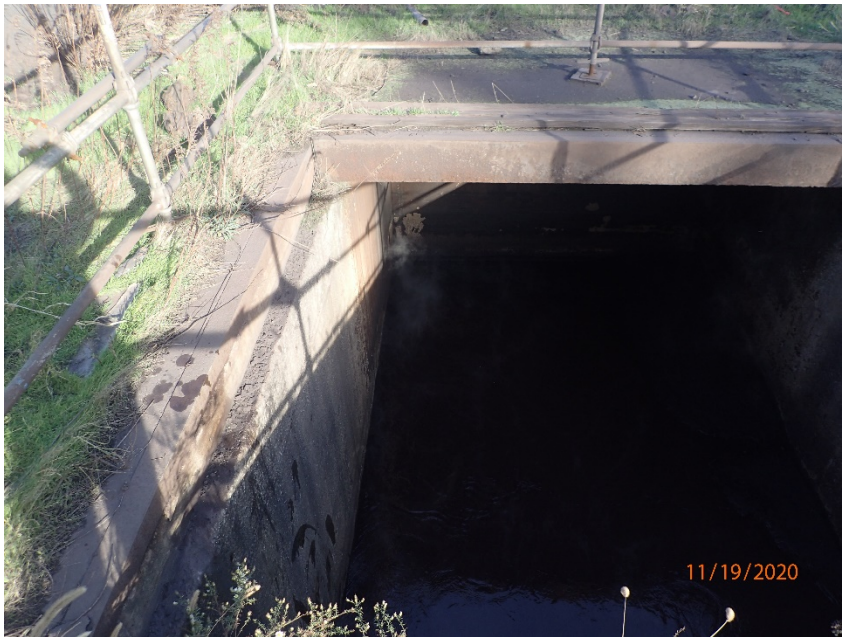
11: PB190011

Mr. Oxsalida then noted the BFRS Hot Well level was at 603.3' Above Sea Level, information he observed from the control screen in the lab by the cyanide destruct cells. At 603.3' Above Sea Level, the level of the water in Manhole 2114 was above the seals for the connection pipe to Outfall 002, but below the top of the standpipe. If the seals for the connection pipe to Outfall 002 were sound, there would be no introduction of wastewater to Outfall 002 from this manhole.

The concentration of dye from Sample Location #00 was 53.9 ppb. This was less than the concentration of dye after the initial introduction of dye, which was at 64 ppb. The concentration of dye from the Sample Location #13 was 84.1 ppb.

Description: Taking a sample from sample location #00 to analyze for concentration of dye. The standpipe overflow is in this manhole. Water was not flowing into the standpipe.

Location: Manhole 2114 – Vault with standpipe overflow.

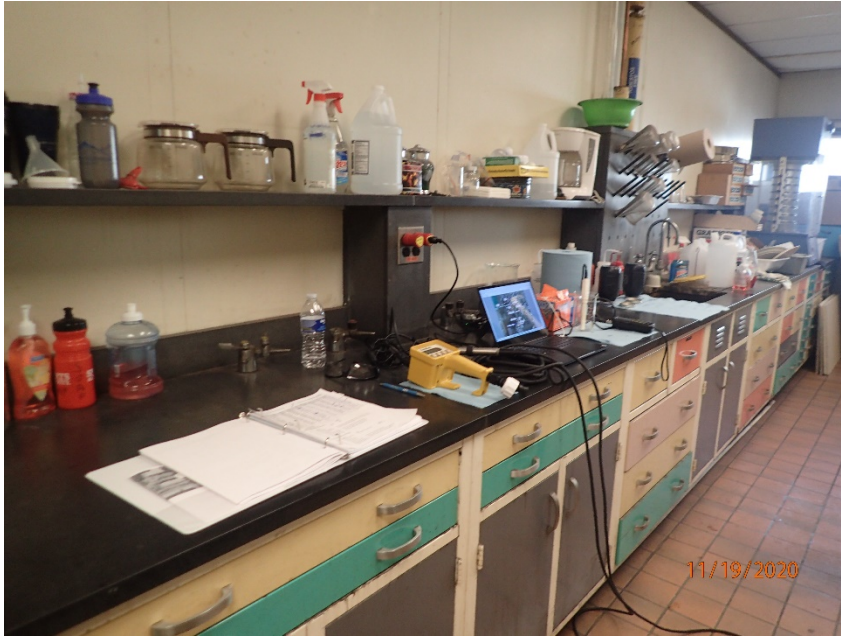
12: PB190012

In the lab, Mr. Oxsalida analyzed the two samples taken from Sample Locations #00 and #13 for concentration of dye, conductivity and pH. Mr. Oxsalida used a fluorometer which was calibrated daily against a standard and a blank. EPA observed the calibration logs.

Description: Lab set up for analyzing for dye, pH, and conductivity.

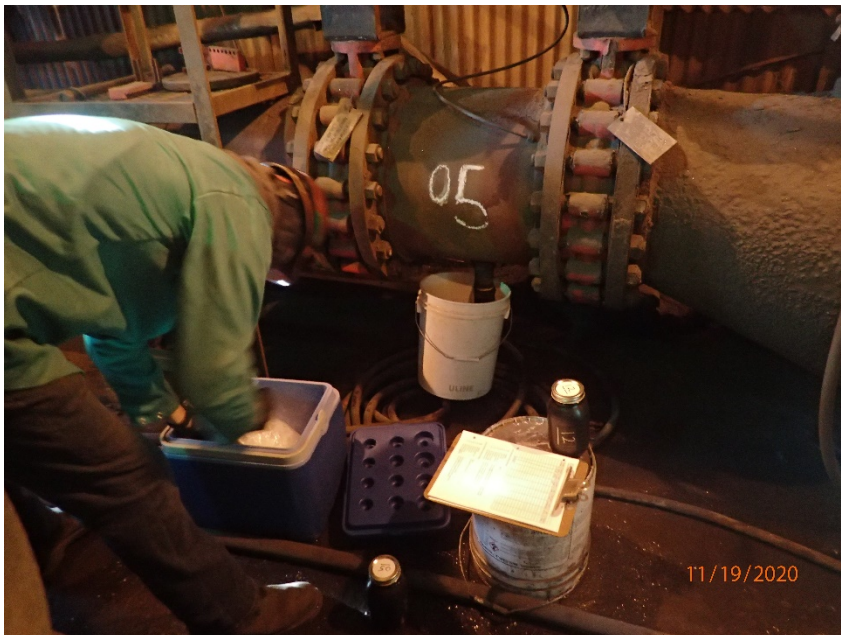
13: PB190013

Description: Taking a sample from sample location #05.

Location: D Furnace double block and bleed interstitial area between the Blast Furnace Recycle System and Lake Water.

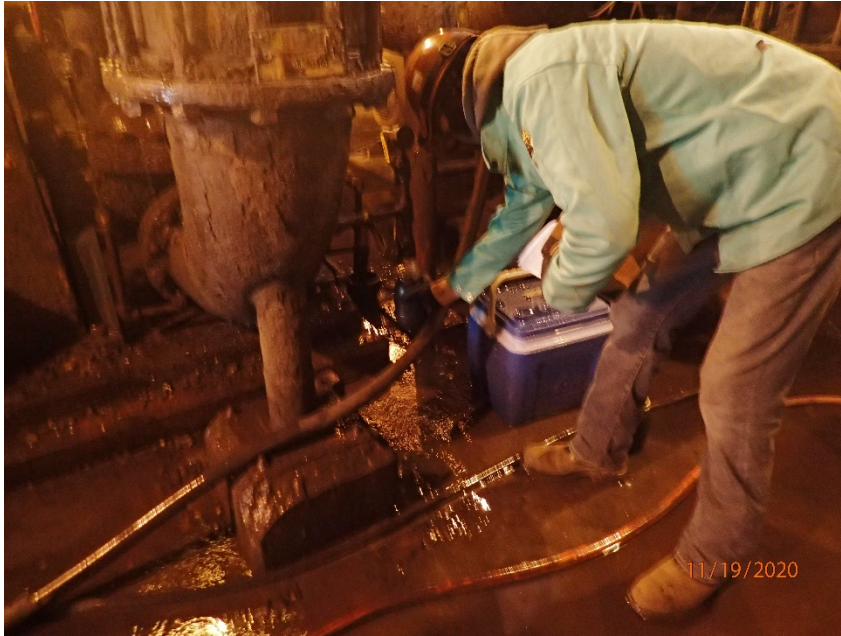
14: PB190014

Description: Taking a sample from sample location #12.

Location: D Furnace Lake Water Non-contact Cooling Water Header.

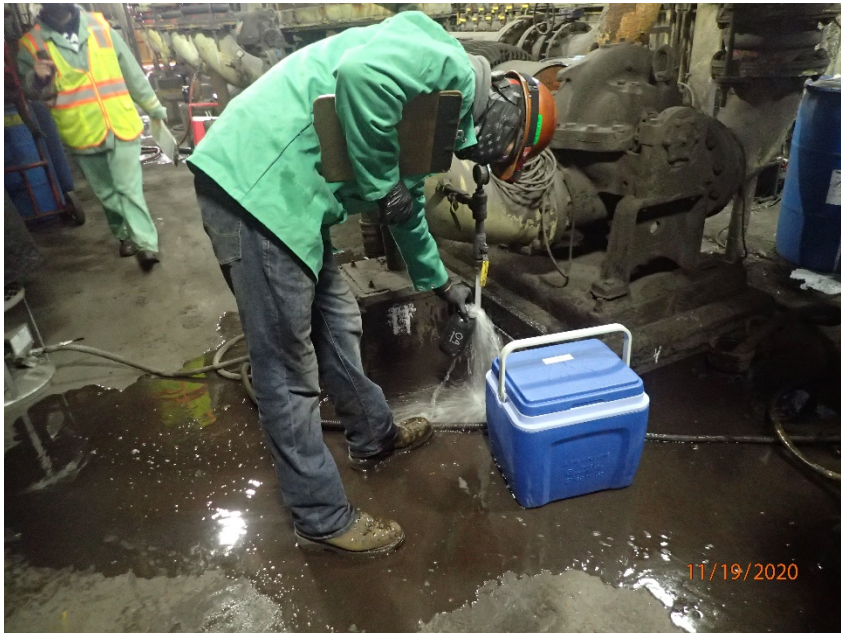
15: PB190015

Lastly, Mr. Oxsalida explained that the sample from Sample Location #11 was taken from the wrong side of the pump, but the samplers will compensate for that by taking a double composite during the next round.

Description: Taking a sample from what was thought to be sample location #04 but it was the wrong location. It was actually sample location #11.

Location: C Furnace Lake Water Non-contact Cooling Water Header.

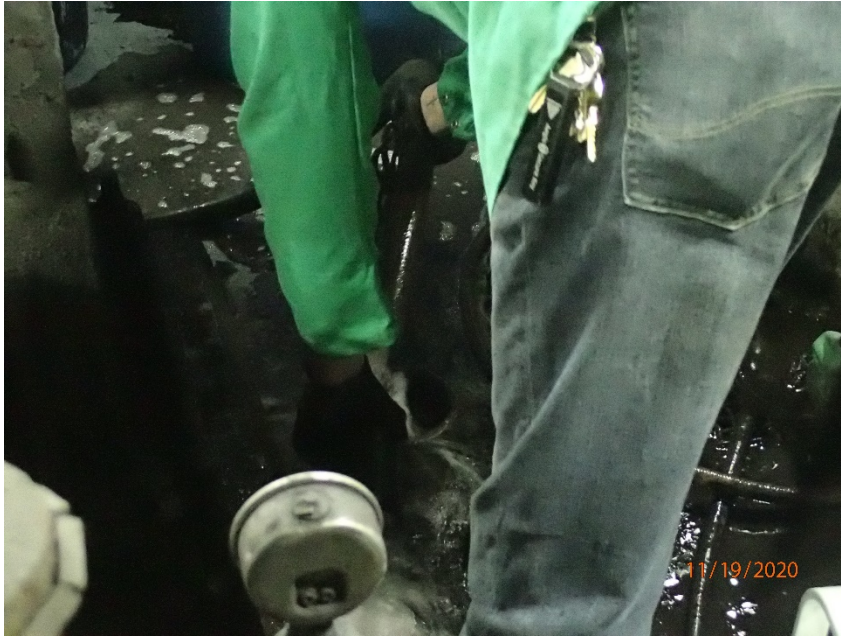
16: PB190016

Description: Taking a sample from correct sample location #04.

Location: Hose from C Furnace double block and bleed interstitial area between the Blast Furnace Recycle System and Lake Water.

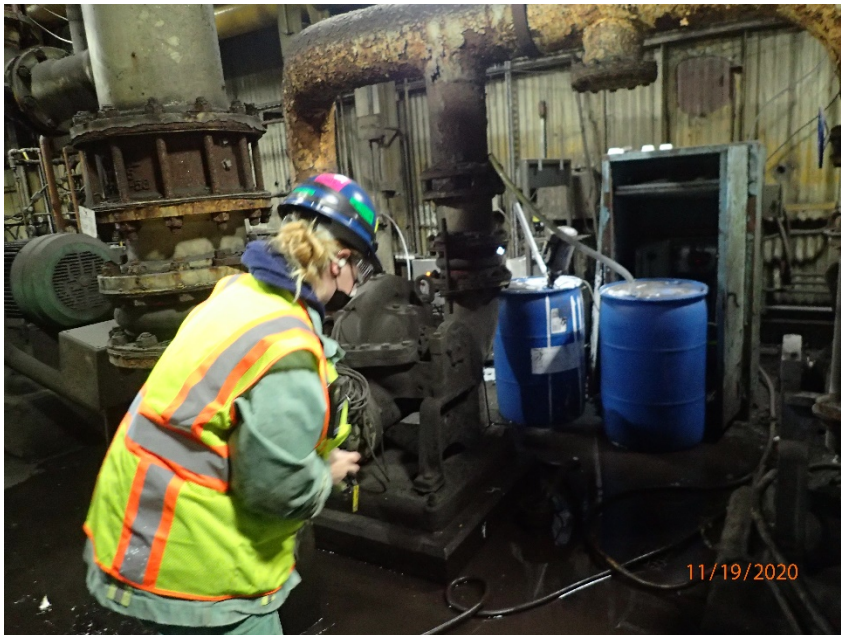
17: PB190017

Description: Identifying the sample location #04.

Location: Hose from C Furnace double block and bleed interstitial area between the Blast Furnace Recycle System and Lake Water.

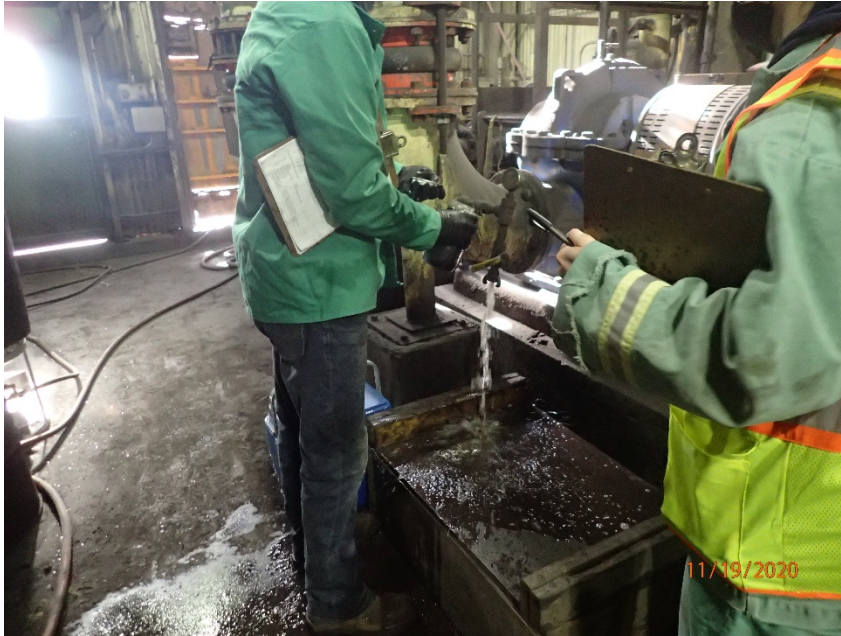
18: PB190018

Description: Taking a sample from sample location #11.

Location: C Furnace Lake Water Non-contact Cooling Water Header.

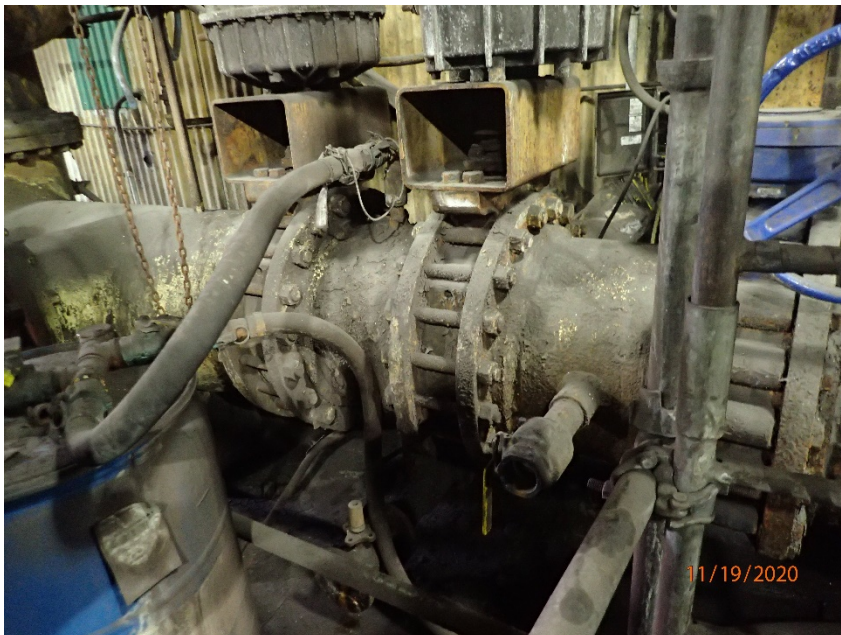
19: PB190019

At 9:48 A.M., EPA observed the samples taken from Sample Location #04, the double block and bleed valve for the C Furnace Lake Water Recycle System. At 9:50 A.M., EPA observed the sample taken from Sample Location #11, the C Furnace Lake Water NCCW Header. EPA observed that the double block and bleed valve for the C Furnace Lake Water Recycle System was functionally the same as the one at the D Furnace, but there was a hose connected to the valve in the interstitial area between the isolation valves. The hose led to a floor drain where the sample was taken.

Description: The double block and bleed valve for C Furnace. Similar in function to the D Furnace double block and bleed valve, but with a hose attached to the valve from the interstitial area between the isolation valves.

Location: C Furnace double block and bleed interstitial area between the Blast Furnace Recycle System and Lake Water.

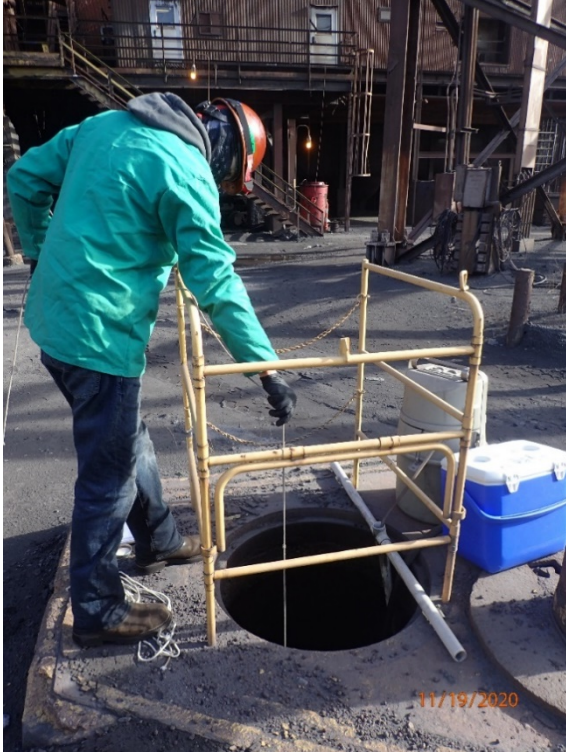
20: PB190020
Description: Taking a sample from sample location #02.
Location: Storm Sewer Manhole #2816.
Date/Time: November 19, 2020 10:00 A.M.

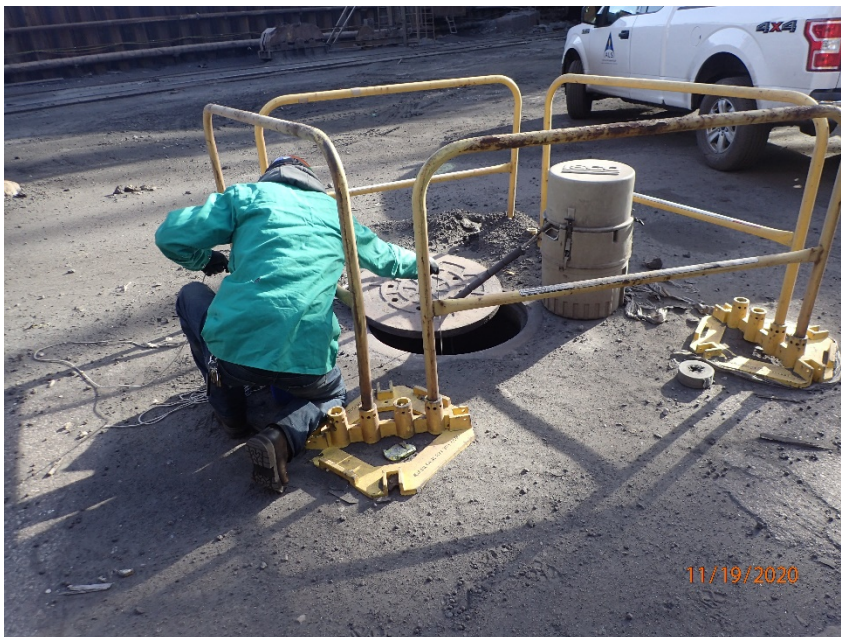
21: PB190021
Description: Taking a sample from sample location #01.
Location: Storm Sewer Manhole #2316.
Date/Time: November 19, 2020 10:06 A.M.

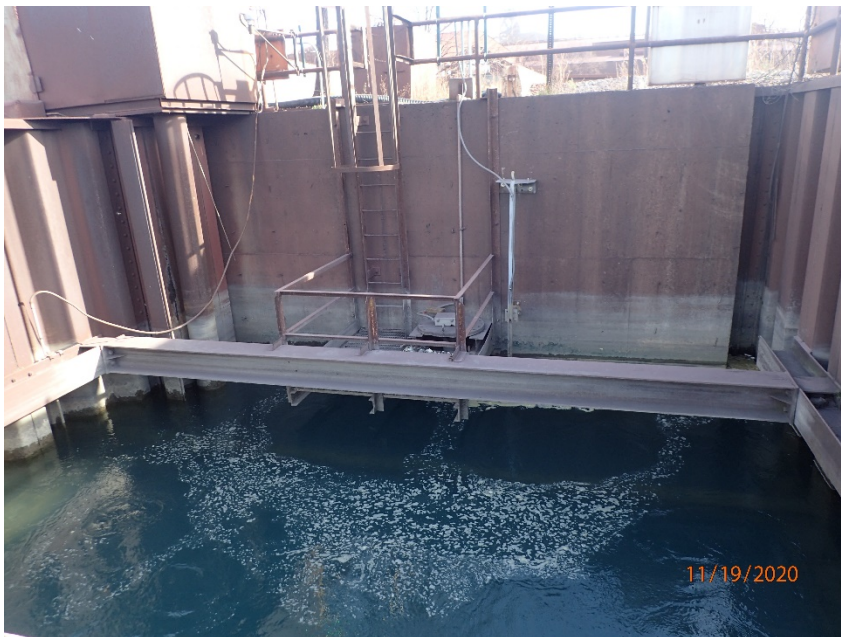
23: PB190023

Similarly, EPA observed the remaining sampling for this round of sampling for Mr. McAfee. Sample Location #02 is Storm Sewer Manhole 2816 and Sample Location #01 is Storm Sewer Manhole 2316. Sample Location #06 is Outfall 002. At Outfall 002, EPA observed that the Lake Michigan water level was lower than previously observed on other site visits. EPA hypothesized that the strong southwest winds could be the reason.

Description: Lake water is lower than usual – probably due to strong southwest winds.

Location: Outfall 002.

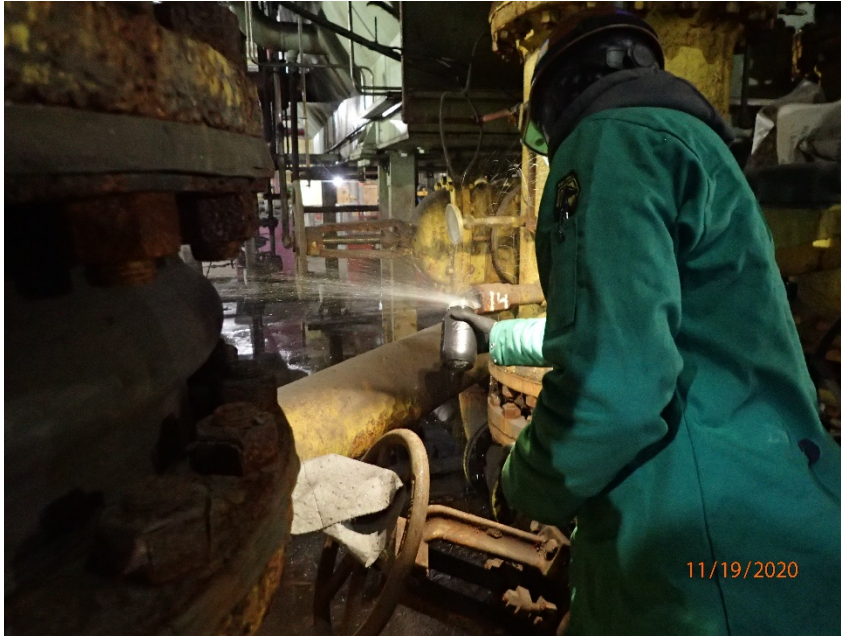
24: PB190024

Description: Taking a sample from sample location #14. This sample location is for the background levels in Lake Michigan water.

Location: Lake Michigan Non-contact Cooling Water from tap in Power House.

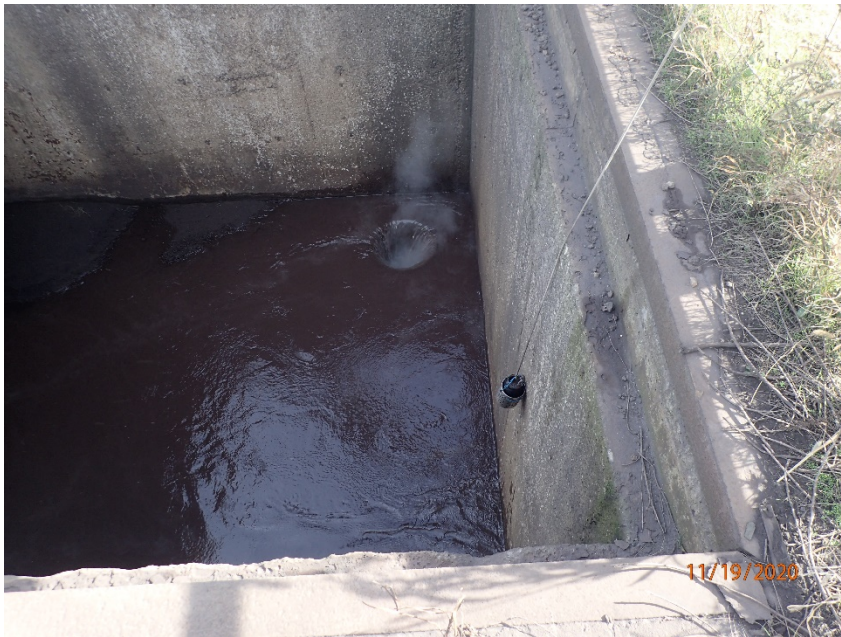
25: PB190025

At 10:43 A.M., EPA, Ms. Swanson, and Ms. Zunica then followed Mr. Owen to his second round of sampling. The first sample was taken from Sample Locations #00 and #13, the same locations that EPA observed Mr. Oxsalida take samples from earlier in the day. EPA noted that water was flowing into the standpipe in BFRS/DIW Manhole 2114 and the water level was 603.4' Above Sea Level, according to the computer screen in the lab by the cyanide destruct unit.

Mr. Oxsalida also stated that although BFRS/DIW Manhole 2114 was overflowing into the standpipe, he was not detecting any dye that would indicate that the seals for the connection to Outfall 002 were a problem. In fact, he stated that from the first hour of sampling, he was not seeing dye anywhere it shouldn't have been. And where there was dye, the concentration was less than anticipated. He did not know the cause of this.

Description: Taking a sample from sample location #00. Water was flowing into the standpipe at this time.

Location: Manhole 2114 – Vault with standpipe overflow.

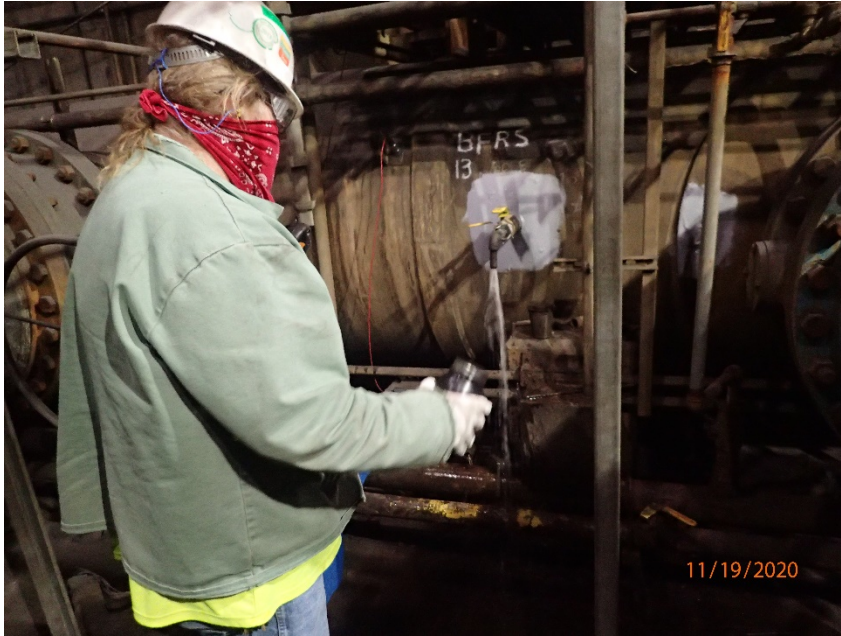
26: PB190026

Description: Taking a sample from sample location #13, Blast Furnace Recycle System recycle process water from high lift pump header.

Location: Basement of the Blast Furnace Closed Water Pump Station.

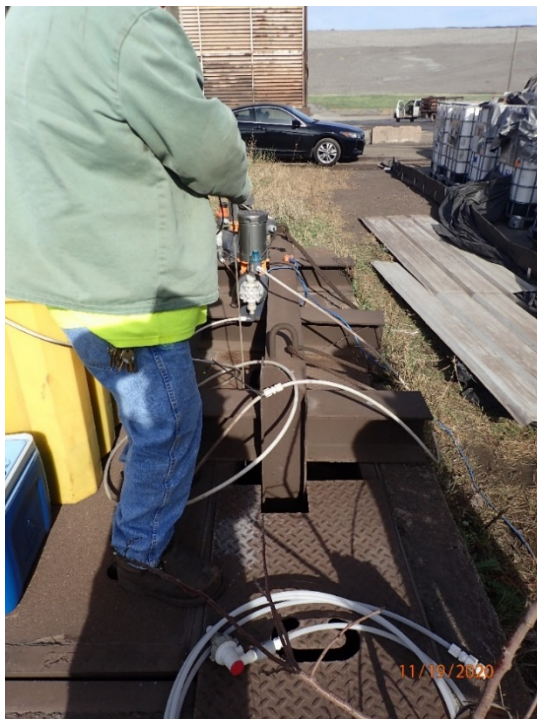
27: PB190027

Description: Taking a sample from sample location #9.

Location: Waste Water Pump Station No. 2 – Downstream of Manhole 2114.

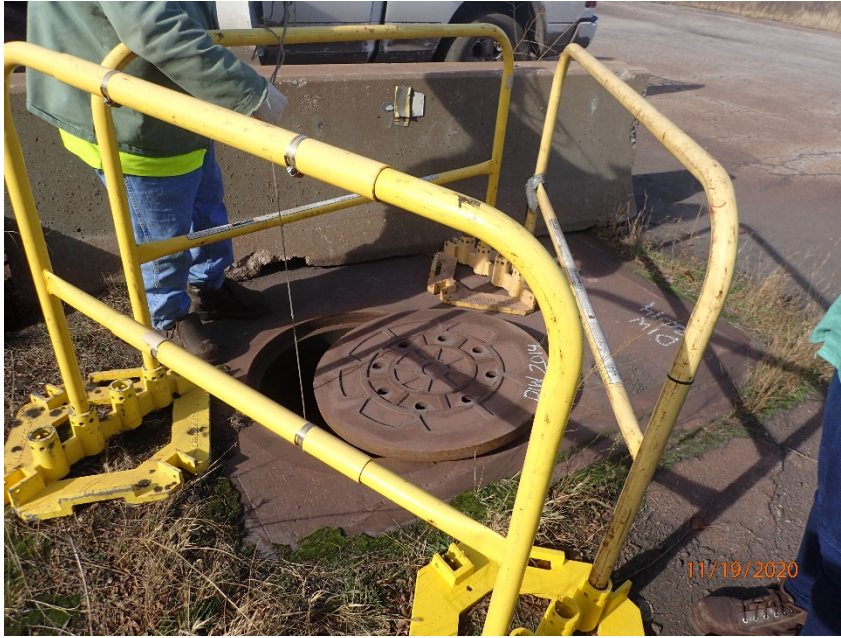
28: PB190028

Description: Taking a sample from sample location #08

Location: Dirty Industrial Wastewater Manhole 2014.

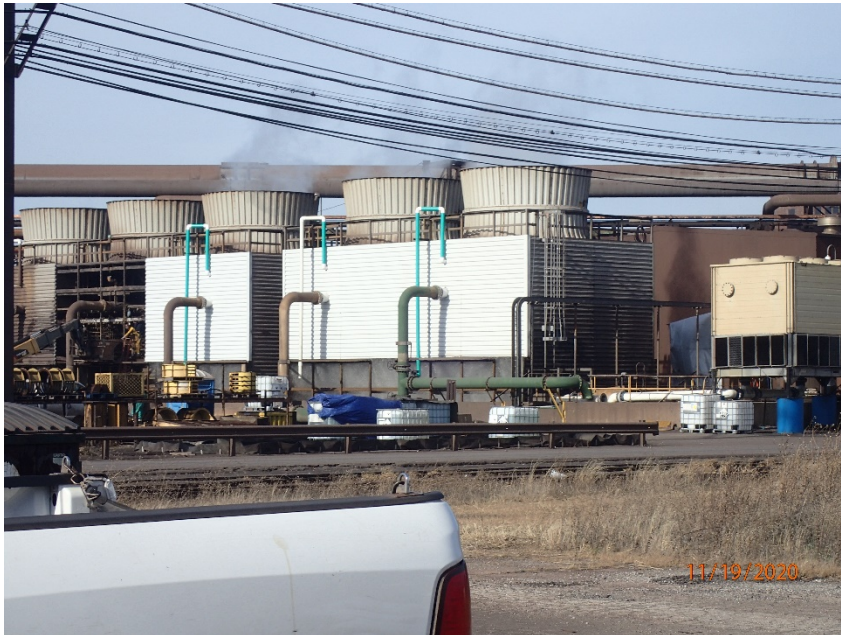
29: PB190029

At 11:04 A.M., Mr. Owen took a sample from Sample Location #09, a manhole west of Wastewater Pump Station No. 2, which is downstream of Manhole 2114. At 11:14 A.M., Mr. Owen took a sample from Sample Location #08, the DIW manhole 2014. From this location, EPA observed that three of the cooling towers had been repaired and rehailed. In a previous site visit, only one had been completed.

Description: Refurbishing of three of the Cooling Towers has been completed.

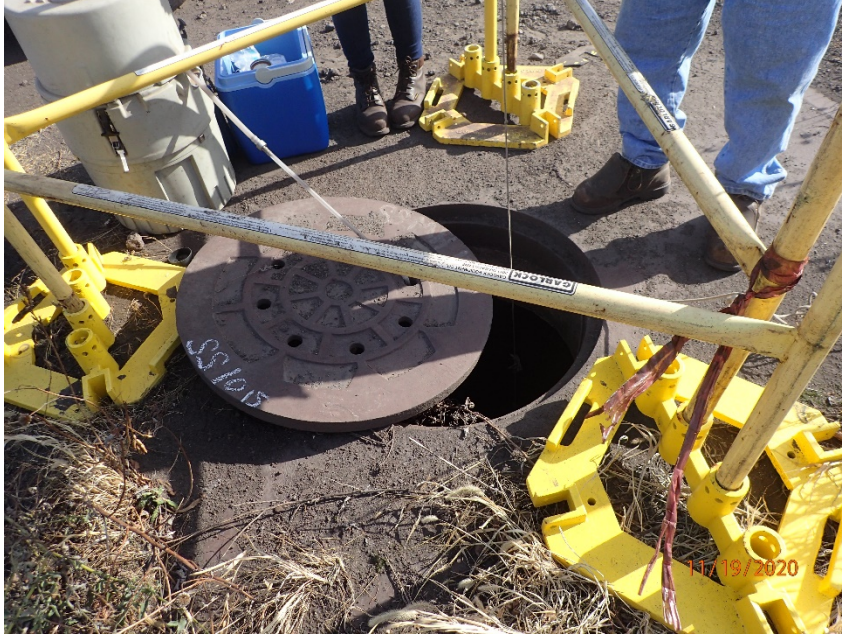
30: PB190030

Description: Taking a sample from sample location #03.

Location: Storm Sewer Manhole 1015.

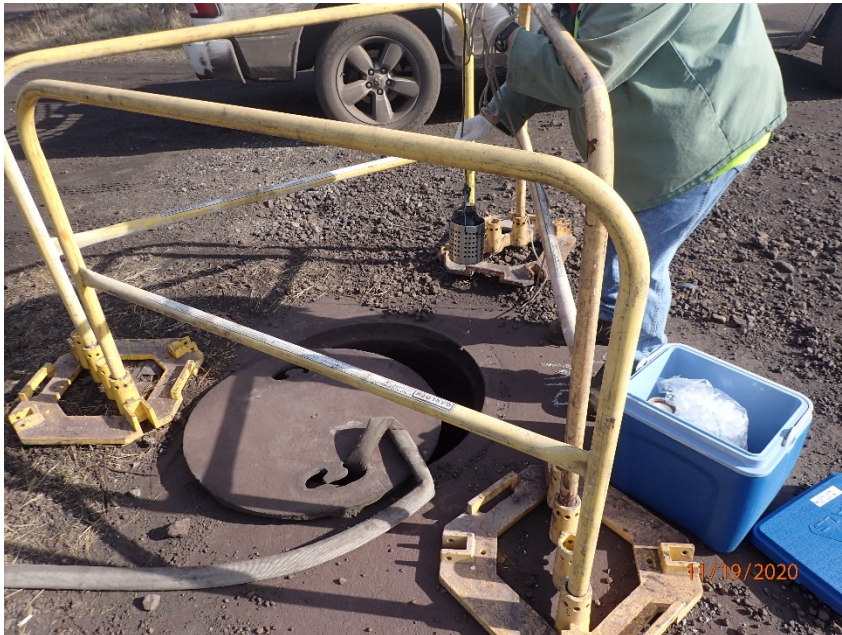
31: PB190031

Description: Taking a sample from sample location #07.

Location: Dirty Industrial Sewer Manhole 1515.

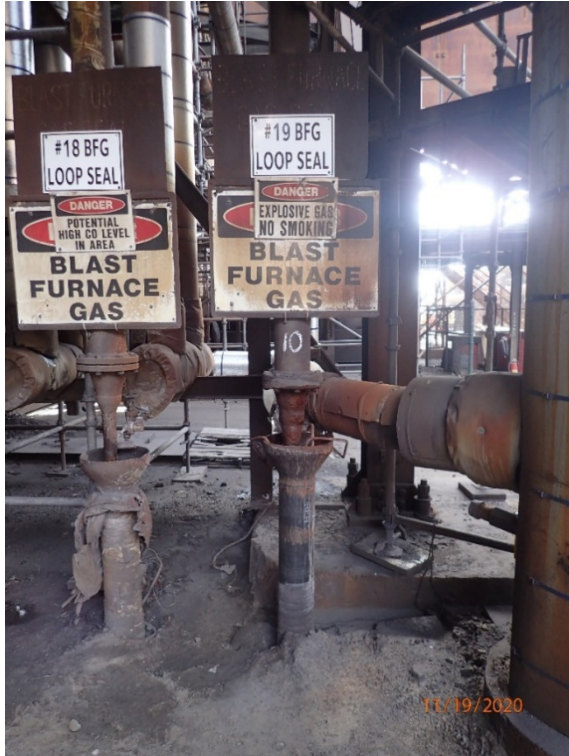
32: PB190032

Description: Sample location #10 is from the #19 Blast Furnace Gas Loop Seal.

Location: #19 BFG Loop Seal west of the Power Station.

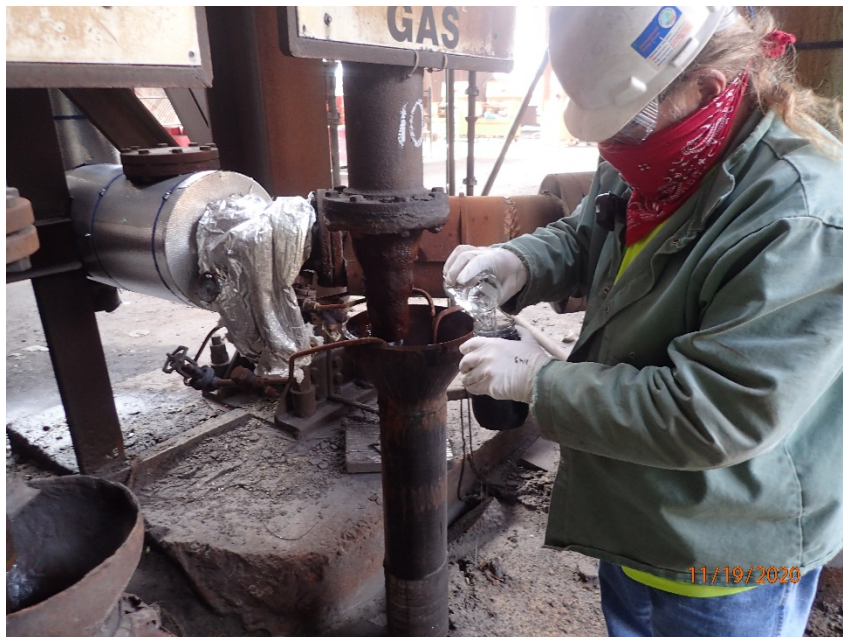
33: PB190033

Description: Taking a sample from sample location #10.

Location: #19 BFG Loop Seal west of the Power Station.
