**UNITED STATES ENVIRONMENTAL PROTECTION AGENCY**  
**REGION 5**  
**77 WEST JACKSON BOULEVARD**  
**CHICAGO, IL 60604-3590**

Subject: February 24, 2021 and February 25, 2021 SSO Reconnaissance Inspection Report

**Purpose:** Commonfields of Cahokia – SSO Reconnaissance Inspection Trip Report

**Facility:** Commonfields of Cahokia Sewer District

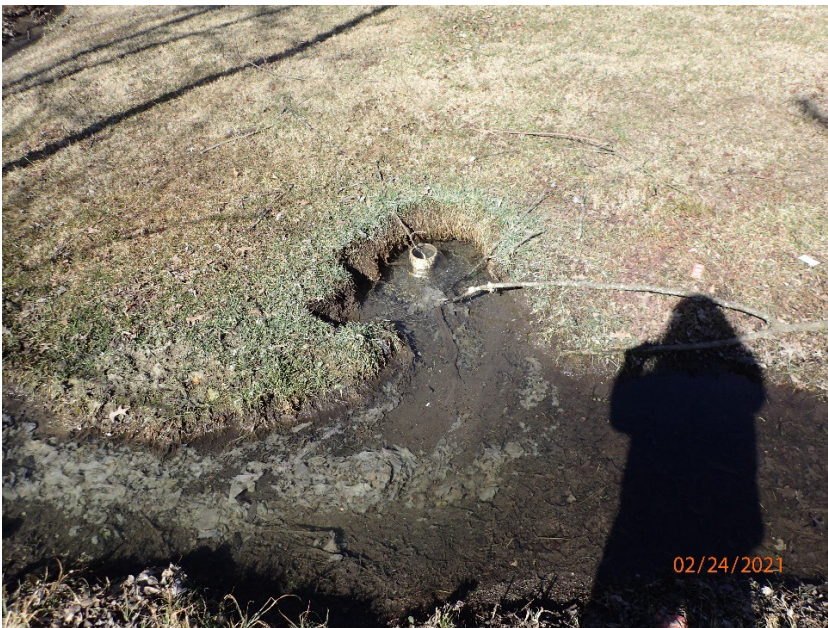
1: P2240052

Description: Cleanout on North 82<sup>nd</sup> Street was discharging in dry weather. Note toilet paper debris in the ditch.

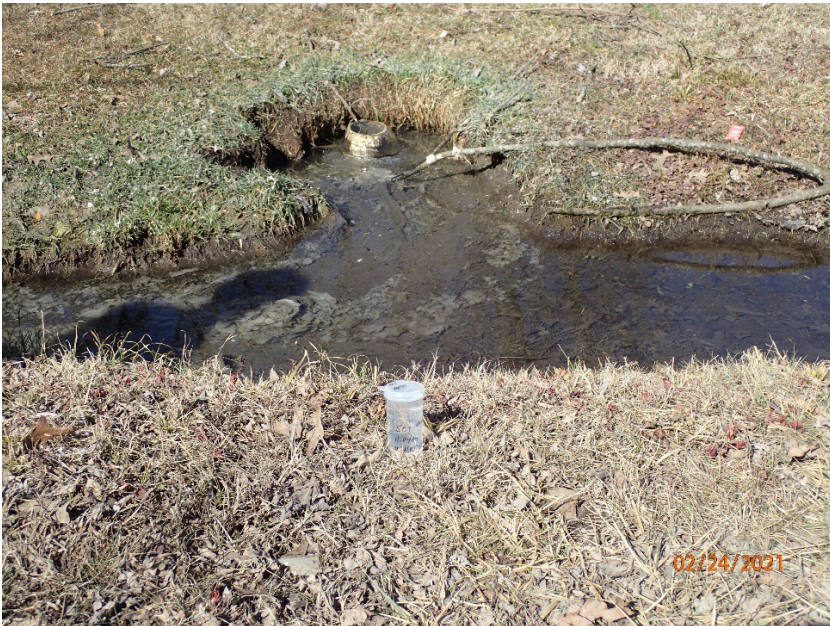
1: P2240054

Description: EPA took sample S01 at 11:04 A.M. from the discharge from the cleanout on North 82<sup>nd</sup> Street.

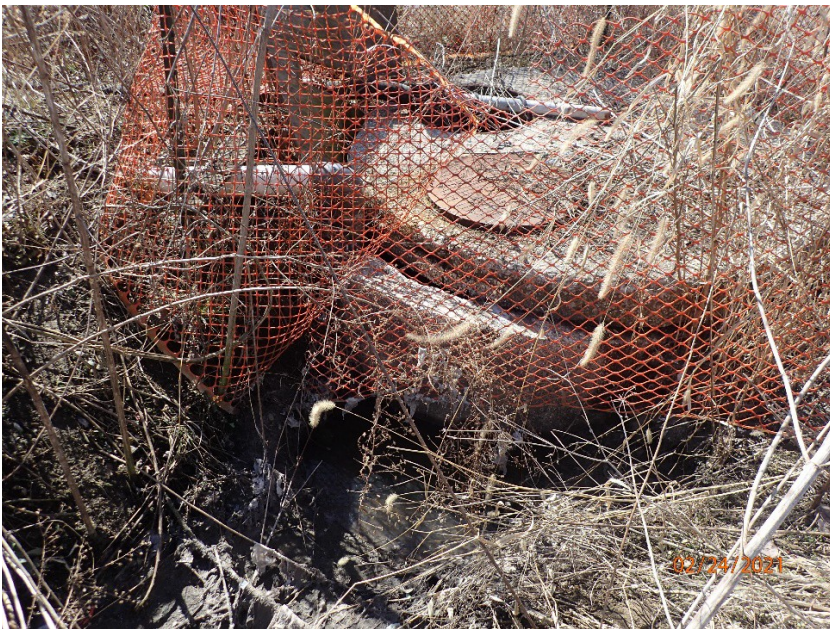
2: P2240055

Description: Lauralee and Violet Lift Station was not discharging on the day of the inspection.

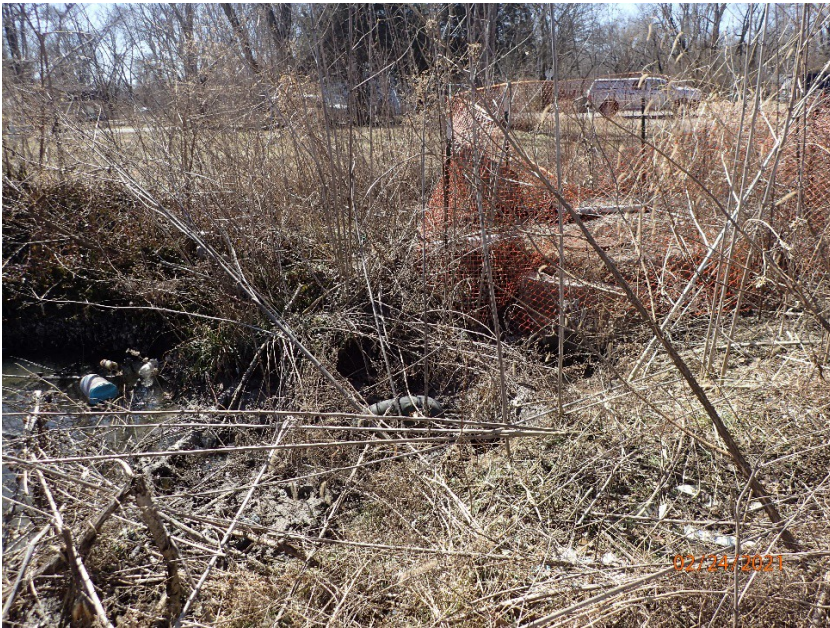
3: P2240056

Description: Lift station was not discharging on the day of the inspection.

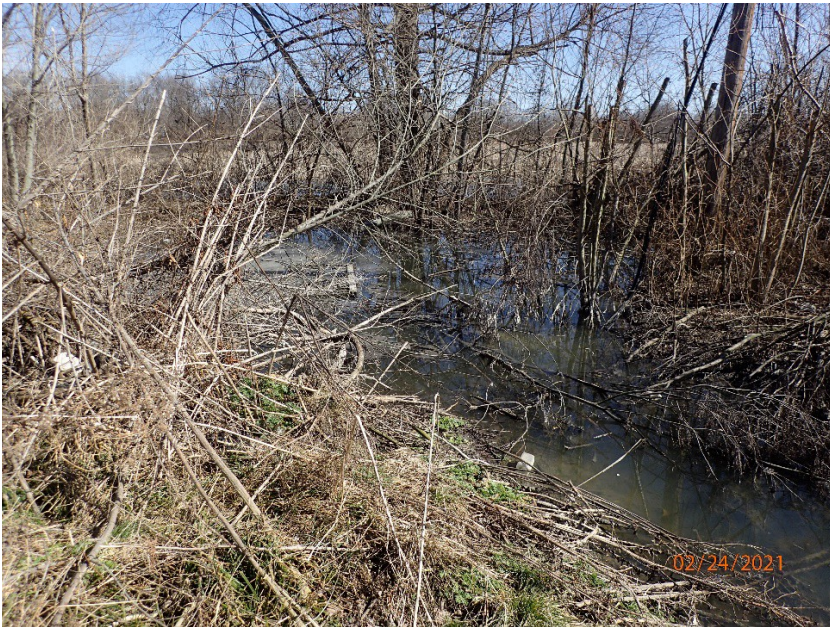
4: P2240057

Description: Ponded water next to the lift station.

EPA and IEPA discussed several of the other Commonfields lift stations. Mr. Traiteur stated that Lift Station #22, at Lauralee and Violet, was inoperable. He said that the manhole for this lift station had settled about four feet and that caused the manhole and piping to the lift station to fill with sand. There is a submersible pump in the lift station to pump the wastewater downstream. When flows come into the lift station from gas-powered pumps upstream, they come in at a higher rate than the submersible in the lift station is able to pump it out and it then overflows. Mr. Traiteur stated that the discharge doesn't go anywhere but stays in a depression near the station.

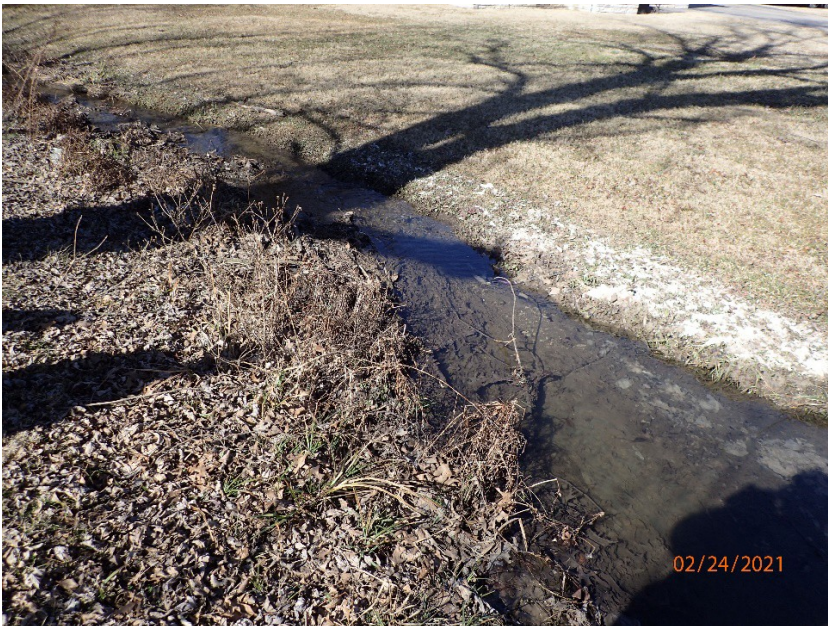
6: P2240059

Description: EPA documented the flow pathway from the cleanout on North 82<sup>nd</sup> Street to Canal #1. Note the toilet paper debris on the bank of the pathway.

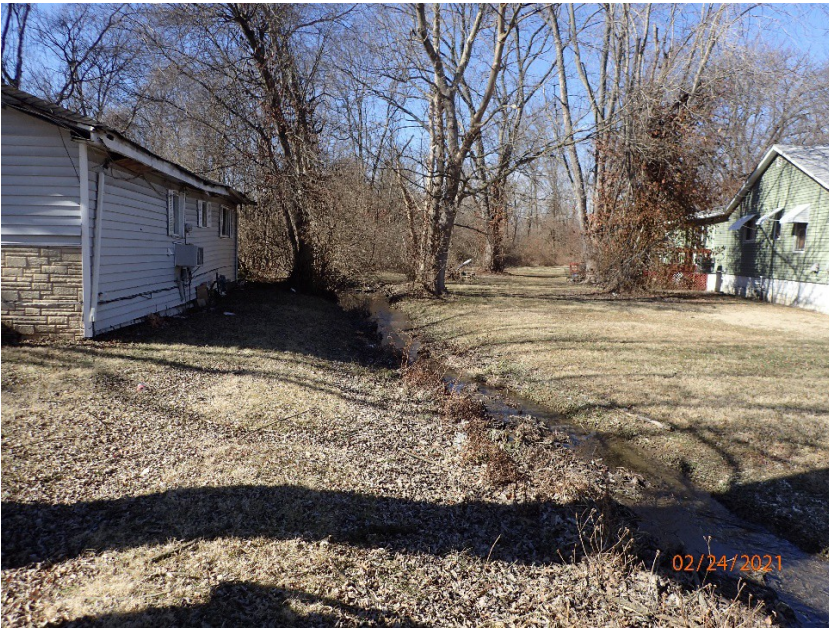
7: P2240060

Description: The flow from the cleanout on North 82<sup>nd</sup> Street continues to the northwest between the homes.

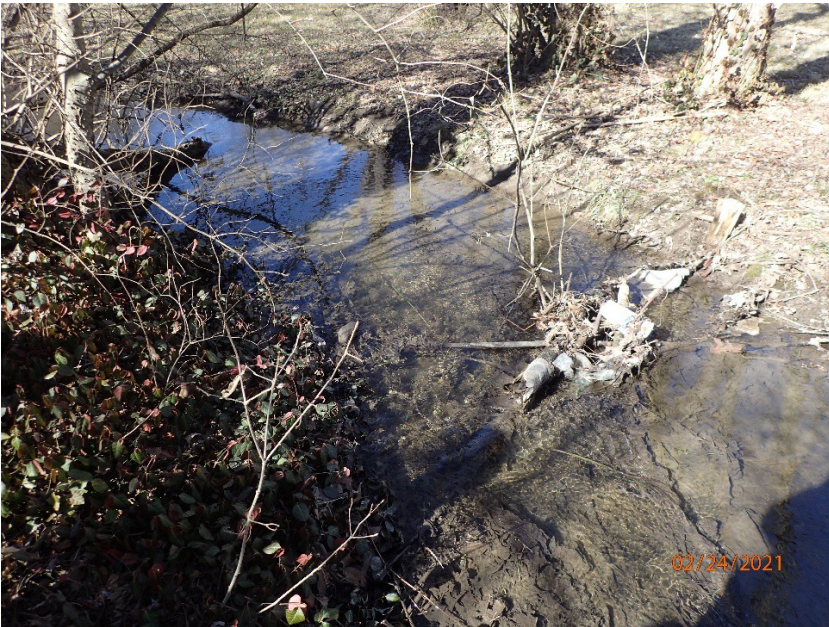
8: P2240061

Description: The flow pathway curves and follows the back property line of the homes on North 82<sup>nd</sup> Street. Looking downstream. Note the sanitary waste caught on the stick in the channel.

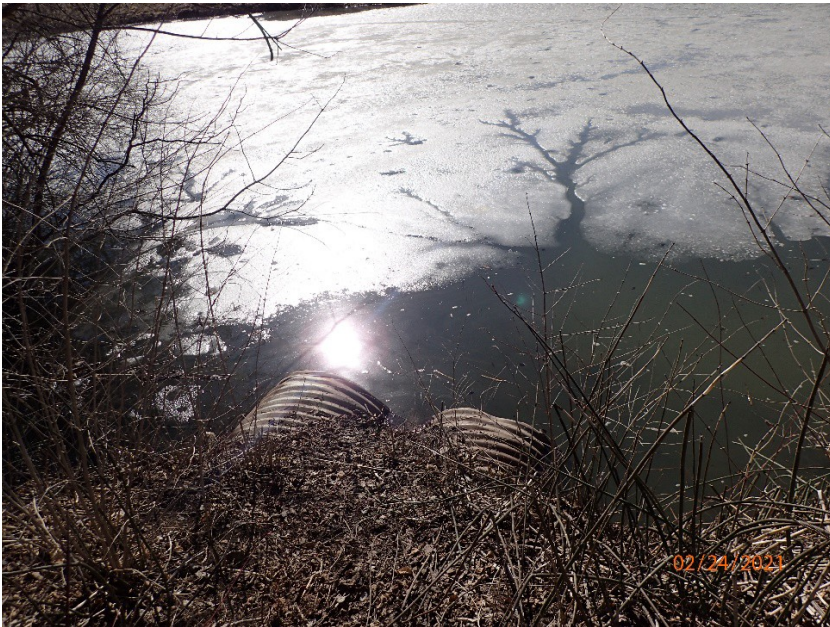
26: P2240079

Description: Looking downstream at outlet of twin culverts under North 80<sup>th</sup> Street into Canal #1.

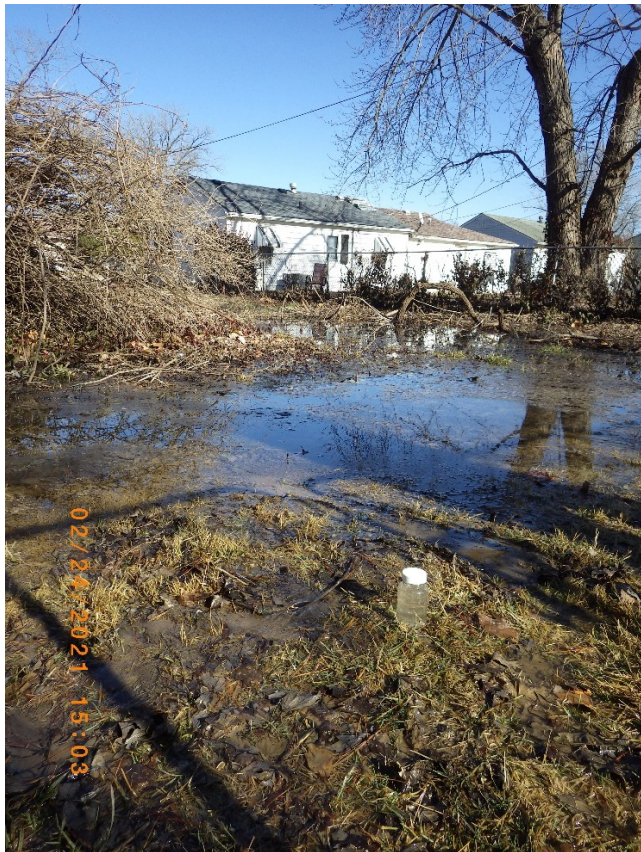
278: CFCD0001\_20210224

While observing Lift Station #21, Mr. Flatebo noted that there was water coming up out of the ground near the lift station. Since there was evidence of recent excavation activity around the lift station, and not knowing if the water coming up from the ground was drinking water or wastewater, Mr. Maraldo took a bacteria sample, D01, at 3:00 P.M. Mr. Flatebo immediately drove to meet Ms. Rogers at the laboratory in Missouri to drop off both samples together. Mr. Maraldo informed Mr. Traiteur's staff of the potential water line break and they offered to coordinate with Illinois American Water, who maintains the drinking water system in this area.

Description: EPA took sample D01 at 3:00 P.M. from the bubbling discharge from the alley between Lake Dr. and Park Place

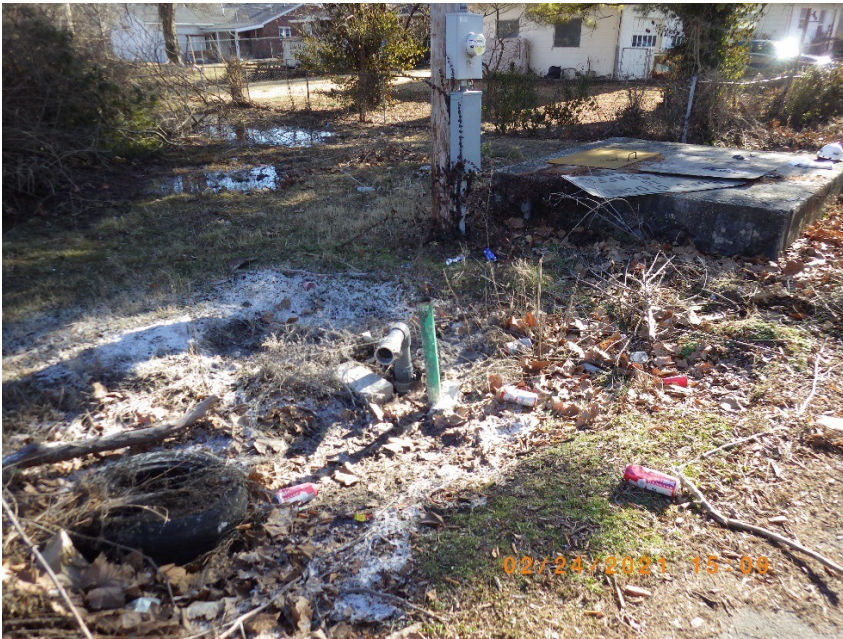
289: CFCD0002\_20210224

Mr. Maraldo also observed evidence of a recent sewage discharge at Lift Station #21, including toilet paper debris surrounding a discharge pipe, fitted for a hose connection.

Description: Toilet paper debris surrounding a discharge pipe, fitted for a hose connection, for Lift Station #21.

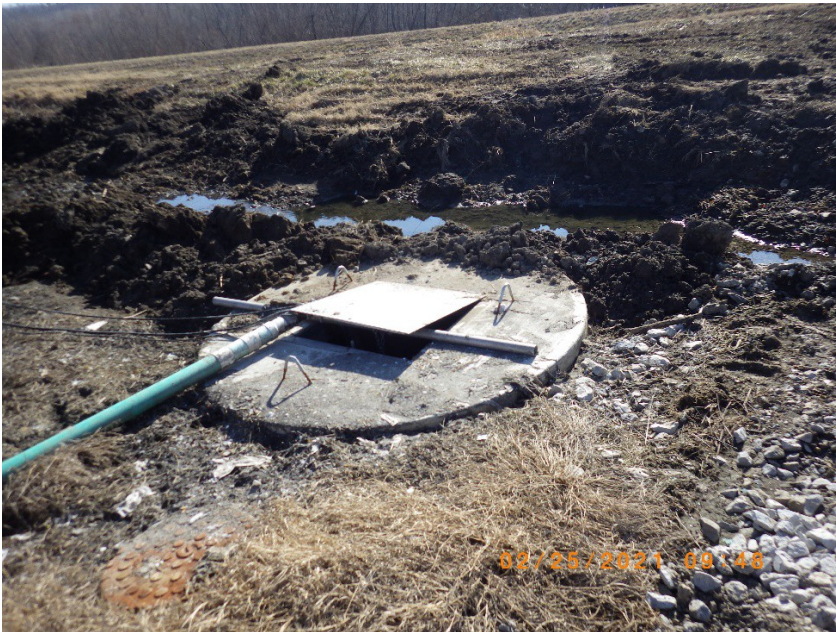
30: CFCD0001\_20210225

Description: Lift Station #20. EPA noted that the vault cover was open to accommodate a pipe used to support a bypass pump. Note bypass piping.

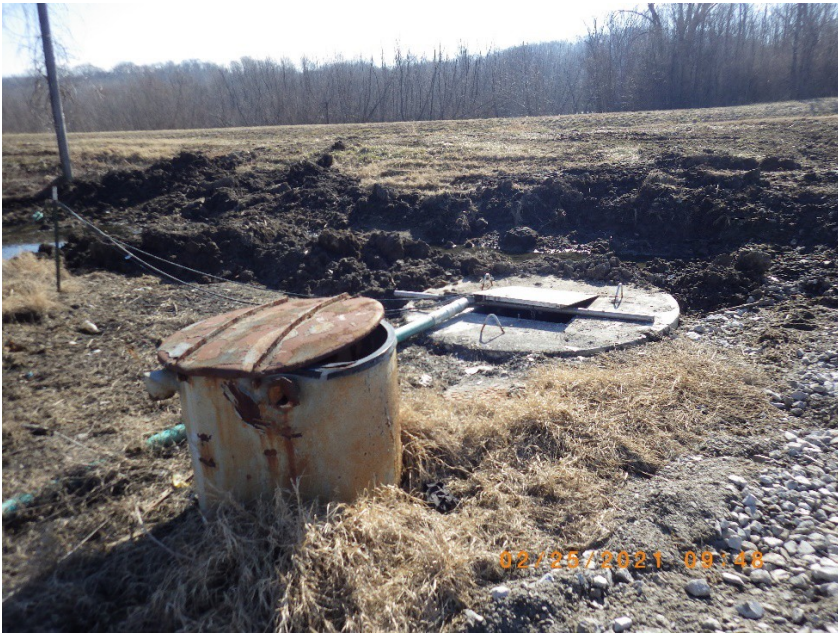
31: CFCD0002\_20210225

Description: Lift Station #20. EPA noted control vault cover was slightly open.

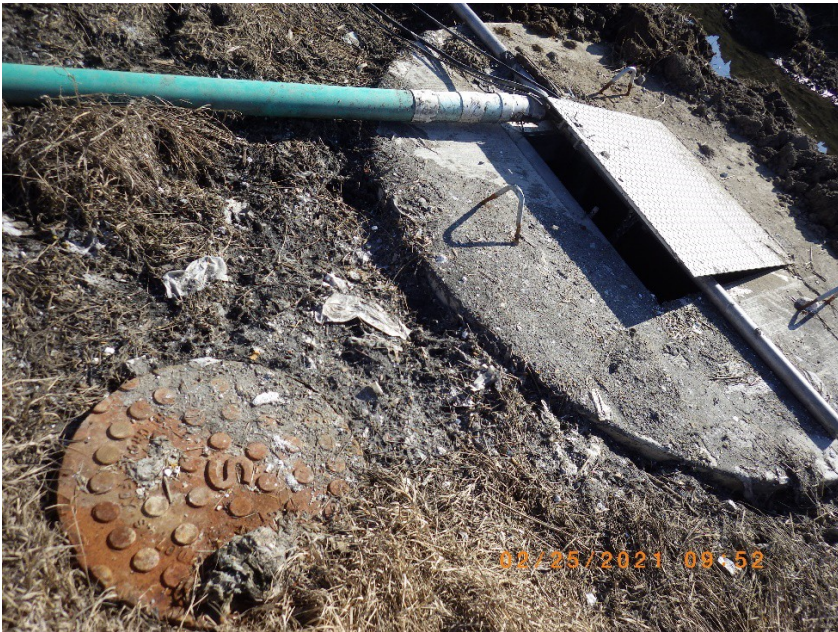
32: CFCD0003\_20210225

Description: Lift Station #20. EPA noted toilet paper debris around the lift station.

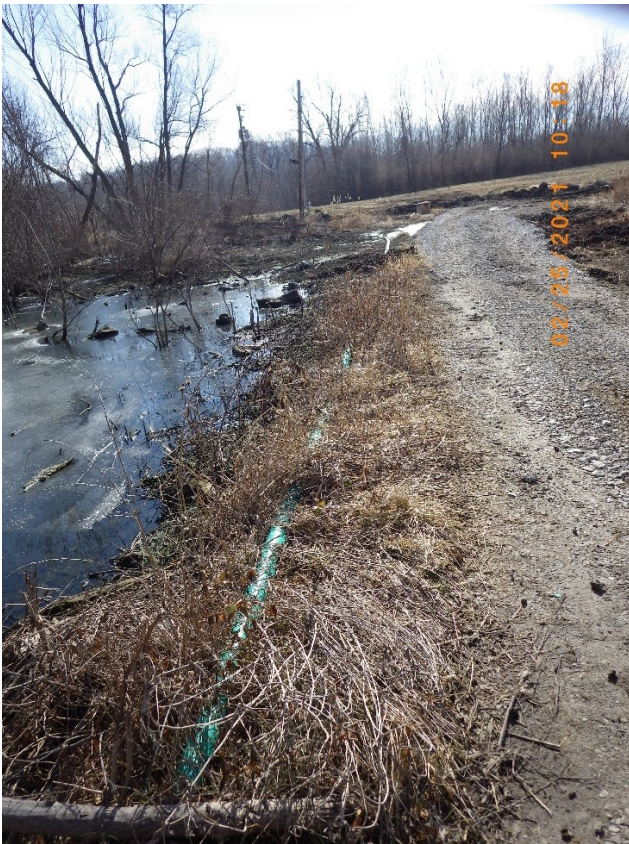
33: CFCD0004\_20210225

Description: Lift Station #20. Bypass pipe from lift station to manhole on Missouri Ave.

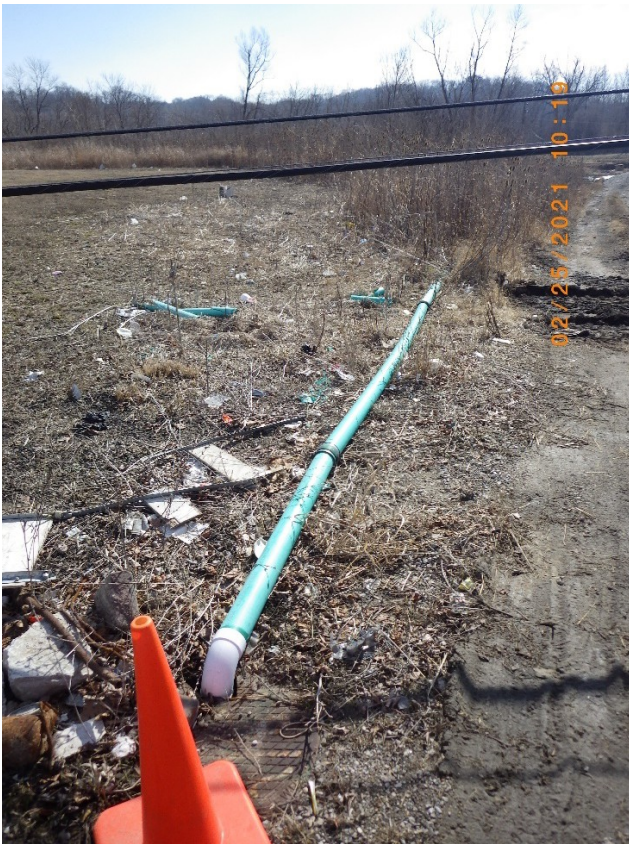
34: CFCD0005\_20210225

Description: Lift Station #20. Bypass pipe from lift station entering manhole on Missouri Ave.

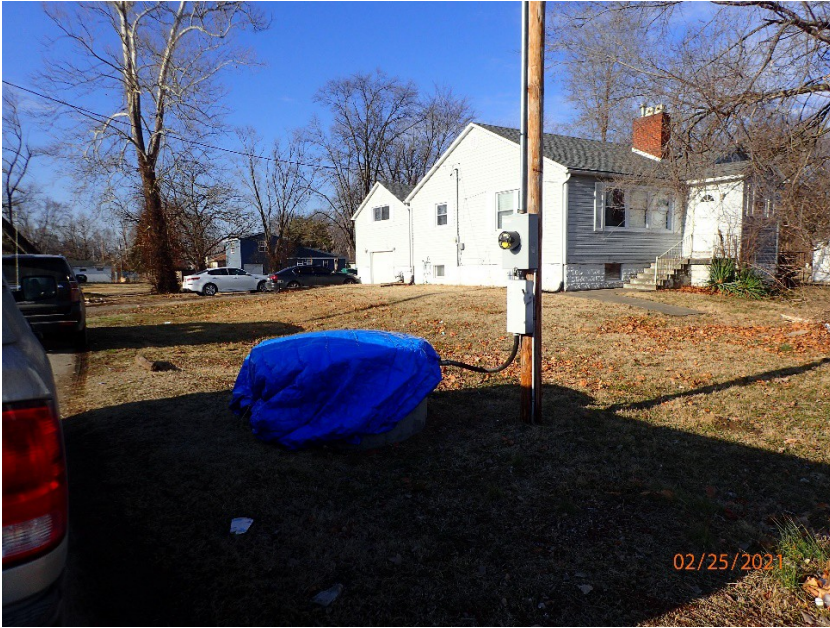
29: P2250080

Description: Lift Station #4 is covered with a blue tarp. EPA noted that the electric box was on.

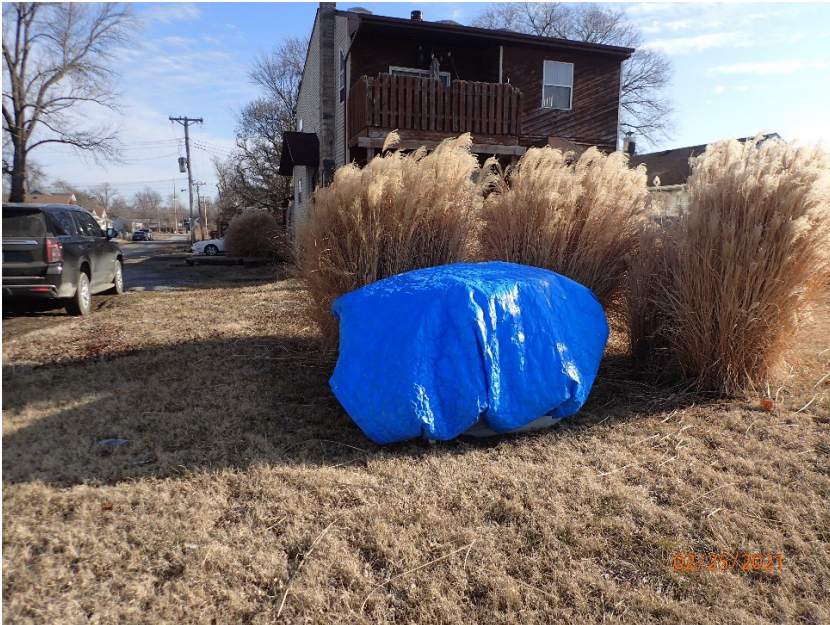
36: P2250081

Description: Lift Station #12 is also covered by a blue tarp. The lid underneath is cracked. EPA noted that there were repetitive sounds coming from the pumps in the lift station.

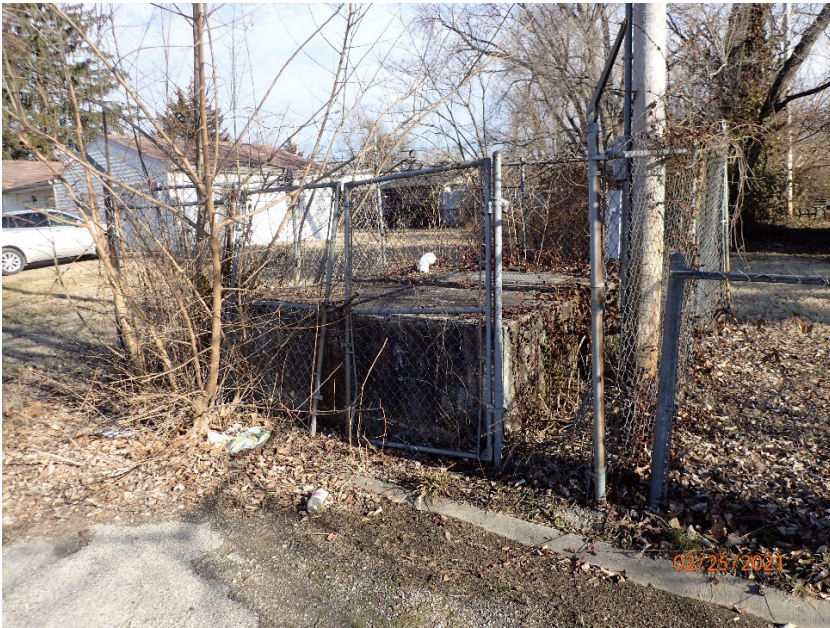
30: P2250082

Description: Lift Station #27 was behind fencing which did not completely enclose the lift station. Commonfields of Cahokia identifies this lift station as the Willie Holmes Pill Box.

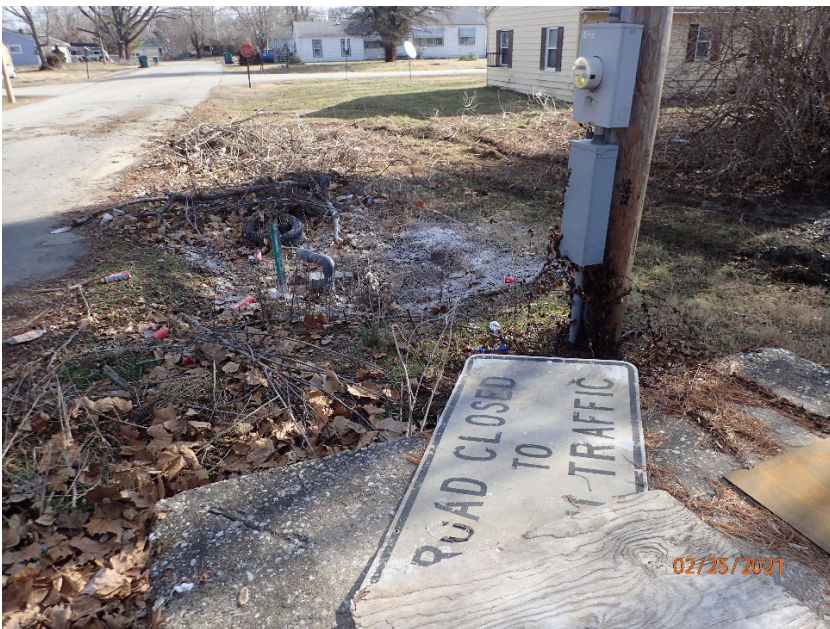
31: P2250083

Description: Lift Station #21, also named Lake Drive Pill Box, had evidence of recent overflow. EPA observed sanitary waste near the lift station.

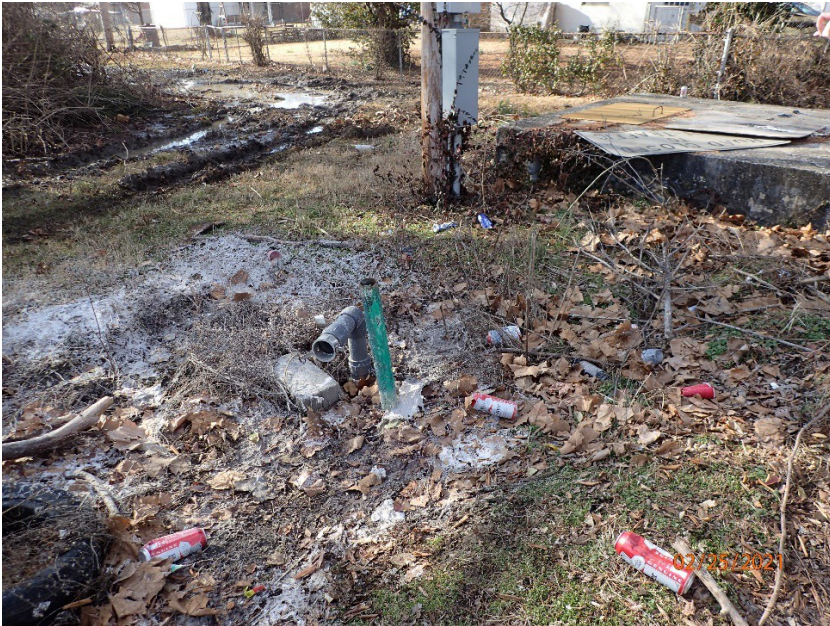
32: P2250084

Description: Sanitary waste was observed on the ground around Lift Station #21. This station needs to be pumped out by Commonfields of Cahokia personnel three times per week.

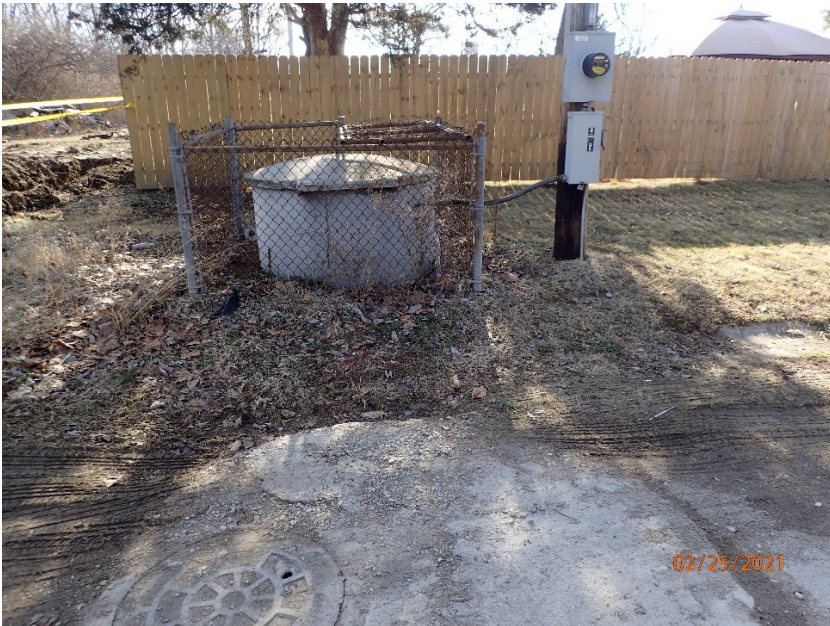
40: P2250085

Description: Lift Station #5's electrical box was turned off.

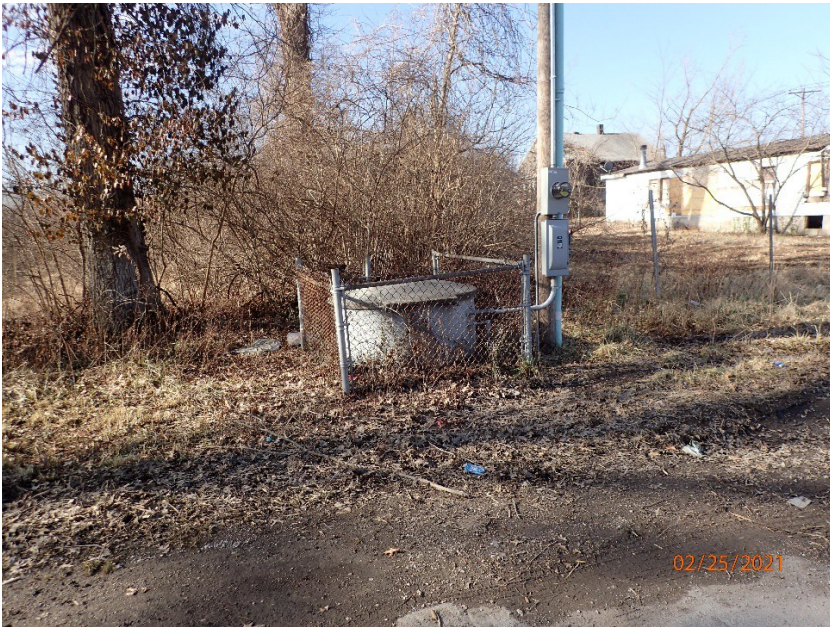
42: P2250087

Description: Lift Station #6 was running and EPA did not see any evidence of overflow. EPA did notice a moderate sewer odor near the lift station.

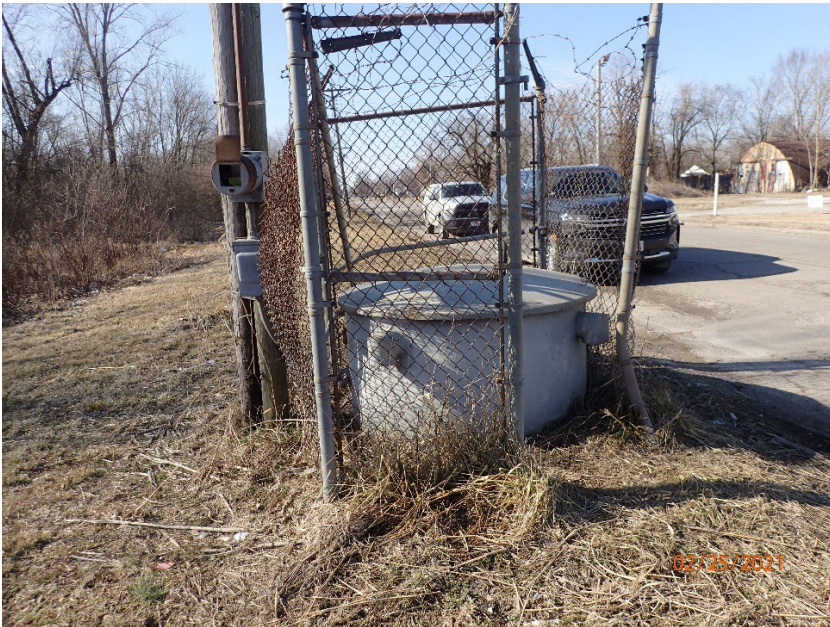
44: P2250089

Description: Lift Station #7 had only one pump in it. Fencing was not completely protective of the lift station.

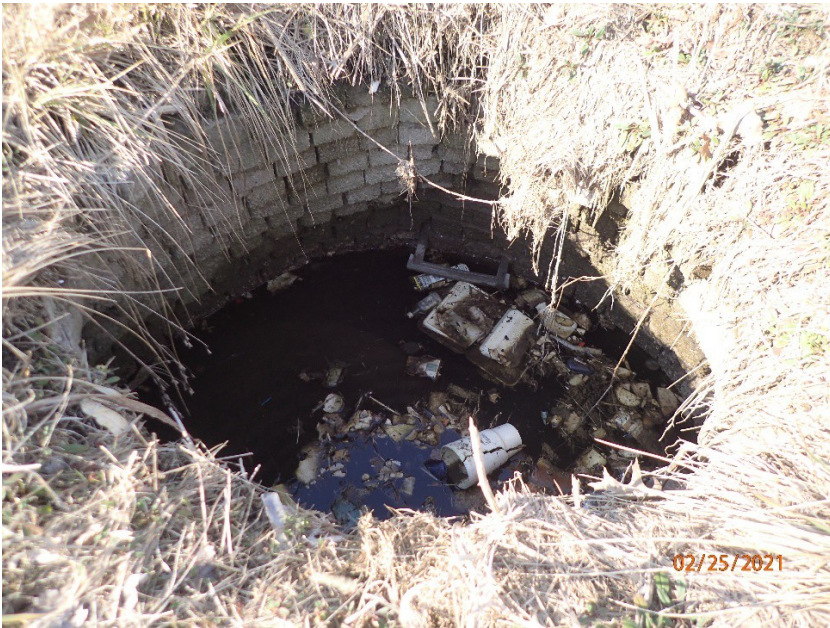
45: P2250090

Description: Just southwest of Lift Station #7 is an uncovered brick manhole that was filled with water. EPA told the Manager of Commonfields of Cahokia about this safety hazard on 2/25/21.

EPA told Mr. Traiteur about the uncovered brick sewer near Lift Station #7 and that it was a safety hazard. Mr. Traiteur stated that he would go look at it and get it covered. EPA also told Mr. Traiteur about other maintenance issues the inspection team observed, including the safety hazard of the open manhole at Lift Station #8, the open manhole northwest of the Block House, the sanitary waste laying in a pile by Lift Station #27, and the sanitary waste by the manhole northwest of the Block House. Mr. Maraldo mentioned to Mr. Traiteur that there appears to be a general lack of maintenance in the system and asked if Commonfields had a sufficient staff of skilled sewer technicians and operators. He stated he was the only person on staff with sufficient training and experience in sewer operations and maintenance.

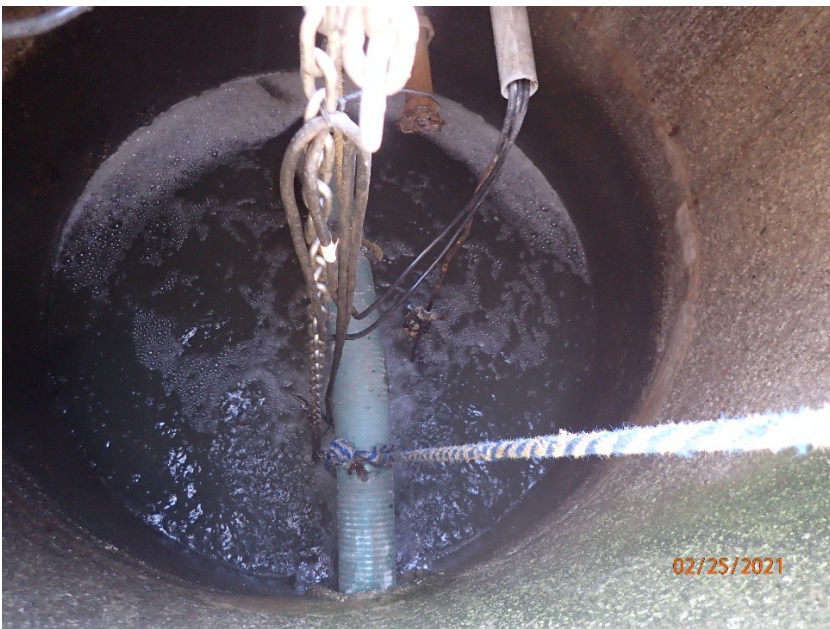
46: P2250091

Description: Lift Station #8 was not operational. The open manhole had a pipe across it from which a submersible pump was hanging. The manhole contained water.

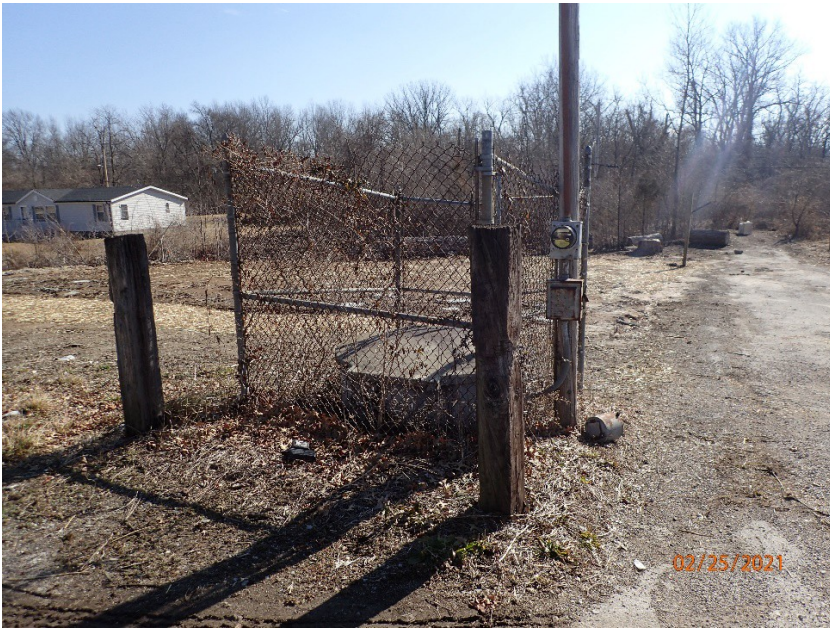
49: P2250094

Description: Lift Station #8 is not operational.

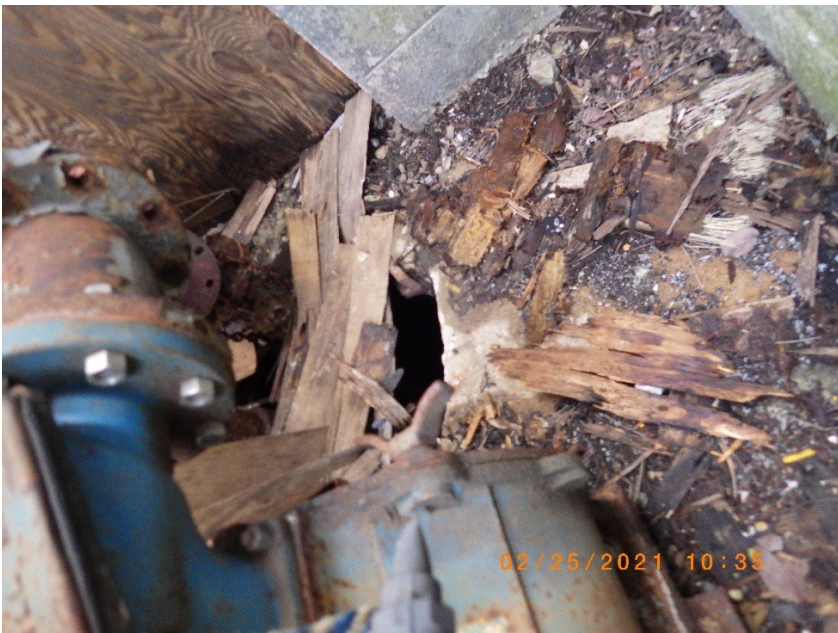
54: CFCD0007\_20210225

Description: Lift Station #13. Lift station wet well cover damaged and open to the elements.

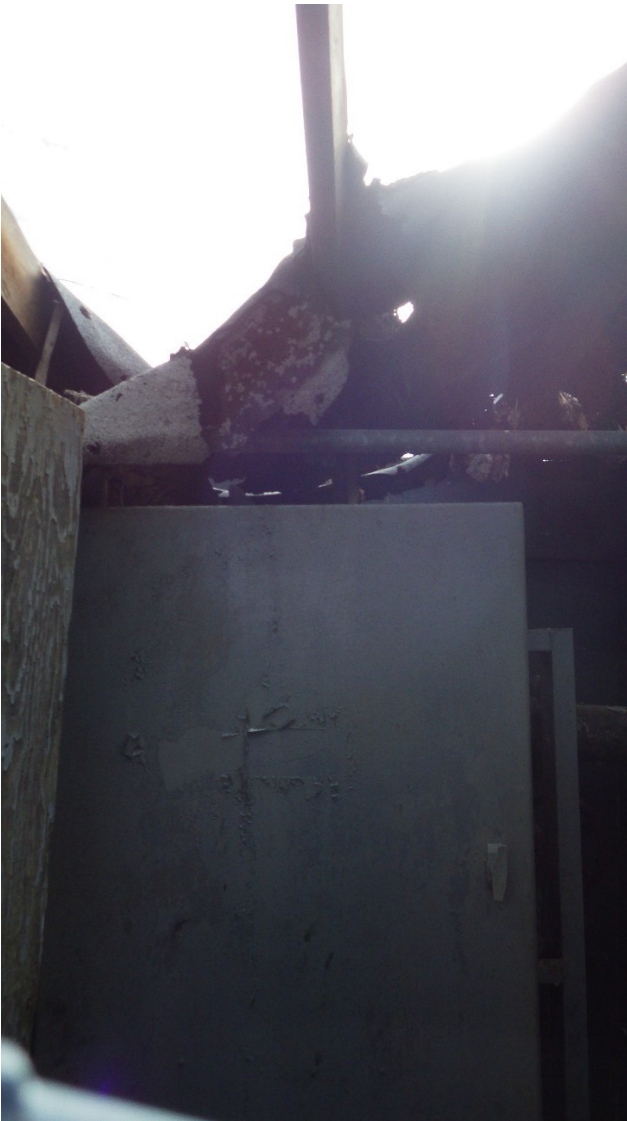
55: CFCD0008\_20210225

Description: Lift Station #13. Ceiling of lift station building damaged and open to the elements.

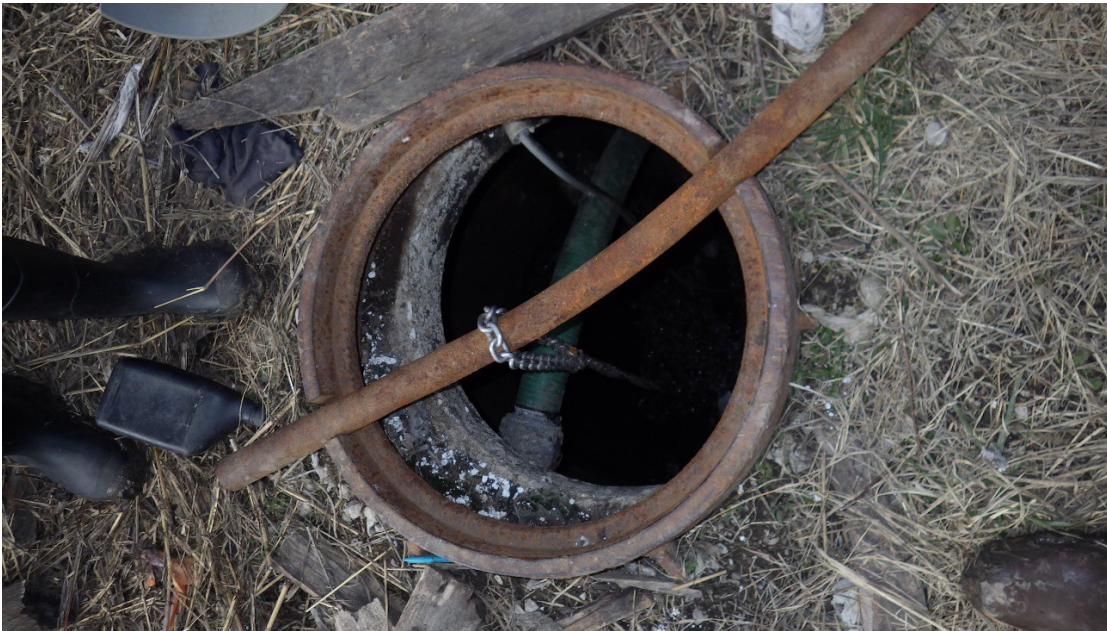
56: CFC0009\_20210225

The inspection team then walked further northwest and observed a submersible pump in a manhole. The manhole did not have a cover on it and Mr. Stitely observed a child's shoe laying near the manhole. There was sanitary waste laying next to the manhole from when it had been cleaned out.

EPA told Mr. Traiteur about the observation of the submersible pump in the manhole northwest of Lift Station #13, the Block House Lift Station. Mr. Traiteur explained that since the Block House Lift Station is not operational and is abandoned, the manhole is being used to pump wastewater directly to Lift Station #22 at Lauralee Drive and Violet Drive. Mr. Traiteur stated that the piping to and from the Block House is broken in several places.

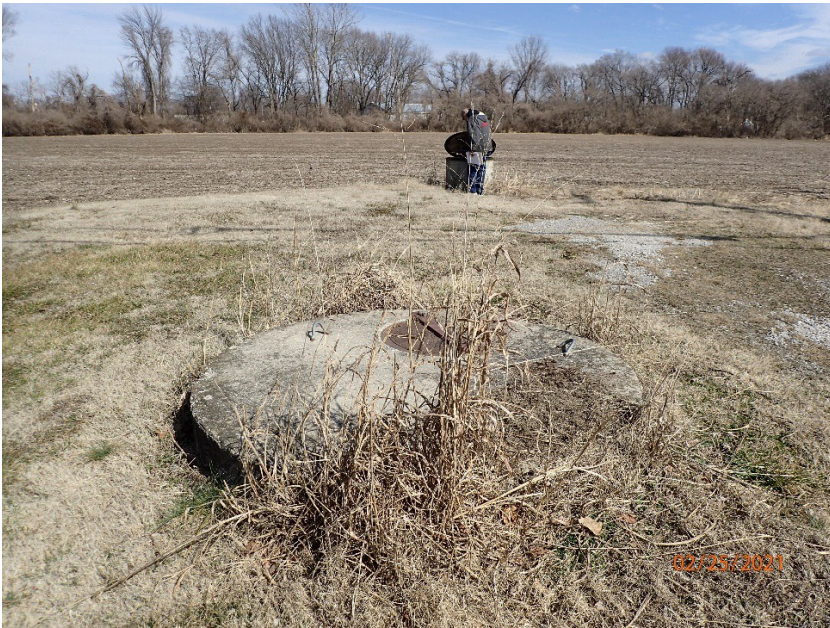
58: P2250099

Description: Lift Station #14 is in an open field behind residential area. The deep manhole in the background is not locked and is a safety hazard.

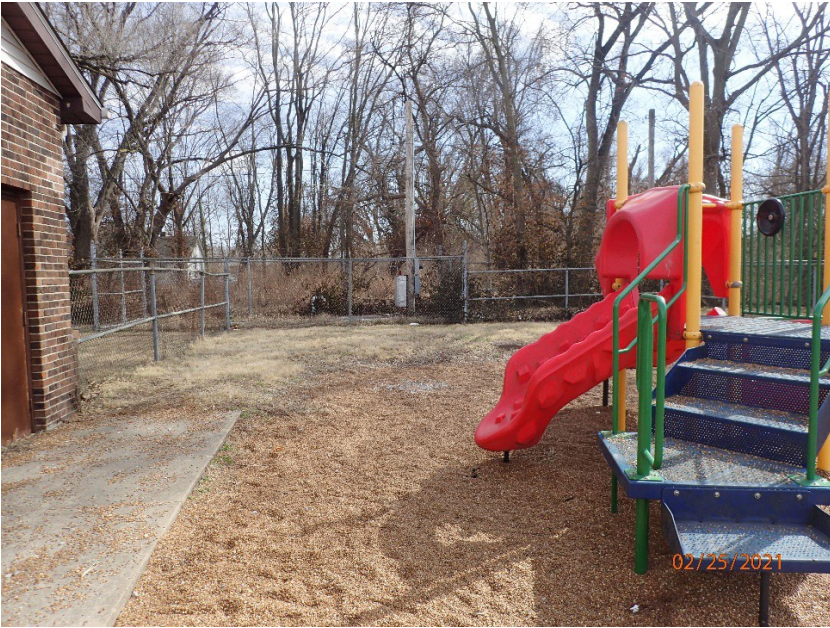
60: P2250101

Description: EPA observed the lift station behind the playground and noted that the slope of the ground was toward the playground, which was in a slight depression.
