Re: Sanitary Sewer Inspection Report

Purpose: Village of Cahokia – Sanitary Sewer System Inspection Report

Facility: Village of Cahokia Sanitary Sewer System

Date of Inspection: April 21-22, 2021

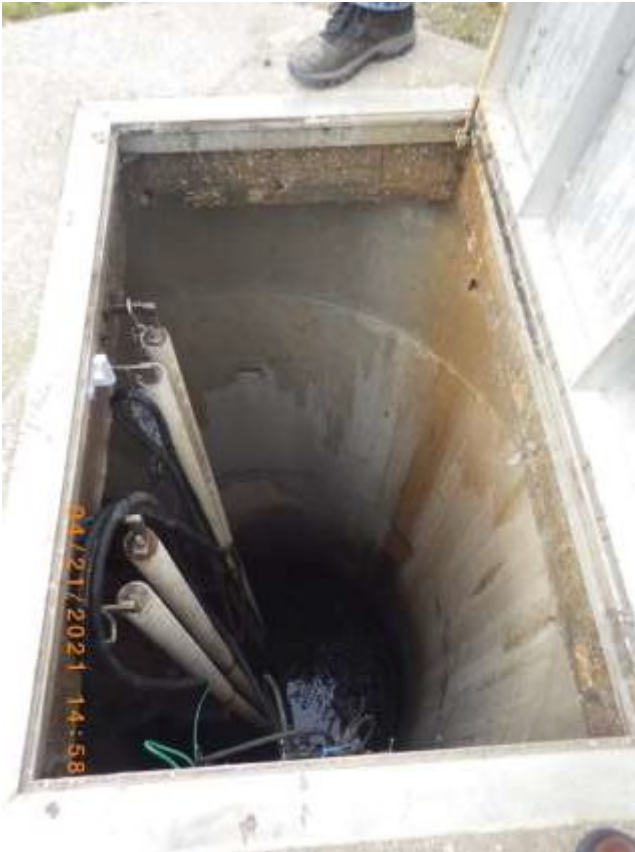
1: VCAH0001

Description: Lift Station #19 (Shack). This is one of the deepest lift stations in the Village.

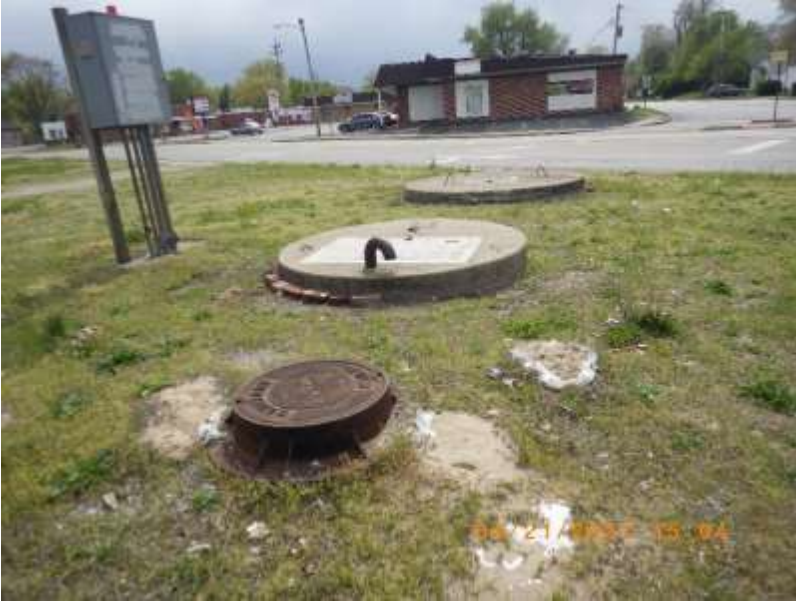
2: VCAH0002

Description: Lift Station #19 (Shack).

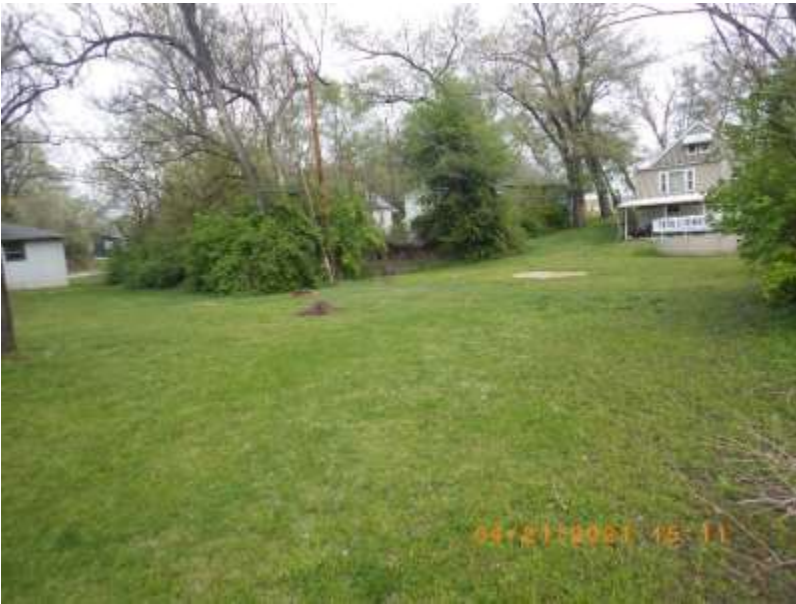
3: VCAH0003

Description: Stormwater flood area. Foreman said flooding occurs here during 2-3" rains.

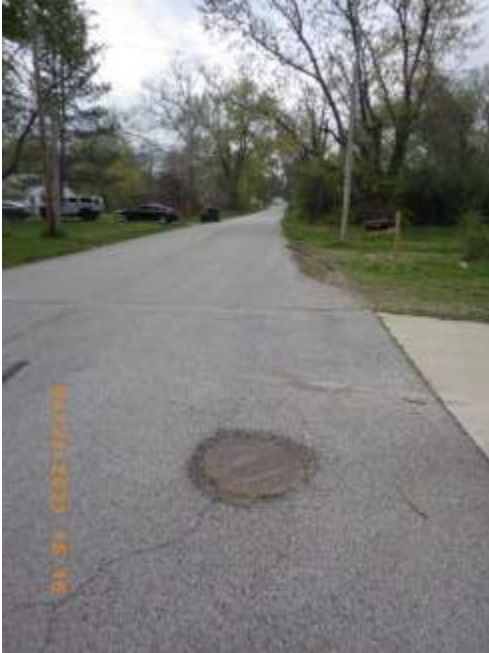
4: VCAH0004

Description: Stormwater flood area. Manhole in photo surcharges during flooding.

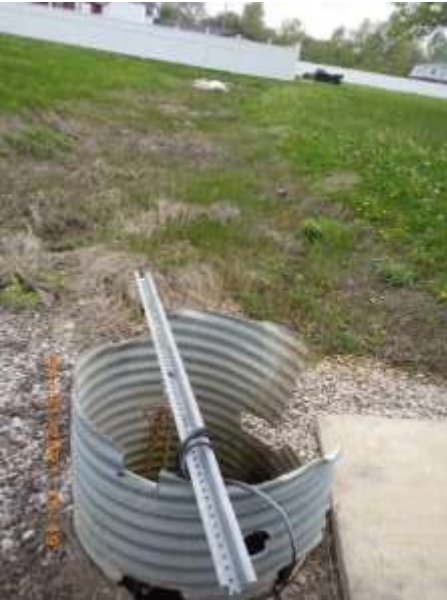
5: VCAH0005

Description: Stormwater pump station [identified as station 998 for purposes of this report]. Pumps storm water to stormwater manhole along Jerome Lane.

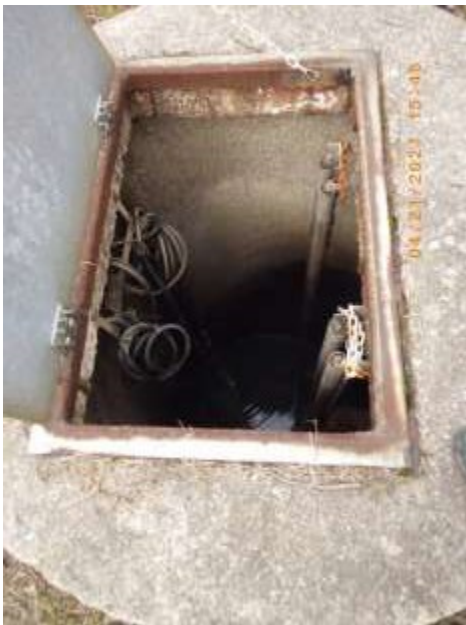
9: VCAH0009

Description: Lift Station #2 (Judith).

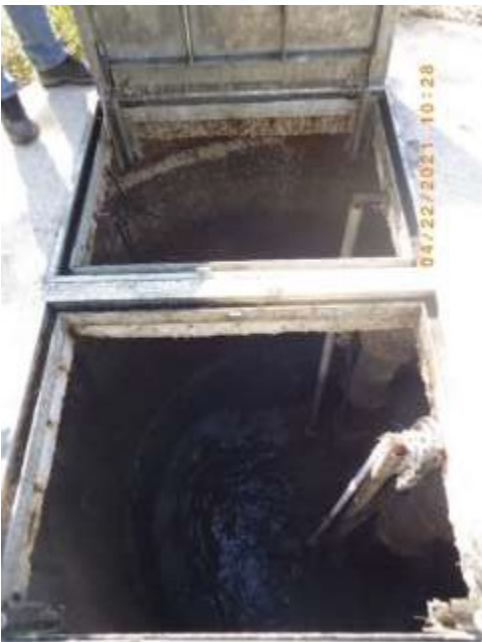
11: VCAH20001

Description: Lift Station #28, known as Station 5A (rear). Sewage from Commonfields of Cahokia enters the Village sewer system here.

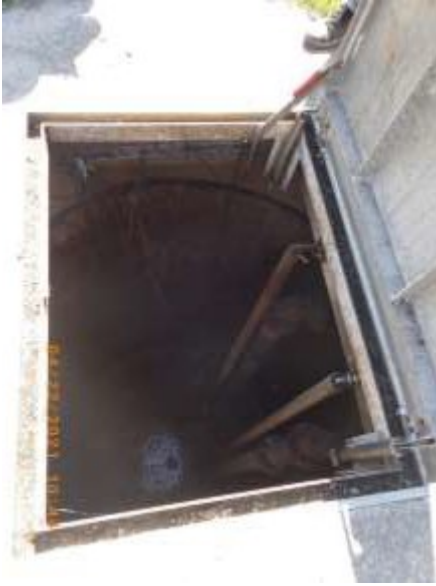
12: VCAH20002

Description: Lift Station #27, known as Station 5A (front). Handles flow from nearby trailer park and nursing home.

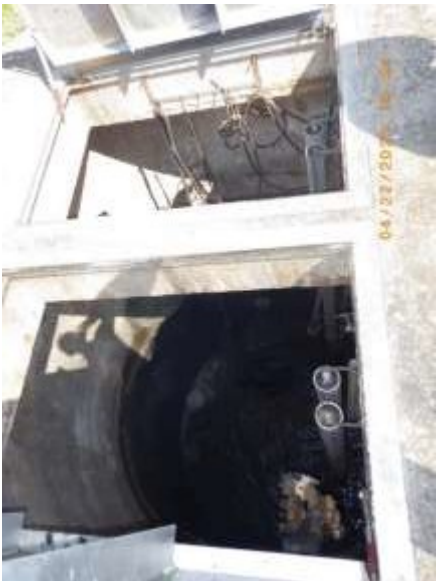
13: VCAH20003

Description: Lift Station #26, known as Station 3 (Diversion). This station has new rails and chains.

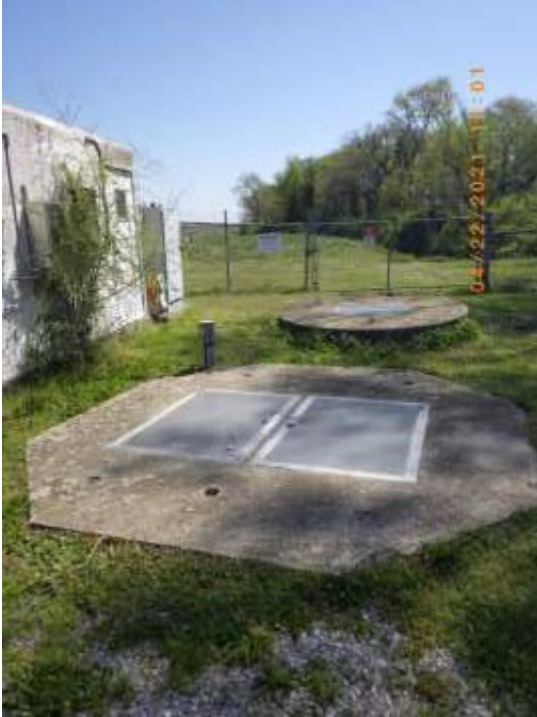
14: VCAH20004

26	Jerome & Wesley Station 3 (Diversion)	4/22/21; 10:54 a.m.	Known as Station 3 (Diversion), near airport. This station has new rails and chains (Photo VCAH20003) and begins force main to Sauget. The vault box was unlocked and I observed a missing gooseneck air vent, exposing vault to precipitation (Photo VCAH20004). The Foreman added a new lock to vault cover prior to departing the lift station.	VCAH20003 VCAH20004

Description: Lift Station #26, known as Station 3 (Diversion). Note air vent hole on vault pad (in front of vault doors) with missing gooseneck cap, exposing vault to precipitation.

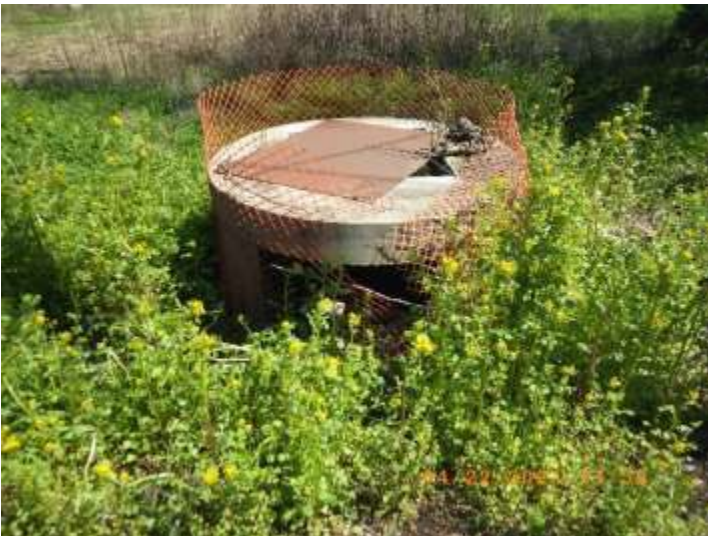
15: VCAH20005

Description: Stormwater pump station to Dead Creek [identified as station 999 for purposes of this report].

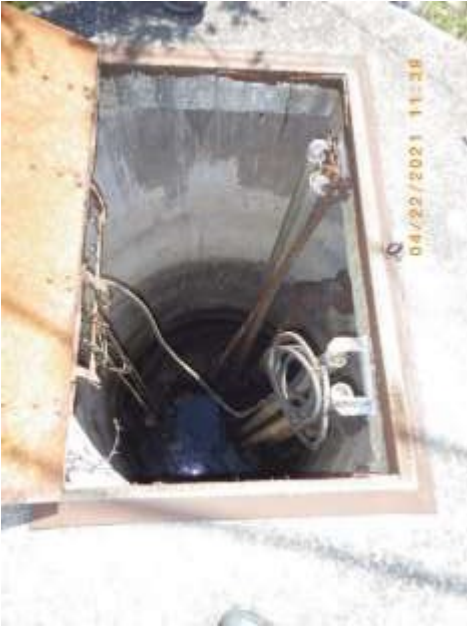
16: VCAH20006
Description: Lift Station #24.
Location: Mississippi & David
Camera Direction: 100°
Date/Time: 4/22/21; 11:39 a.m.

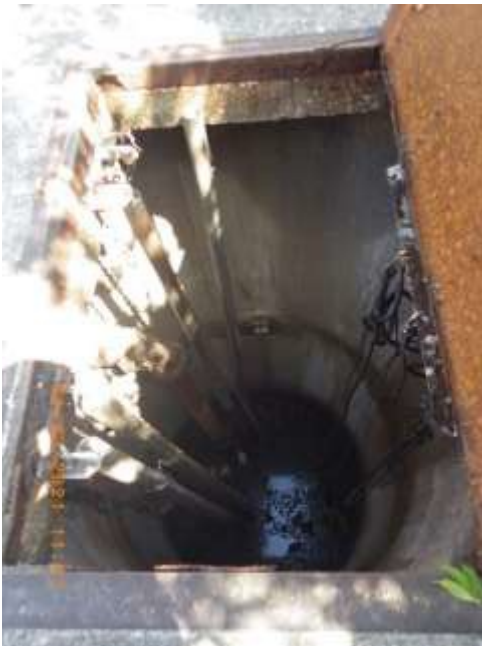
17: VCAH20007
Description: Lift Station #17. Note detached rail.
Location: Mississippi & David
Camera Direction: 19°
Date/Time: 4/22/21; 11:47 a.m.

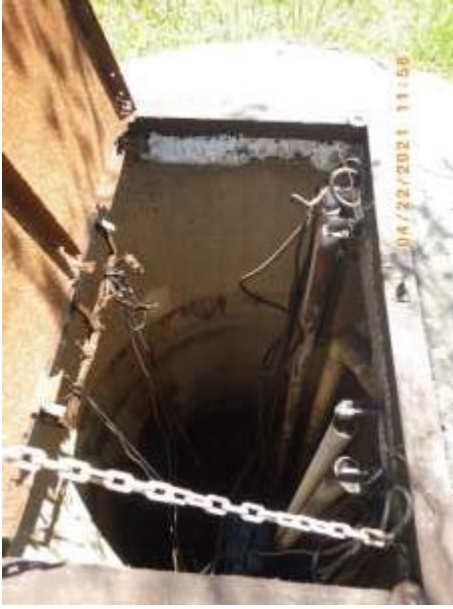
18: VCAH20008

Description: Lift Station #7. Note rusted components and edges of cover.

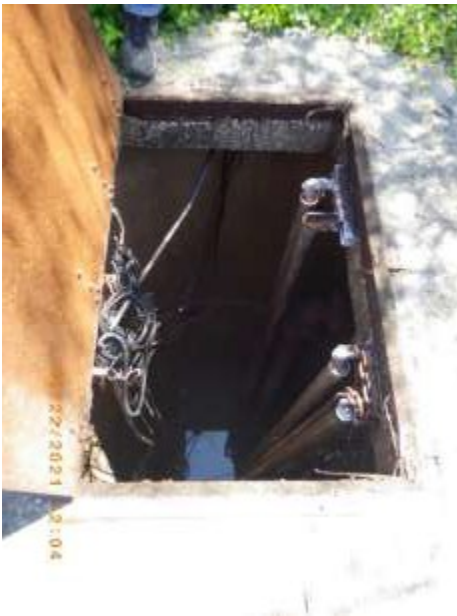
19: VCAH20009

Description: Lift Station #20, known as Singer Station. Hanger needs replacement.

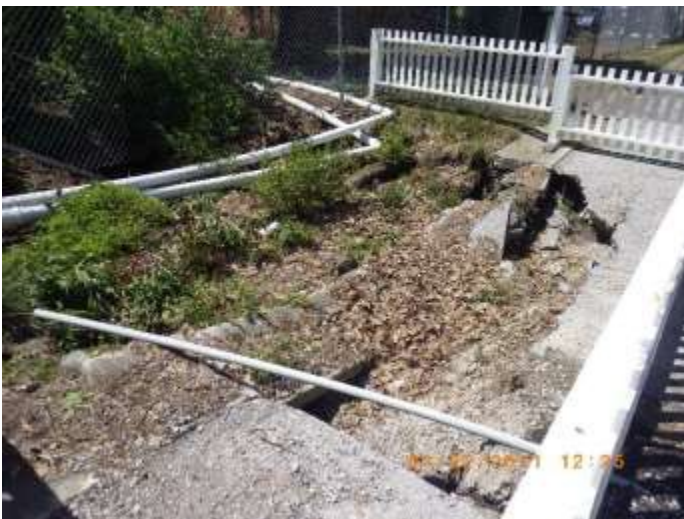
21: VCAH20011

NA	Circle Creek Ln.	4/22/21; 12:25 p.m.	Manhole failure area. The site was secured with temporary fencing around a collapsed sewer manhole (Photo VCAH20011). The Foreman believes the collapse was due to tree root and high water table, and added that repairs are scheduled to start next month. The failure started in May 2020 according to the Foreman.	VCAH20011
30	Falling Springs & Il 157	4/22/21; 12:35 p.m.	Known as Washington Station. The Foreman stated that this was the deepest and newest lift station in the Village. The station was in good shape. From here, sewage is pumped to a 30" line then gravity flows to Sauget and American Bottoms WWTP. We broke for lunch after inspecting this station.	VCAH20012
23	St. Monica & St. Maud Dr.	4/22/21; 1:53 p.m.	Known as St. Monica Station. We returned from lunch break and began the inspection at this location. The Foreman said this is an old and reliable lift station in need of replacement. I did not descend the ladder into the station well to observe its condition (Photo VCAH20013).	VCAH20013

- Lack of automatic alarms or auto dialers to alert sewer staff of lift station failures or issues;
- Need for better record-keeping for lift station inspections and identification of maintenance issues; and
- Collapsed sewer manhole on Circle Creek Drive.

Description: Manhole failure area. The site was secured with temporary fencing around a collapsed sewer manhole.

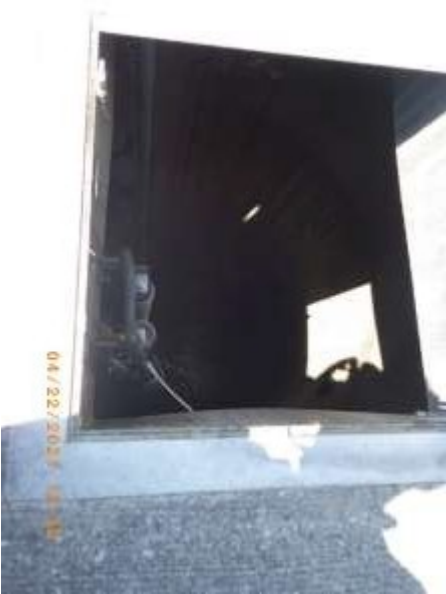
22: VCAH20012

Description: Lift Station #30, known as Washington Station. The Foreman stated that this was the deepest and newest lift station in the Village.

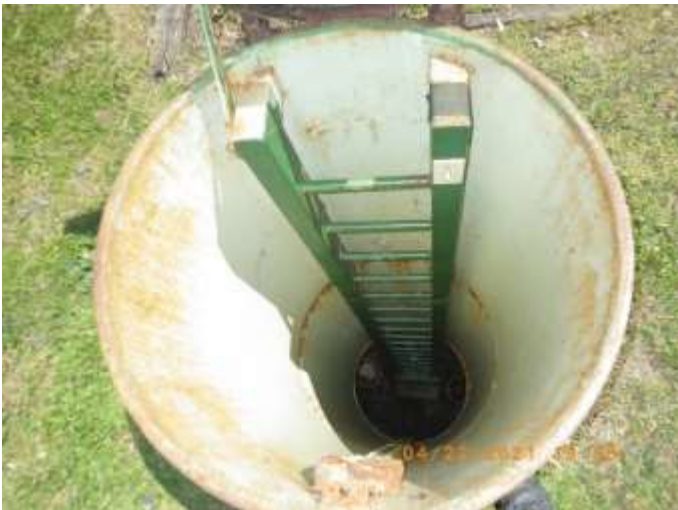
23: VCAH20013

Description: Lift Station #23, known as St Monica Station. The Foreman said this is an old and reliable lift station in need of replacement.

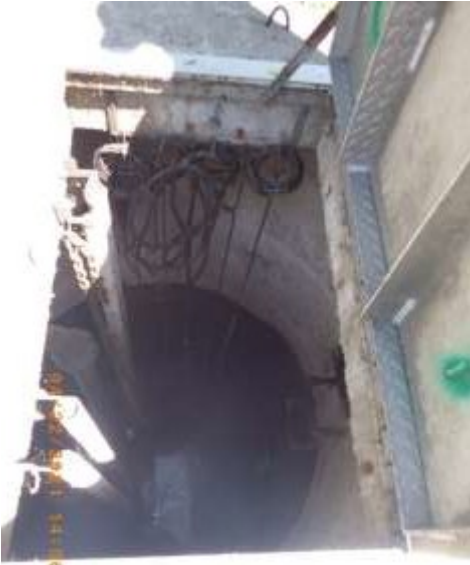
24: VCAH20014

Lift Station No.	General Location	Date/Time	Notes	Photos
22	St. Margaret & St. Justin	4/22/21; 2:06 p.m.	Known as St. Margaret Station. Only one pump operational.	VCAH20014
6	Cooper & IL Rt 157	4/22/21; 2:23 p.m.	Known as Cooper Station. Upon arrival I noticed an area with a recently filled ground collapse near a vault (VCAH20017). According to Foreman, this is the oldest lift station in the Village and one of the highest flow stations. I observed the incoming flow vault (VCAH20015) and pump station (VCAH20016). The Foreman mentioned that sewer gasses were deteriorating the walls of the lift station structures. At this point we were joined by EPA inspectors Joan Rogers and Ted Flatebo who were in the area and wanted to meet the Foreman. We concluded the physical inspection of lift stations and returned to the Village office to conduct the close out conference.	VCAH20015 VCAH20016 VCAH20017

Description: Lift Station #22, known as St. Margaret Station.

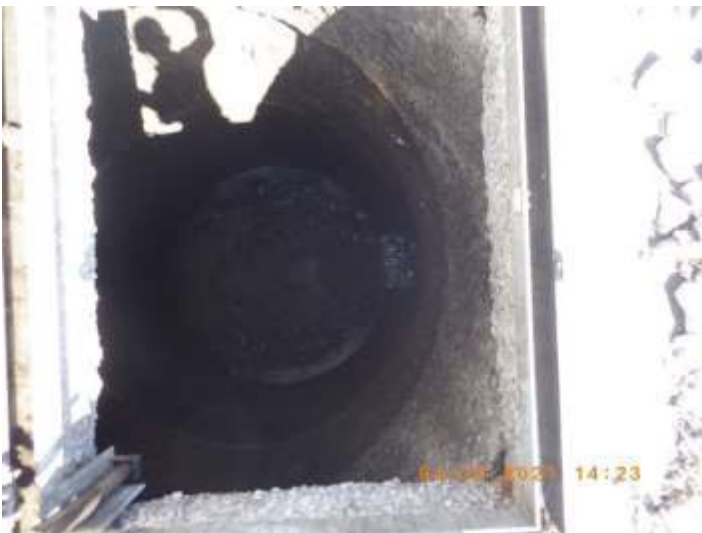
25: VCAH20015

Description: Lift Station #6, known as Cooper Station. Incoming flow vault.

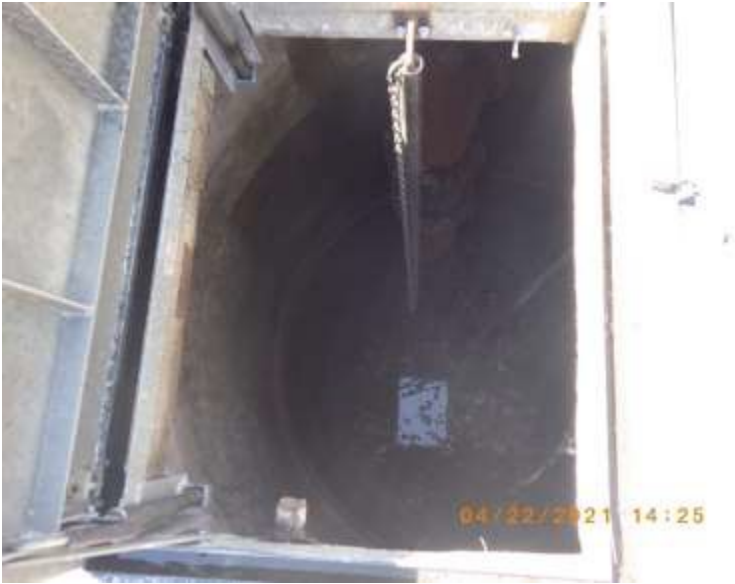
26: VCAH20016
Description: Lift Station #6, known as Cooper Station. Pump station.
Location: Cooper & IL Rt 157
Camera Direction: 260°
Date/Time: 4/22/21; 2:25 p.m.

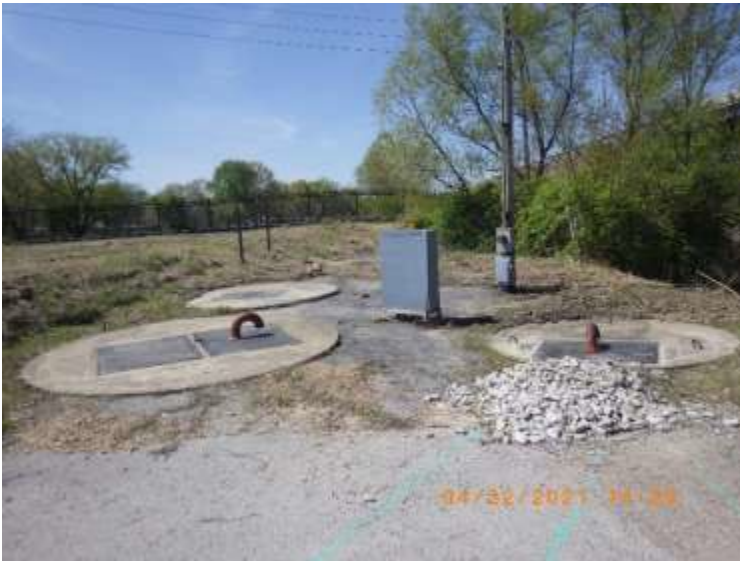
- Sewer staffing. A total of three sewer maintenance staff is far below expected staffing levels for operation and maintenance of a sewer system with such a large number of lift stations, and for a community of over 10,000 residents (EPA, 1973);
- Sewer overflows in flood prone areas, and related silting of sewer lines contributing to backups;
- Practice of pumping ponded stormwater with potential sewage contamination to Dead Creek;
- Heavy grease observed in Lift Station #1;
- Poor condition of several lift stations, including Lift Station #4, missing air vent gooseneck on Lift Station #26, detached rail on Lift Station #17, hanger replacement needed in Lift Station #20, deteriorating lift station walls due to sewer gasses and ground collapse near Lift Station #6, and lift stations (#10, #20, and #22) operating on only one pump;

27: VCAH20017
Description: Lift Station #6, known as Cooper Station. Note cobbles filling in ground collapse in front of inflow vault.
Location: Cooper & IL Rt 157
Camera Direction: 326°
Date/Time: 4/22/21; 2:29 p.m.
