**Five-Year Review Report**  
**Fourth Five-Year Review Report**  
**for**  
**Eagle Mine Superfund Site**  
EPA ID COD081961518

**Minturn**  
**Eagle County, Colorado**

September 2013

Prepared By:  
United States Environmental Protection Agency  
Region 8  
Denver, Colorado

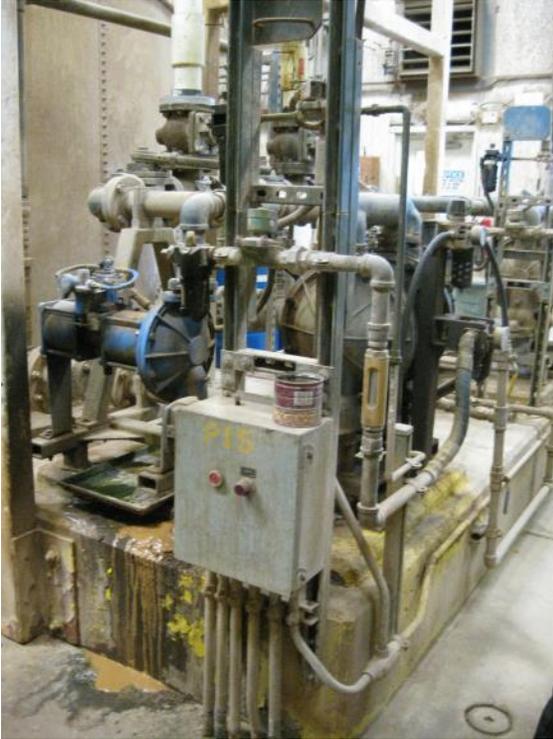
<b>OU(s): 1</b>	<b>Issue Category: Operations and Maintenance</b>			
	<b>Issue:</b> There is a leaking sludge compressor at the WTP.			
	<b>Recommendation:</b> Repair or replace the compressor.			
<b>Affect Current Protectiveness</b>	<b>Affect Future Protectiveness</b>	<b>Implementing Party</b>	<b>Oversight Party</b>	<b>Milestone Date</b>
No	Yes	PRP	EPA/State	9/30/2014

Leaking sludge compressor at WTP

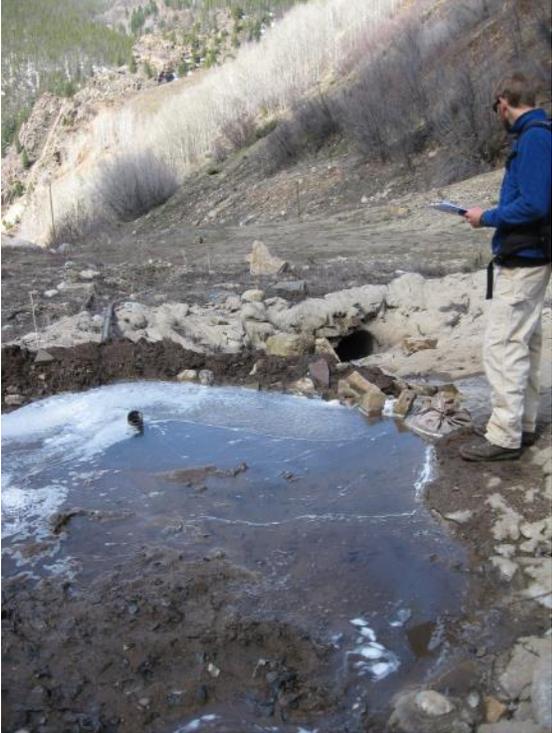
Lower collection basin with overflow going into pipe to Rock Creek

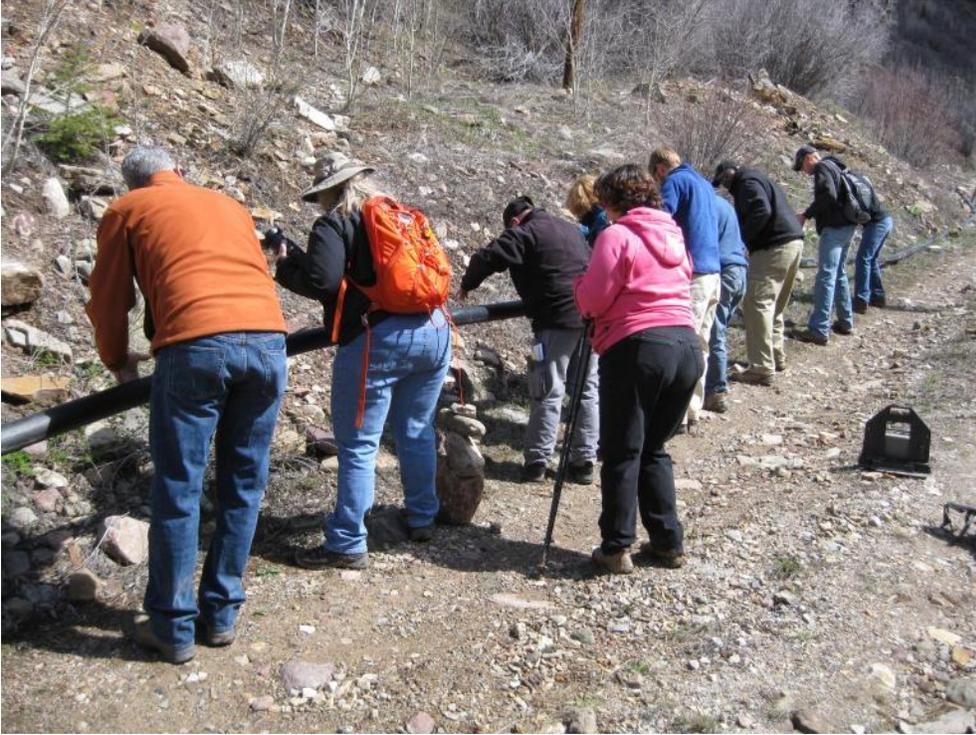
Plugged pipe from lower collection basin being cleared by site inspection team

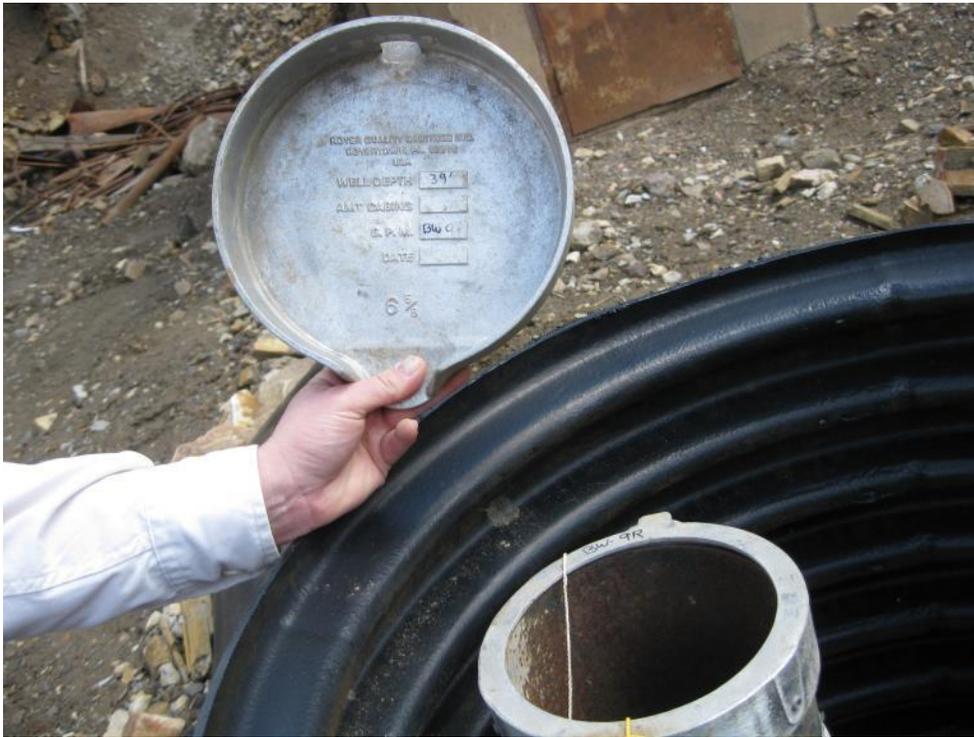
<b>OU(s): 1</b>	<b>Issue Category: Site Access/Security</b>			
	<b>Issue:</b> A number of wells on the Site are unlocked.			
	<b>Recommendation:</b> Secure all wells currently in use and properly abandon any wells that are no longer functional.			
<b>Affect Current Protectiveness</b>	<b>Affect Future Protectiveness</b>	<b>Implementing Party</b>	<b>Oversight Party</b>	<b>Milestone Date</b>
No	Yes	PRP	EPA/State	12/30/2014

Unlocked well at MDD vault

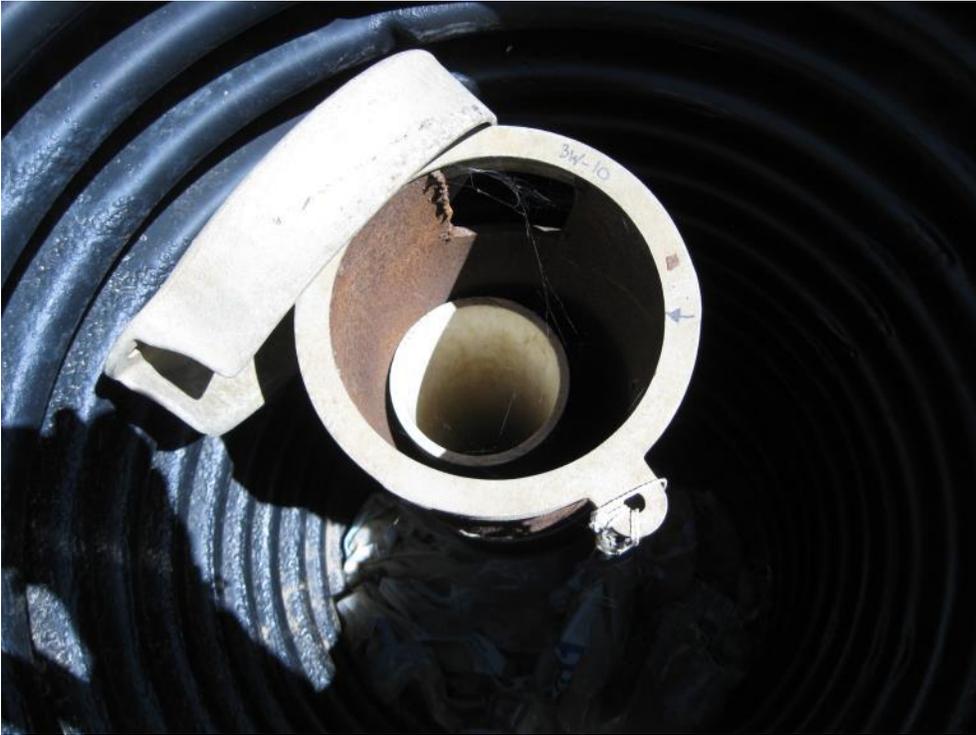
Unlocked well at Belden

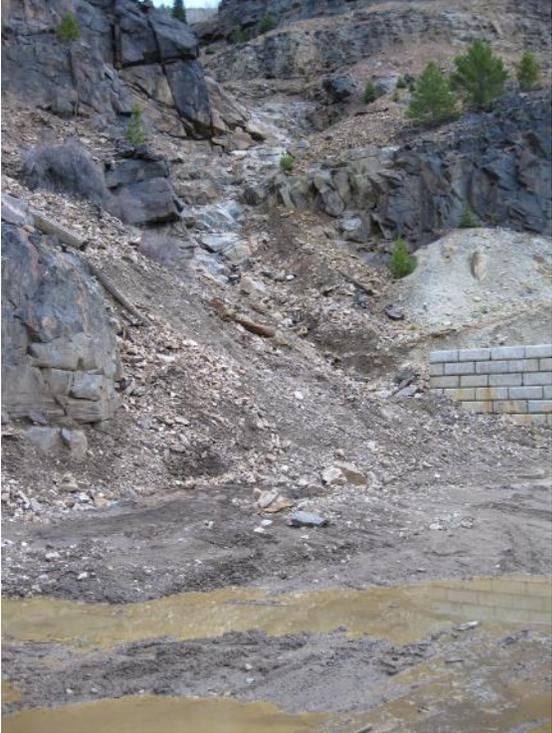
<b>OU(s): 1</b>	<b>Issue Category: Operations and Maintenance</b>			
	<b>Issue:</b> Significant water flow was observed from the Ben Butler drainage to the Ben Butler culvert near Belden, which was draining directly into the Eagle River without being treated. In addition, the culvert was filled in when the crib walls were built.			
	<b>Recommendation:</b> Determine how to correct the flow issue and take appropriate action.			
<b>Affect Current Protectiveness</b>	<b>Affect Future Protectiveness</b>	<b>Implementing Party</b>	<b>Oversight Party</b>	<b>Milestone Date</b>
No	Yes	PRP	EPA/State	10/30/2013

Ben Butler drainage near Belden and ponding on road below

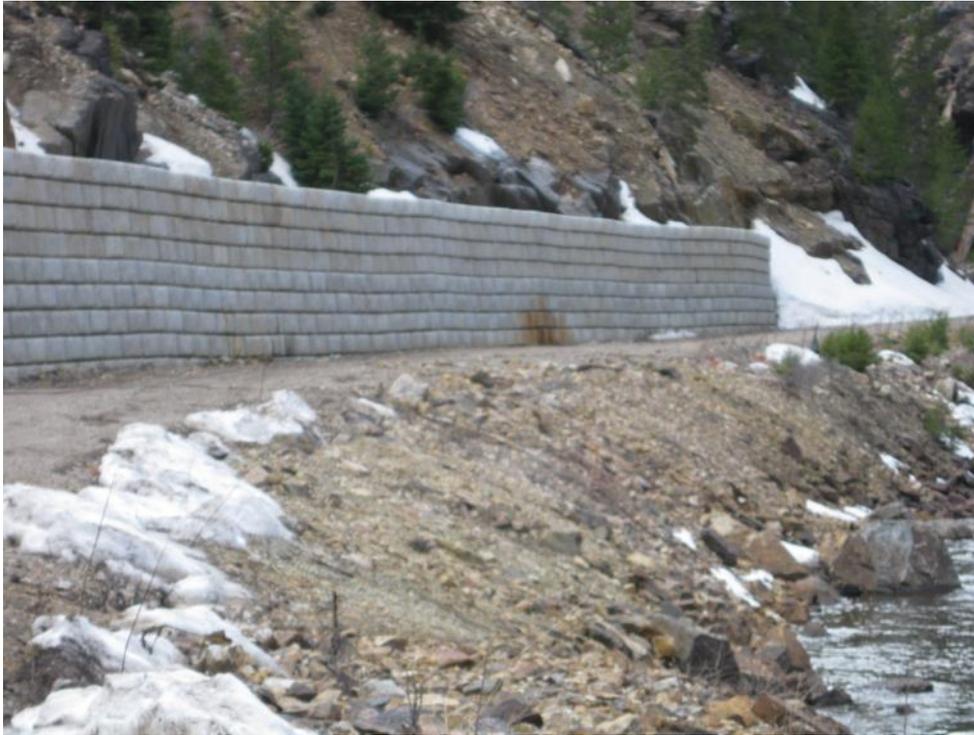
Staining on retaining wall from Doghole seep piping valve

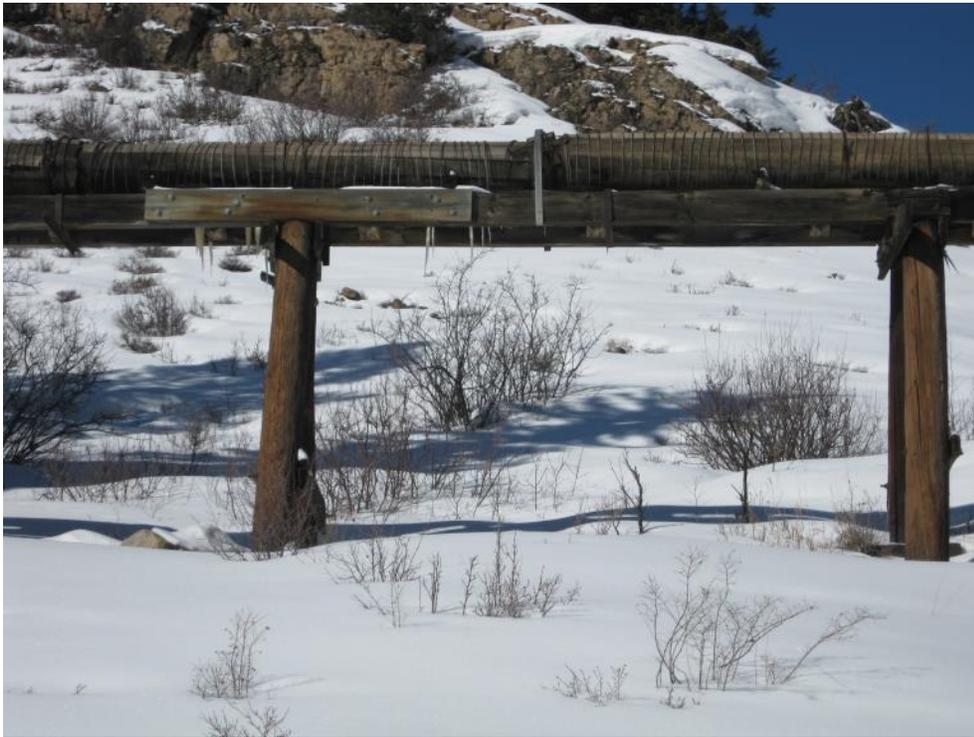
<b>OU(s): 1</b>	<b>Issue Category: Operations and Maintenance</b>			
	<b>Issue:</b> Numerous releases of contaminated mine water have been reported over the last five years and significant O&M issues related to the conveyance system were observed during the site inspections.			
	<b>Recommendation:</b> Consider upgrades for the WTP and conveyance system and continue to implement recommendations from the prior WTP and conveyance system audits.			
<b>Affect Current Protectiveness</b>	<b>Affect Future Protectiveness</b>	<b>Implementing Party</b>	<b>Oversight Party</b>	<b>Milestone Date</b>
No	Yes	PRP	EPA/State	9/30/2014

Recently repaired area of the pipeline conveyance system with icicles indicating areas of leaking

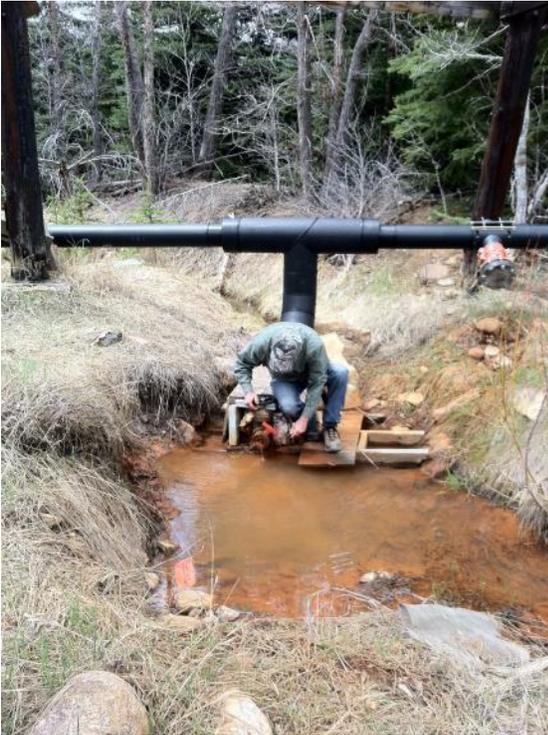
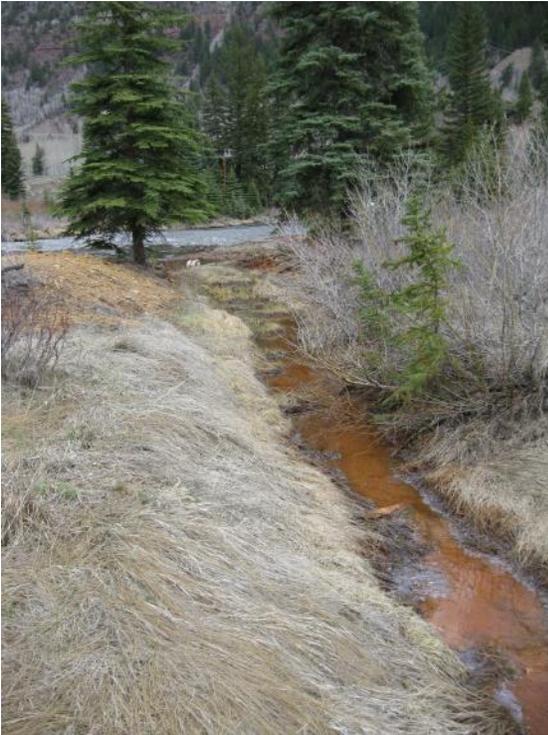
<b>OU(s): 1</b>	<b>Issue Category: Operations and Maintenance</b>			
	<b>Issue:</b> The bypass line had a temporary repair of a leak at Rex Flats.			
	<b>Recommendation:</b> Complete planned valve replacement.			
<b>Affect Current Protectiveness</b>	<b>Affect Future Protectiveness</b>	<b>Implementing Party</b>	<b>Oversight Party</b>	<b>Milestone Date</b>
No	Yes	PRP	EPA/State	10/30/2013

Leak in bypass line

Leak in bypass line draining towards Eagle River

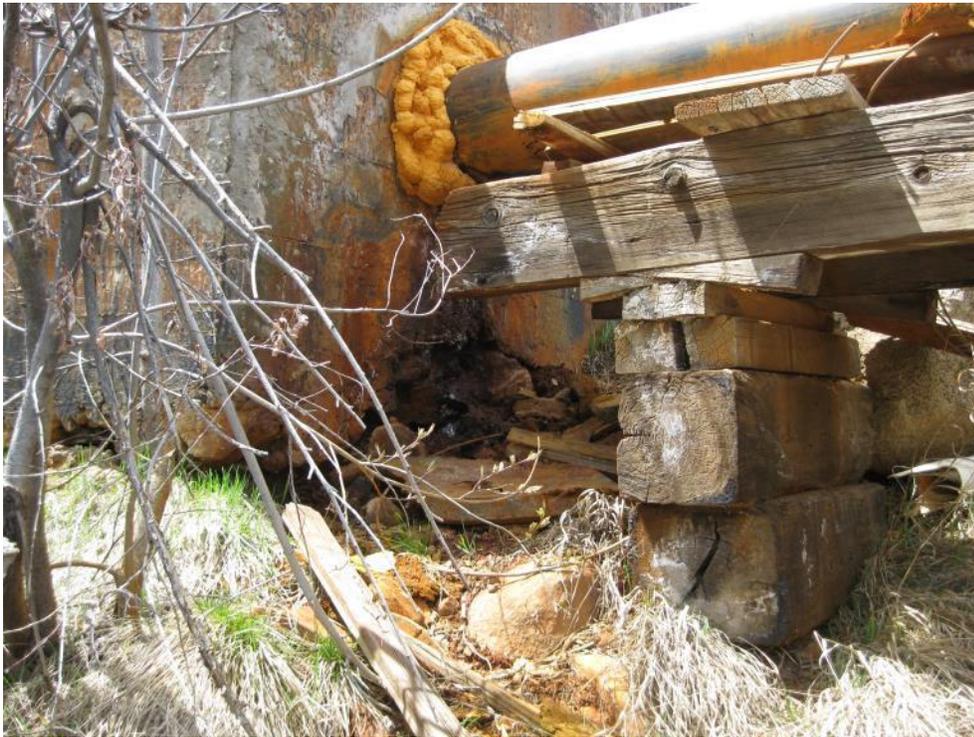
Repaired OTP manhole area of January 2011 sump overflow

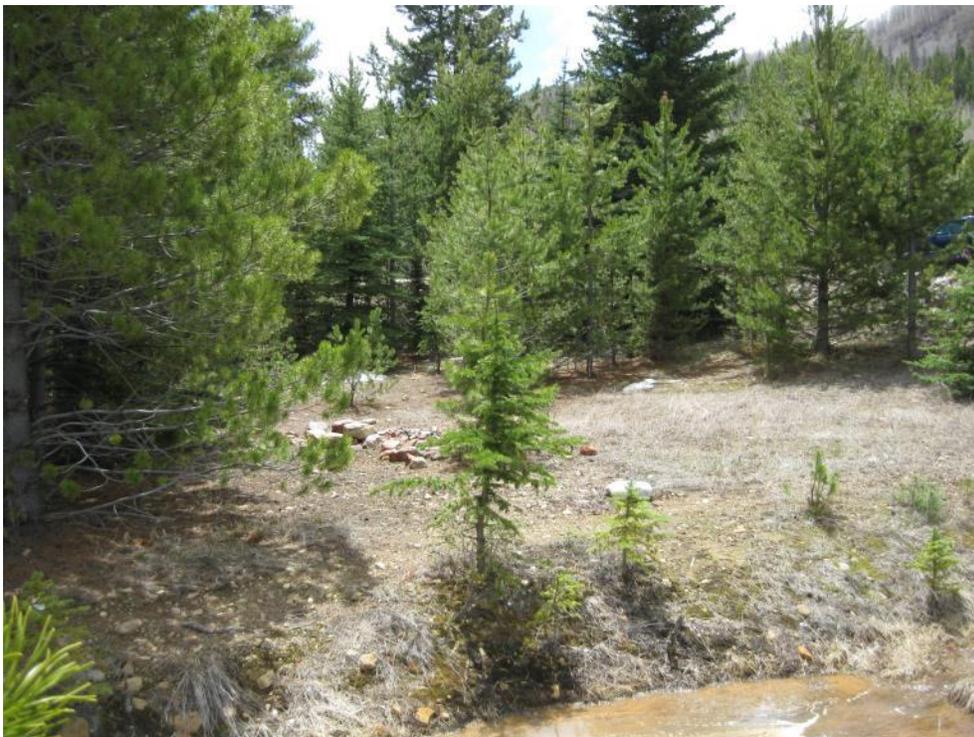
Evidence of camping next to south run-on ditch of OTP

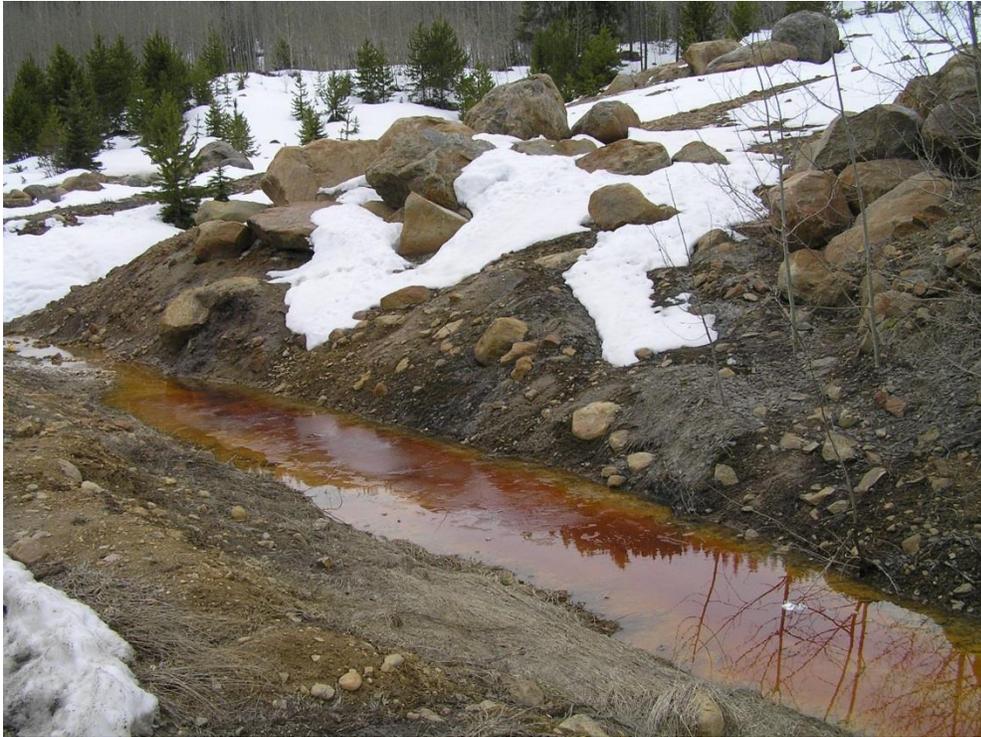
Ponding of contaminated water in the borrow ditch

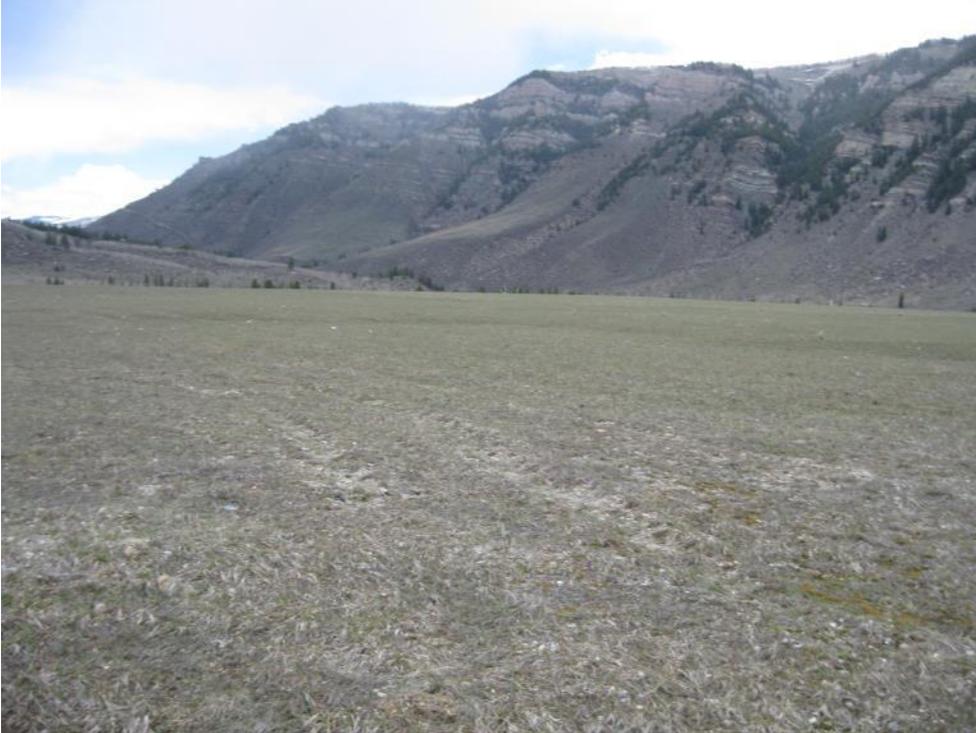
Broken barbed wire fence at OTP

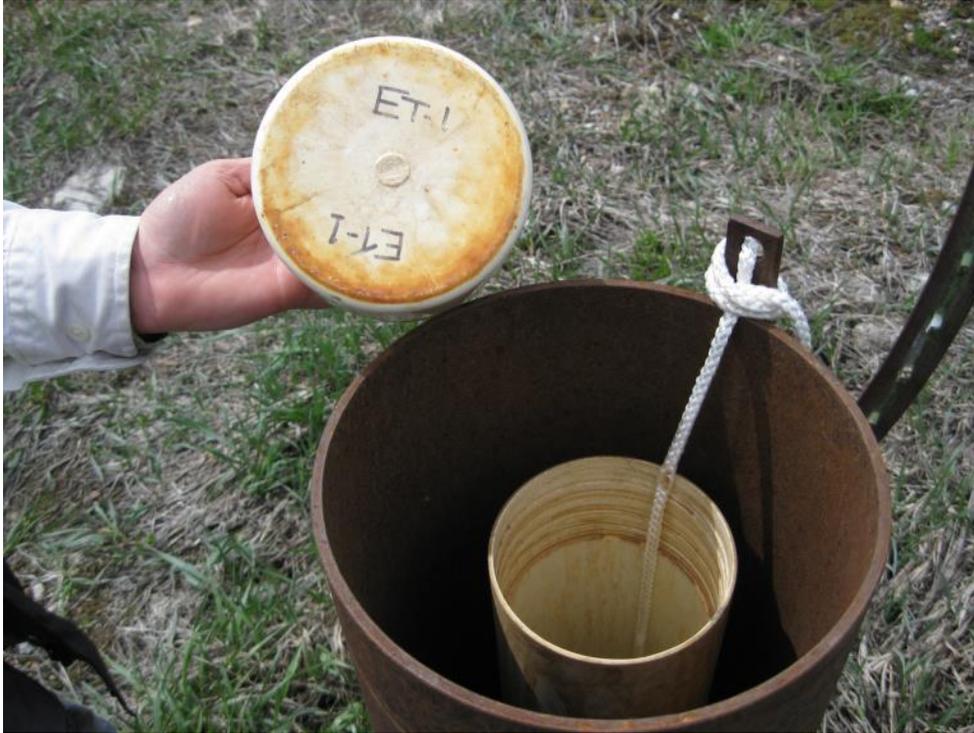
Unlocked well at CTP
