# SHAFT BLOW-OUT HAZARD OF CHECK AND BUTTERFLY VALVES

The Environmental Protection Agency (EPA) and Occupational Safety and Health Administration (OSHA) are issuing this *Alert* as part of their ongoing efforts to protect human health and the environment by preventing chemical accidents. Under CERCLA, section 104 (e), the Clean Air Act (CAA), and the Occupational Safety and Health Act (OSH Act), EPA and OSHA have authority to conduct chemical accident investigations. Additionally, in January 1995, the Administration asked EPA and OSHA to jointly undertake investigations to determine the root cause(s) of chemical accidents and to issue public reports containing recommendations to prevent similar accidents. EPA and OSHA have created a chemical accident investigation team to work jointly in these efforts. Prior to the release of a full report, EPA and OSHA intend to publish *Alerts* as promptly as possible to increase awareness of possible hazards. *Alerts* may also be issued when EPA and OSHA become aware of a significant hazard. It is important that facilities, HSERCs, LEPCs, emergency responders and others review this information and take appropriate steps to minimize risk.

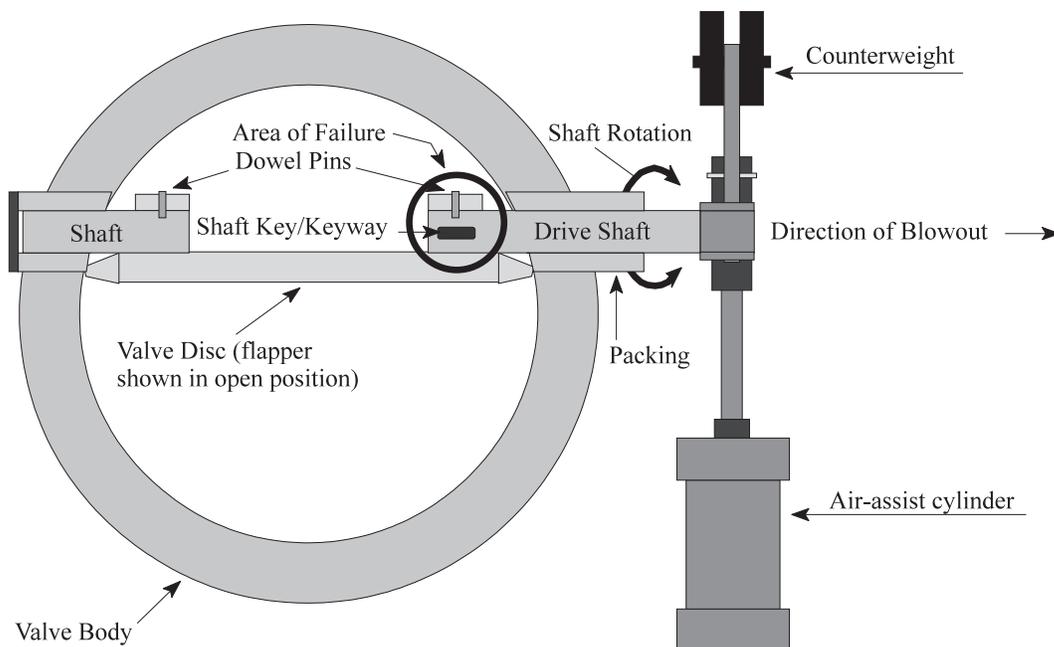
Simplified cross-sectional view of check valve (flow direction is into page)

The check valve was designed with a drive shaft that connects the internal valve disk to an external pneumatic cylinder (see diagram on next page). The valve failed when a dowel pin designed to fasten the drive shaft to the disk sheared and a key designed to transfer

torque from the drive shaft to the disk fell out of its keyway, disconnecting the drive shaft from the disk. System pressure was high enough to eject the unrestrained drive shaft from the valve, carrying with it the external counterweight assembly, weighing over 200 lbs., a distance of 43 feet away.

Valves subject to this hazard may be designed with a two-piece valve stem (sometimes referred to as a "stub-shaft" design). In each of the cases described above, the malfunctioning component was a Clow stub-shaft Model GMZ pneumatically assisted swing check valve (see diagram below). In these check valves, one stem piece functions as a drive shaft that connects the internal valve disk to an external air-assist cylinder and counterweight assembly. The drive shaft penetrates the pressure boundary through a stuffing box. The exterior portion of the drive

shaft is connected to a pneumatic piston and counterweight, and the interior portion of the shaft is coupled directly to the valve disk using a cylindrical hardened steel dowel pin and a rectangular bar key. This arrangement provides a power-assist to close the valve during compressor shut down, preventing reverse flow of compressed gases. These particular valves have probably not been produced since 1985, but still exist in some process facilities constructed before that date. Similar valves currently or previously produced and sold by other valve manufacturers may also be subject to this hazard.

Facilities should review their process systems to determine if they have valves installed that may be subject to this hazard. If so, facilities should conduct a detailed hazard analysis to determine the risk of valve failure. Check valves or butterfly valves which are subject to several or all of the above design and operational factors are at high risk for shaft blow-out. Detailed internal inspections may be necessary in order to identify high-risk valves. Facilities should consider replacing high-risk valves at the earliest opportunity with a blow-out resistant design. Several blow-out resistant designs of check and butterfly valves are available. If immediate valve replacement is impossible or impractical, facilities should consider immediately modifying the valves to prevent shaft blow-out. Valve manufacturers should be consulted in order to ensure that any modifications made are safe.
