<b>Project Name:</b> Anaconda Aluminum Company	<b>Site Location:</b> Columbia Falls Aluminum Company Site, Flathead County, Montana	<b>TDD No:</b> 0004/1305-04
---	---	--------------------------------

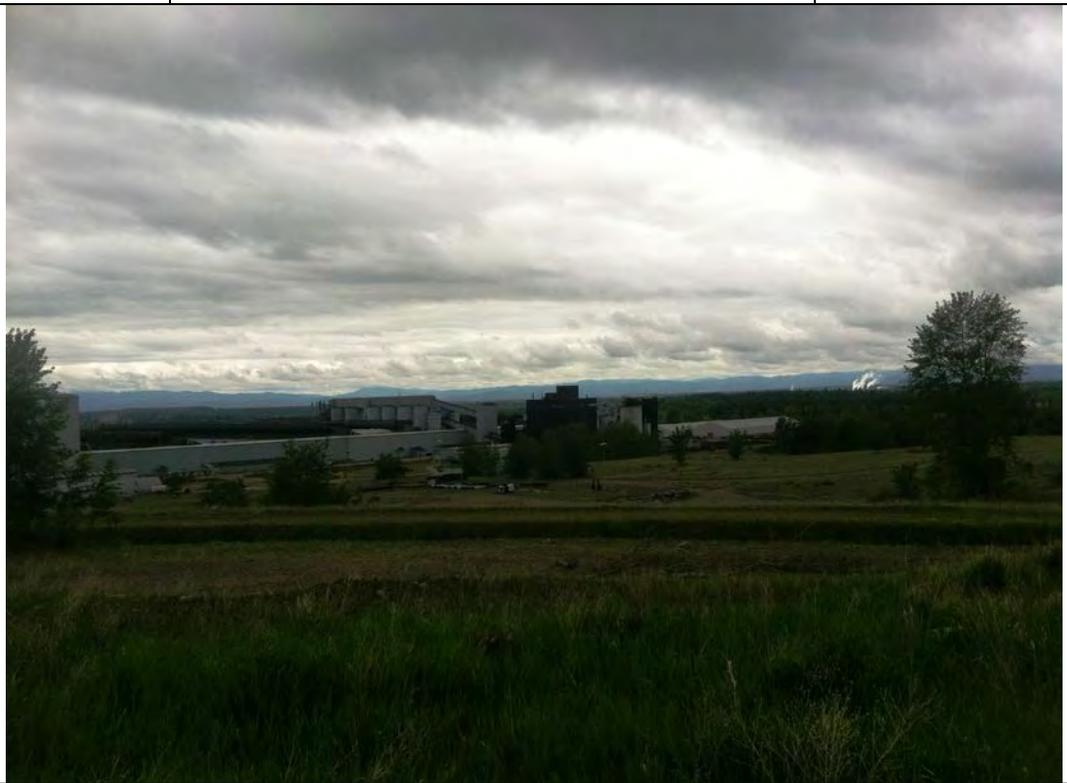
<b>Photo No.</b> <b>1</b>	<b>Date:</b> 6/3/2013
<b>Direction Photo Taken:</b>  SE	
<b>Description:</b>  Anaconda Aluminum property overview.

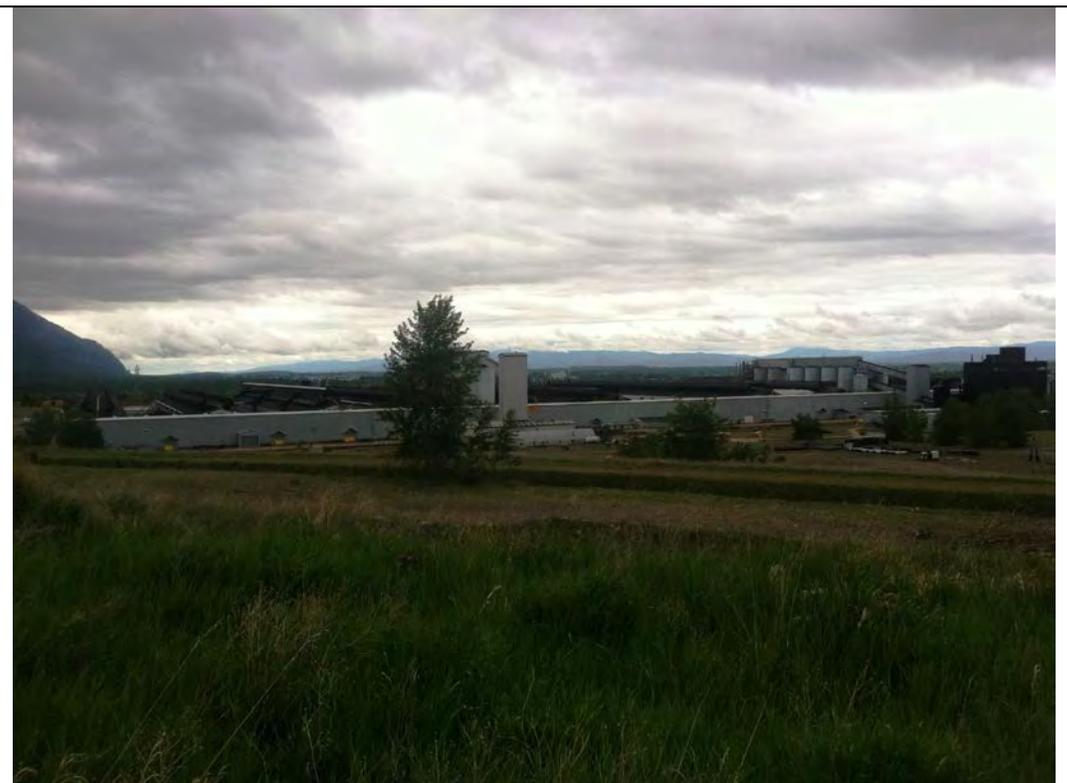
<b>Photo No.</b> <b>2</b>	<b>Date:</b> 6/3/2013
<b>Direction Photo Taken:</b>  SSE	
<b>Description:</b>  Anaconda Aluminum property overview.

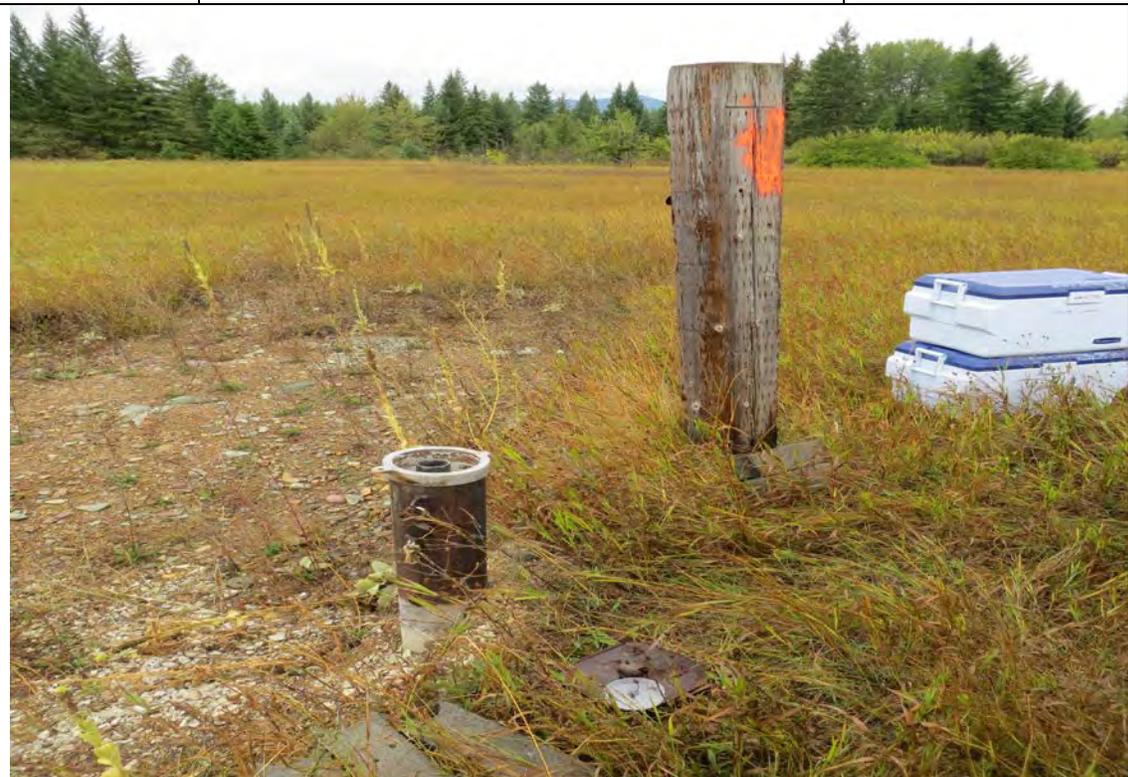
<b>Photo No.</b> <b>3</b>	<b>Date:</b> 9/24/2013
------------------------------	---------------------------

Showing location for groundwater sample: CF-GW-MW-01.

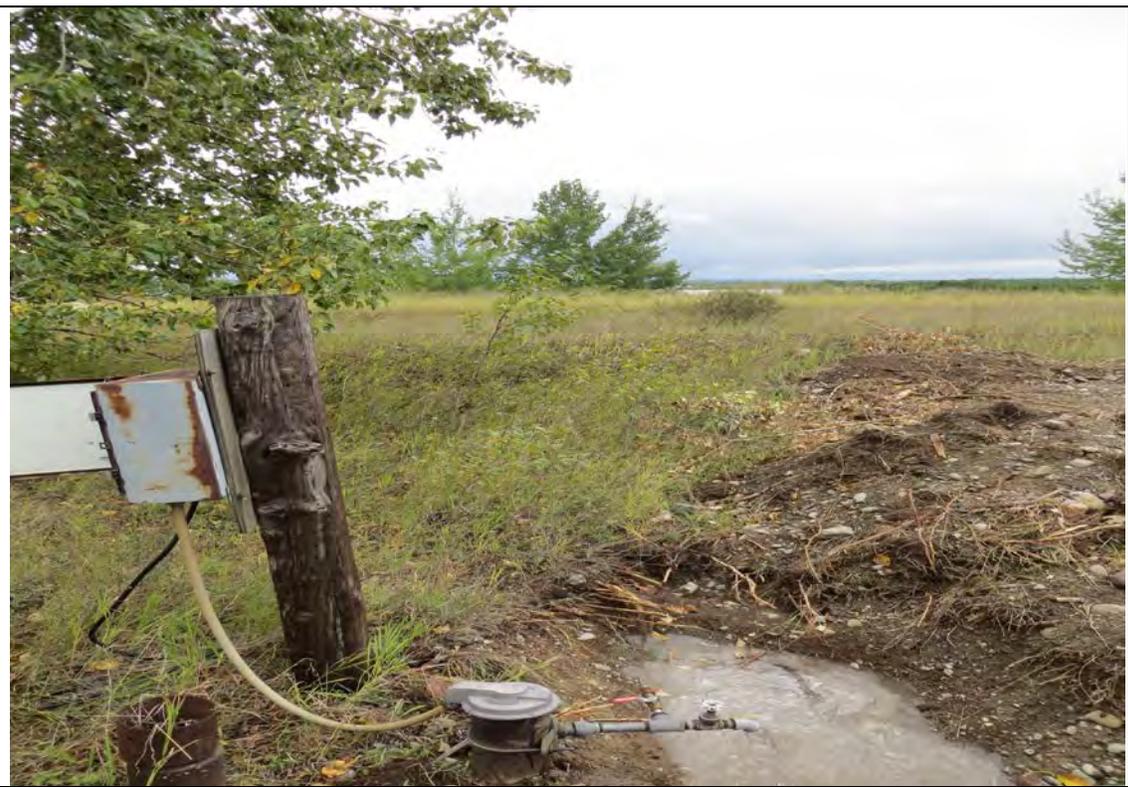
<b>Photo No.</b> <b>4</b>	<b>Date:</b> 9/24/2013
------------------------------	---------------------------

Showing location for groundwater sample: CF-GW-MW-02.

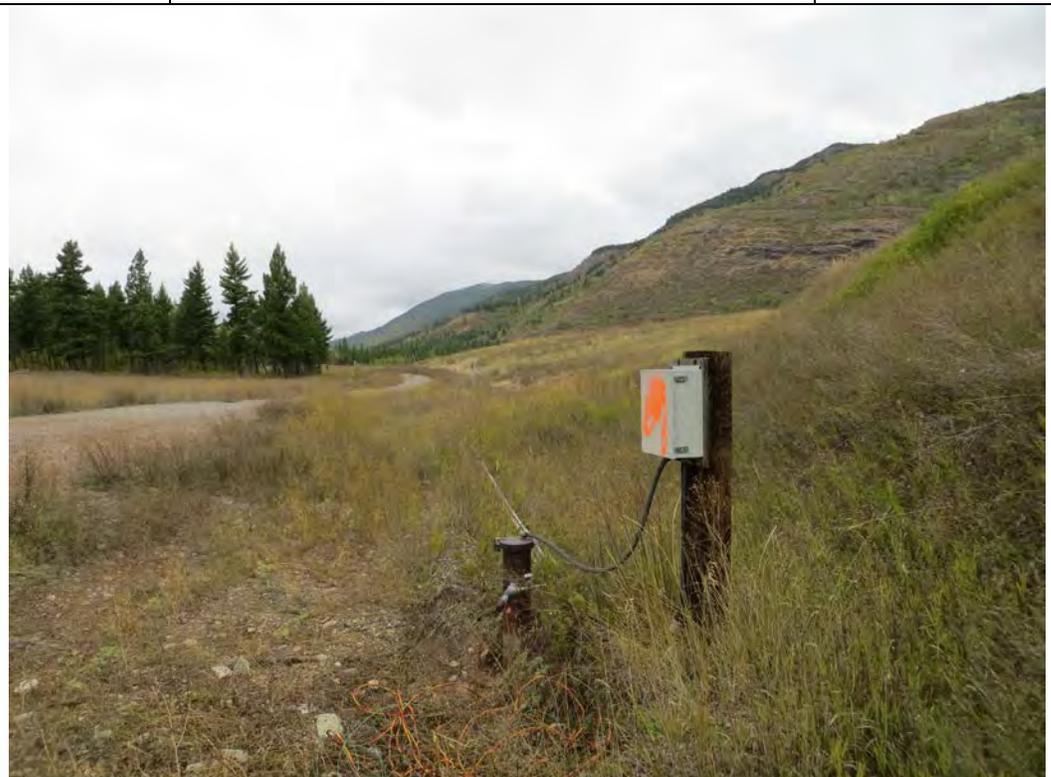
<b>Photo No.</b> <b>5</b>	<b>Date:</b> 9/24/2013
<b>Direction Photo Taken:</b>  N	
<b>Description:</b>  Showing location for groundwater sample: CF-GW-MW-03. Old Wet Scrubber Sludge Pond (E) in background.

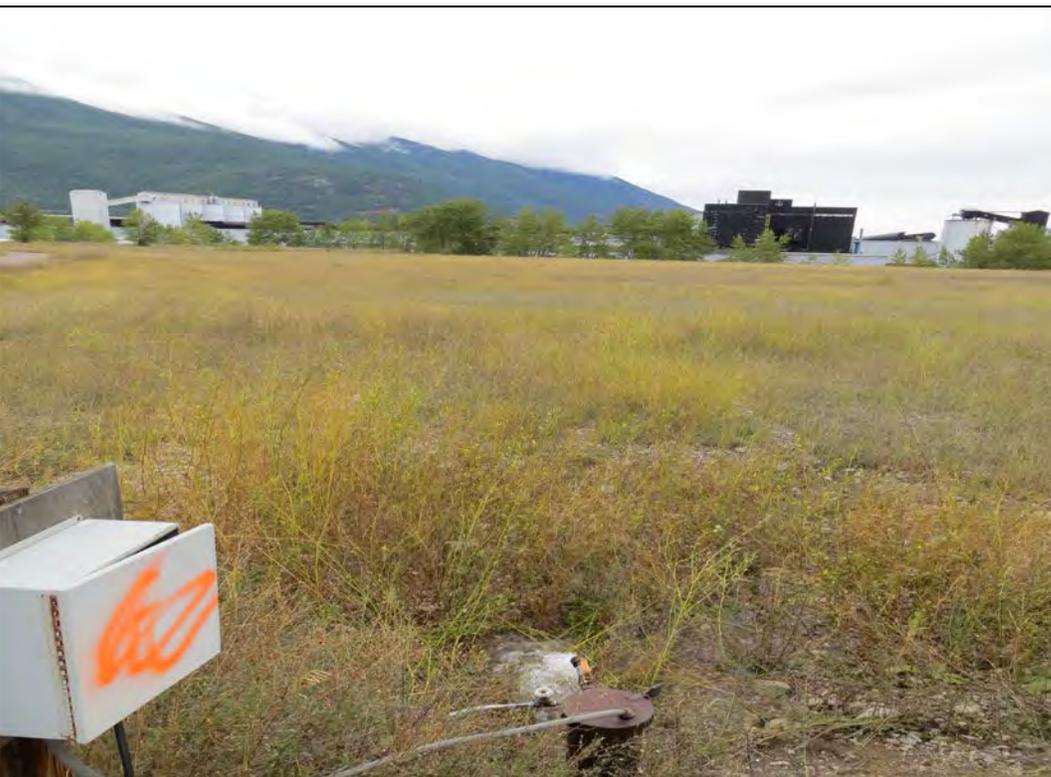
<b>Photo No.</b> <b>6</b>	<b>Date:</b> 9/24/2013
<b>Direction Photo Taken:</b>  S	
<b>Description:</b>  Showing location for groundwater sample: CF-GW-MW-04.

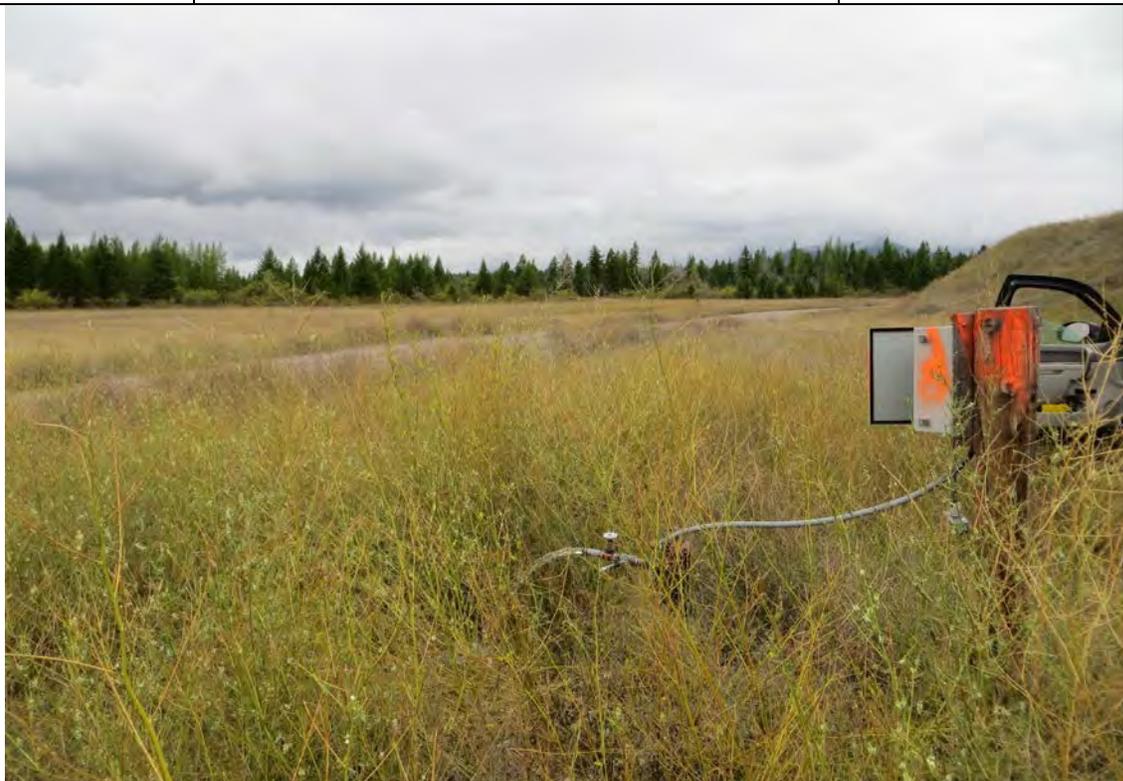
<b>Photo No.</b> <b>7</b>	<b>Date:</b> 9/24/2013
<b>Direction Photo Taken:</b>  NW

Showing location for groundwater sample: CF-GW-MW-05. Old Wet Scrubber Sludge Pond (NE) in background.

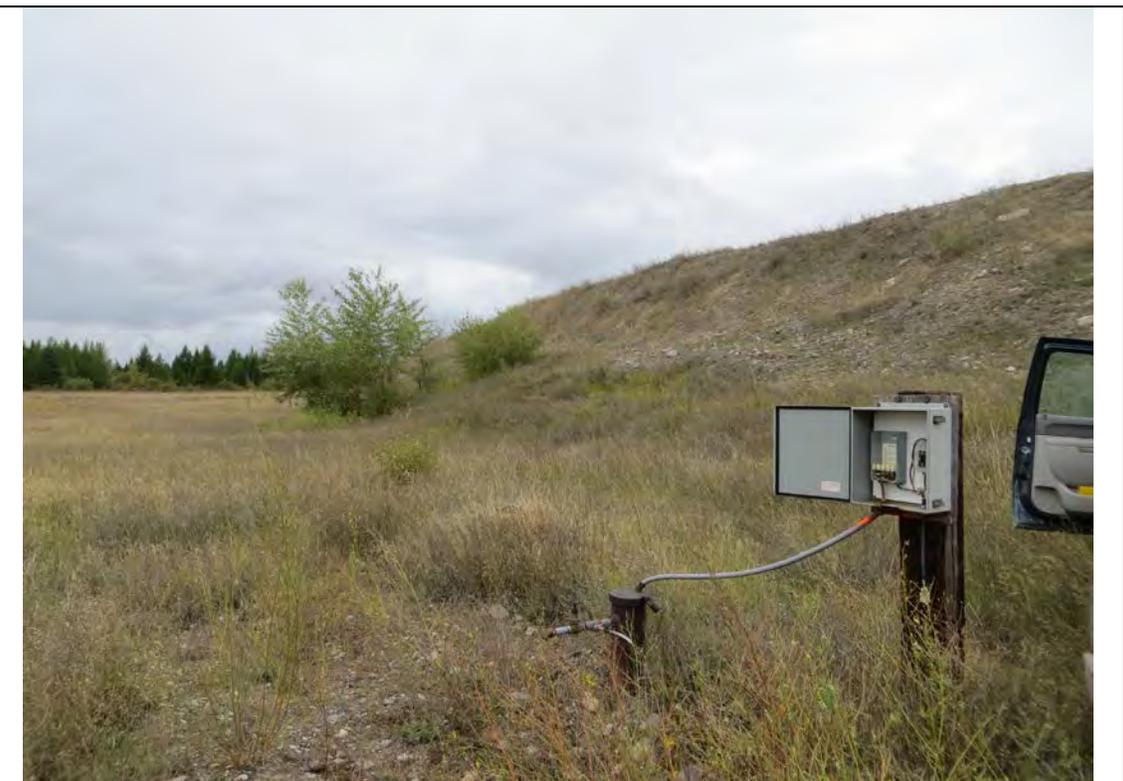
<b>Photo No.</b> <b>8</b>	<b>Date:</b> 9/24/2013
<b>Direction Photo Taken:</b>  NNW

Showing location for groundwater sample: CF-GW-MW-06. Old Wet Scrubber Sludge Pond (NE) in background.

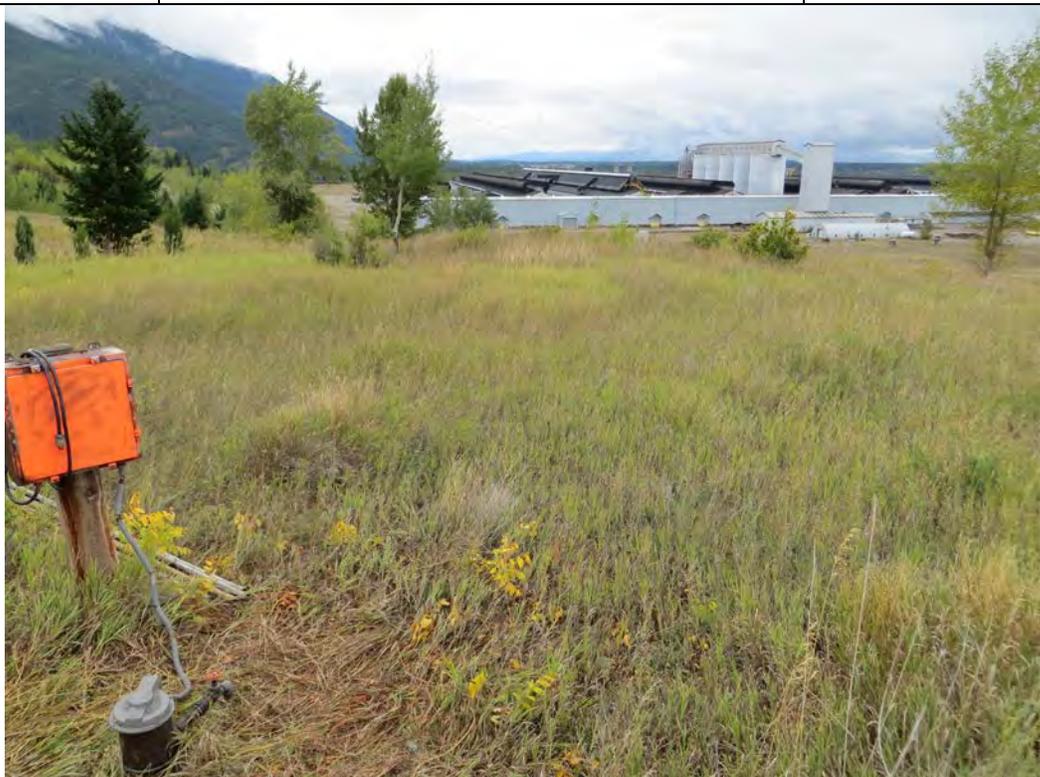
<b>Photo No.</b> <b>9</b>	<b>Date:</b> 9/24/2013
<b>Direction Photo Taken:</b>  S

Showing location for groundwater sample: CF-GW-MW-07.

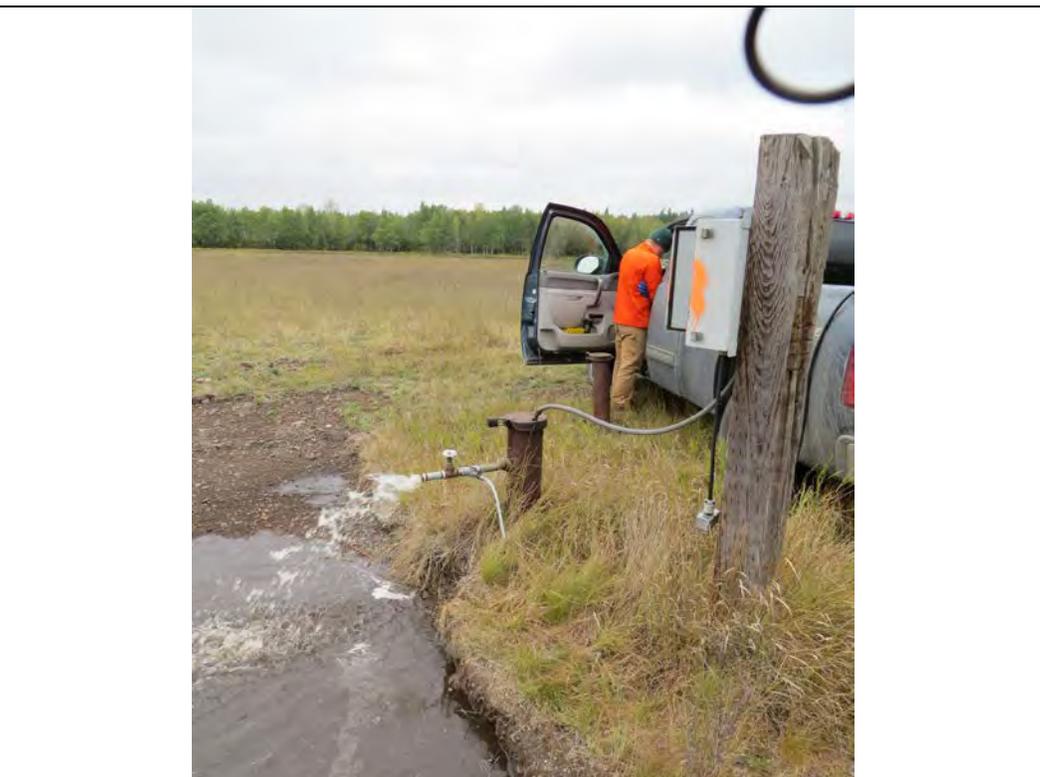
<b>Photo No.</b> <b>10</b>	<b>Date:</b> 9/24/2013
<b>Direction Photo Taken:</b>  W

Showing location for groundwater sample: CF-GW-MW-08.

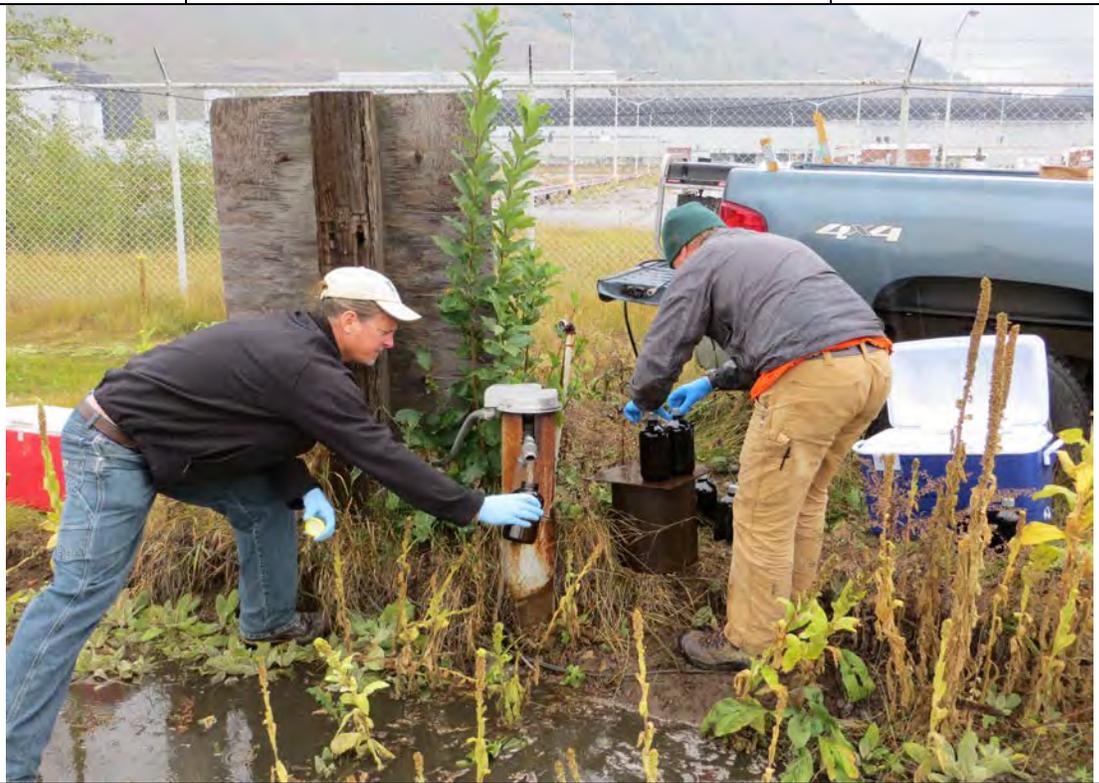
<b>Photo No.</b> <b>11</b>	<b>Date:</b> 9/24/2013
-------------------------------	---------------------------

Showing location for groundwater sample: CF-GW-MW-09. CFAC plant in background.

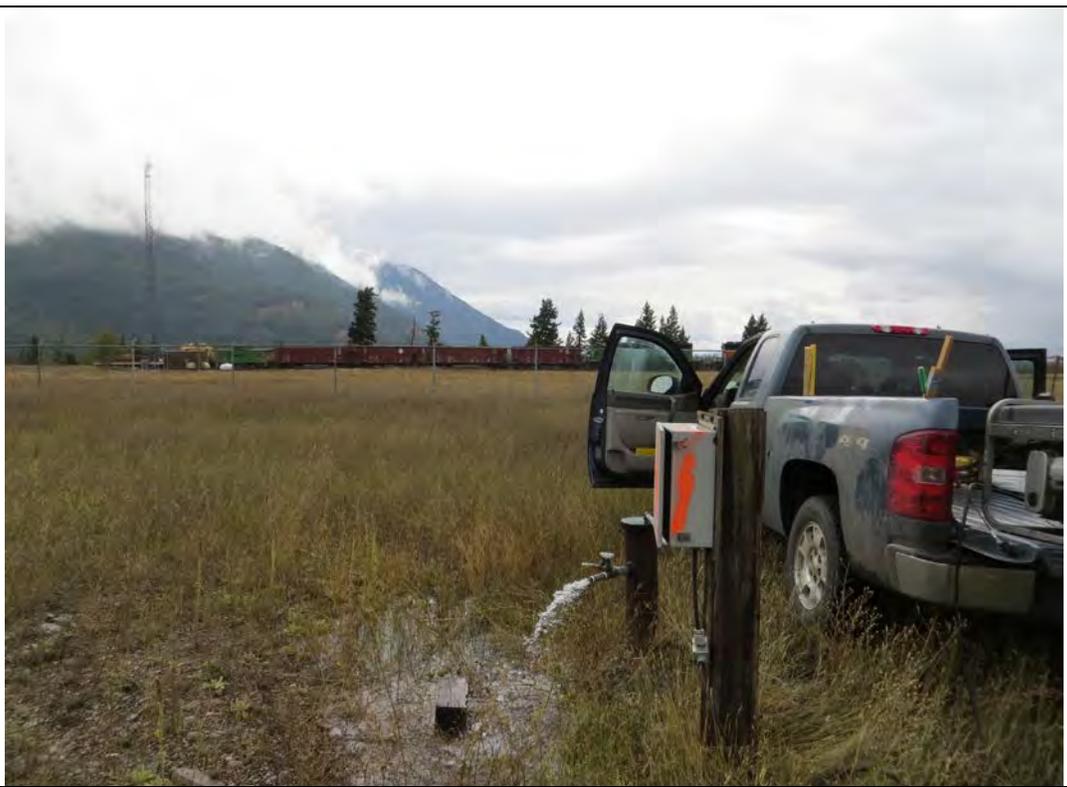
<b>Photo No.</b> <b>12</b>	<b>Date:</b> 9/24/2013
-------------------------------	---------------------------

Showing location for groundwater sample: CF-GW-MW-10.

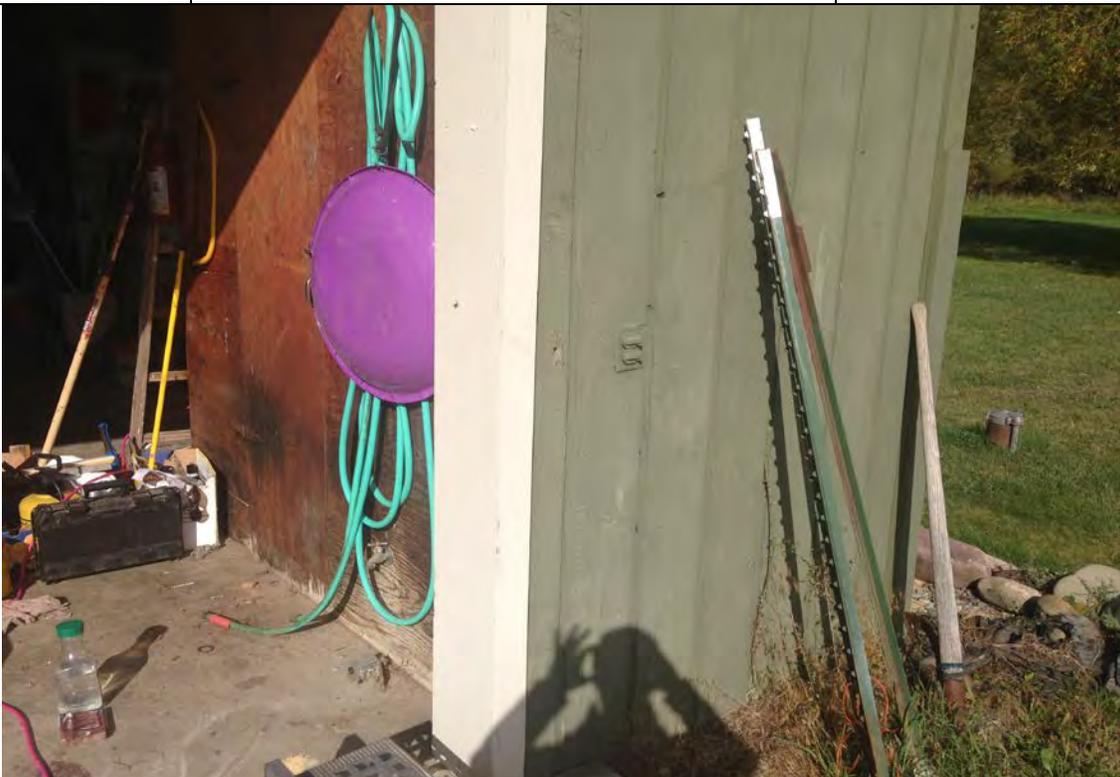
<b>Photo No.</b> <b>13</b>	<b>Date:</b> 9/26/2013
-------------------------------	---------------------------

**Description:**  
Showing location for groundwater sample: CF-GW-MW-12.

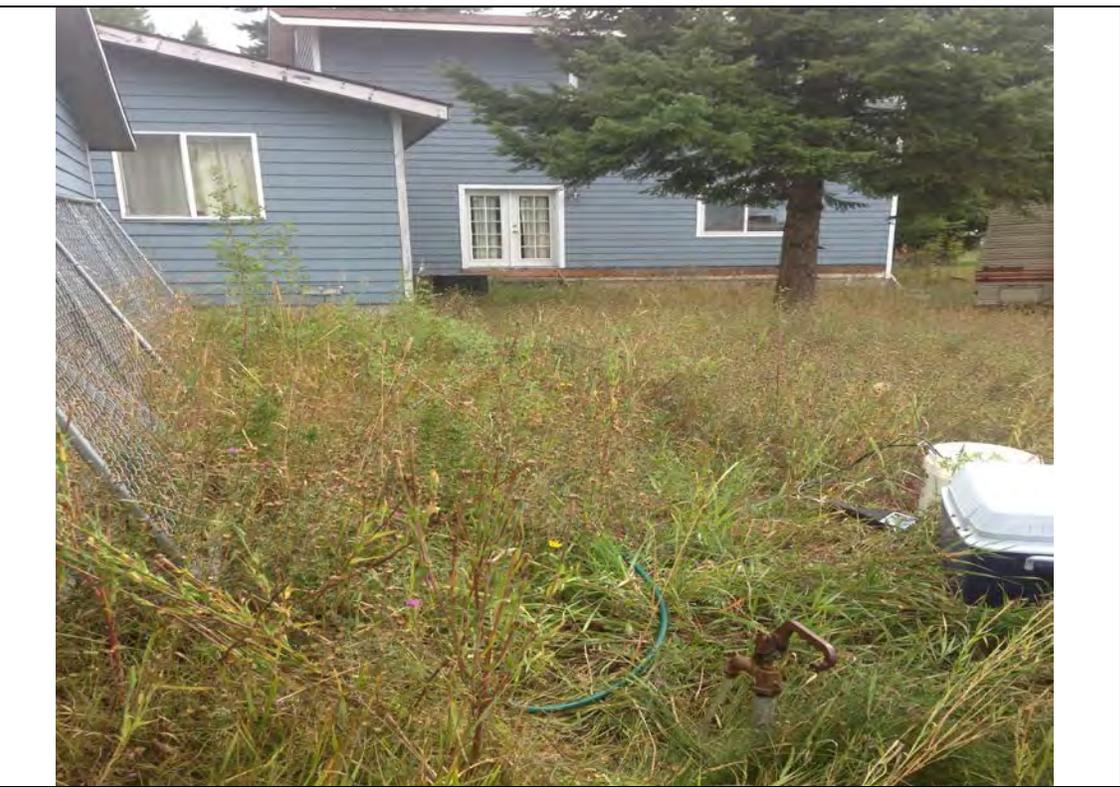
<b>Photo No.</b> <b>14</b>	<b>Date:</b> 9/26/2013
-------------------------------	---------------------------

**Description:**  
Showing location for groundwater sample: CF-GW-MW-13.

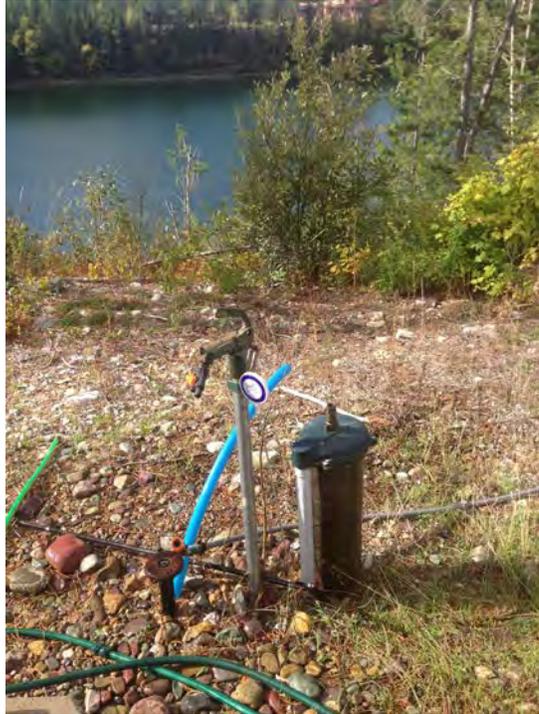
<b>Photo No.</b> <b>15</b>	<b>Date:</b> 9/26/2013
<b>Direction Photo Taken:</b>  E

Showing location for groundwater sample: CF-GW-MW-15.

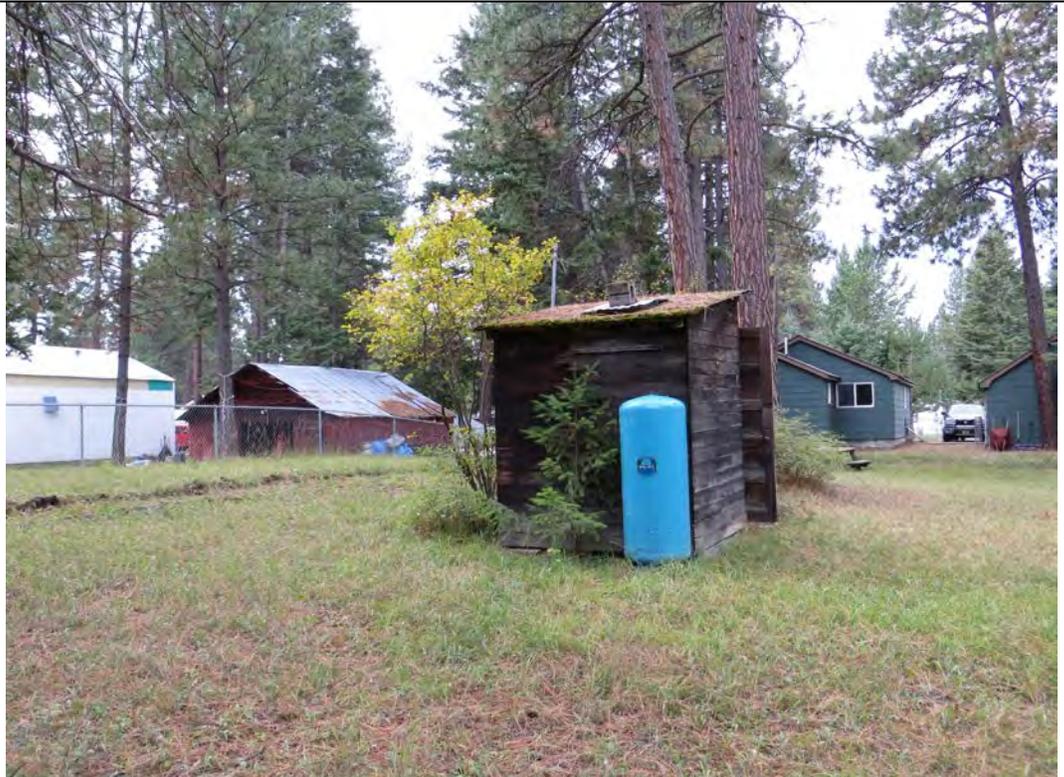
<b>Photo No.</b> <b>16</b>	<b>Date:</b> 9/27/2013
<b>Direction Photo Taken:</b>  SW

Showing location for groundwater sample: CF-GW-OP-02.

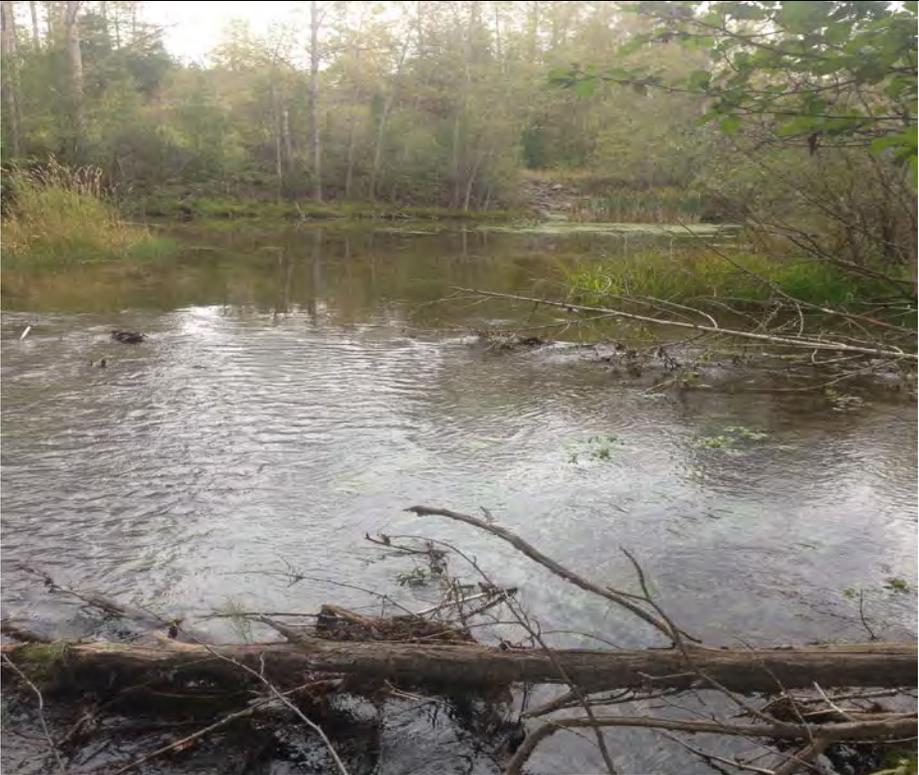
<b>Photo No.</b> <b>17</b>	<b>Date:</b> 9/27/2013

<b>Direction Photo Taken:</b>  W		
<b>Description:</b>  Showing location for surface water sample: CF-SW-01.

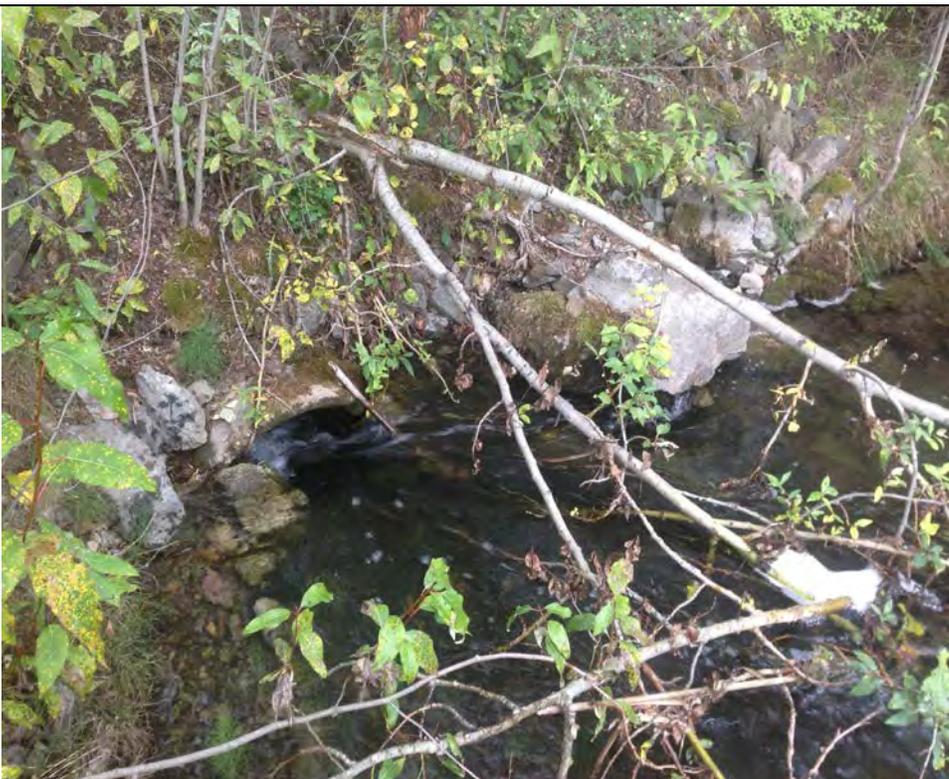
<b>Photo No.</b> <b>18</b>	<b>Date:</b> 9/27/2013

<b>Direction Photo Taken:</b>  S		
<b>Description:</b>  Showing location for sediment sample: CF-SD-01.

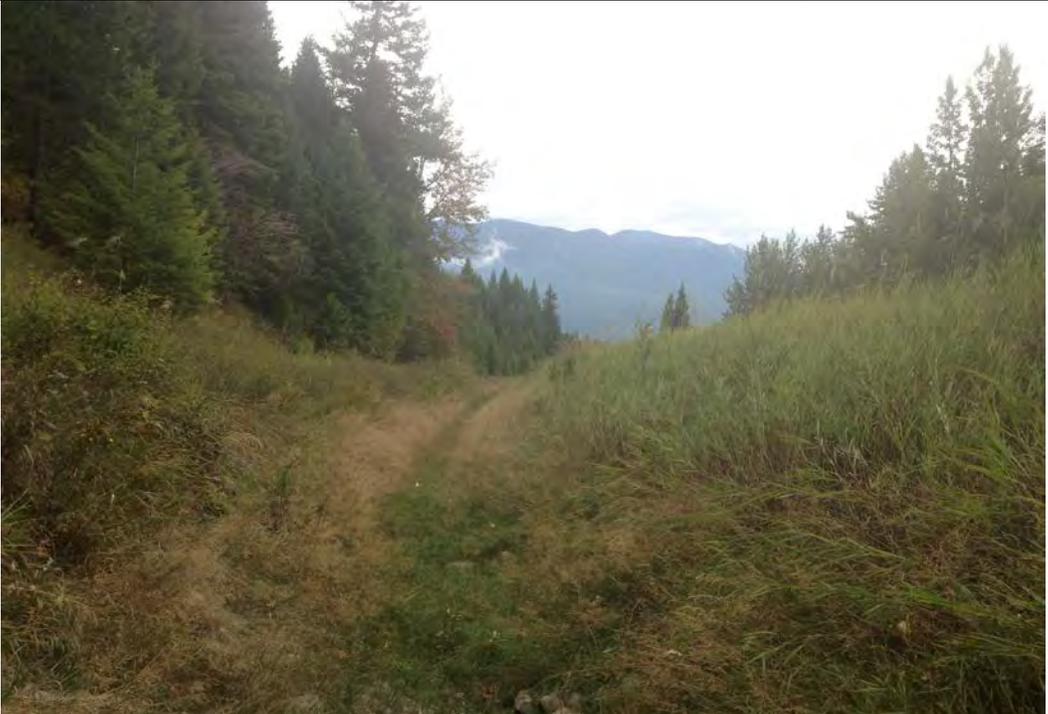
<b>Direction Photo Taken:</b>  SE			
<b>Description:</b>  Showing location for sediment sample: CF-SD-02.

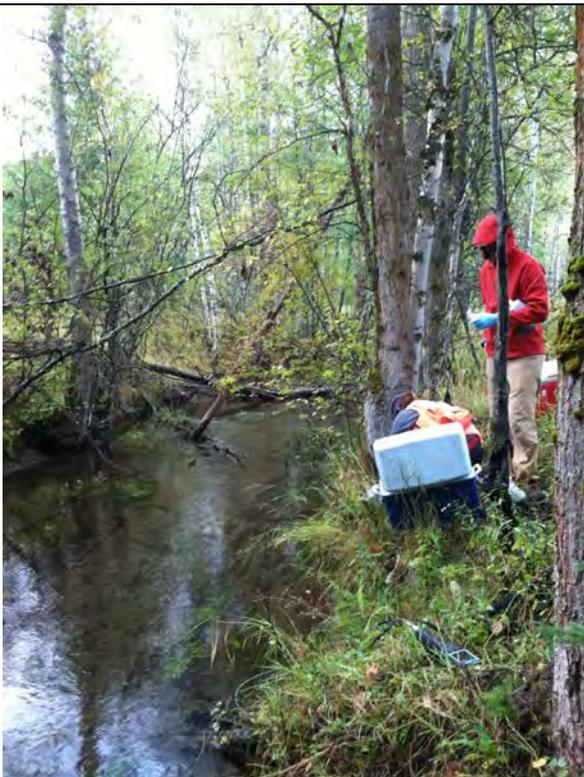
<b>Photo No.</b> <b>20</b>	<b>Date:</b> 9/30/2013

<b>Direction Photo Taken:</b>  W		
<b>Description:</b>  Showing location for surface water sample: CF-SW-03.

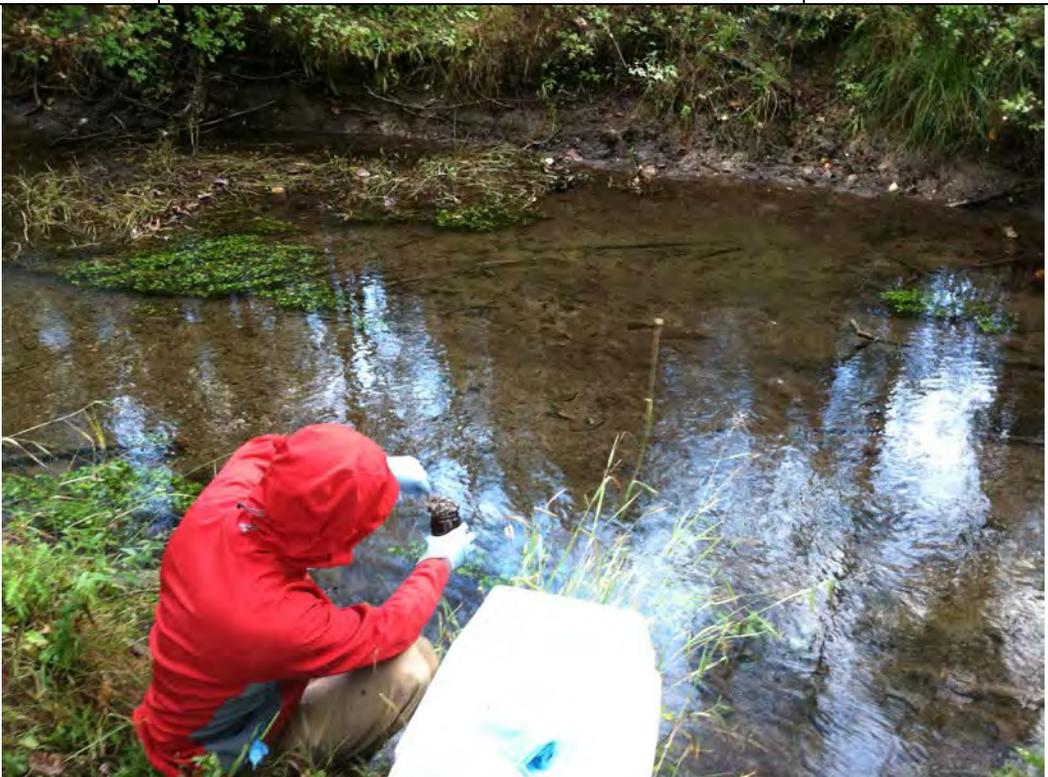
<b>Photo No.</b> <b>21</b>	<b>Date:</b> 9/30/2013
<b>Direction Photo Taken:</b>  N

Showing location for sediment sample: CF-SD-03.

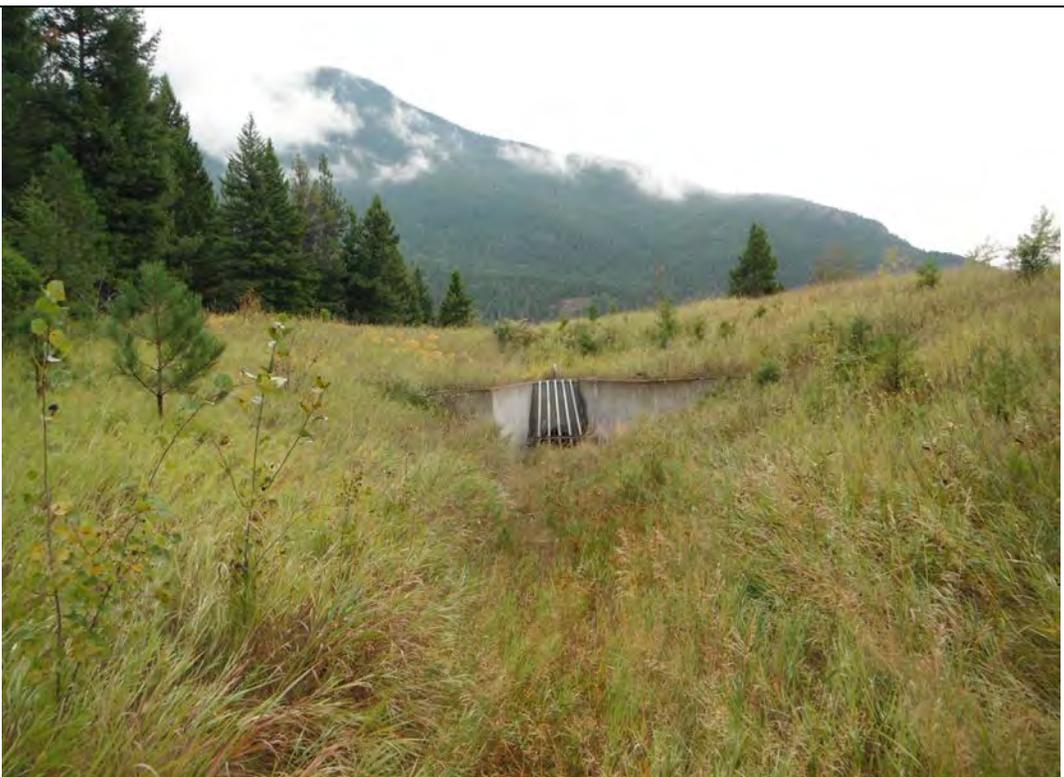
<b>Photo No.</b> <b>22</b>	<b>Date:</b> 9/24/2013
<b>Direction Photo Taken:</b>  S

Showing location for sediment sample: CF-SD-04. Culvert where Cedar Creek Reservoir Overflow drainage begins subsurface flow in background.

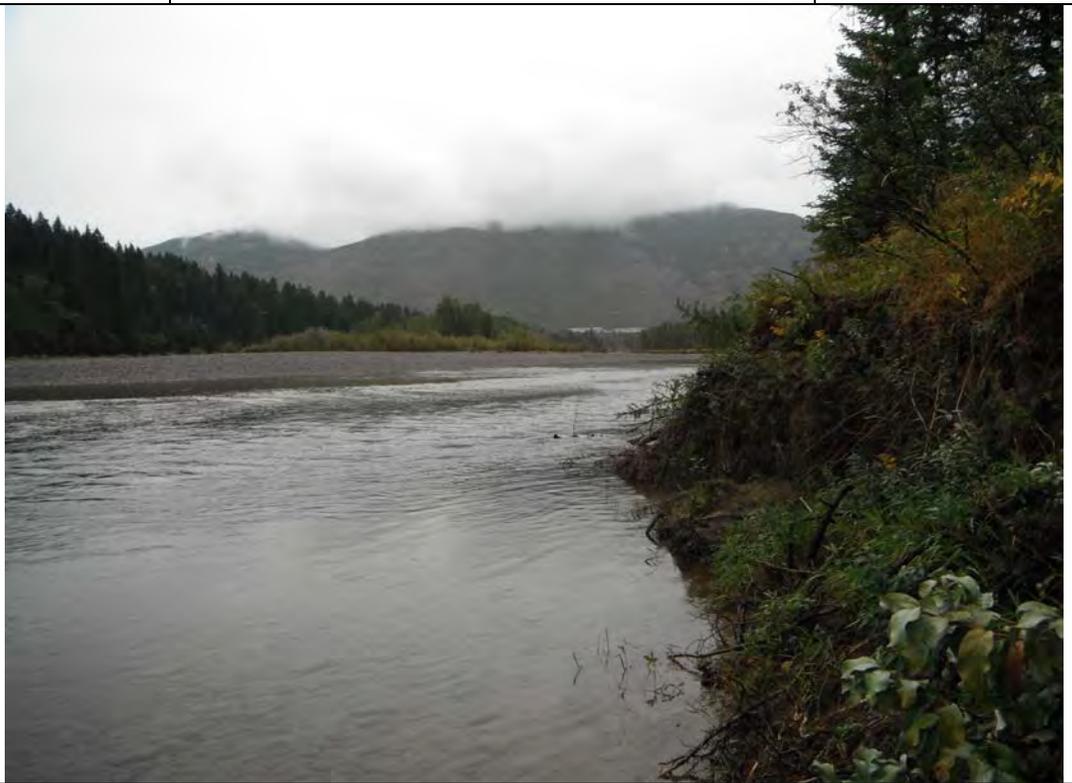
<b>Photo No.</b> <b>23</b>	<b>Date:</b> 9/25/2013
<b>Direction Photo Taken:</b>  N

**Description:**  
Showing location for co-located sediment/surface water samples:  
CF-SD-05 / CF-SW-05.

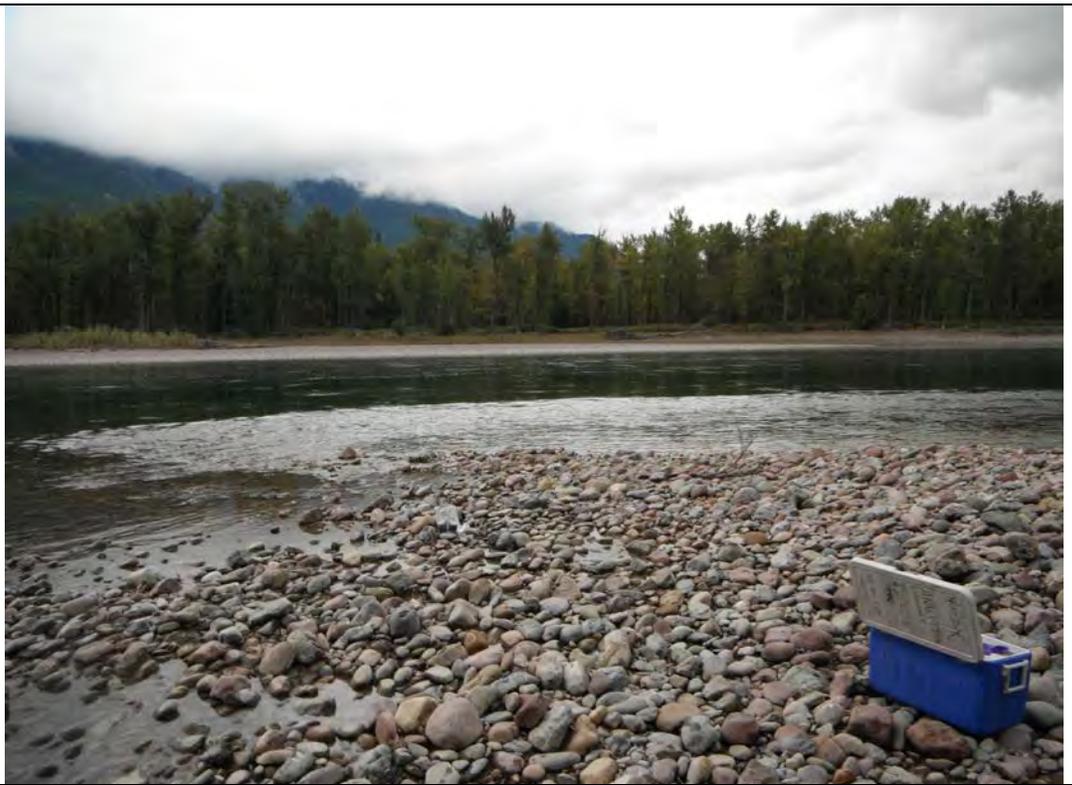
<b>Photo No.</b> <b>24</b>	<b>Date:</b> 9/25/2013
<b>Direction Photo Taken:</b>  SE

**Description:**  
Showing location for co-located sediment/surface water samples:  
CF-SD-06 / CF-SW-06.

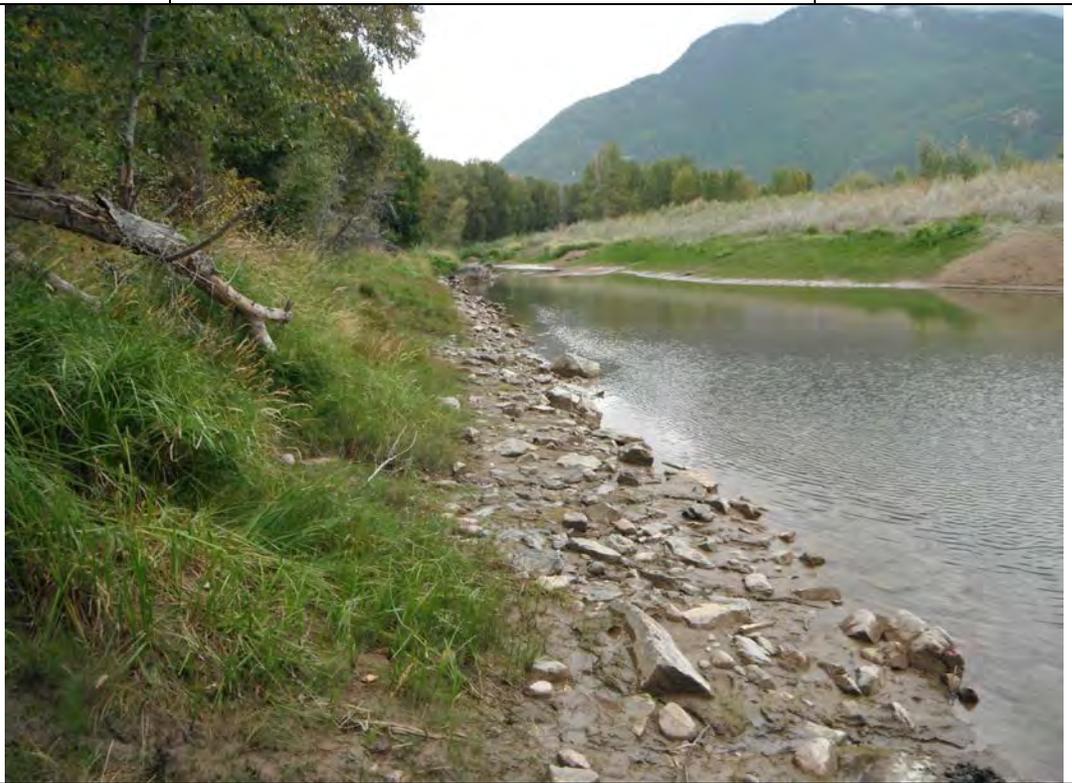
<b>Photo No.</b> <b>25</b>	<b>Date:</b> 9/25/2013
-------------------------------	---------------------------

**Description:**  
Showing location for co-located sediment/surface water samples:  
CF-SD-07 / CF-SW-07.

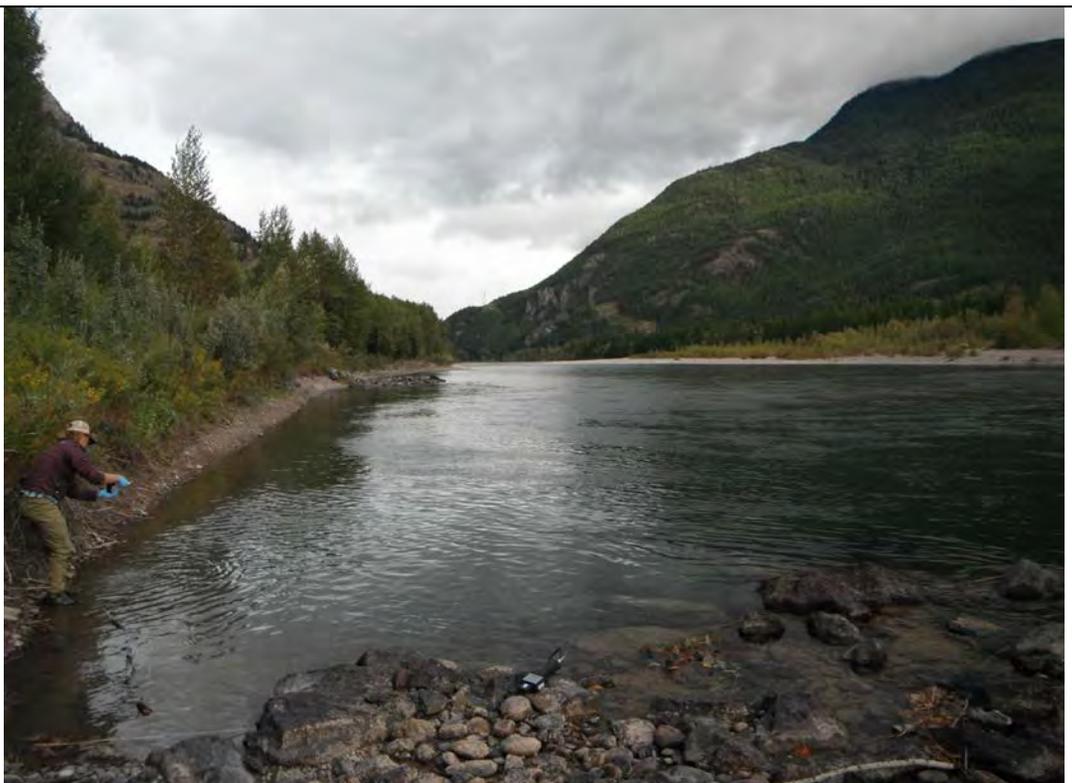
<b>Photo No.</b> <b>26</b>	<b>Date:</b> 9/25/2013
-------------------------------	---------------------------

**Description:**  
Showing location for co-located sediment/surface water samples:  
CF-SD-08 / CF-SW-08.

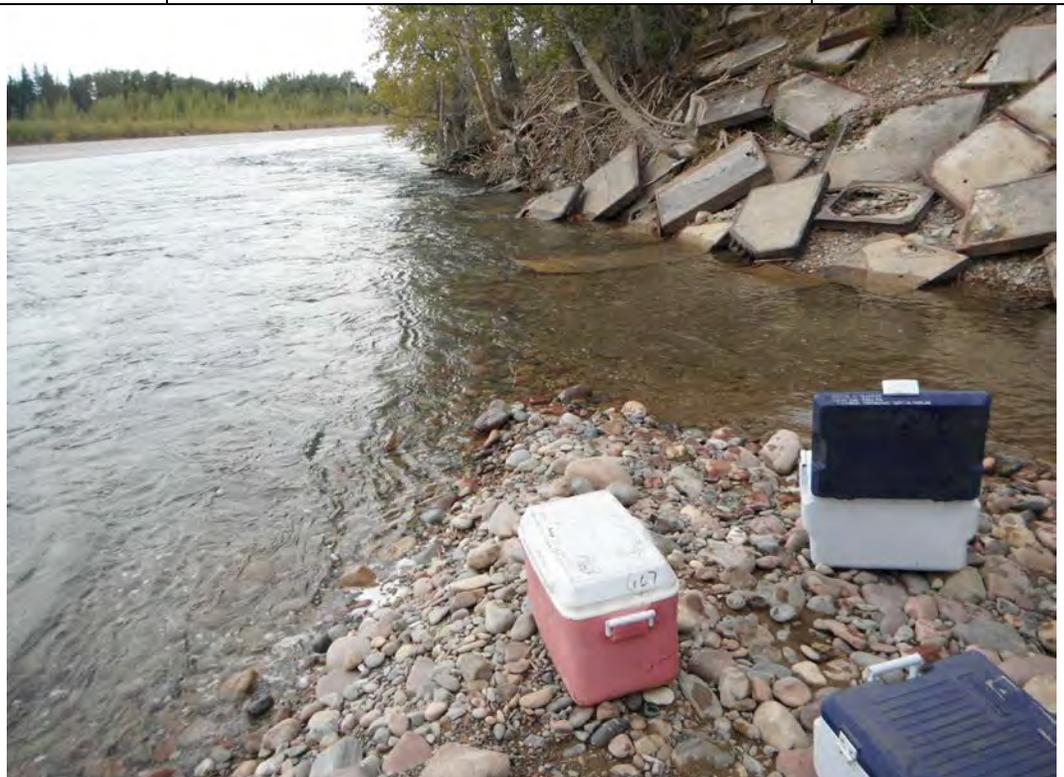
<b>Photo No.</b> <b>27</b>	<b>Date:</b> 9/26/2013
<b>Direction Photo Taken:</b>  W

**Description:**  
Showing location for co-located sediment/surface water samples: CF-SD-09 / CF-SW-09. Cement potliner plant flooring on riverbank in background.
